LIEBE offline tests report:

Tests and actions performed without LBE, 30/08/2018:

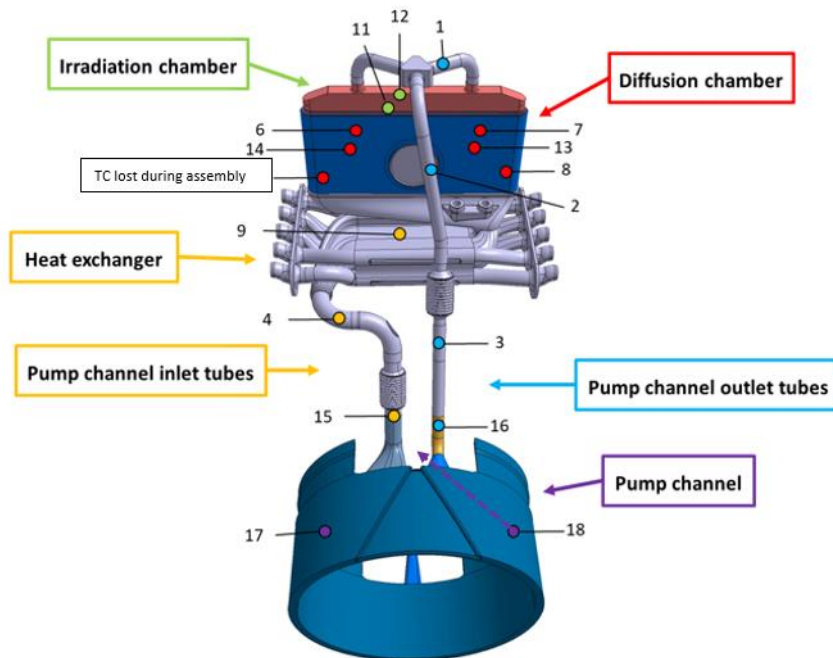
Figure 1: Schematic of the LIEBE loop with the 18 positions of the heating element + thermocouple pairs

All the pairs were in good place except TC18 that was found to be close to the positions 15 and 16. The heating element was still heating the zone 18.

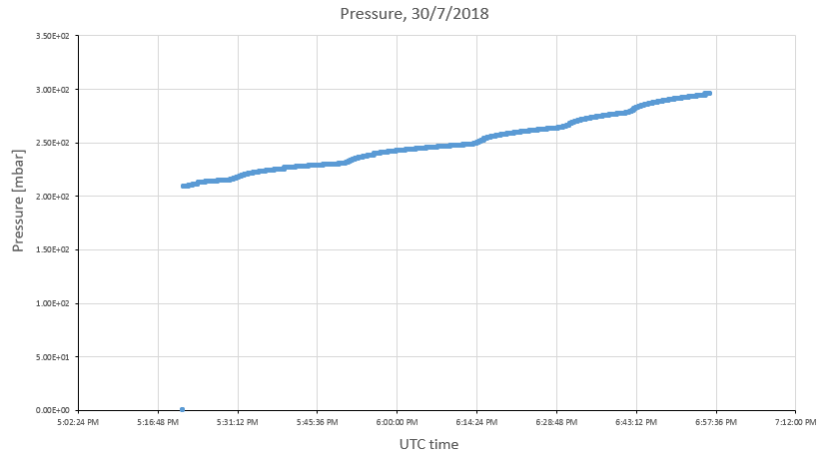
Figure 2: Pressure in 2nd envelope during outgassing of the loop.

The pressure sensor stopped working after 4 days of tests.

Considering that the previous sensor bought for LIEBE was never operational, probably the model chosen is just unreliable. However, the constant power cuts during the tests and the temperatures reached at the connection with the sensor ($\approx 100^{\circ}\text{C}$), close to the maximum allowed by the manufacturer might have helped to reduce the lifetime of the device.

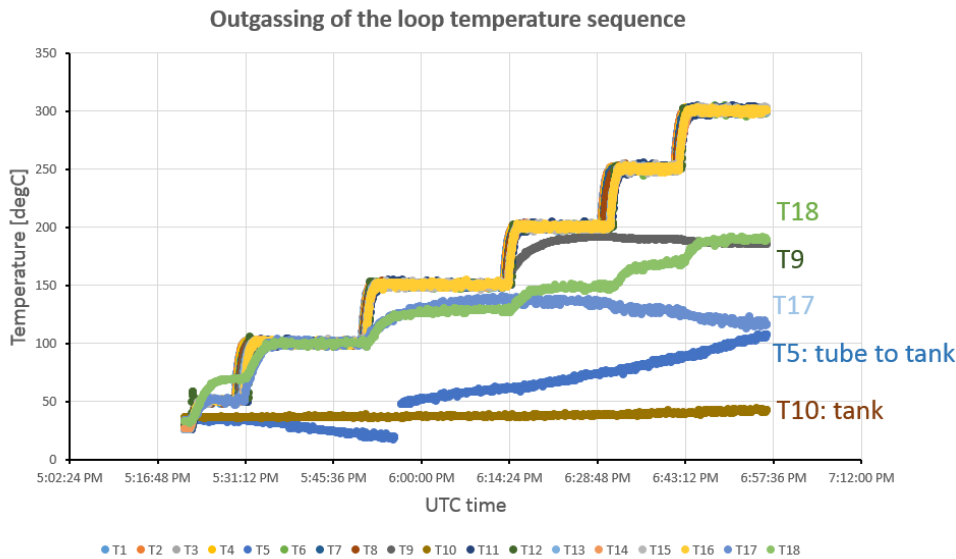
Figure 3: Temperature sequence during outgassing of the LIEBE loop, note that TC5 connection was inverted.

During the outgassing sequence, it was already seen that positions 9, 17 and 18 could not reach the lowest operational temperature, 200°C, by themselves. Moreover, the bottom of the pump channel was cold, close to room temperature, since there is no heating element in that position.

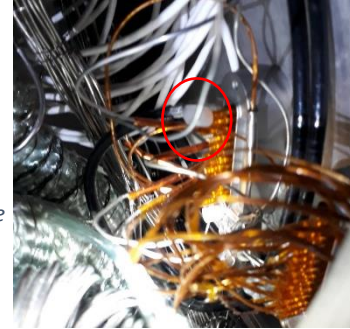
Later on during the tests, it was seen that some insulating material from the level sensor cable melted during operation. Unexpected readouts could come from here, figure.7.

Figure 7: Picture of the LIEBE inside connections for TC and level sensors.

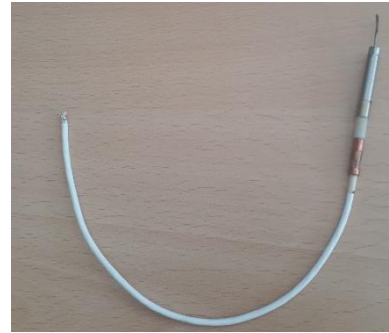
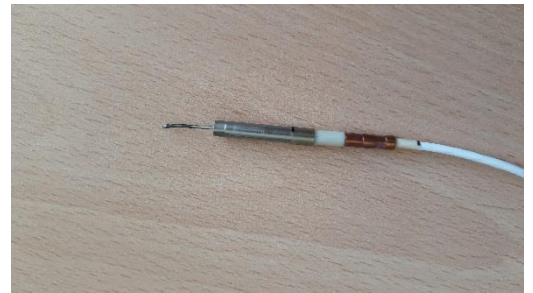
After the power cut at 12:24pm triggered by the pressure interlock, 3 heating elements stopped working, HE2, HE4, and HE12. HE4 was found completely broken, figure.14. In addition, the broken HE4 caused a short-circuit damaging the relay for control. The consequence was that control of the HE was lost and 21 Amps were sent constantly to the target through the broken cable. This unforeseen effect misled the cause of the problem until replacement of the relays, which showed no positive effect. The damage seems to come from a mechanical defect first that led to a higher resistance of the wire which finally melted. It must be highlighted that the miss functioning of the controls was seen offline due to the proximity of the power supply. It would not have been seen online. The damage on HE2 and HE12 is still not assessed.

Figure 14: Heating element 4 broken.

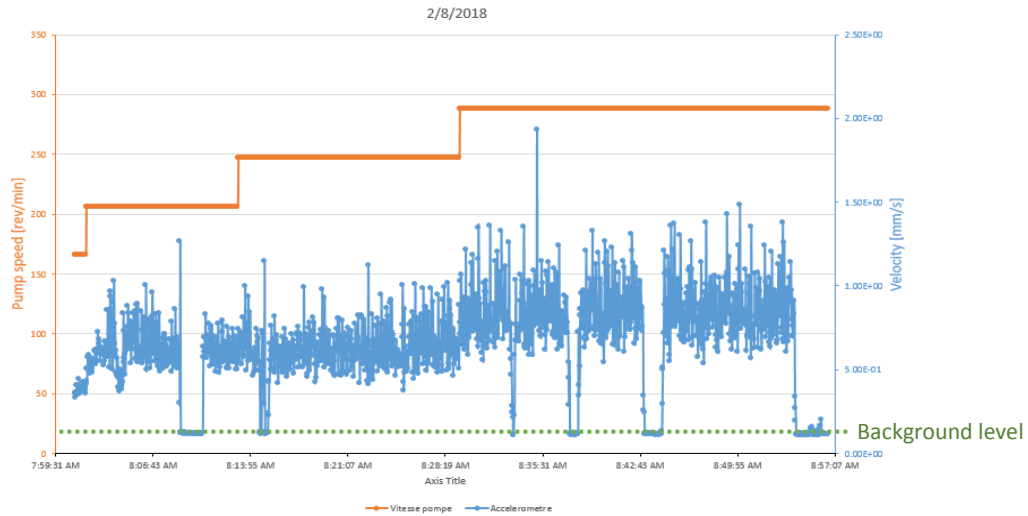
Figure 16: Vibration and pump speed from 9:00am to 10:00am

At the start of the EM pump, higher vibration levels were detected indicating cavitation, figure.16, 206rev/min - 0.26mm/s under vacuum compared to 0.75mm/s on average with cavitation. Cavitation issues could be explained by having a partially filled channel. That would mean that LBE was in a solid state somewhere in the loop, probably at the heat exchanger, or that a plug was stopping the flow. It has to be noted again that, even after a night warming up the loop, the LBE in the channel is cold since little heating power is placed there, as seen previously during the outgassing tests. Consequently, cavitation in a first instance was expected.

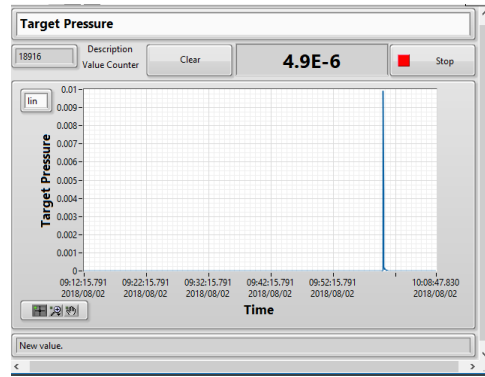
Figure 18: Pressure leak.

The vacuum interlock triggered at 10:00am, figure.18. A very sharp and narrow peak, which agrees with the hypothesis of still having some argon bubbles trapped in the loop. It also coincides with the heating up of the tube to the tank trying to release zone 4. Melting of LBE on the linking tube entrance could liberate remaining argon.

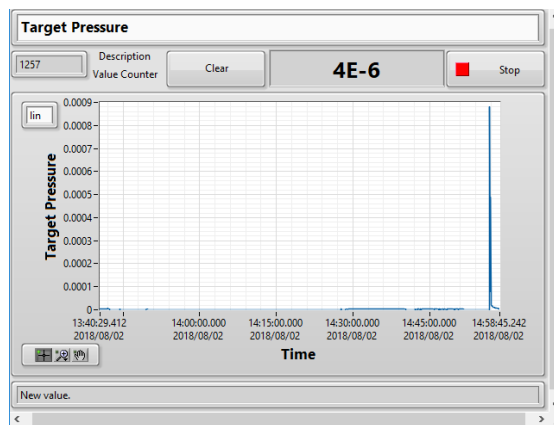
Figure 28: Another pressure leak, this event occurred 4 times in the same day of tests.

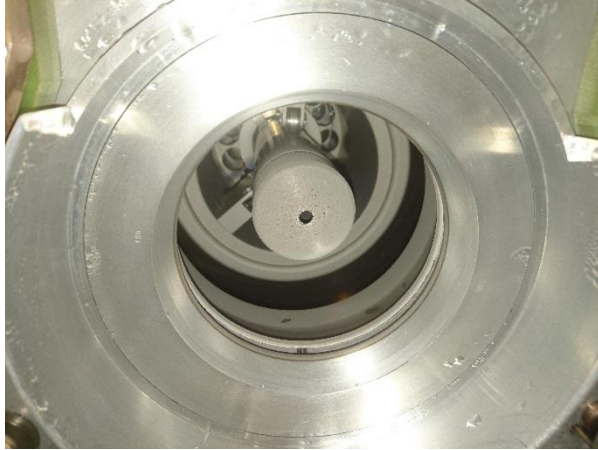
Uncoupling of the LIEBE target from offline separator showed that macroscopic amounts of LBE escaped the loop entering the ion source and front-end. The extraction electrode and the insulator ceramic were completely coated with LBE.

Figure.32: Extraction electrode coated with LBE

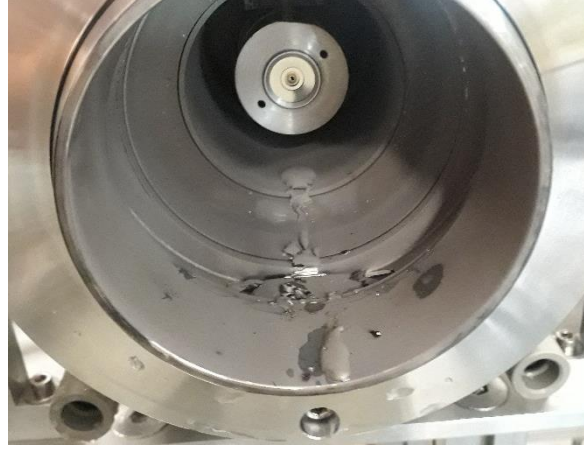
Figure.33: Macroscopic quantities of LBE underneath the ion source

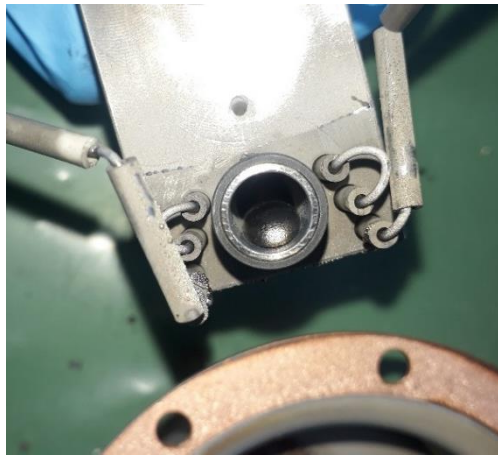
Figure.35: Picture of the transfer line filled with solid LBE

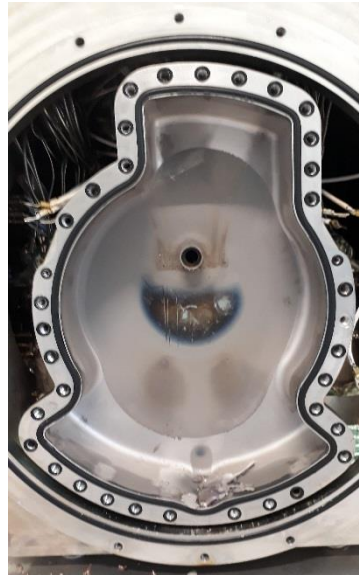
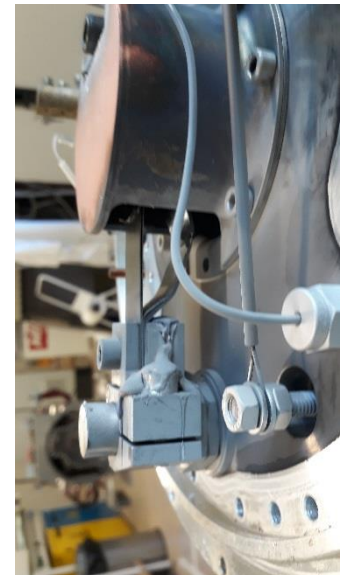
The LIEBE base was open to check the interior of the ion source and the transfer-line connecting the loop to the ion source, figure.34. The base was completely coated with LBE, showing condensation on the cold parts of the assembly and bigger quantities on the path of the liquid through the ion source. A partially filled transfer-line was found, figure.35, indicating that the liquid LBE reached that zone. It is clear from the post-analysis that LBE in liquid phase from the loop reached the transfer line level. Consequently, the ion source vacuum chamber was filled with LBE that was being evaporated while the ion source was hot. That can explain the short-circuited anode and the high levels of Lead contamination seen in the faraday cup.

Figure.34: Pictures of ion source vacuum vessel and the line connection underneath the source
