**ALARA level II – Group 1 - ISOLDE YETS 2017-2018 and operation 2018**

**Justification, optimisation and REX**

EDMS 1570850

24/08/2018

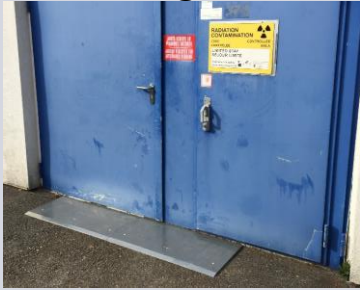
REX	RESULTS / ACTION / PICTURE
<p>New fixed ramp installed to cross the entrance of building 179 with the forklift more easily (see REX from EDMS 1570850)</p>	<p><b>R</b> = Forklift with box did not get stack at the exit of the building</p>

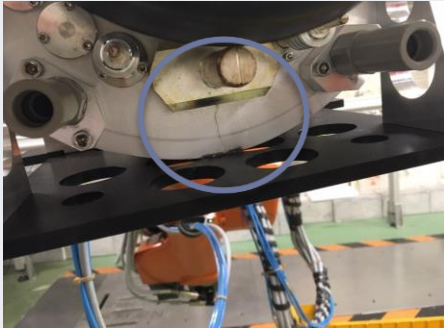
<p>Integrity of the targets checked before putting them inside the boxes in order to detect any problems (see REX from EDMS 1570850)</p>	<p><b>R</b> = It permits to detect traces of a leak on target #611 planned to be reused for 2018 operation. This target was moved manually to an ISR waste disposal box.</p>

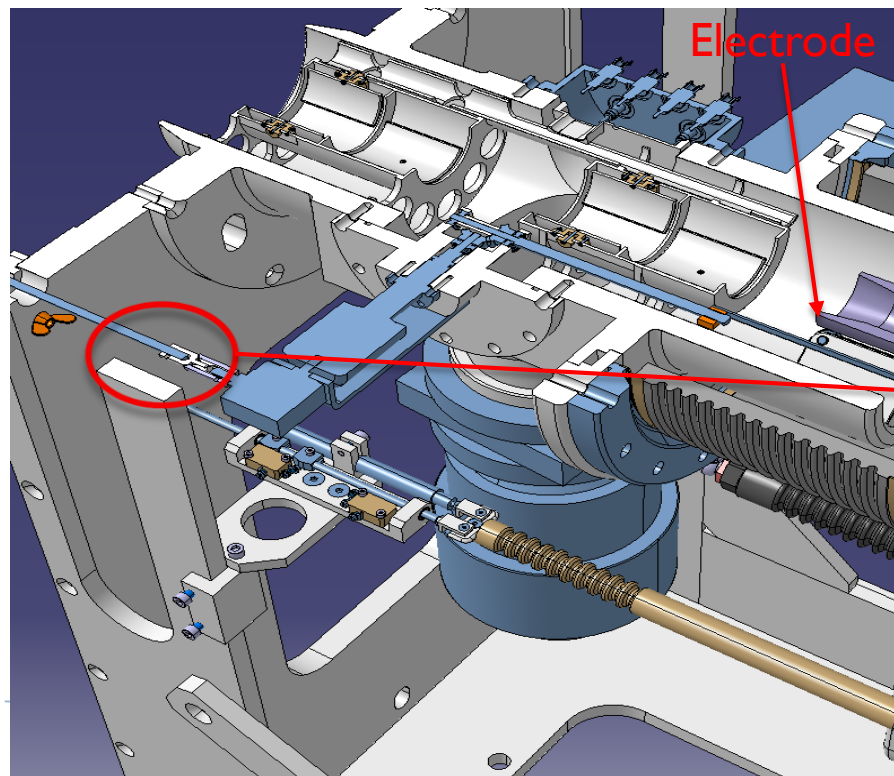
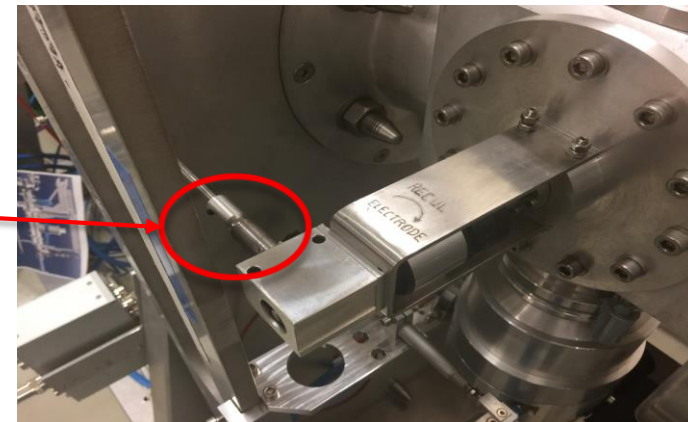
The next day, a second operator examined the FE, and found that the problem was linked to two screws untighten that had caused calibration problems (see following slide)

A= On next generation of FE installed during LS2, a system with cotters will replace these screws and remove this type of problem / Stefano Marzari – EN/STI

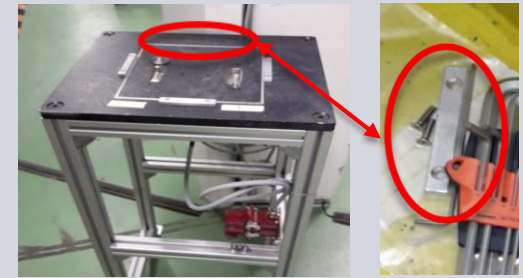
The base of the SEMGRID target is bigger than usual targets therefore a stop piece has been removed on the exchange point to install the SEMGRID target on it

**A** = precise in the next WDP that the stop piece should be removed / Julien Riegert – EN/STI

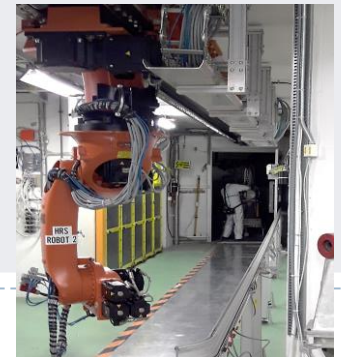
Due to the bad condition of the SEMGRID cable, to avoid moving the SEMGRID target with the cable with the robot, it was decided to plug it directly when the SEMGRID target is on the FE instead of doing it in the middle of the trenches

**R**= The dose received was higher than expected (+16% for collective dose and +27% for individual dose)

**A**= Replace the SEMGRID cable during the LS2 / Richard Catherall – EN/STI

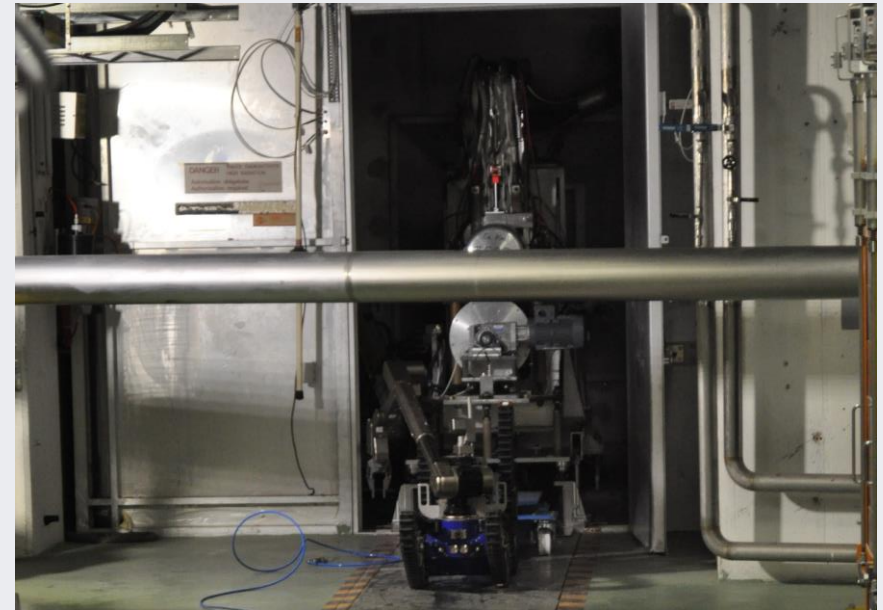
The metal cylinders that help to connect the hypertacks make it difficult to decouple by means of the Telemax

A= -shortening of the cylinders → New tests are foreseen in September 2018 outside the controlled area / Ferran Boix Pamies – EN/STI

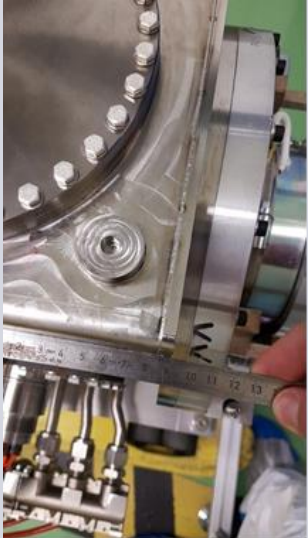
REX : TARGET TESTS	RESULTS / ACTION / PICTURE	
<p>The handle was not correctly positioned for direct gripping to the robot: the handle was moved to allow the target to be correctly positioned on the Front End</p>	<p><b>A=</b> the position of the handle must be marked on the target in order to be able to reposition it correctly in case of removal - 9 cm from the rear face</p>

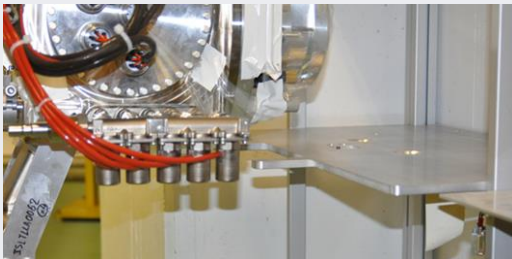
<p>The target could not be positioned on the shelves: because of the solenoid valves</p>	<p><b>A=</b> provide and fix wedges on the shelves to be able to position the LIEBE target / Fix also the position of the solenoid valves as there is a risk of collision with the front end ground braids if the solenoid valves change positions. This has been simulated with the 3D model software CATIA</p>

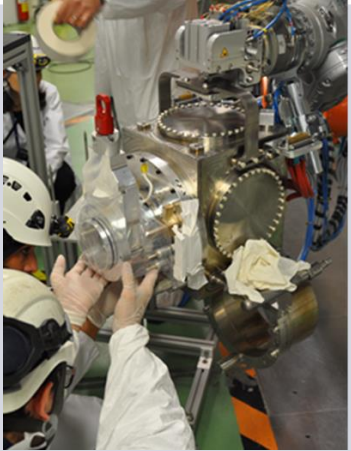
REX : TARGET TESTS	RESULTS / ACTION / PICTURE	
<p>Coupling test of the target on the Front End: the cone, the underside of the target, the guides are protected with plastic and tarlatane to avoid contaminating the target</p>	<p>A=clean with alcohol the guides after removal of the tape to remove glue deposits</p>

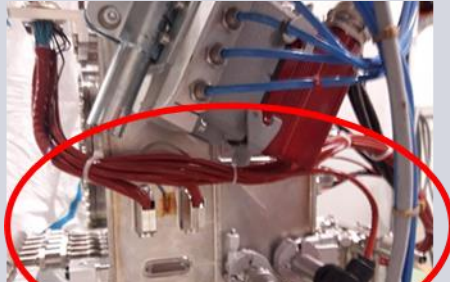
<p>Position the hypertac behind the grounding braids of the Front-End as there is a risk of catching them when the target is removed</p>	<p>A= to add in the new version of the WDP / Julien Riegert – EN/STI</p>	
<p>Push the LIEBE cables closer to the target</p>	<p>A= - to add in the new version of the WDP / Julien Riegert – EN/STI - Use of radiation resistant collars to hang cables (no plastic collar)</p>

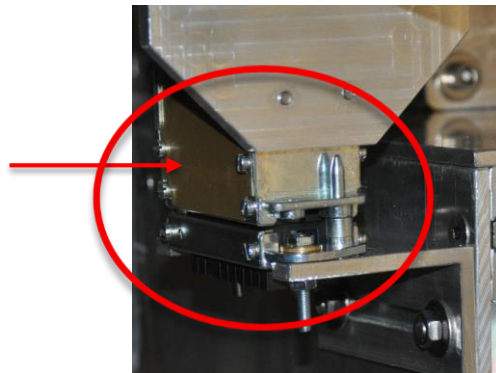
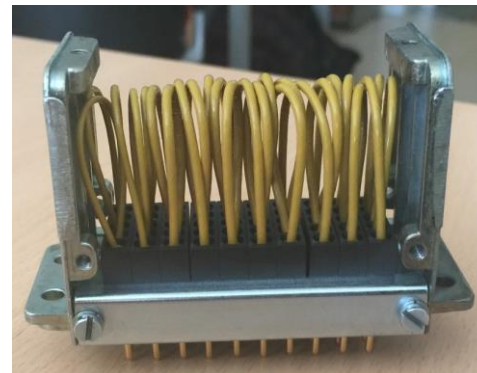
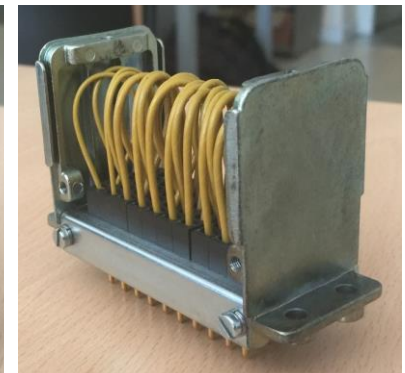
**A=** - There were remounted without their cover : theses hypertacs will be used once, by consequence it is not important if there will be damaged (without their cover) during their removal after LIEBE intervention at the end of the year.

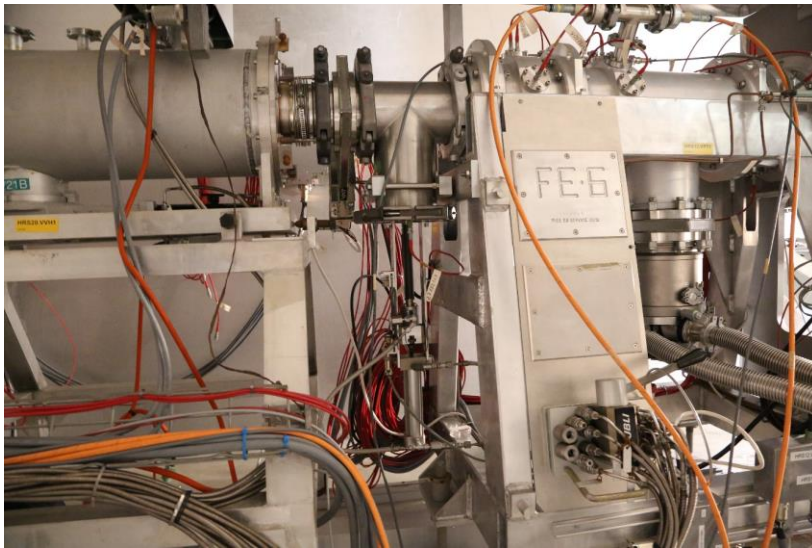
HRS Front-End  
*(picture taken during inspection)*

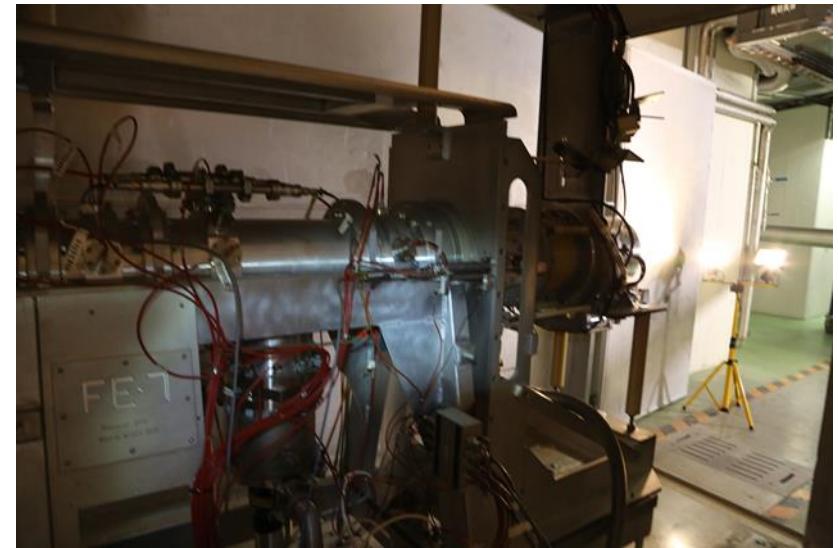
GPS Front-End  
*(picture taken during inspection)*

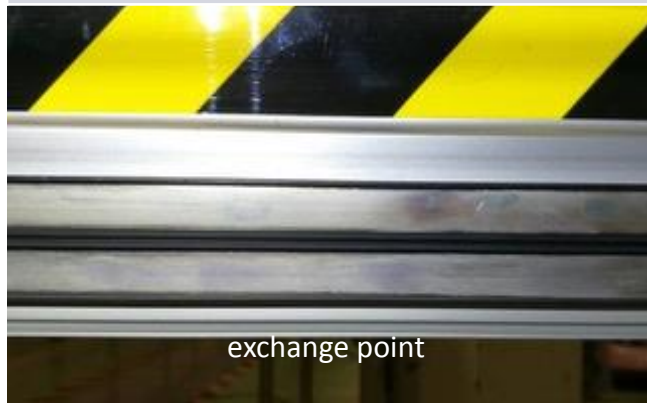
exchange point

REX	RESULTS / ACTION / PICTURE
<p>During MONTRAC test, some problems appeared to reach the Irradiation Point with all the available shuttles. After inspection, the deterioration of the power rail (dust presence), as long as the presence of dust this fault caused a poor electrical contact between the shuttle wheels and the power rail.</p>	<p><b>R / A =</b> After analysis, it was decided to clean the power rails without changing any spare parts because of their unavailability : This intervention was performed in another impact (see details part 14.) The identification of this default during MONTRAC maintenance has avoided failure during MEDICIS operation.</p>

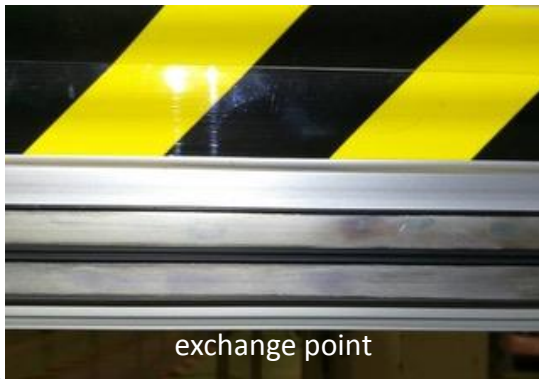
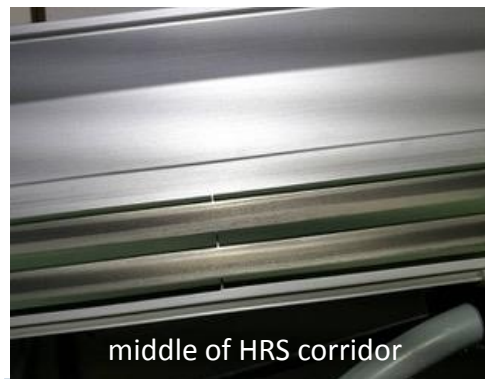
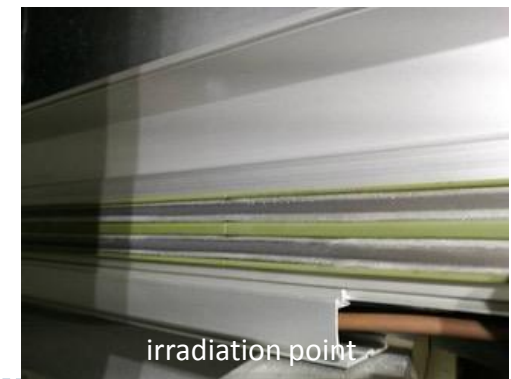
During MONTRAC test (see part.11), some problems appeared to reach the Irradiation Point. All the available shuttles were used with similar results → After inspection, this fault was due to the poor electrical contact between the shuttle wheels and the power rail. The main problem is the deterioration of the power rail, with the presence of dust, which visibly increase while approaching the HRS Front End

- Inspection, cleaning of the rails and functioning tests
- Option 1 : change the conductor bands without the isolators on the rail activated
- Option 2 : change the conductor bands with the isolators on the rail activated
- Option 3 : Clean the shuttles wheels

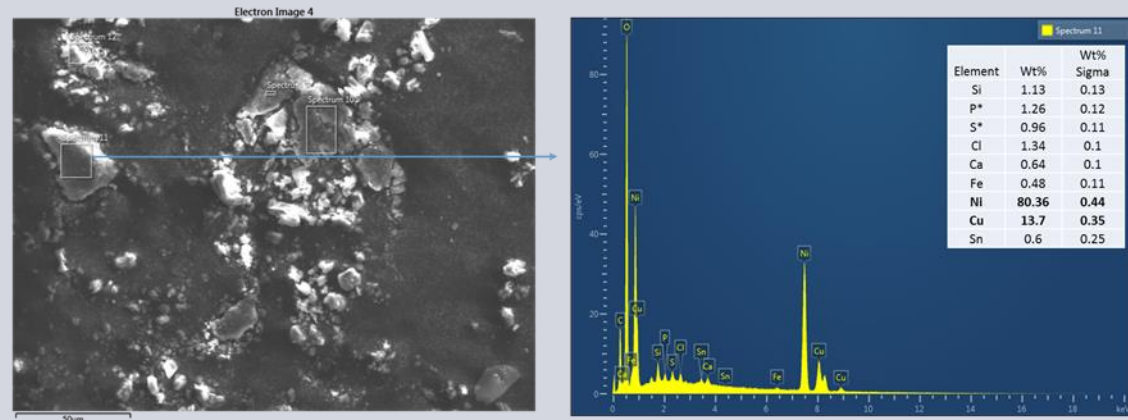
**R=** The results shows an important amount of Oxides (O).

**A=** During the LS2, 3 options are possible to fix this problem / Regis Seidenbinder – EN/STI:

- OPTION 1: Change the rails for new rails with an oxidation resistant material (permanent solution)
- OPTION 2: Cover the rails with a coating resistant to oxidation (permanent solution)
- OPTION 3: Clean the rails (temporary solution to repeat)

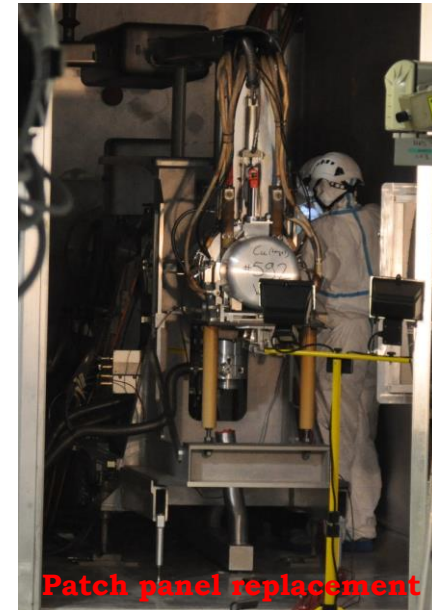
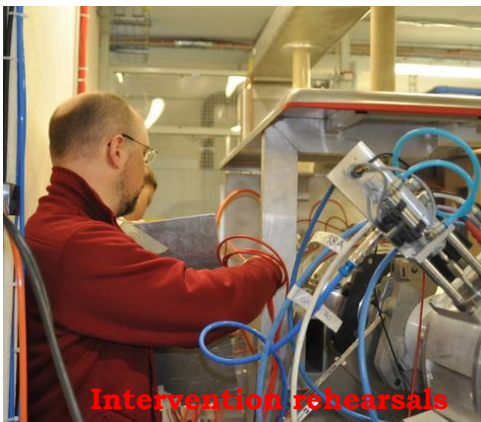
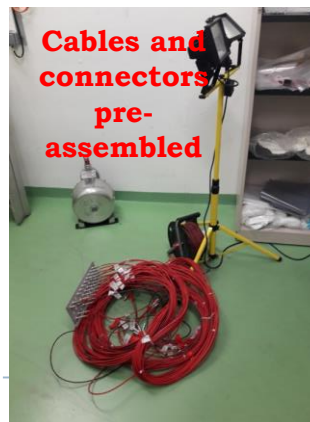
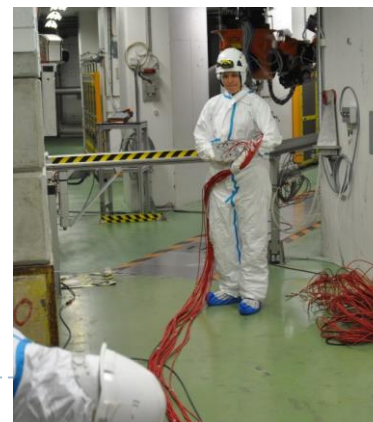
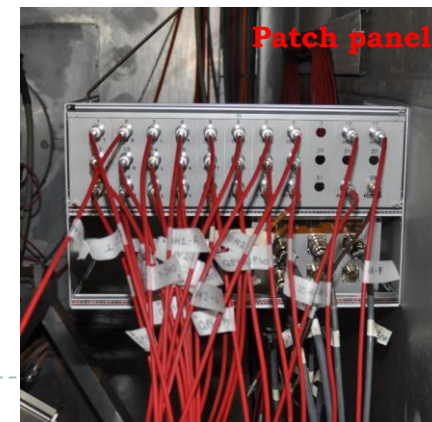
During the removal of the old cables connected to the FE and linked to the old patch panel, there were another cables entangled with them. It was necessary to disconnect them, untangle them with the old patch panel cable and reconnect them on the FE

The threshold of the DMC (dose received) was configured too low and the alarm activated prematurely. To communicate more easily in the Faraday cage (patch panel replacement step) it was necessary to go out to deactivate and reactivate the DMC
