Fermilab Coil Fabrication Status and Non-Conformity Report

9th HL-LHC Collaboration Meeting at Fermilab – 14-16 October 2019

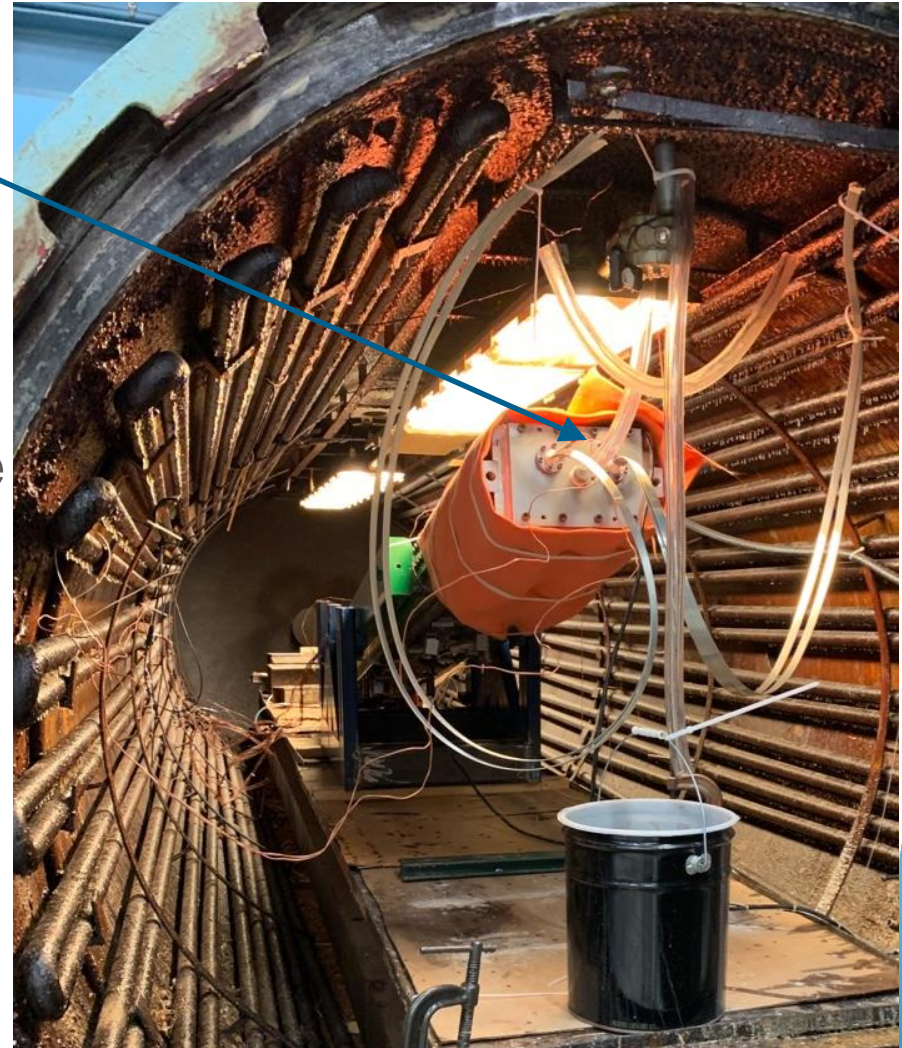
- Coil A114 had epoxy visible sooner than typical
- Coil 114 had 30% less epoxy in coil than typical when epoxy visible by weight
- At the end of filling, we decided to complete a pressure cycle as used for the CLAS12 project to see if the epoxy level in the tube would change.
 - Pumped chamber to 1 torr and saw no change in epoxy level in tube. Returned chamber to atmospheric pressure.
- No other indicators of strange behavior

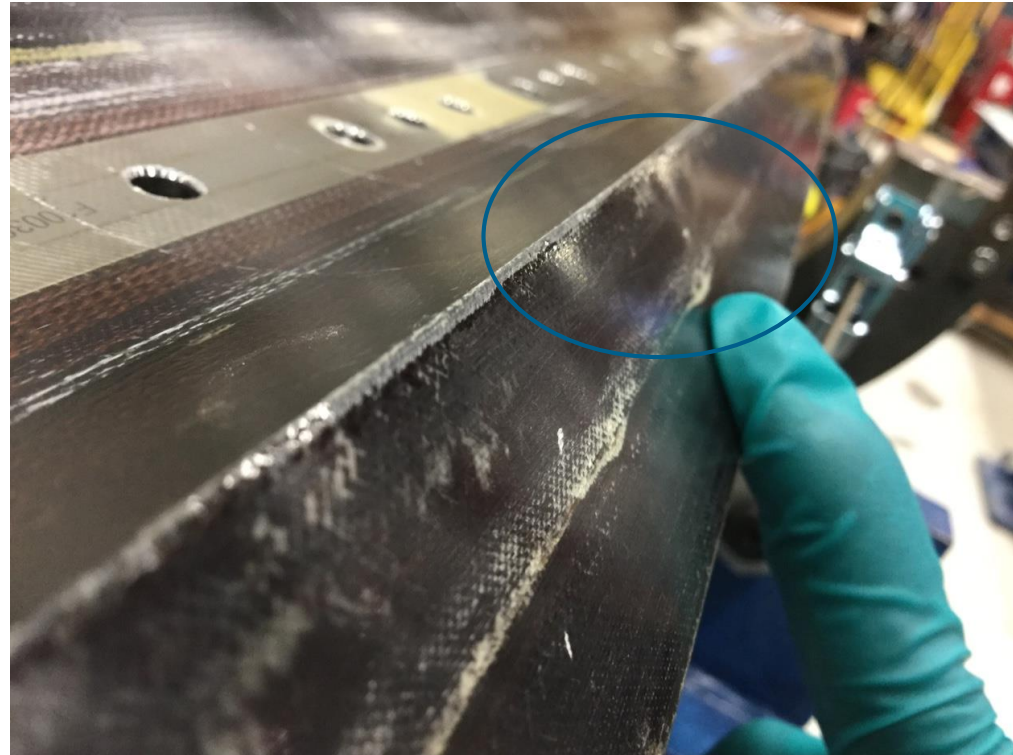
QXFA114 Visual Inspection

- Midplane G11 shim (125 μm) stuck to midplane shim SS tooling & delaminated from the coil in 2 places.

- Investigated coil midplane adhesion to tooling midplane
 - Performed test of several SS midplane/G11 mold released samples to investigate poor tooling release after impregnation.
 - Performed 10-stack mold release test.
 - ✓ Zyvax mold release and FNAL waxy mold release performed as expected.
 - Unable to identify cause of tooling adhesion after impregnation.
- All impregnation process steps & equipment have been checked and reviewed.
 - Traveler steps
 - Pumps, scales, T/C's
 - ✓ No abnormalities found.
- ✓ Coil CMM and Electrical Tests are normal.
- Coil epoxy defects on ID, severity unknown.
- G11 midplane insulator delamination appears to be minor.
- Final disposition of coil and DR #11754 is by G. Ambrosio.

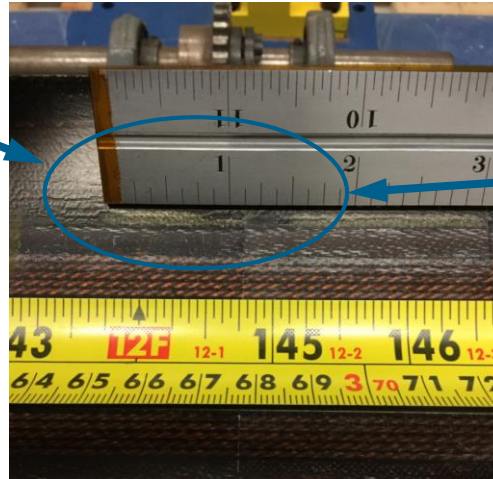
QXFA114 Visual Inspection

- Epoxy voids seen on ID of coil.

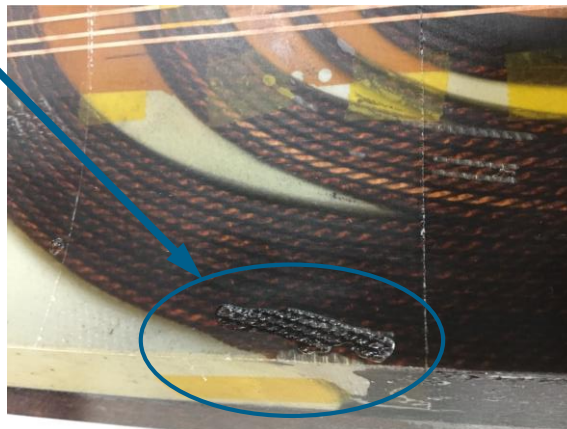
- One surface bubble on coil OD

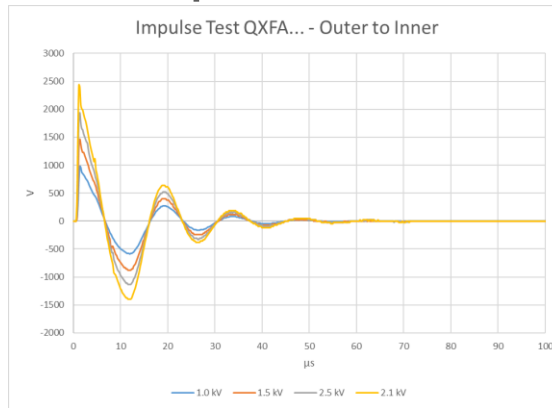
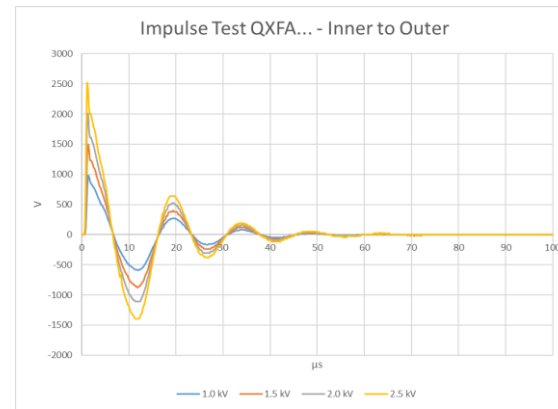
QXFA114 Electrical Tests & CMM Measurements

- All final electrical test performed and passed
 - VTB01 is open

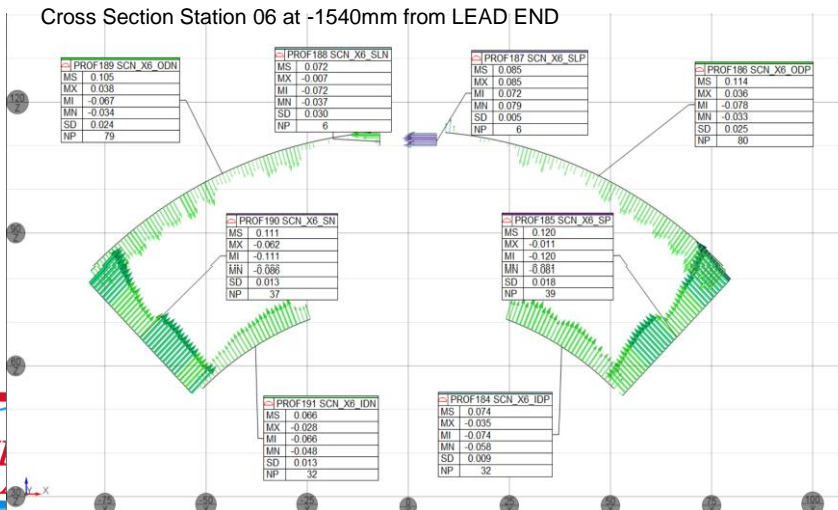
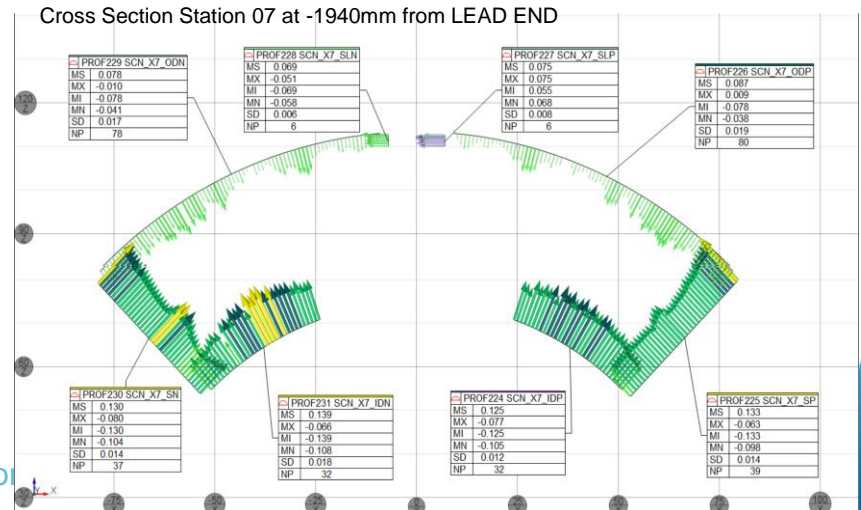
- CMM results are typical.

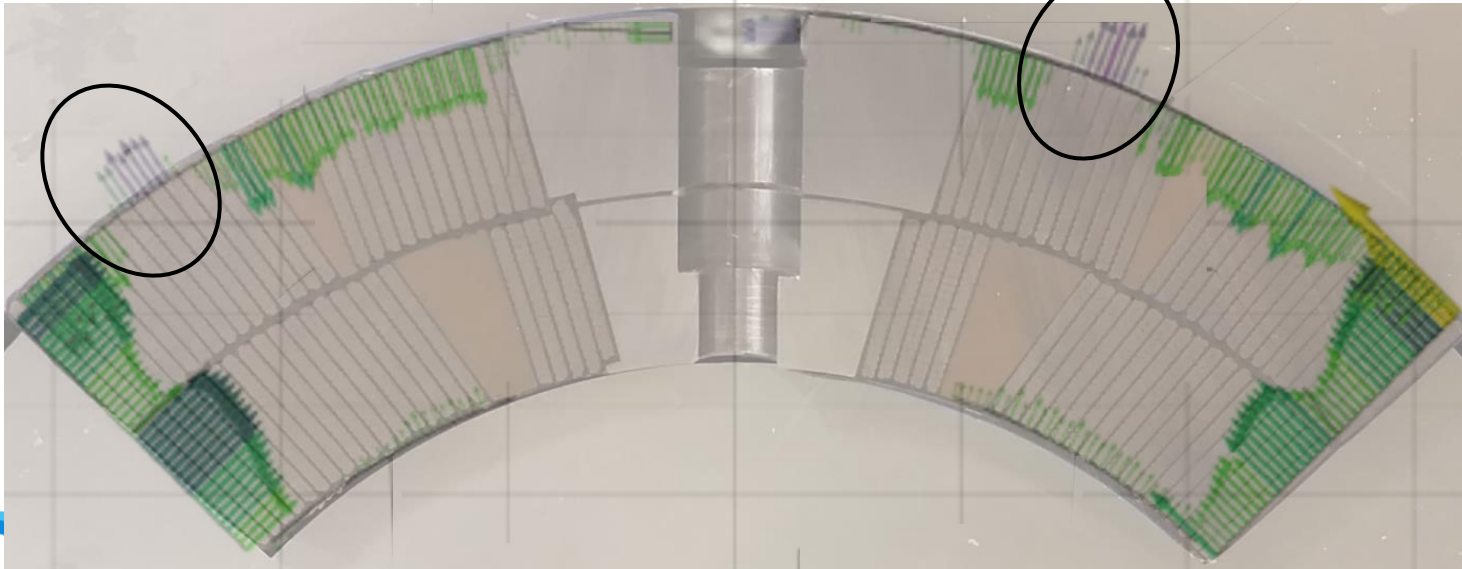
DR-11869, QXFA115 Ridge Anomaly, Accepted

- QXFA115 CMM measurements indicate a bump on the coil about 0.09 mm above the coil outer surface that runs longitudinally about 2 m long and is about 5 turns wide on the transition side of the coil.
- A similar but smaller bump is on the coil about 0.05 mm above the coil outer surface that runs longitudinally about 3 m long and is about 5 turns wide on the non-transition side of the coil
- CMM is used to measure 14 discrete cross sections of the coil.
- Pressure sensitive film (Fuji film) used to characterize surface.

- Bump source is S2 glass delamination
- CMM probe pressure is very light
- No signal from Fuji pressure film
- Coil accepted & shipped to LBNL.

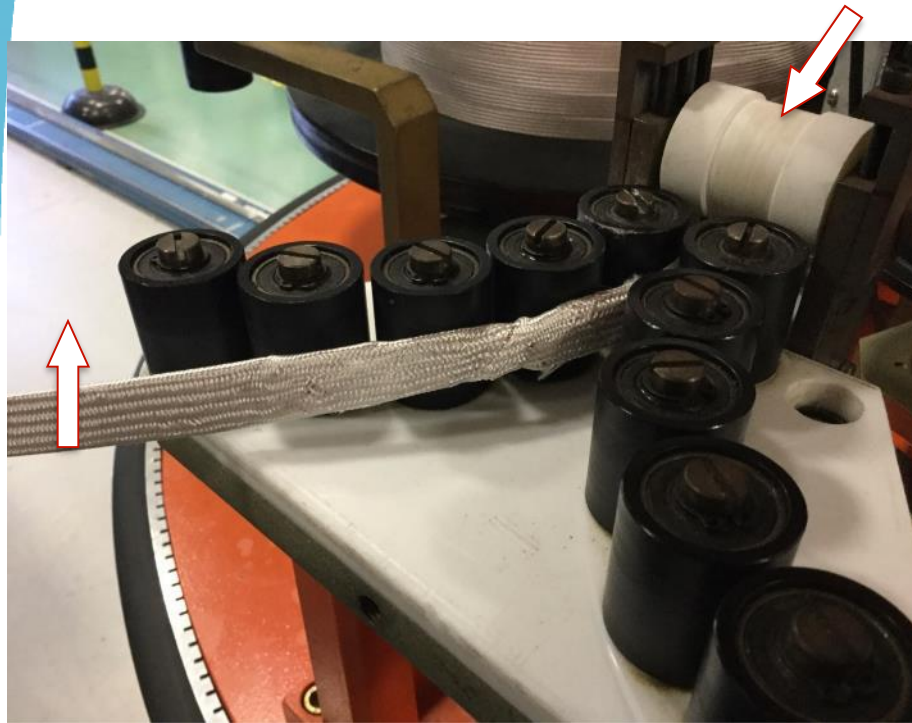
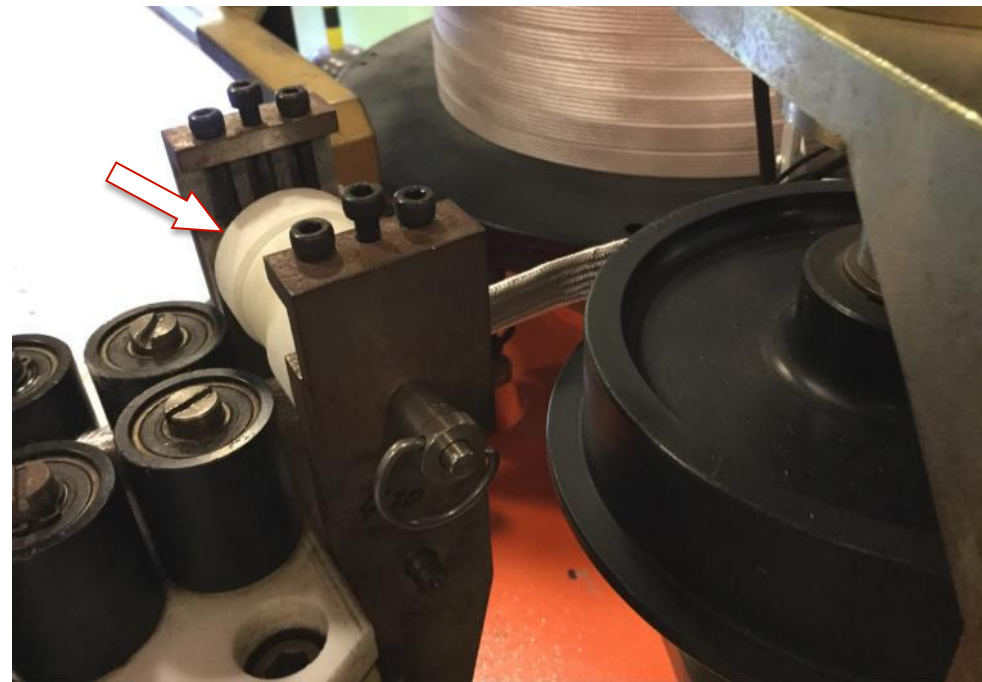
DR-11878, QXFA118 Roped Cable & Strand Damage, **Rejected**

- On August 15, 2019 outer layer cable roped
 - 15th turn on the transition side (2 turns after wedge)
 - Due to hard way bend against the white roller.

- Obtained final disposition of coil QXFA118
 - Reviewed by conductor & cable folks
 - Dispositioned by Giorgio Ambrosio
- Back wound coil to retrieve all parts: wedges, pole pieces, end parts
- Adjusted boom to nominal position
- **Designed & procured taller rollers**, due end of Oct.
 - Mitigate strand damage
- **Boom position checked prior to each coil winding.**
- Coil QXFA119, inner layer completed on Selva.

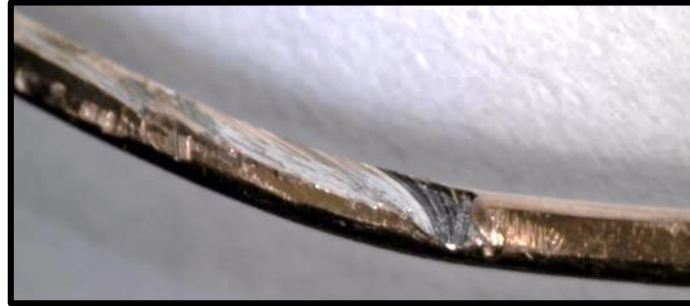
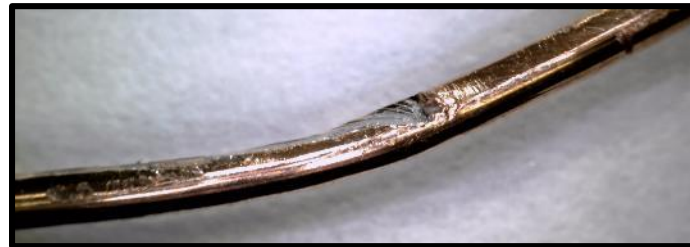
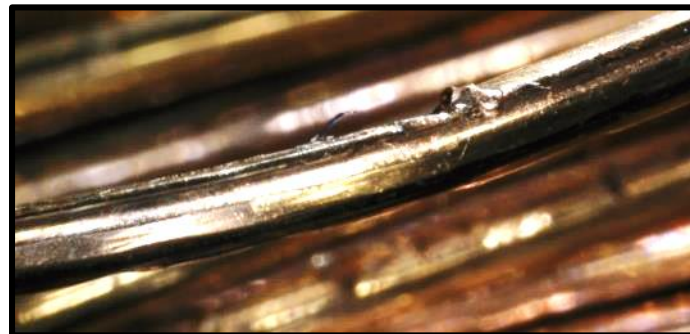
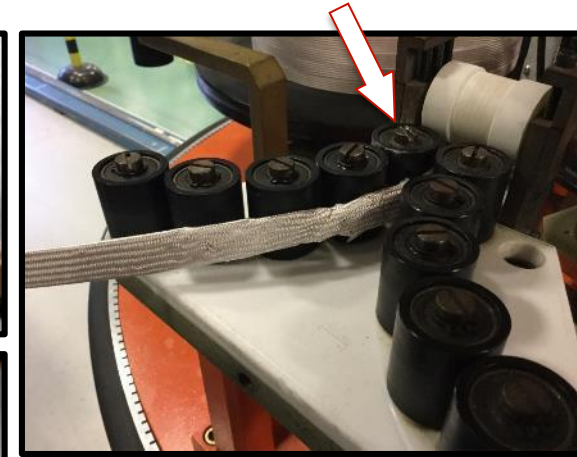
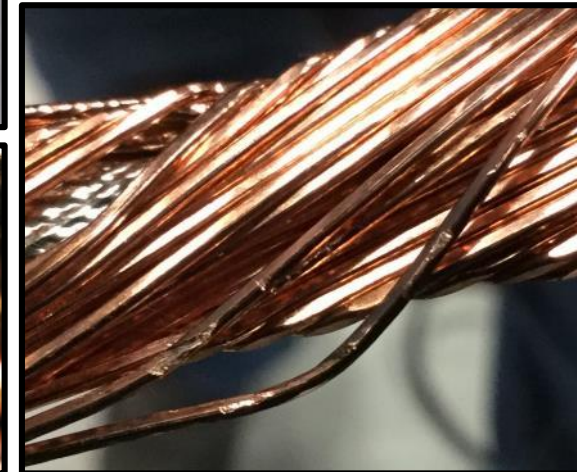
QXFA118 Strand Damage

- Strand damage likely caused by the strand dragging against top edge of vertical guide roller(s) after the cable collapsed.

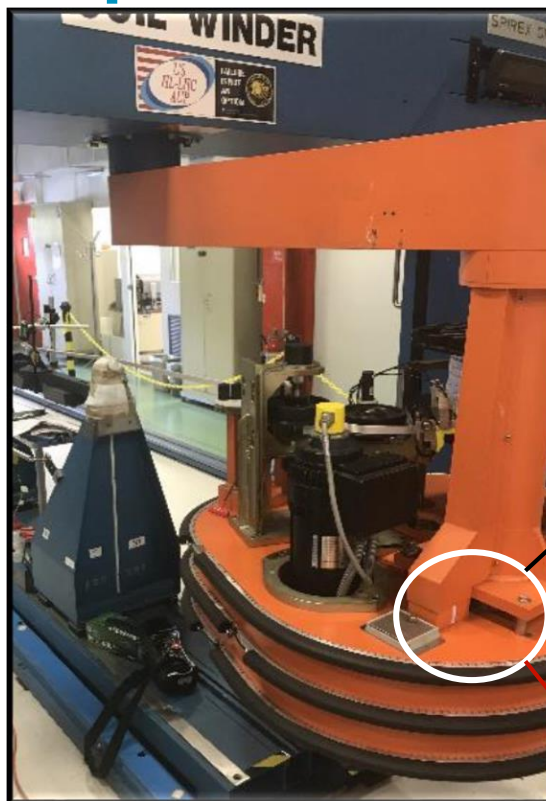
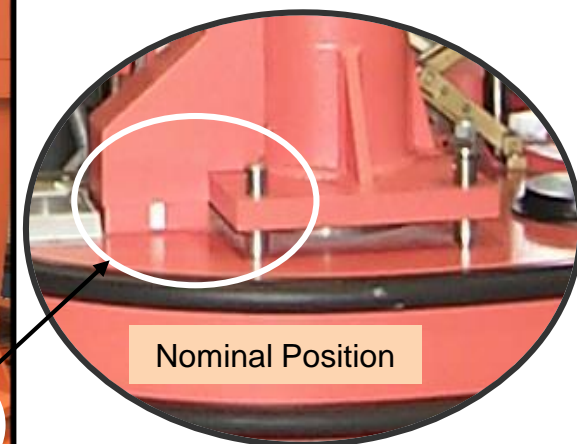
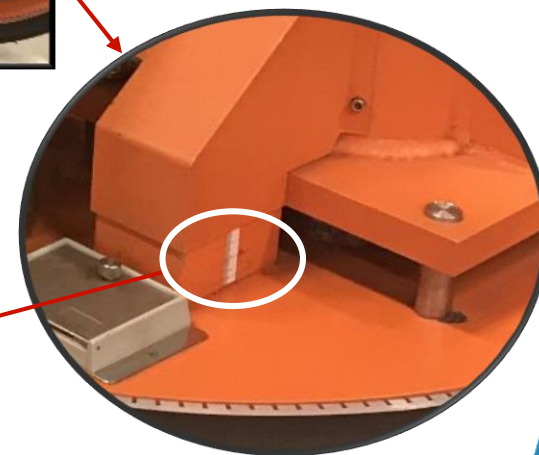
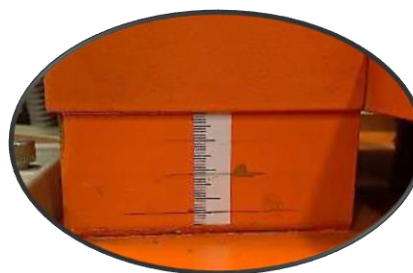
QXFA118 Roped Cable Cause

- The boom height has a 4 cm range set at 2.5 cm from the bottom and used for both inner and outer coil winding.
- Winding the inner layer had no adverse impact on the cable.
- During outer layer winding, the winding mandrel is higher than the boom causing upward pressure on the white roller and eventual cable collapse.
