Coil fabrication status at CERN

Susana Izquierdo Bermudez

9th HL-LHC Collaboration Meeting

14-16 October 2019

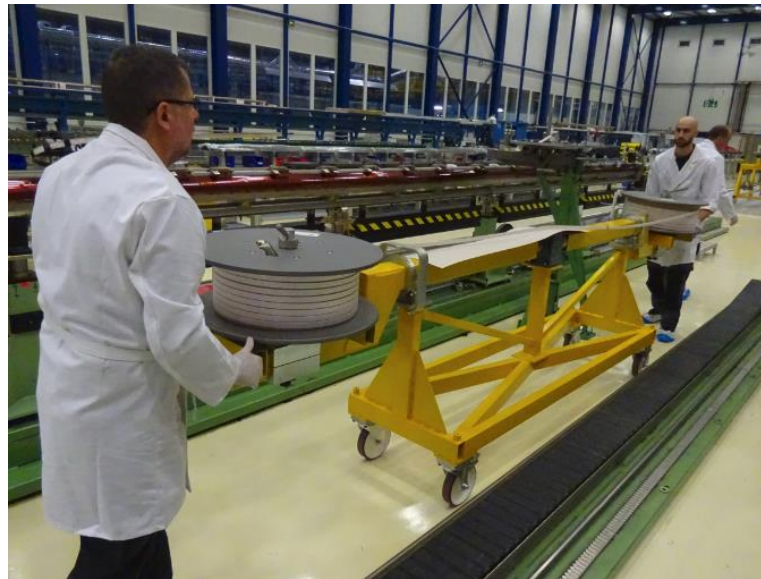
- **One** critical non-conformity (coil 106)
- Interchange of the cable lengths in inner and outer layer reels → not enough cable to wound outer layer. IL unwound, OL used for short model.
 - [NC report EDMS 1830153](#)
 - Action: Checklist and cable reel measurements

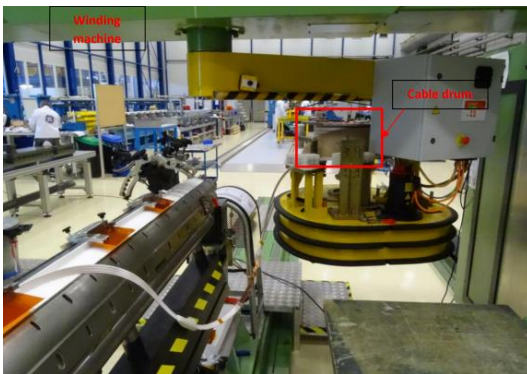
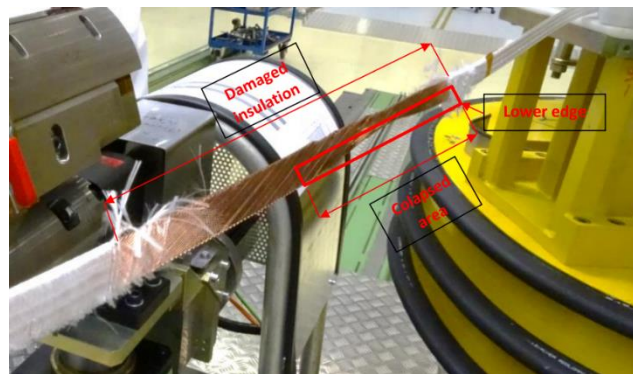
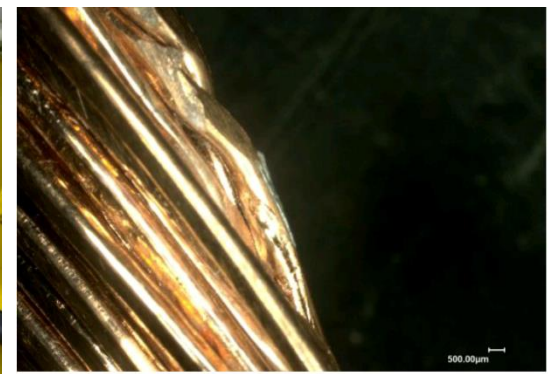
- **One** critical non-conformity (coil 201)
- During winding OL (turn 1), cable collapsed. Coil was finished, and it will be used for the second mechanical assembly test (MQXFBMT2).
 - Root cause: OL cable drum not fixed on the winding arm. [NC report EDMS 1964025](#)
 - Action item: Add QC - check list of preconditions prior start of winding

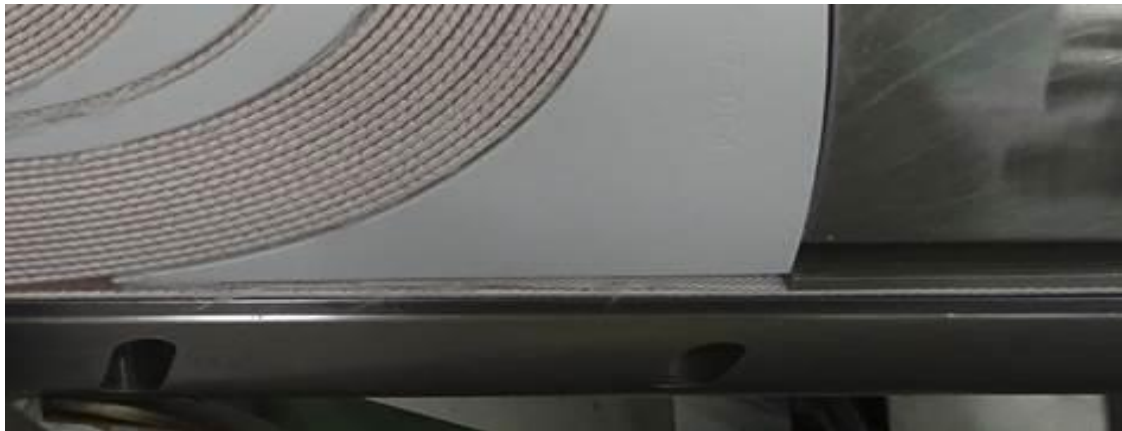
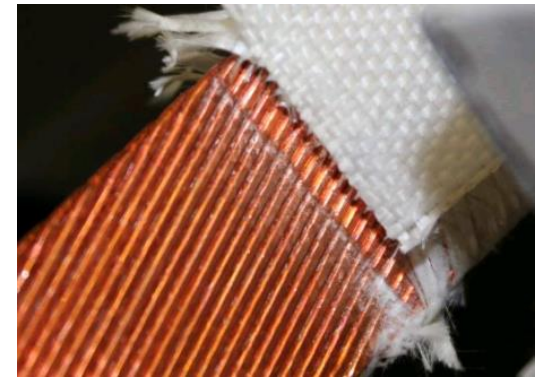
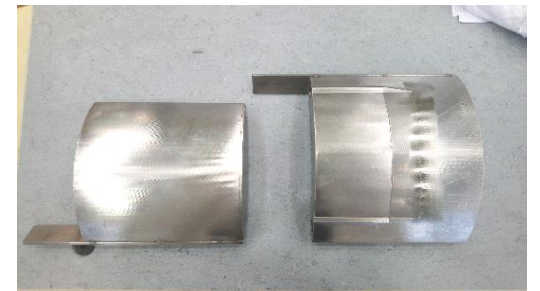
- **One** critical non-conformity (coil 205)
- Lead filler was blocked during curing, resulting on a damage of the
 - Root cause: Bad installation of the lead filler [NC report EDMS 2087338](#)
 - Action: Filler welded to splice block

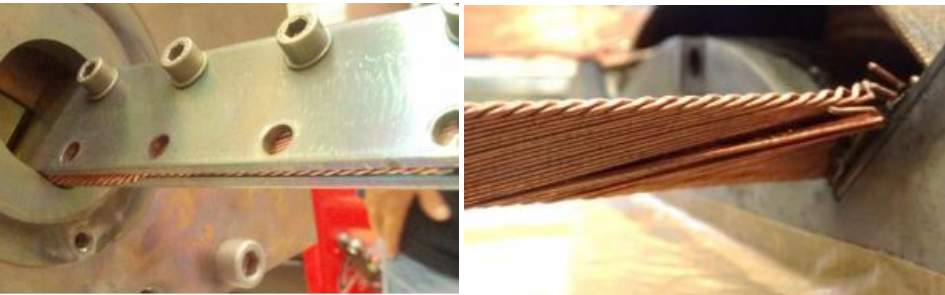
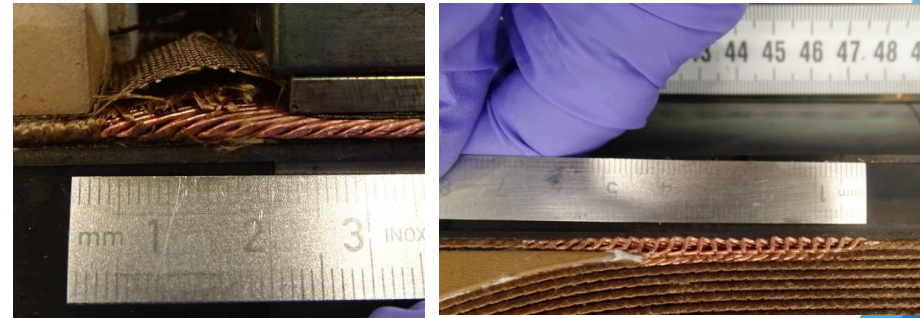
Heat treatment – NC (1/2)

- Leads got severely damaged in coil 103 during heat treatment.
 - Root cause: Non-verified tooling to support of the coil leads during heat treatment block the cables
[NC report EDMS 1831925](#)
 - Action: No tooling adaptation without prior approval
- Damage of the cable in the splice region of coil 204, over a length of 600 mm.
 - Root cause: Bad installation of the lead filler → got bonded to the cable [NC report EDMS 2112154](#).
 - Action: Lead filler welded to splice block

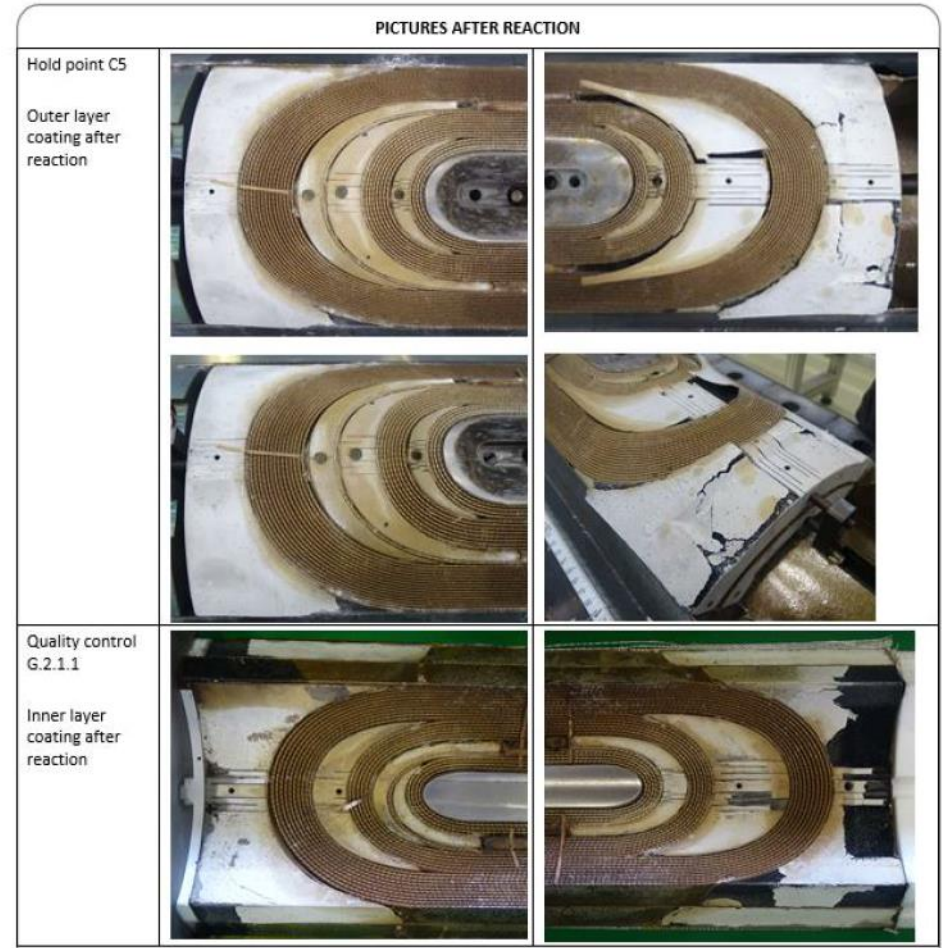
- Short coil to end-shoe after impregnation in coils 201, 202 and 203.
- Root cause: Alumina coating on the end-spacers delaminates after heat treatment. [NC report EDMS 2113779](#) & [NC report EDMS 2142901](#)
- Action:
 - End spacers will be coated by AUP supplier
 - Heat clean S2 glass table installed around spacers

QH-to-coil (V)	Coil-to-endshoe (V)
Coil 101	1000 (R=15 GΩ)
Coil 102	1000 (R=5 GΩ)
Coil 104	1000 (R=18 GΩ)
Coil 105	1000 (R=110 GΩ)
Coil 107	1000 (R=54 GΩ)
Coil 108	1000 (R=51 GΩ)
Coil 201	Short RE outer
Coil 109	1000 (R= 1000 GΩ)
Coil 202	Short LE inner
Coil 203	Short LE inner

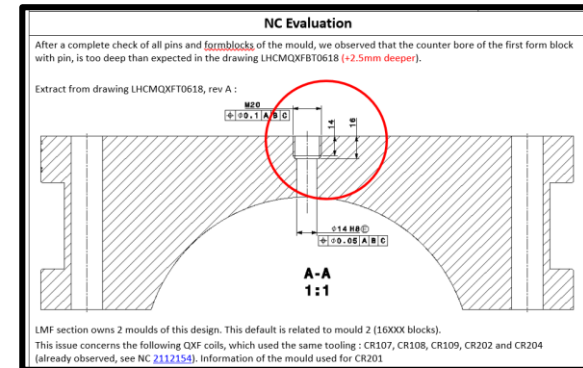
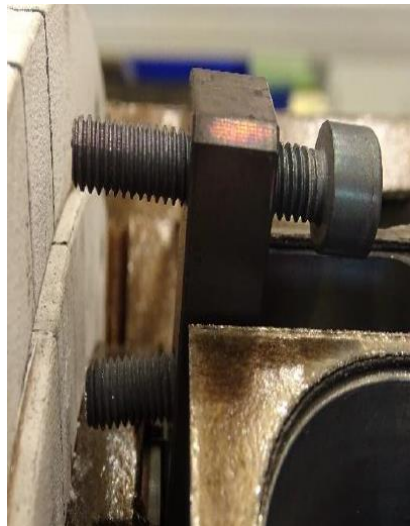
- In coil 204, friction marks pole-centring pin were found.
- The problem re-appear in coil 003. The root cause was identified: defect on one of the reaction blocks, which allowed the engagement of the centring pin with the pole .
- The non-conformed block is discarded, and the clearance pin-pole groove has been increased by 0.05 mm since in the original design it was not sufficient to guarantee sliding in all temperature range.

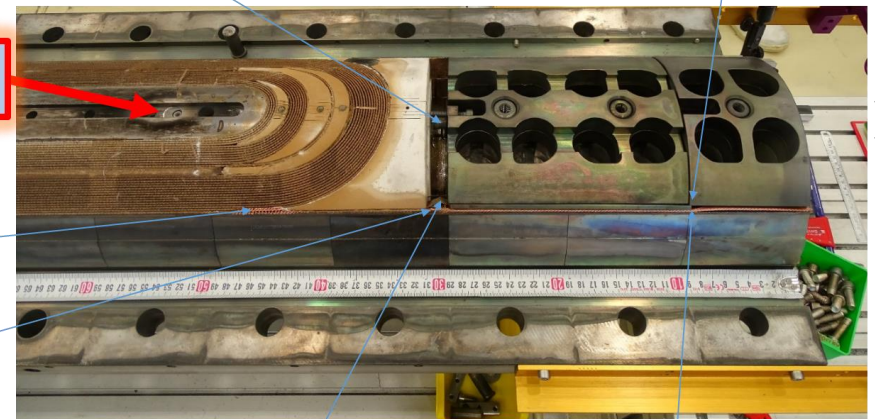
Coil 204

6. Plastic deformation: Guide screws (both extremities !), large thermal expansion and stress

5. Surface damage & cable deformation: surface damage on cable, insufficient length of mica.

7. Friction marks: pole and centring pin

1. Damage: strand/cable

2. Damage: strand/cable

3. Unusual displacement: large gap between vamas block to end-spacer

4. Positioning error: Vamas block to filler wegde contact at pos. 100 mm

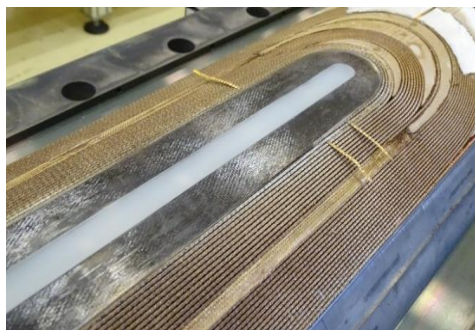
Coil after reaction

- Requirement: HiPot at 500 V
 - Pole is floating, and alignment key is made of G11
 - Max ΔV turn-turn through pole: 50 V
- Corrective Actions:
 - 5 instead of 4 layers of S2 glass between coil and pole starting from coil 202 (b6 correction)
 - Heat clean S2 glass tape before pole insulation (from coil 110)
 - Apply binder starting from midplane and stop at 3rd turn
 - 4 turns from coil 111, and we reduce as well the amount of binder in the turns close to the end parts.

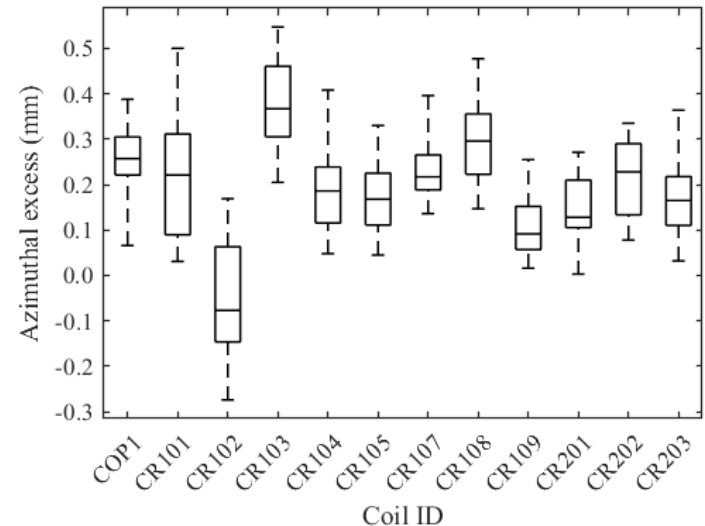
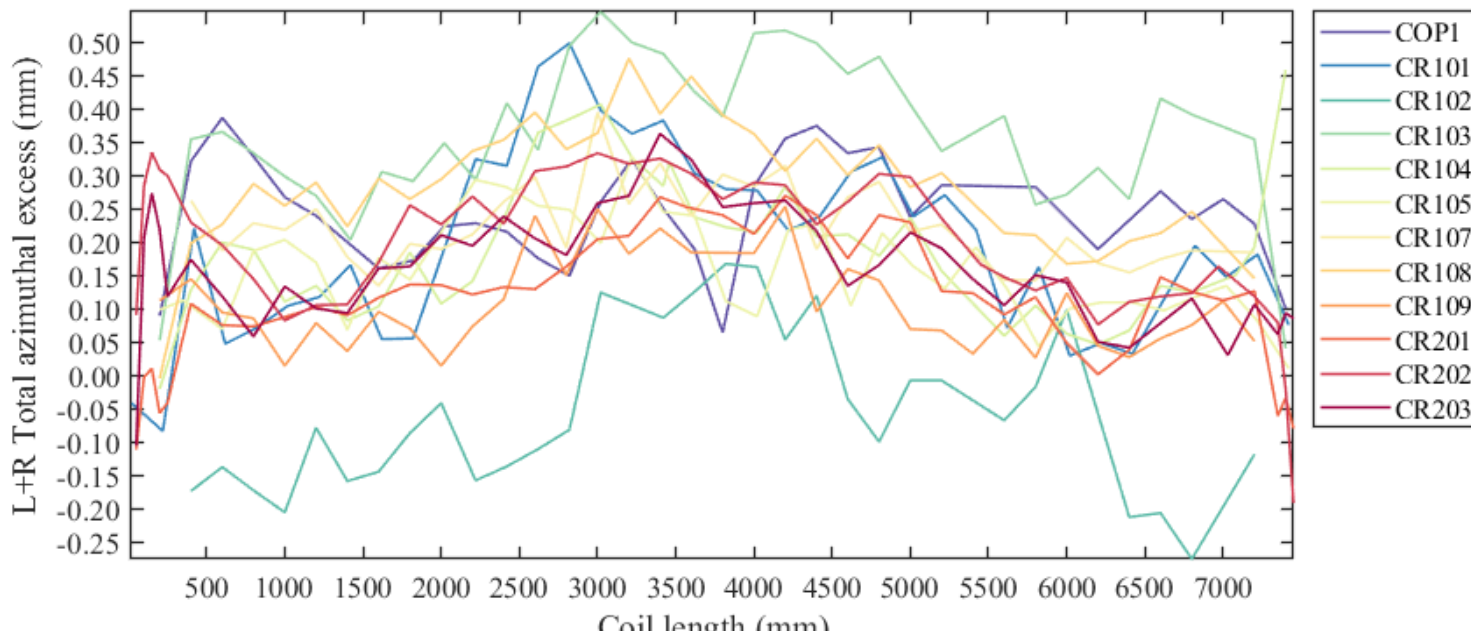
- Coils are systematically bigger than nominal.
- Coils are typically bigger in the centre.
- The difference of coil arc length along magnet axis is ~ 0.300 mm (i.e., 0.150 mm per side)

Remark: Midplane excess computation is performed with nominal OR of 113.376 mm for all coils.

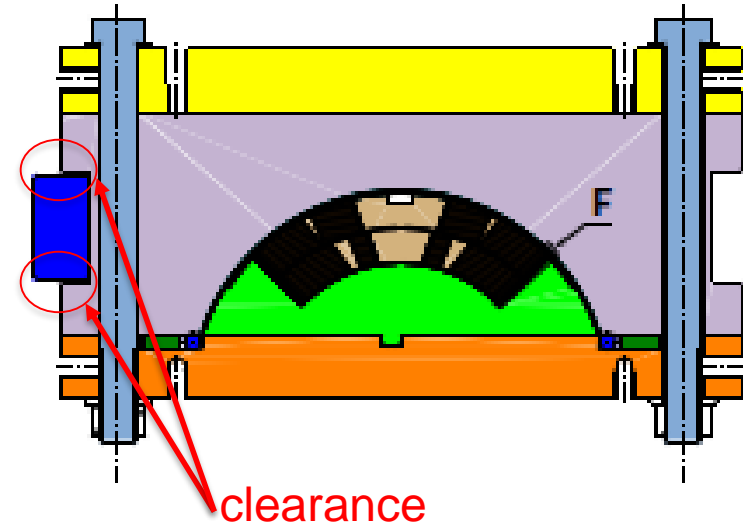
- One of the main difference founds with respect to the short coils are the side bars in the reaction and impregnation mould
 - For MQXFB coils we have the bar only in one side of the tooling
 - We have vertical clearance, so it doesn't serve to the alignment of the blocks but provides longitudinal stiffness.
- In order to understand if the side bars have an impact on the final coil size and asymmetry:
 - Coil 203 and 003 were reacted with bars in both sides
 - We plan to impregnate Coil 204 with bars in both sides and Coil 003 without side bars

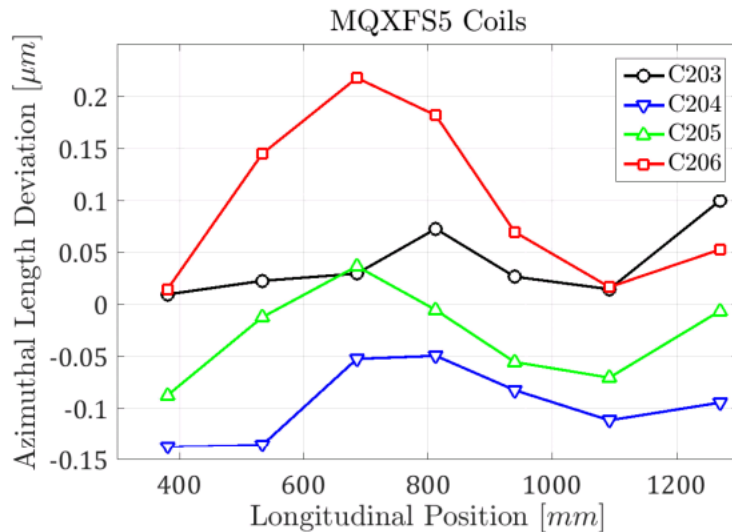
Fig. 6. MQXFS5 coil size along the length. The size deviations from the average are generally contained within $\pm 100 \mu\text{m}$.

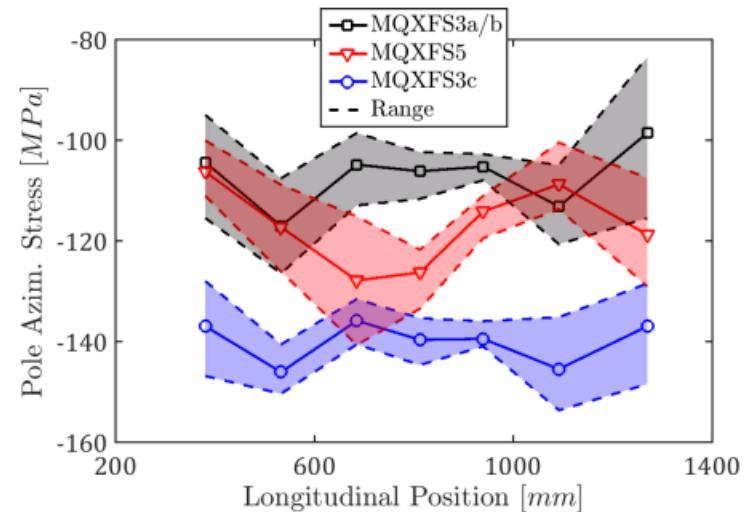
Fig. 7. Azimuthal prestress variation along the straight section. The results are computed on the basis of the measured size of the coils, using the FE approach. The computed stress variation is within $\pm 20 \text{ MPa}$ in all the magnets.
