## Coil Fabrication Status and NCRs - BNL

October 16, 2019

# BNL Coil Fabrication Status

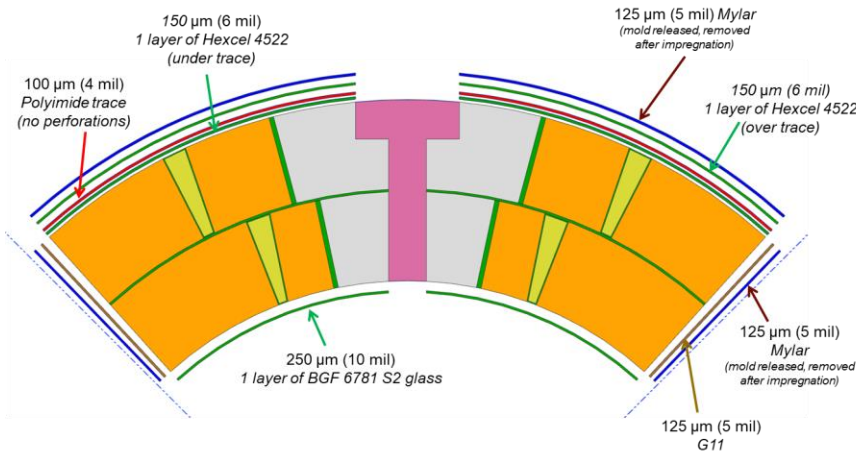
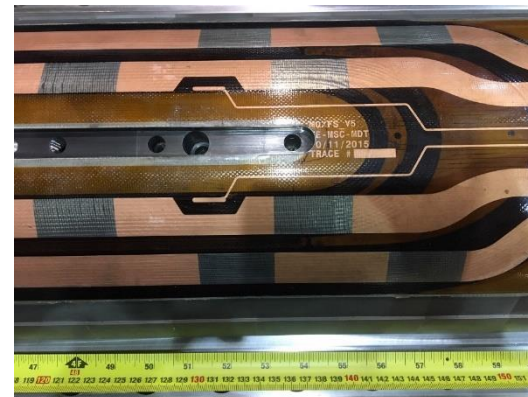
- Coil that was set aside after reaction a few years ago – not impregnated.
- Recently used for an impregnation test with fiberglass under trace.
  - 1 layer of fiberglass was installed under the trace.
  - (change from 2x Hexcel over trace to 1x under & 1x over)
- Impregnation quality looks good.
- Heaters / Coil passed standard electrical checks.

Hipot Checks - leakage < 1  $\mu$ A

QXFS04		Grounded / Monitored Component		
		Coil	LE OL Saddle	RE OL Saddle
Powered Component	PHB01	3680 V - OK	2500 V - OK	2500 V - OK
	PHB02	3680 V - OK	2500 V - OK	2500 V - OK
	PHB03	3680 V - OK	2500 V - OK	2500 V - OK
	PHB04	3680 V - OK	2500 V - OK	2500 V - OK

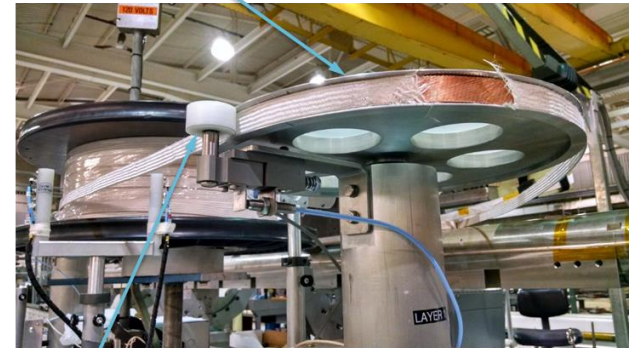
Guide Pulley

# QXFA205 - NCR

- Cable was damaged during winding of inner layer.
  - Winding was paused to address oil leaking from a gearbox.
  - Cable spool was clamped and control power was turned off.
  - Winding was resumed without removing the spool clamp.
  - Immediately paused to remove clamp.
  - When resume again there was some slack in the cable that went unnoticed, as a result the cable was not fully in contact with the guide pulley.
  - When cable tension was applied, the cable was pulled below the guide pulley and got caught against the guide roller bracket.
- Coil was unwound, all parts were recovered.
- Improvements made to prevent in future:
  - Added a guard below the guide pulley to prevent cable from dropping / becoming caught in the event of tension loss.
  - Incorporated interlock to prevent start when spool is clamped.

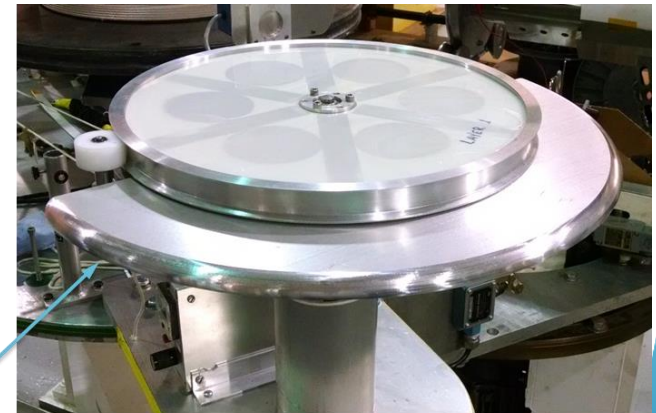
Guide Roller /  
Spring Loaded  
Lump Detector

Guard Added

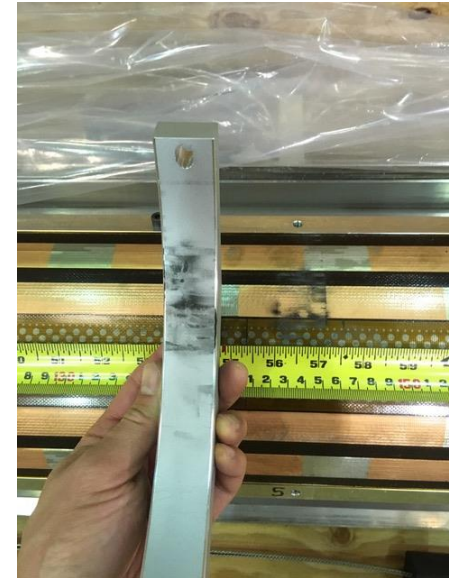
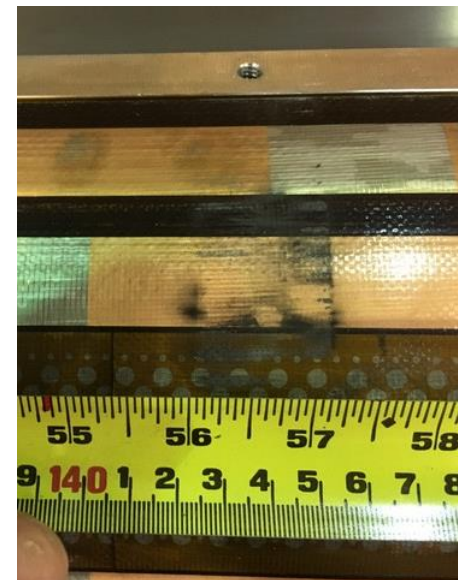
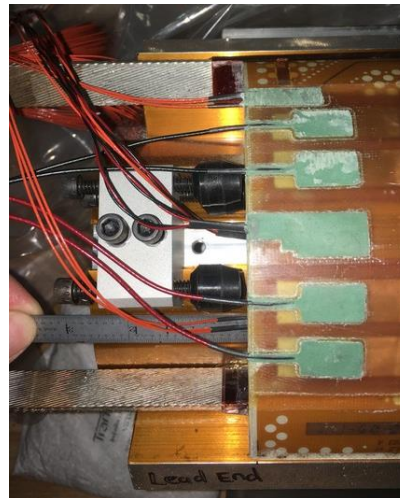
# QXFA206 - NCR

- Coil movement on shipping fixture during transport, discrepancies noted upon receipt at LBNL:
  - Rub marks on coil from aluminum coil OD clamps.
    - Indications of small axial motion.
  - End restraint screws not in contact with coil end.
    - One rubber tip appears to be cracked.
- Coil disposition under evaluation.
- Improvements for future shipments:
  - Add thin rubber between coil and aluminum coil OD clamps.
  - Add lock nuts to end restraint screws.
  - Replace end restraint screw rubber tips with swivel pads.

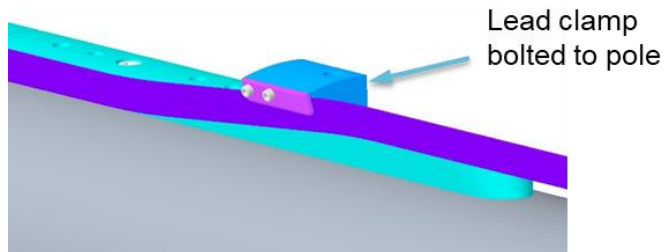
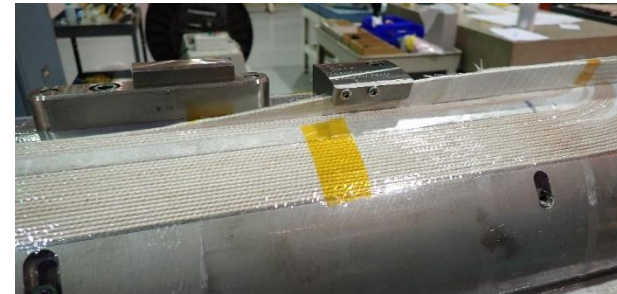
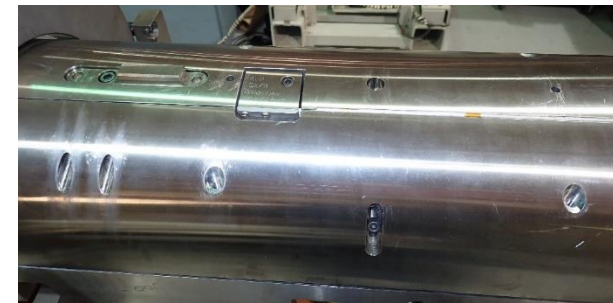
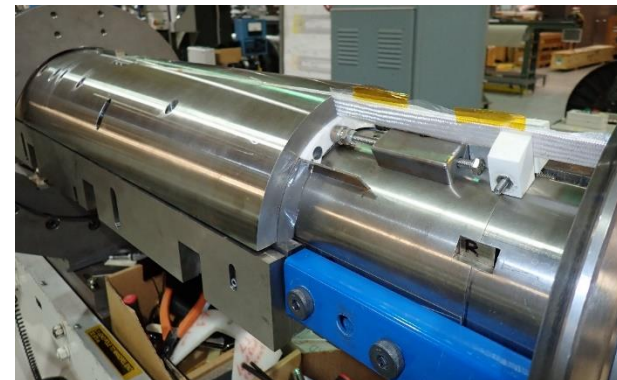
# QXFA208 - NCR

- Cable was damaged during curing of inner layer.
  - Cable was not in correct position in the transition ramp area during curing of layer 1.
  - Transition lead was dislodged during prep for curing / Teflon wrapping.
  - Lead was thought to have been repositioned correctly prior to curing.
  - Damage was discovered after curing layer 1.
- Coil was unwound, all parts were recovered.
- Improvements made to prevent in future:
  - Added clamp on pole to be installed at start of winding, when the lead is initially positioned in the ramp, and to remain in place thru curing.
  - Added clamp at end of coil to be installed before moving L2 spool prior to Teflon wrapping.
  - Revised procedure for installing LE filler segments & inspecting lead prior to curing.
  - Eased sharp edges on filler segments.
