Status of the CM4 repair work

W. Venturini Delsolaro and M. Therasse, on behalf of all the CERN teams involved

ICCC meeting- 1 July 2019

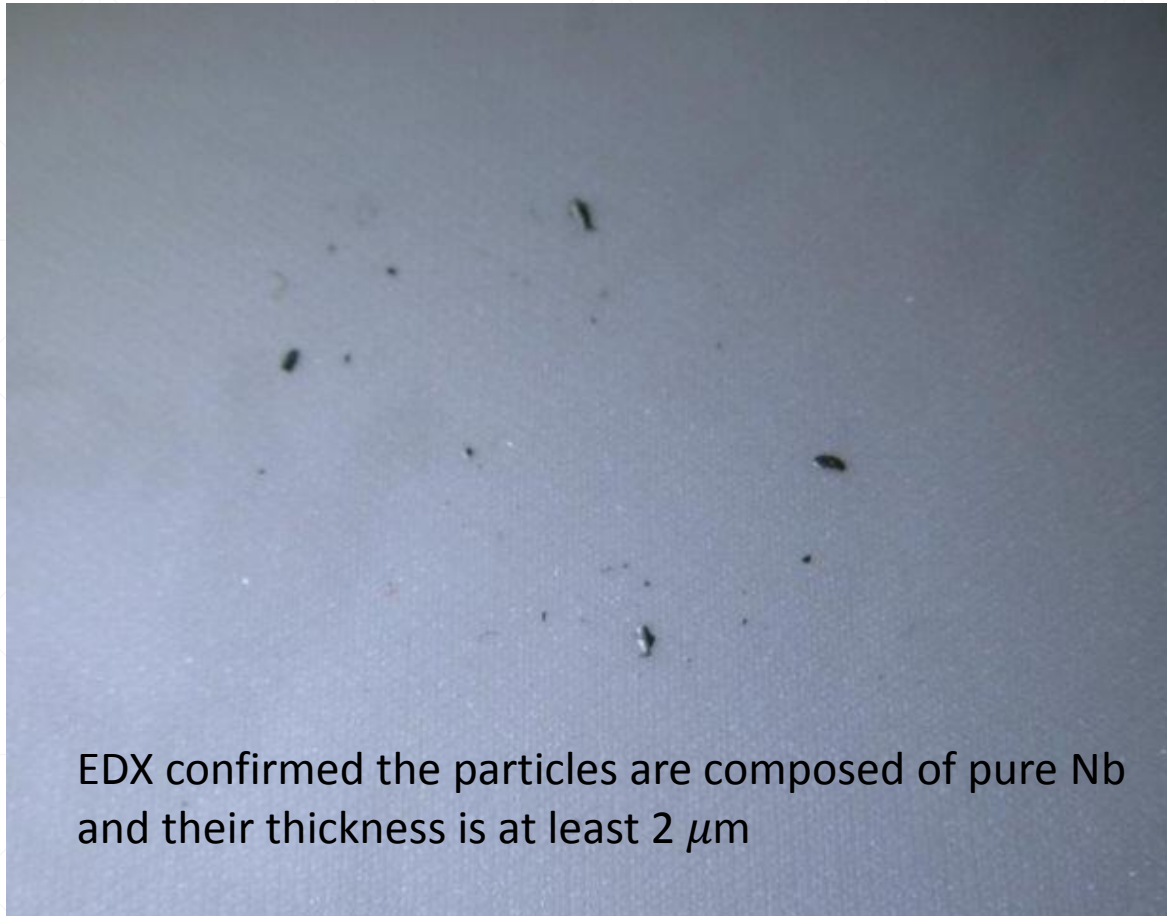
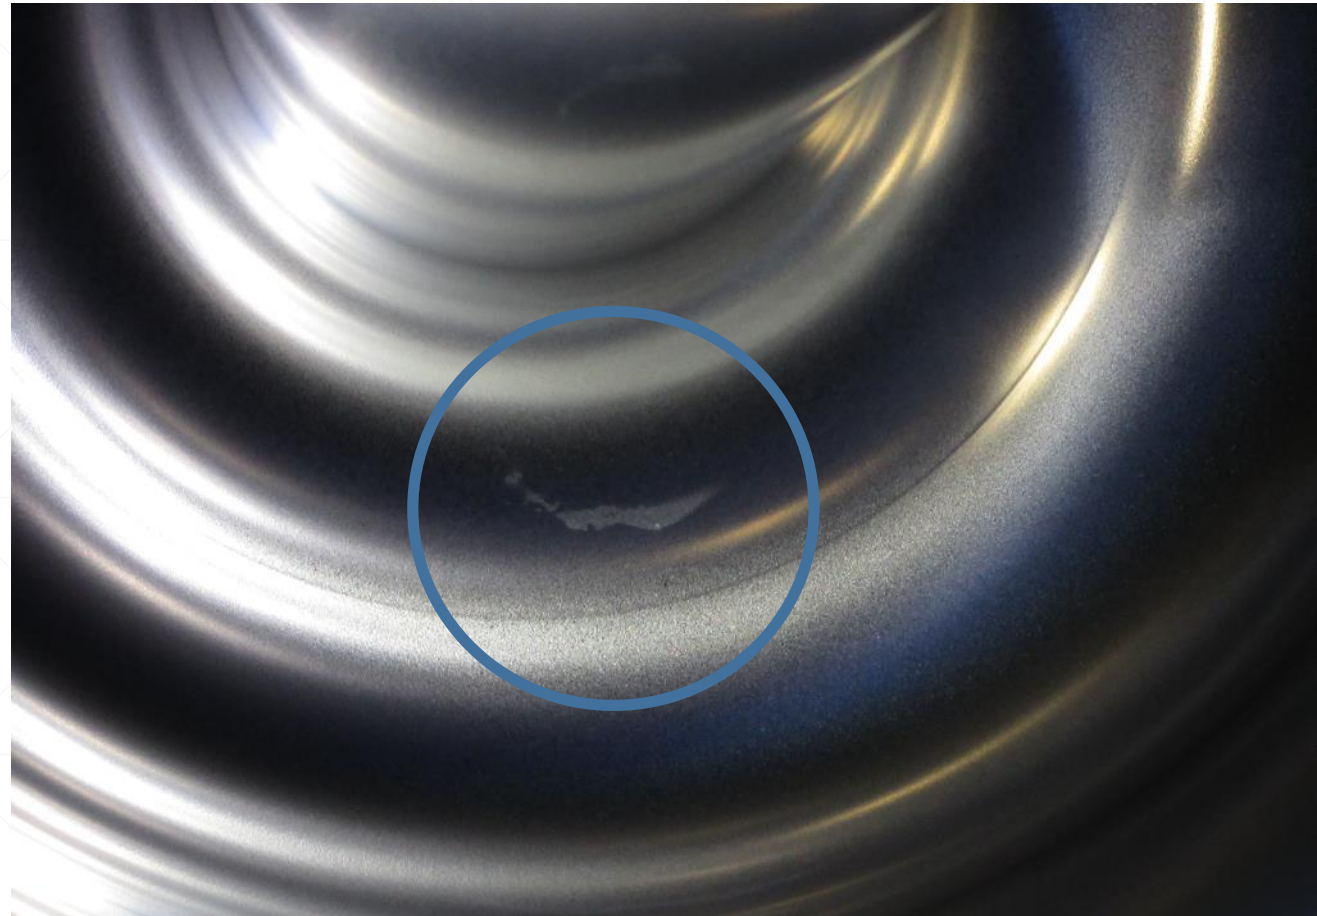
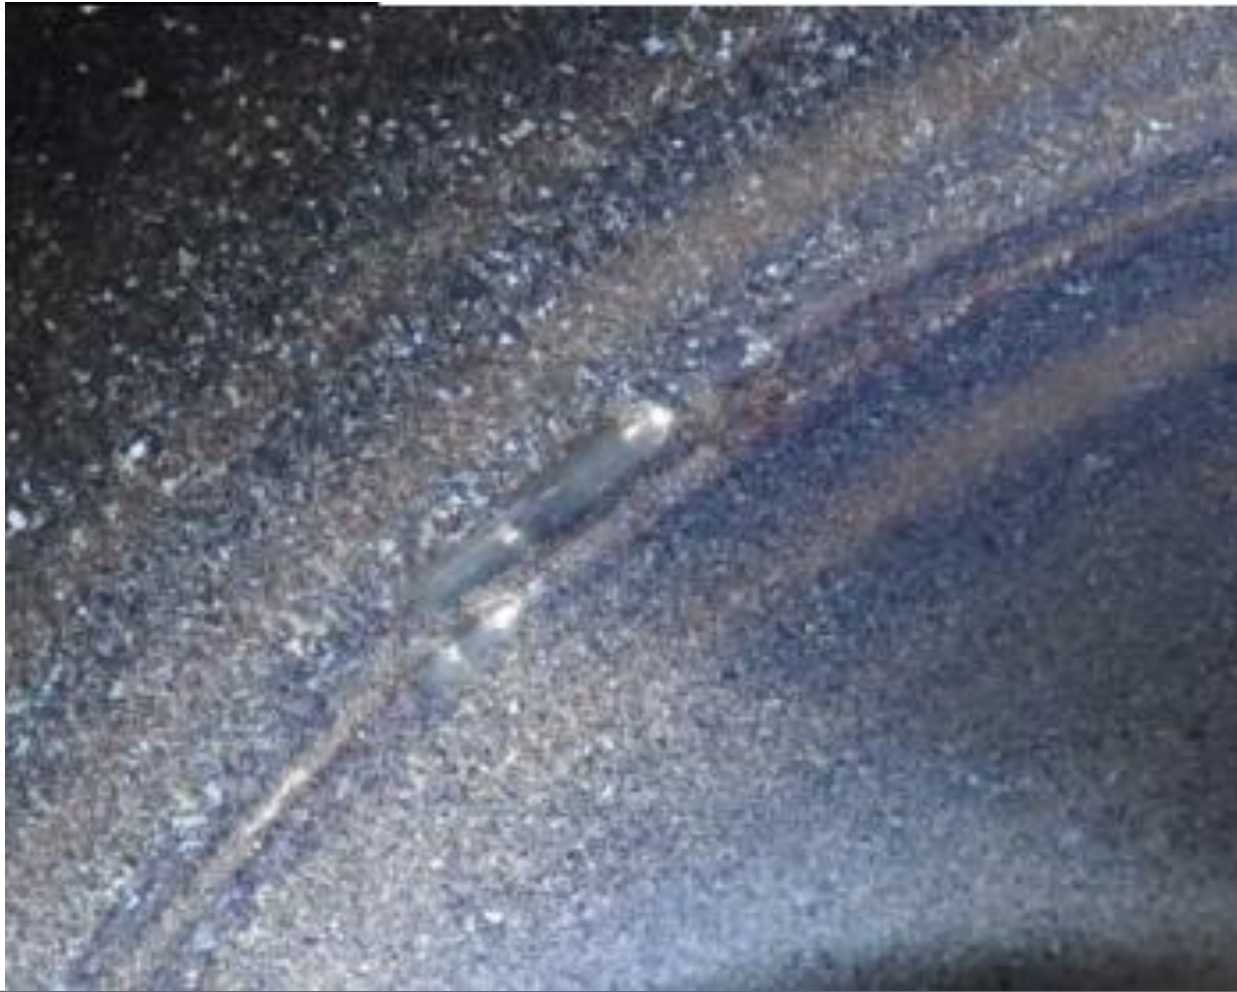
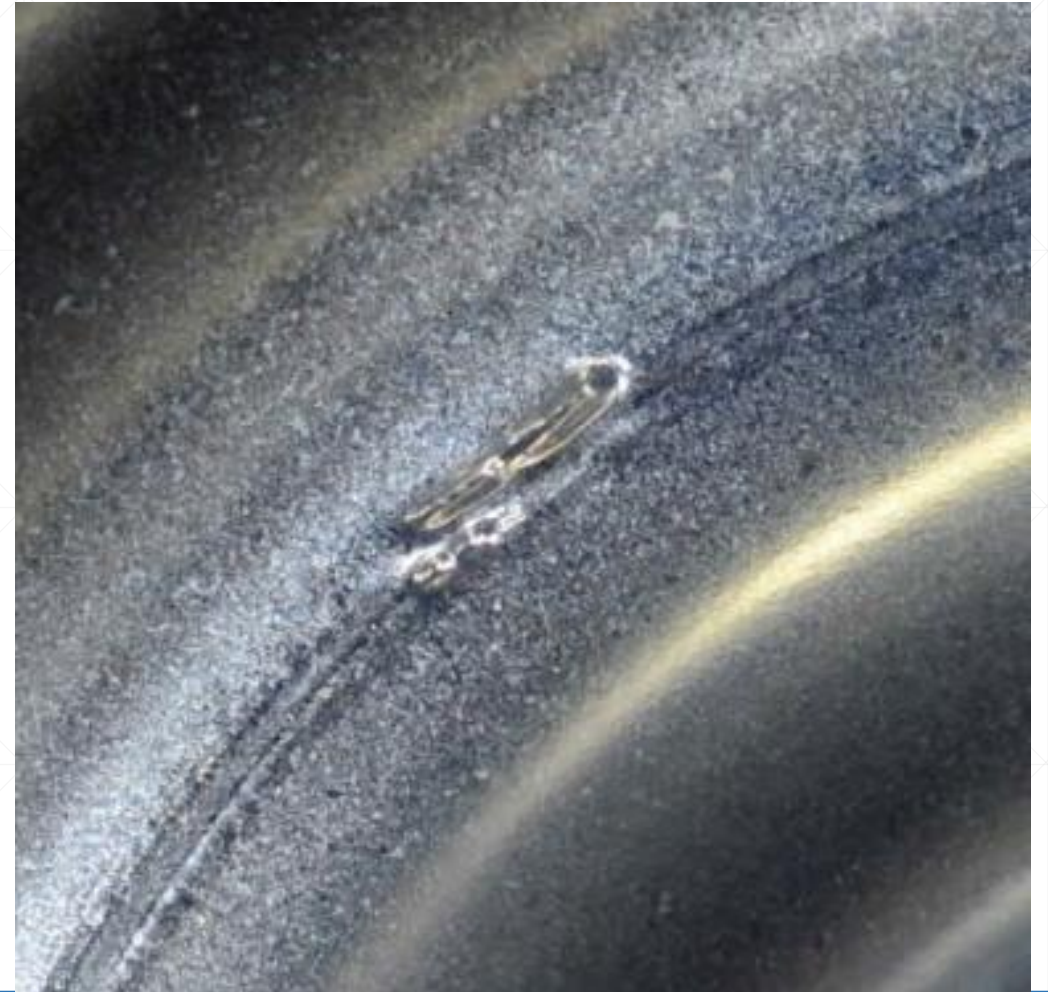
Case of QS18 and QSS2

- Of the three spare cavities available
 - QSS3 did not perform well at vertical test. The reason is now understood (foreign macro-particle on Nb)
 - QSS2 and QS18 had excellent performance in vertical test, but...
- In both cases, after final rinsing particles were found in the filter of the exhaust water
- A careful investigation (optical inspections, SEM/EDX analysis of particles) was conducted
- We can't exclude these particles be fragments of the Nb film detached from the cavity surface
- Consequently, and in order to minimize the risk for the users, BE-RF-SRF and TE-VSC-CC agreed on the following actions:
 - Reinforce measures for slow venting, and avoid re-rinsing of already installed cavities
 - Limit the intervention to the repair of the RF line, without replacing working cavities*
 - Re-test the spare cavities in vertical cryostats (in second half of 2019)

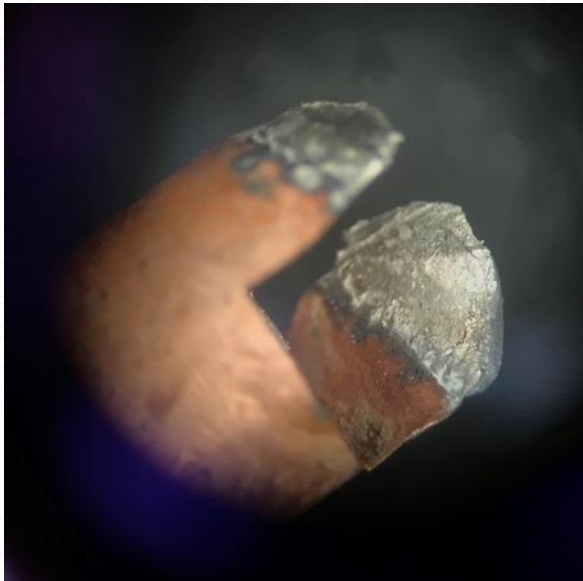
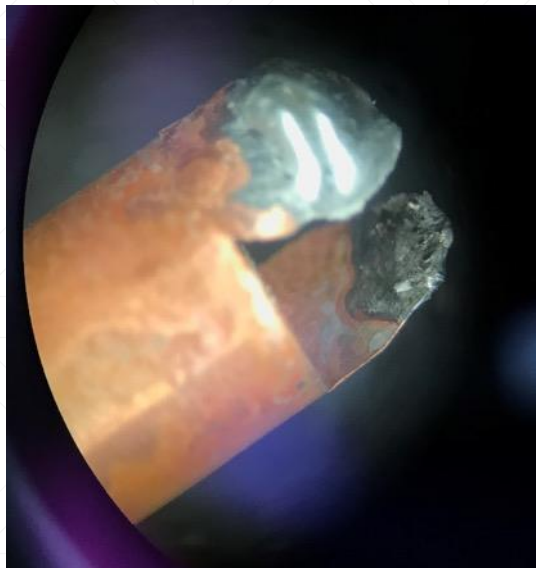
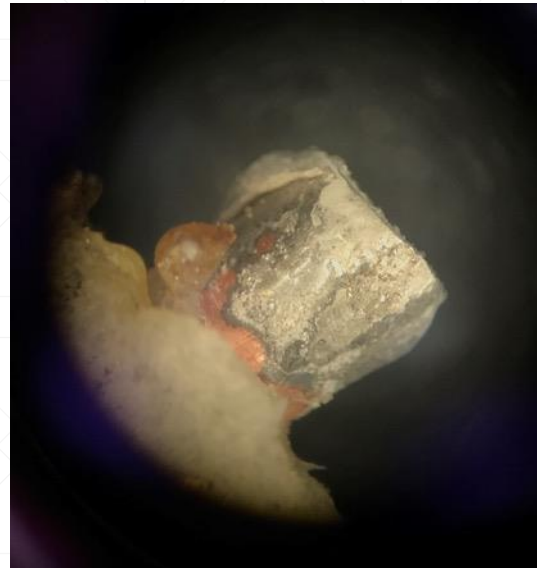
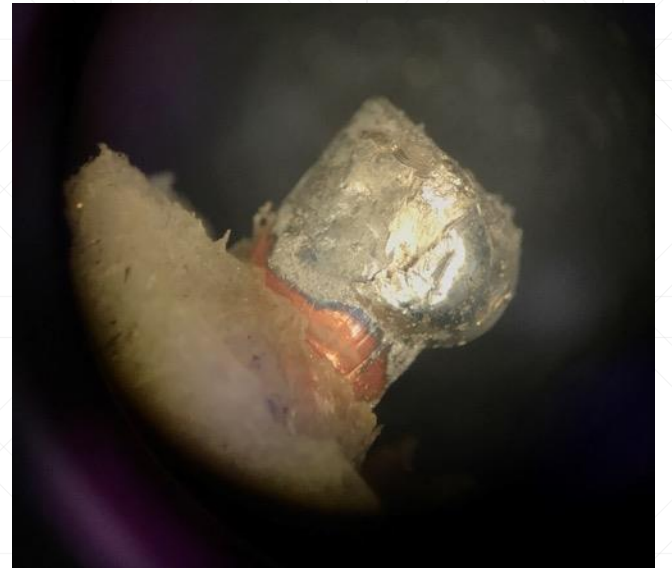
So, what was the matter with CAV3?

The soldering of inner conductor of the coax cable to coupler antenna was damaged after the first cool down.

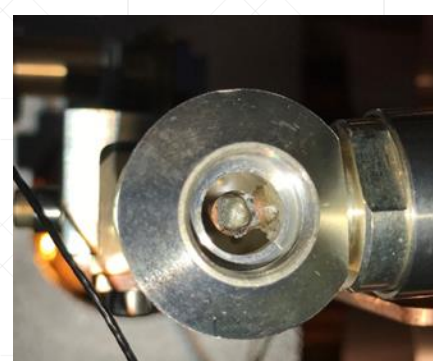
QS17

Inspection of the weak spot at all other cavities revealed similar features albeit less severe

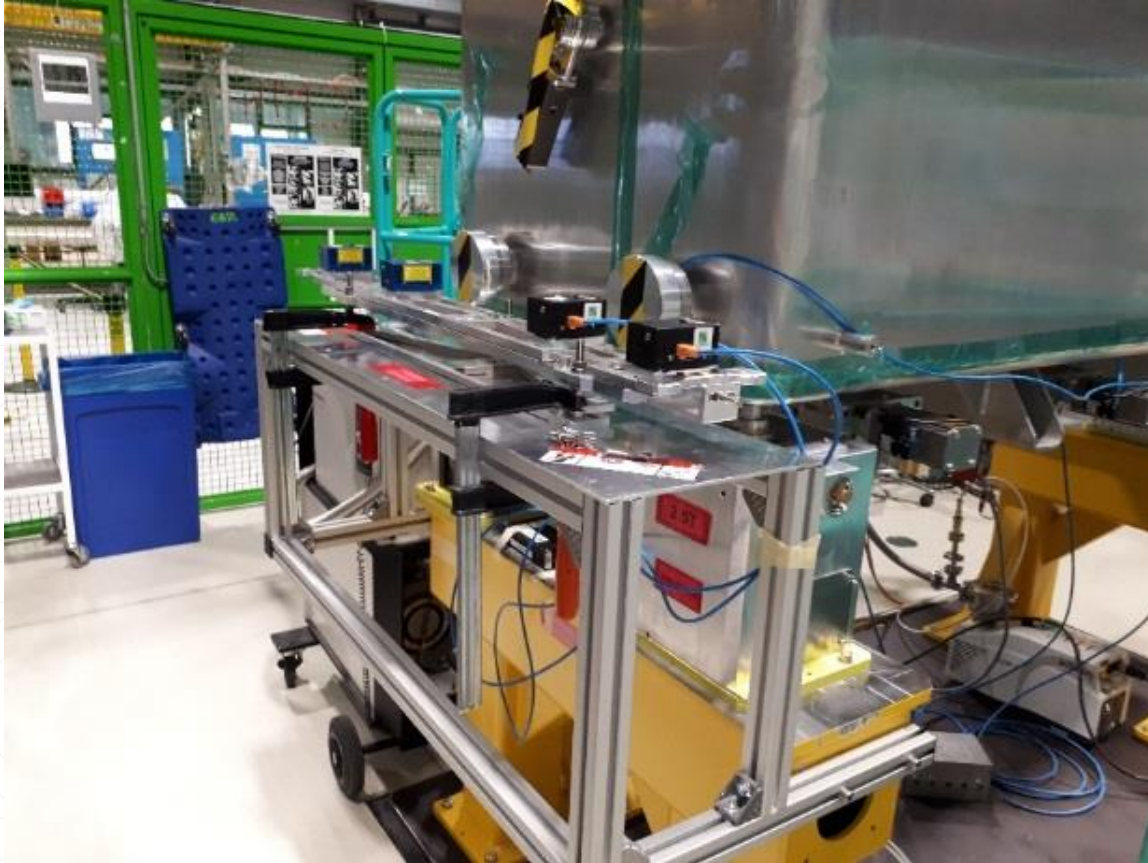
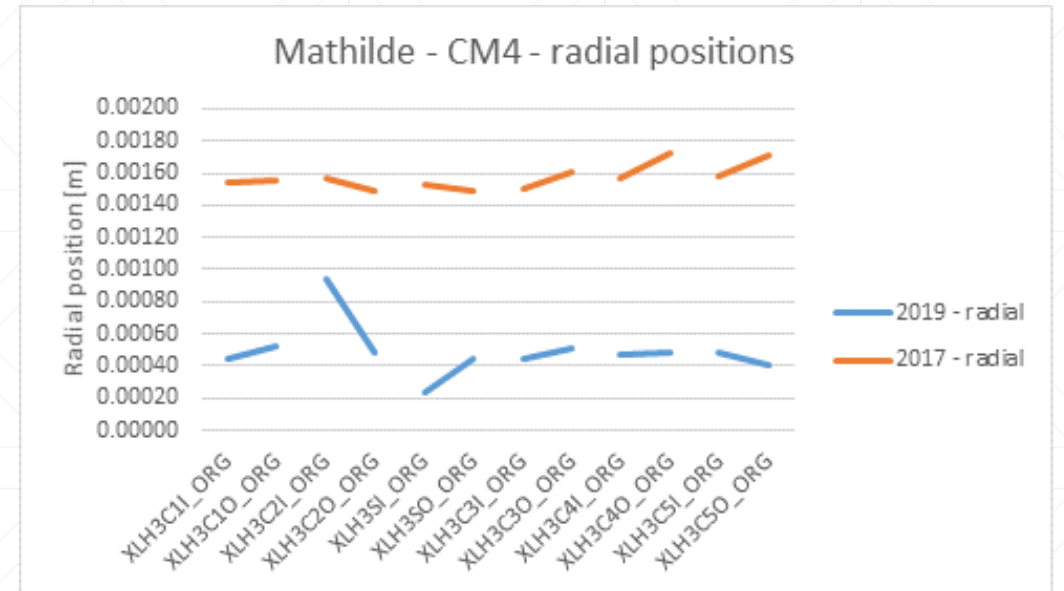
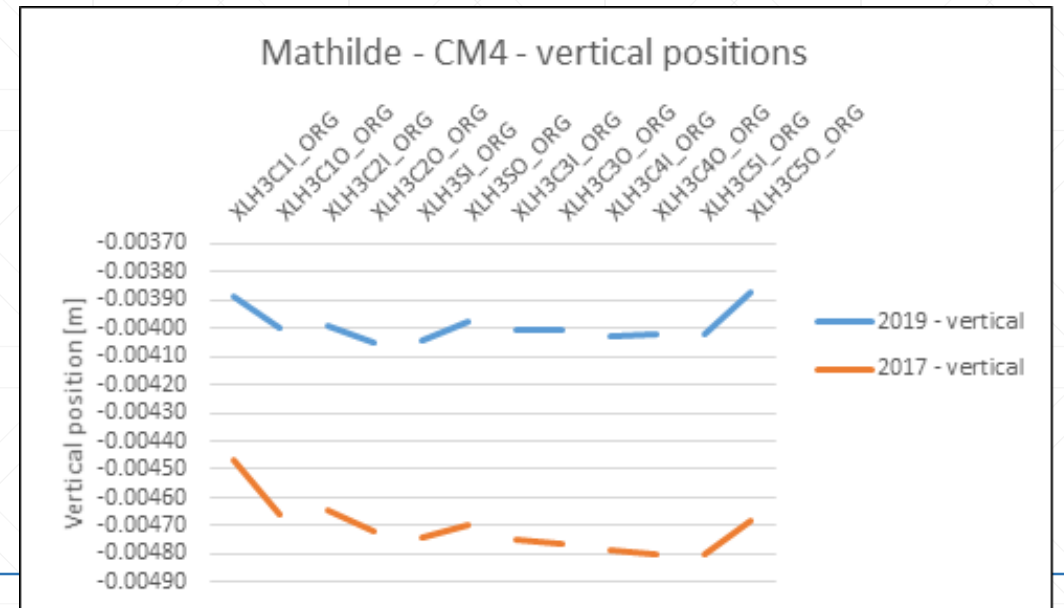
Results of the final survey

- CAV2 and Sol.: radial misalignments of +0.4 and -0.2mm.
- Beam dynamics implications checked by M. Fraser, OK
