PSB TFB Old System Delay Cables Damage Visual Checks

31/05/19

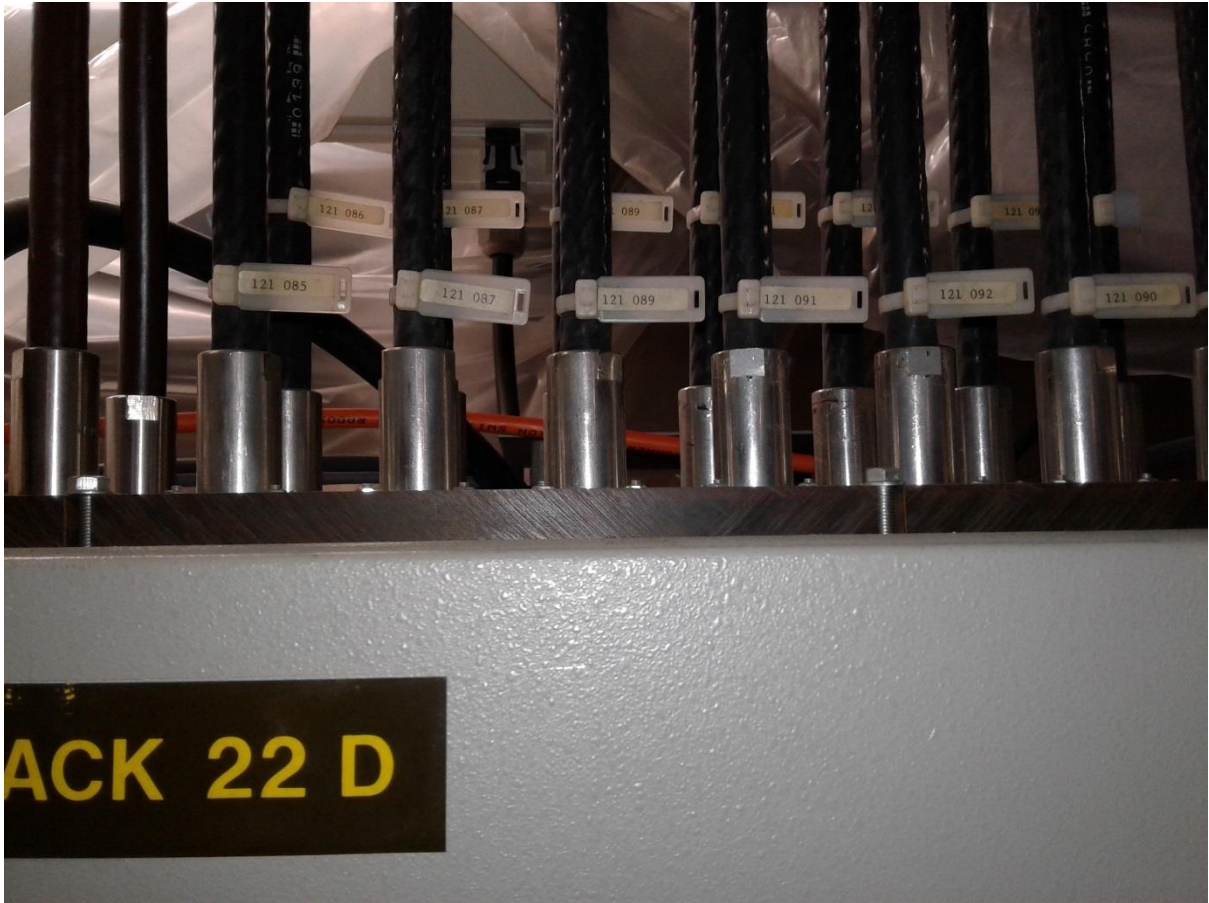
R4 delay cable patch in rack 22D.

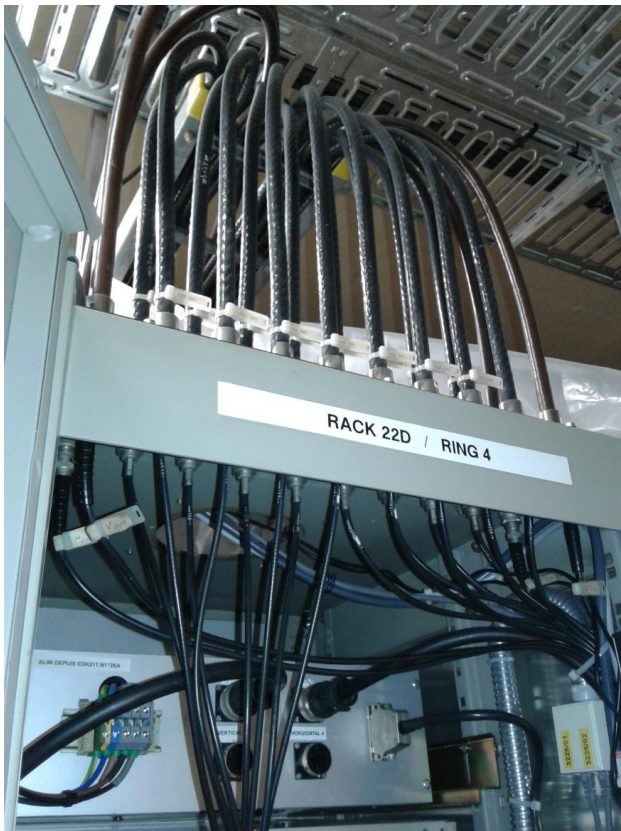
R4 delay cable patch in rack 22D, both sides.

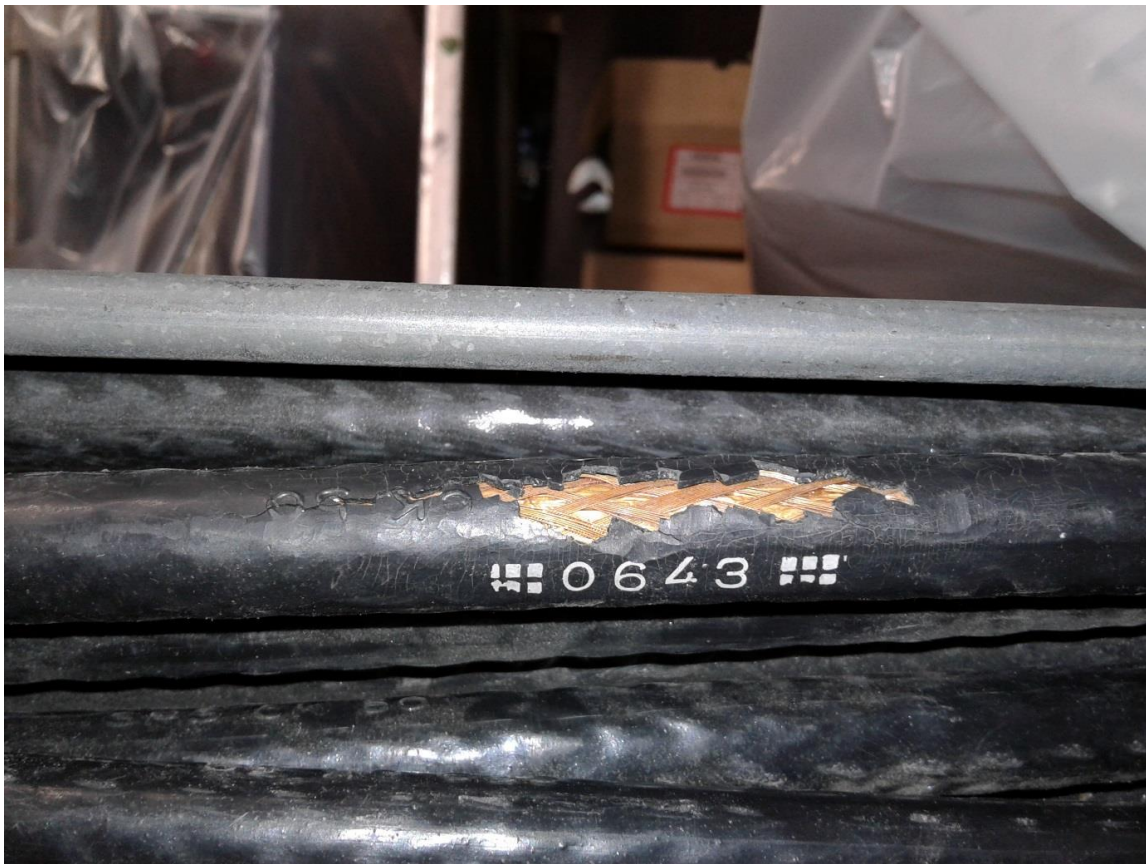
Obvious insulation degradation on a cable going to R22D patch.

The damage appears to be due to the age of the cables, and is only obvious on the external insulation at this point. The system was fully operational with these cables up until the start of LS2.

The system experts should be able to enlighten us as to if these cables need to be replaced.

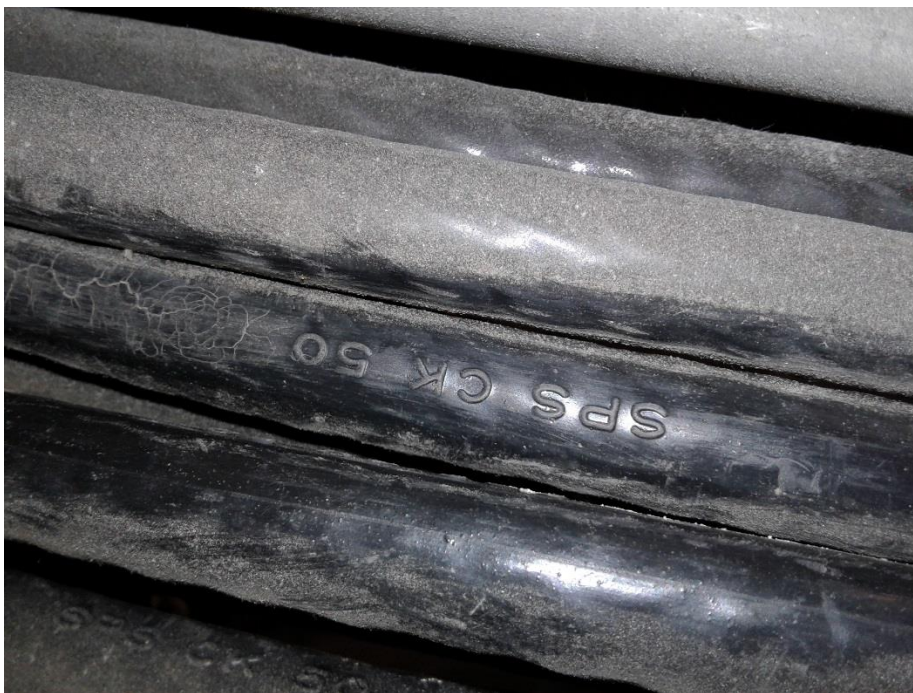
Cable type is CK50.

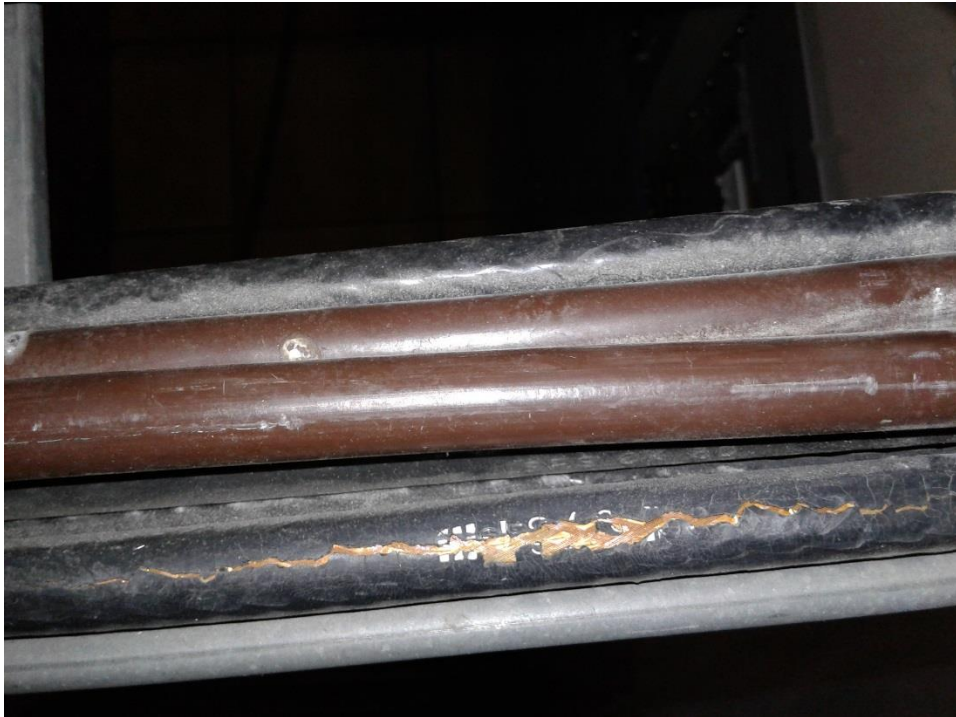
Similar degradation shown on a cable to R22A patch.

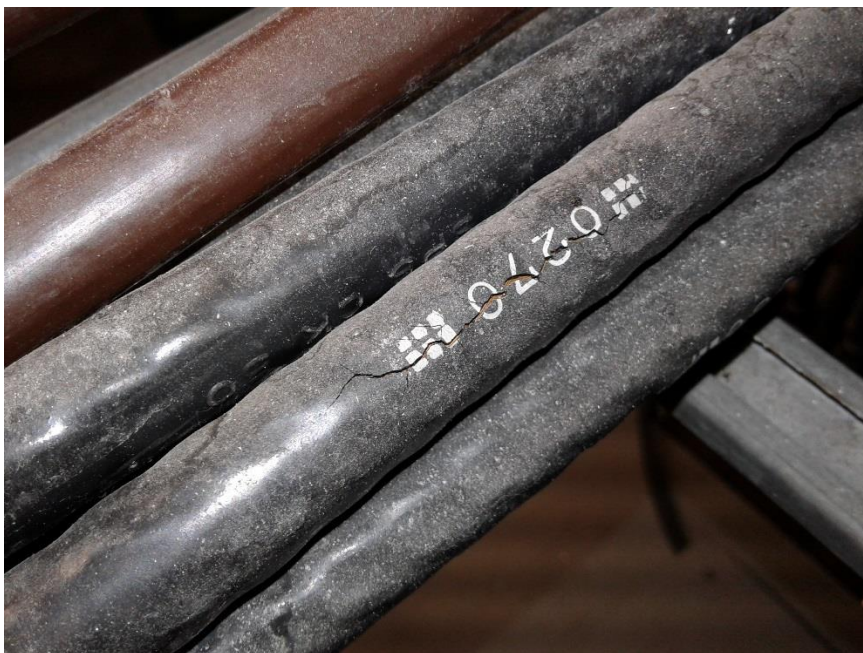
Insulation cracking on a cable going to R21B.

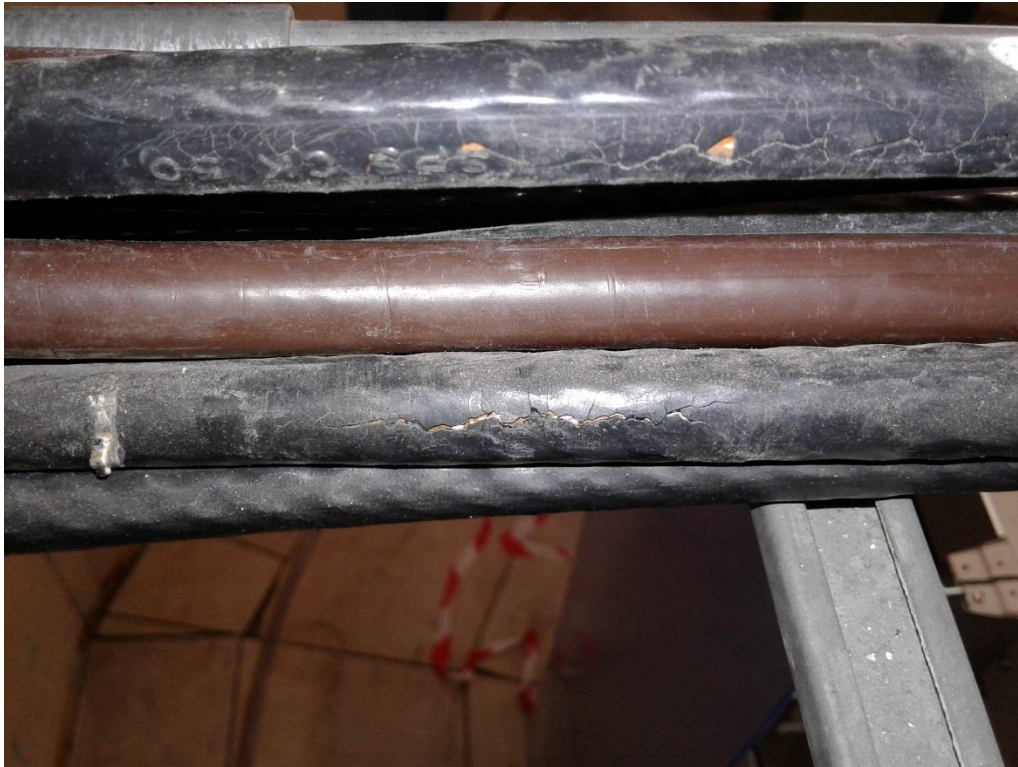
Insulation cracking on a couple of other cables going to R21B.

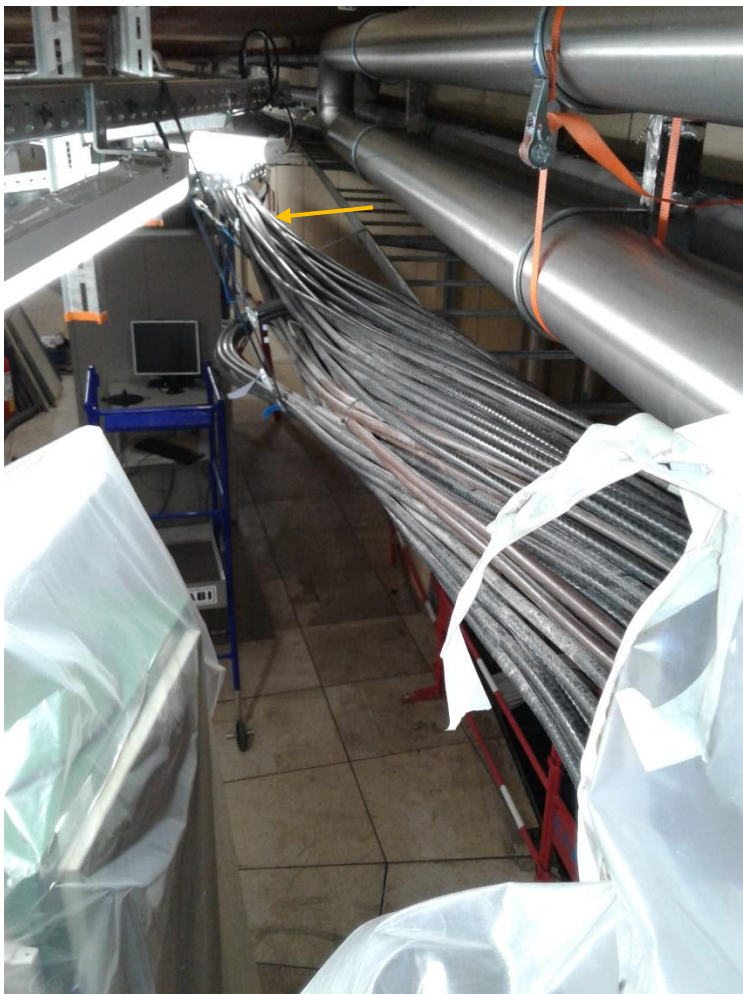
Delay cables have been moved out of cable tray for CV installation work, cables will have to be check for damage after being re-installed.
