Status of the CM4 repair work

W. Venturini Delsolaro and M. Therasse, on behalf of all the CERN teams involved

INTC meeting- 2 July 2019

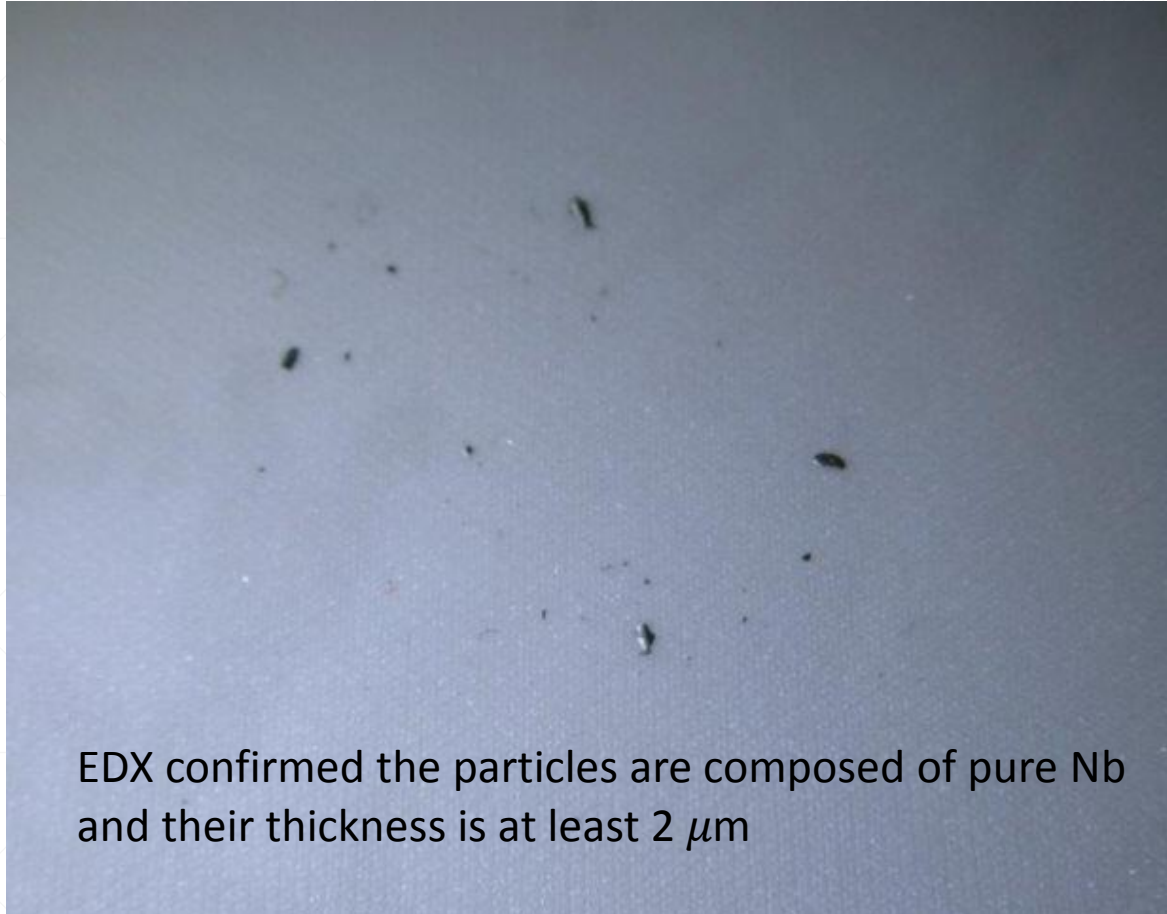
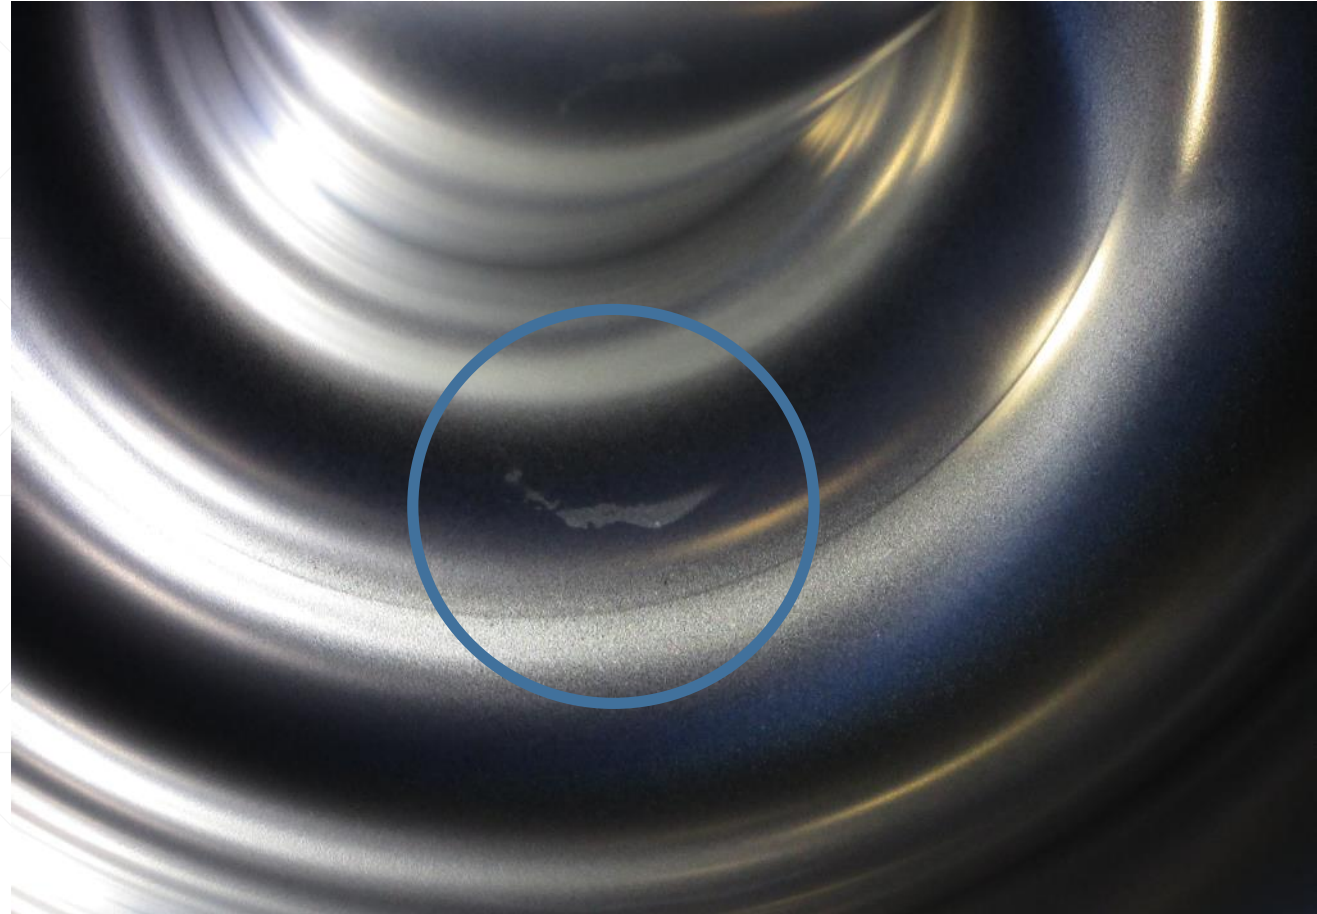
Case of QS18 and QSS2

- Of the three spare cavities available
 - QSS3 did not perform well at vertical test. The reason is now understood (foreign macro-particle on Nb)
 - QSS2 and QS18 had excellent performance in vertical test, but...
- In both cases, after final rinsing particles were found in the filter of the exhaust water
- A careful investigation (optical inspections, SEM/EDX analysis of particles) was conducted
- We can't exclude these particles be fragments of the Nb film detached from the cavity surface
- Consequently, and in order to minimize the risk for the users, BE-RF-SRF and TE-VSC-CC agreed on the following actions:
 - Reinforce measures for slow venting, and avoid re-rinsing of already installed cavities
 - Limit the intervention to the repair of the RF line, without replacing working cavities*
 - Re-test the spare cavities in vertical cryostats (in second half of 2019)
