# Electronics Lessons Learned from GE1/1

Gilles De Lentdecker    **Laurent Pétré**

October 2, 2019

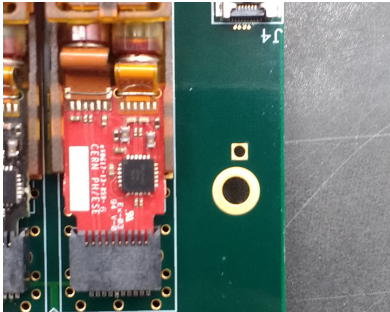
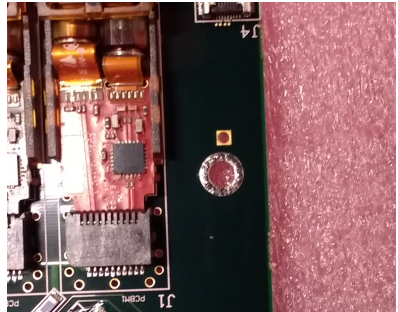
# Modifications while in production

1. Cover with solder the gold plated pad touching the tin-plated brass standoffs:
  - ▶ Prevent galvanic corrosion
  - ▶ By hand on already produced OH (CERN SMD lab)
  - ▶ At production for newly produced OH
2. Improve temperature sensors:
  - ▶ PT100 do not match the SCA ADC characteristics
  - ▶ Replace the PT100 with PT1000
  - ▶ Add a precise resistor for SCA current source calibration
  - ▶ End up with 3 OH versions (stored in DB)

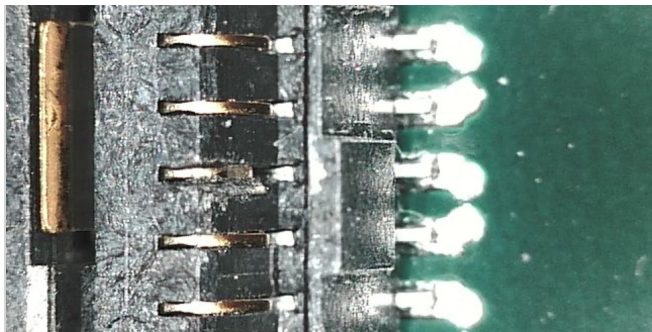
## Failures at QC7

- ▶ More than 15 OHs have been returned to ULB
- ▶ 3 were found with broken SAMTEC pins
- ▶ 4 have a serial number lower than 10 (and need reworking)
- ▶ Other OHs have been repaired, tested and returned to CERN
  - ▶ Not all OHs have been found misbehaving; back in production

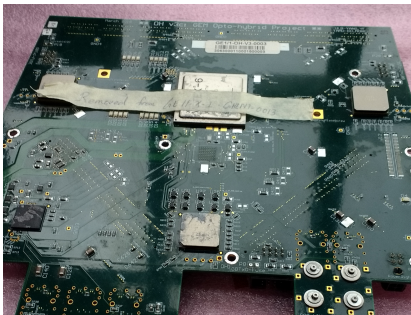
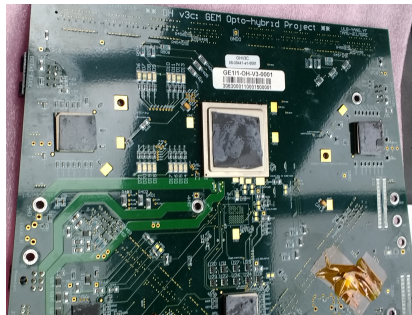
# Keep the OHs clean

- ▶ OHs were not cleaned before shipment from CERN to ULB
- ▶ Thermal paste everywhere:
  - ▶ In the SAMTEC connectors
  - ▶ Under the BGA packages
  - ▶ Inside the VTR<sub>x</sub>/VTT<sub>x</sub>
- ▶ Unnecessary stress experienced during cleaning
- ▶ Also clean with compressed air before assembly

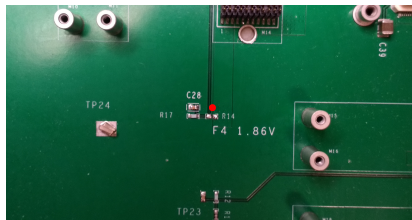
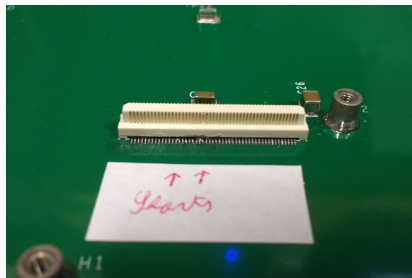
# Soldering

- ▶ Only a few (2-3) returned from CERN
- ▶ But many rejected at ULB
- ▶ Longest component to repair and test
- ▶ Large variety of issues with batch-to-batch variation
- ▶ More thorough tests should be performed at production:
  - ▶ PRBS patterns on the data lines
  - ▶ Test the powering with DC/DC FEAST-like

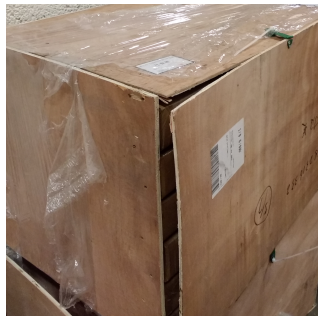
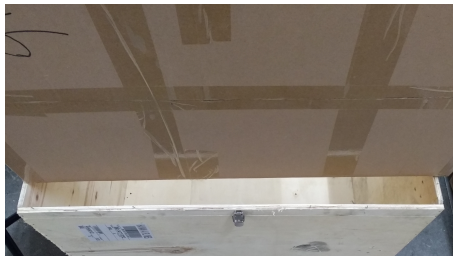
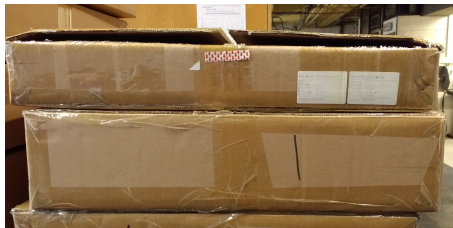
# Packaging

- ▶ GEBs damaged by:
  - ▶ Too light packaging
  - ▶ Too tight packaging
- ▶ Each batch is sent with different packaging:
  - ▶ Difficult to re-pack components
  - ▶ Standardization would be appreciated

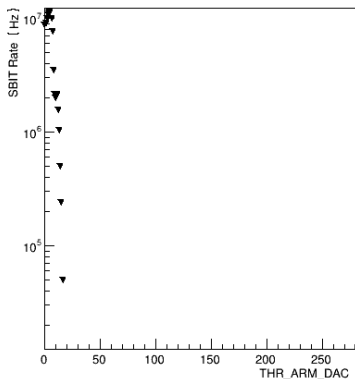
Good Sbits line

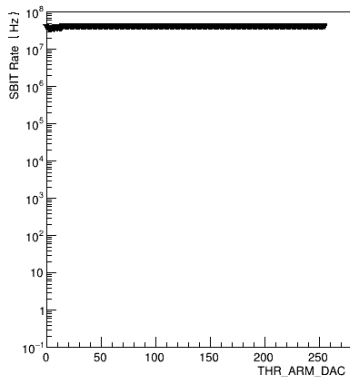
Disconnected/broken Sbits line

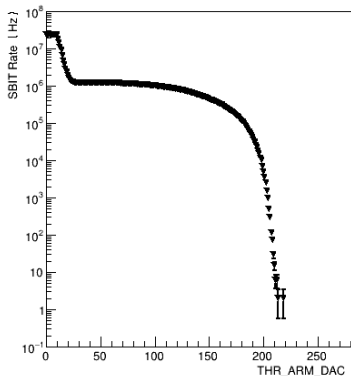
Noise in the frontend

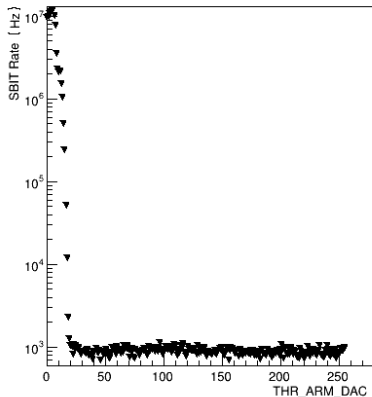
Issue with the OH FW (now fixed)
