KM3NeT Qualification Penetrator Base Module OFP Report of the tests

KM3NeT_QUAL_2019_002

CPPM

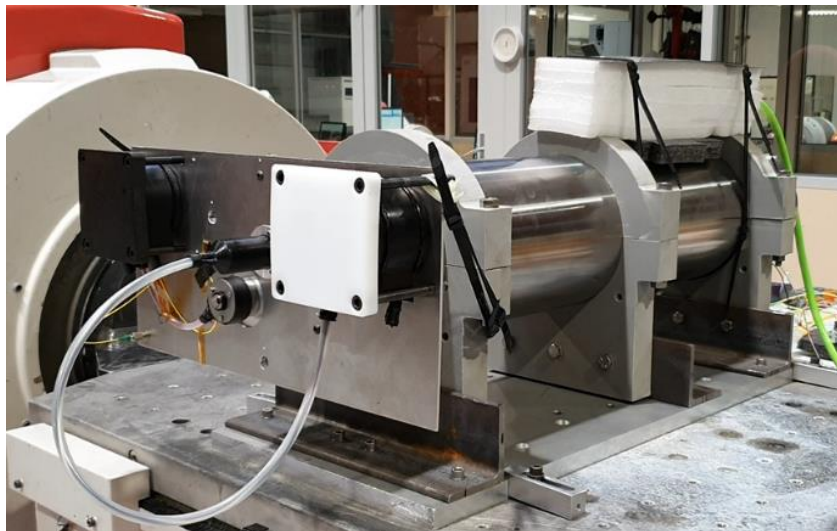
Figure 3: cylinder mounted on the interface plate

It was noticed that the plate where the two BoBs were mounted oscillated a lot when submitted to the certain frequencies of the vibration excitation. A try have been made to limit the amplitude of these oscillation by the use of plastic collars.
