Report: #22

Activity: PS complex

17th February 2020

LS2

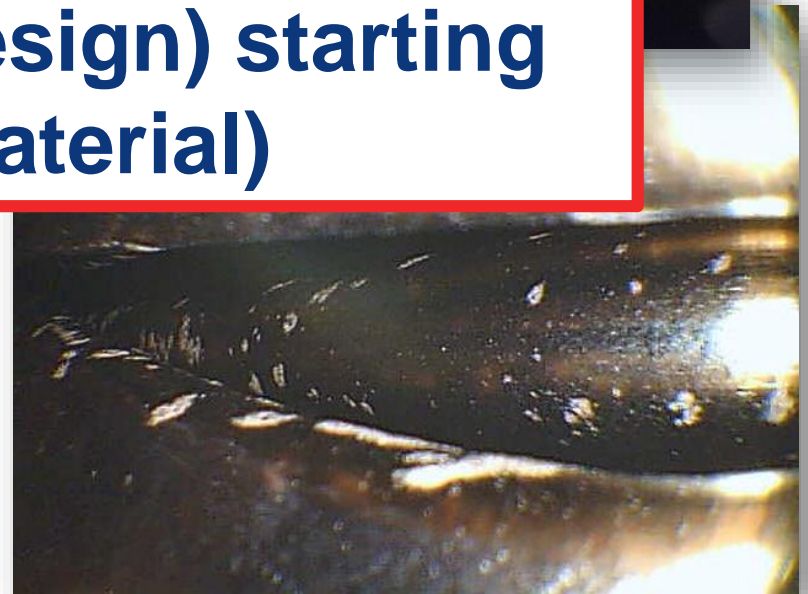
Endoscopy of LINAC4's RFQ:
Damage on the surface of the vanes
Impact on operation
Produced with tolerance 0.02 mm
and Ra 0.8

Carbon copy spare started. To be installed in test stand. 3rd spare (new design) starting (raw material)

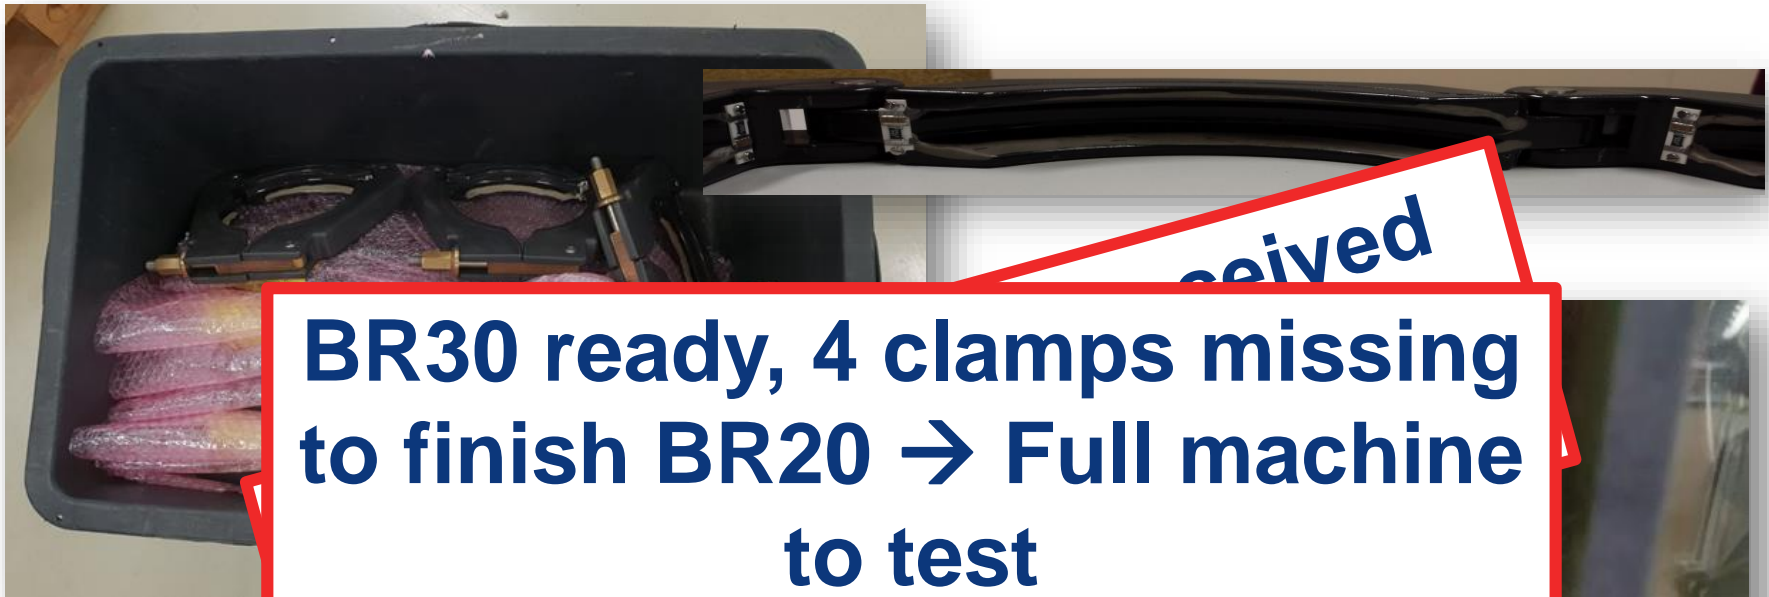
- ❑ Still issues to... bypasses
→ This could have... impact in the progress and ISTs
- ❑ Error during the installation of the first batch
→ Short-circuit through the seal
- ❑ Very poor design → Redesign after LS2

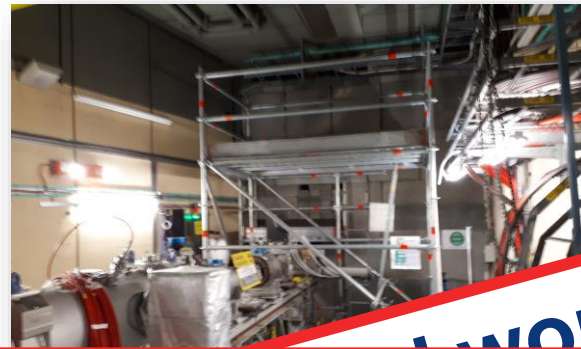
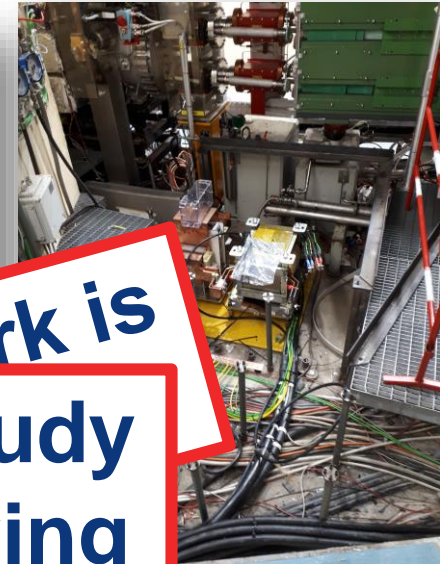
- PSB amount of co-activities out of control
- EN-EL, EN-SMB, EN-CV, TE-EPC, EN-SMM and TE-VSC working in parallel with two scaffolding areas, movable and VIC!
- Planning idea or completion start or finish
- Originally January reserved for the ring and February for transfer lines without co-activity.

Meeting twice a week to study co-activities. Activities during IST!

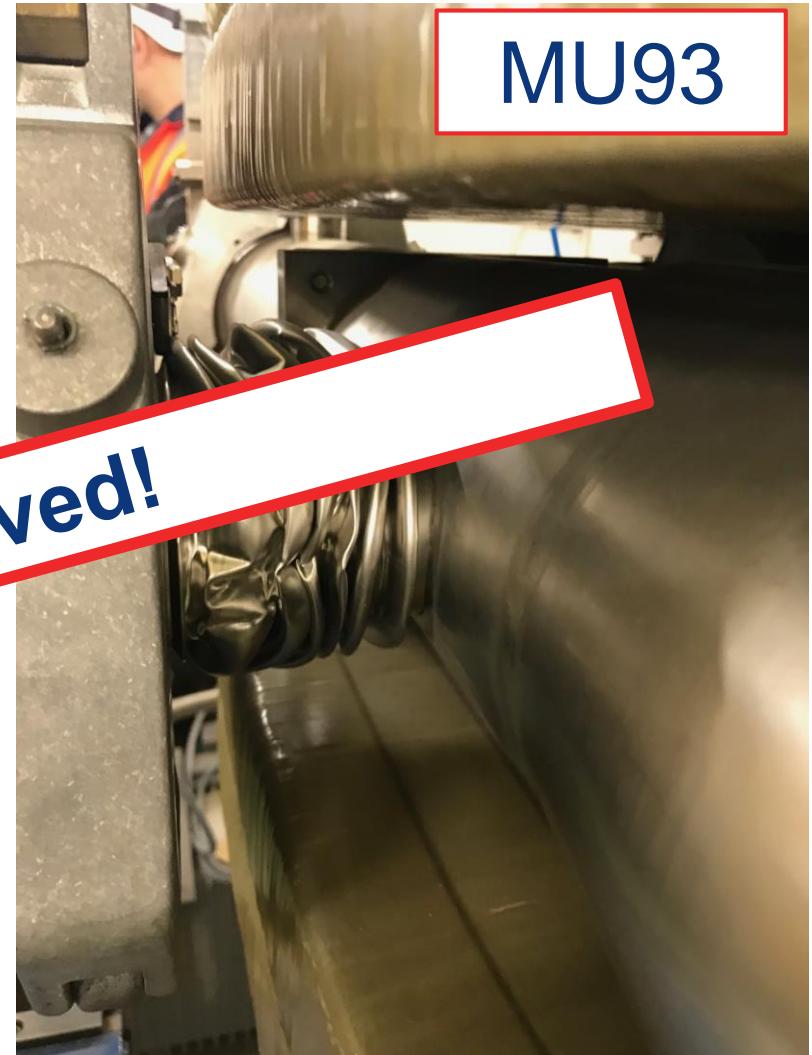
- Survey a recurrent source of delays:
 - Correct tilt of MU96, MU93 and MU75
→ 0.25 mrad (<0.025 mm edge of flange)
 - Agreed maximum movement 1-2 mrad (<0.2 mm edge of flange)
 - Strategy: First MU96 (ok then correct MU93)
 - Survey team (contractor) and transport without supervision and not informed!
 - Use of hydraulic machine (overshoot) broke the bellow (magnet not under vacuum!)
