Report: 28

Activity: LHC Insulation Vacuum

Meeting 03/08/2020

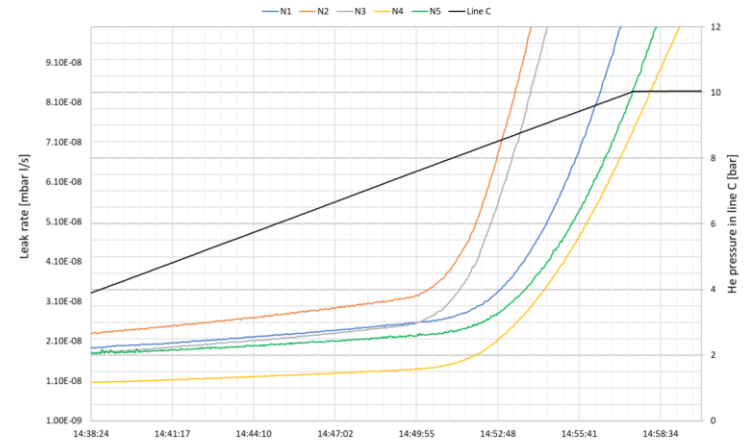
3) Close-up of the next part of the pressurization:

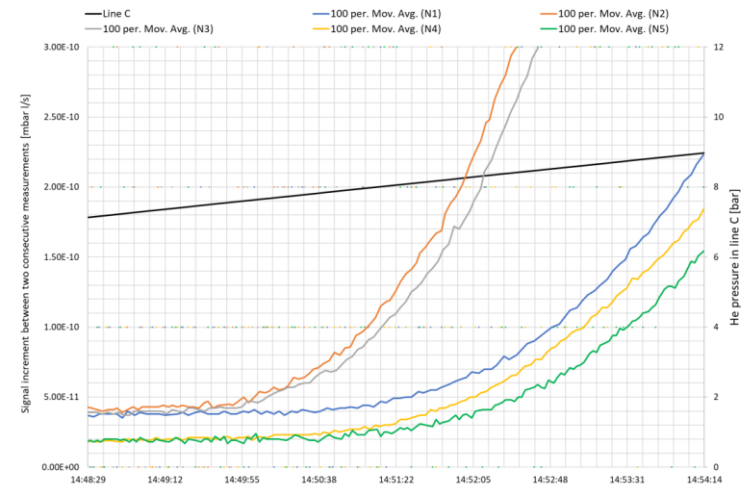
9) Close-up of the moment of the critical raise in the signal (moving average with the period of 100 (~4min))
