Update MBHA-001 test results of the first cool down

2019 December 4 – 11T technical meeting

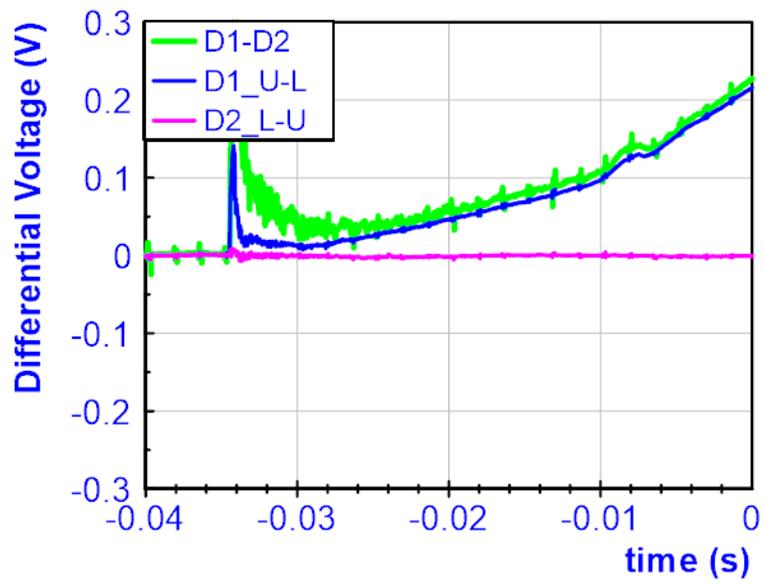
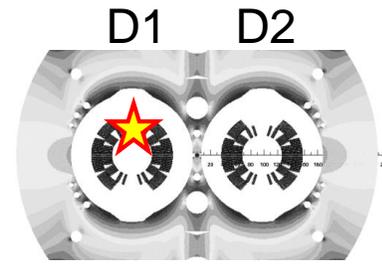
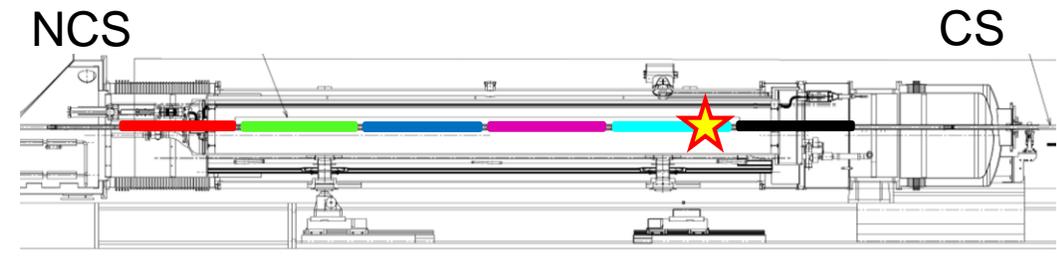
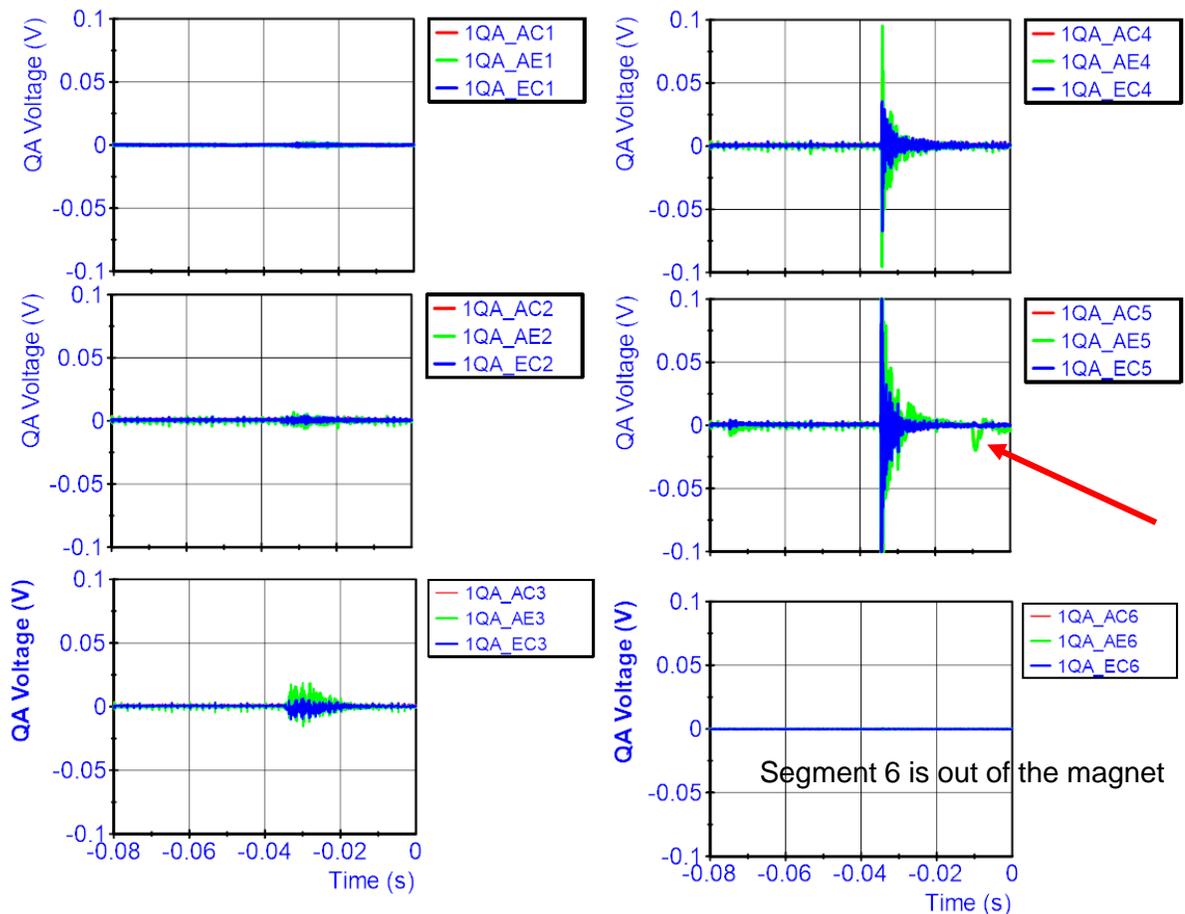
Quench 1: 7830 A @ 1.9 K

Aperture 1
Upper coil
Head connection side
Precursor: Mechanical origin

Quench propagation
QA 5A

Segment 6 is out of the magnet

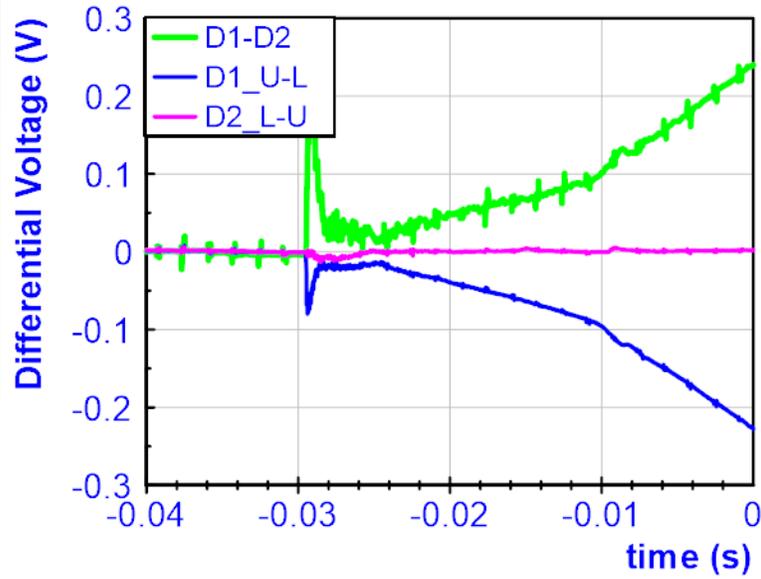
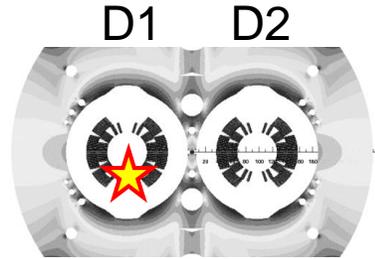
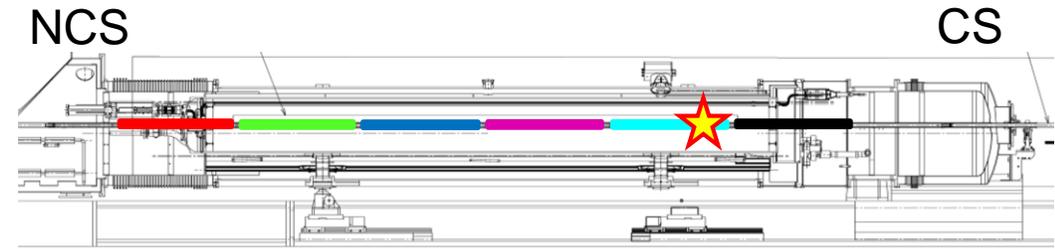
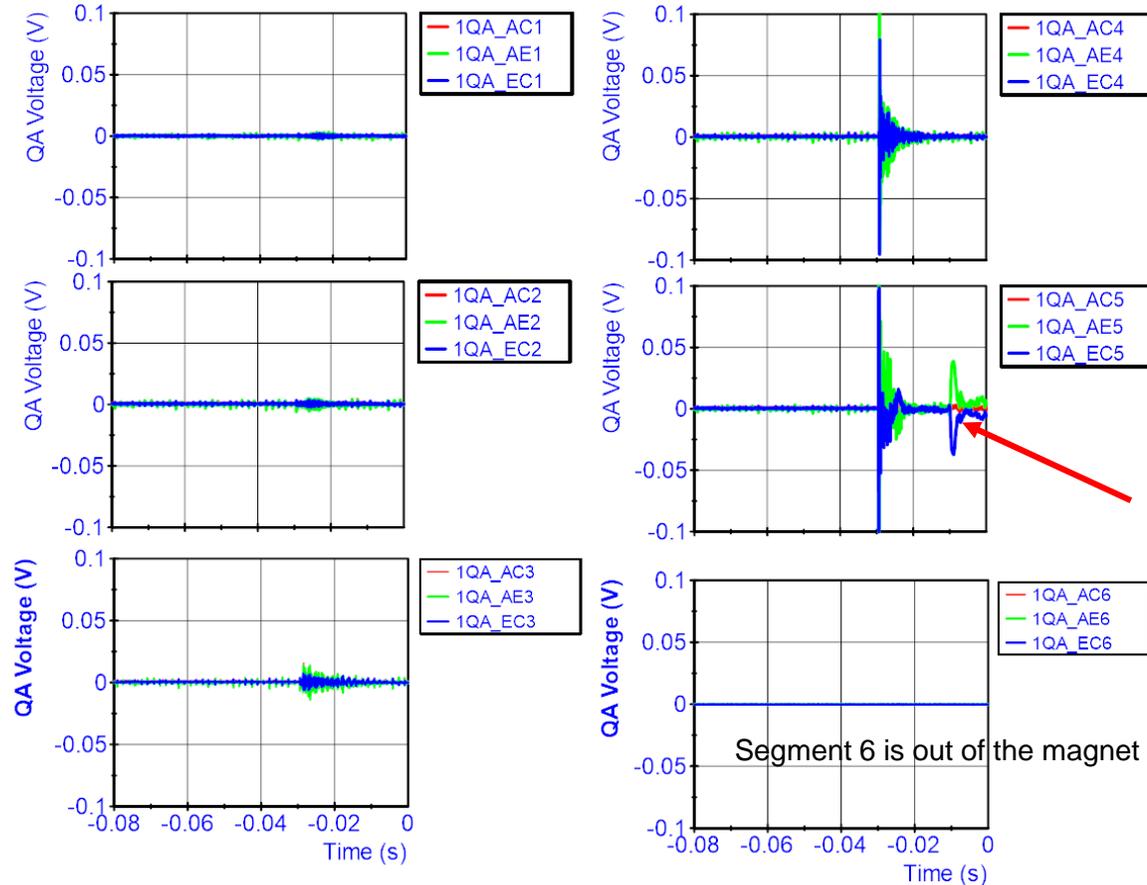
Quench 2: 8480 A @ 1.9 K

Aperture 1
 Lower coil
 Head connection side
 Precursor: Mechanical origin

Quench propagation
 QA 5E

Segment 6 is out of the magnet

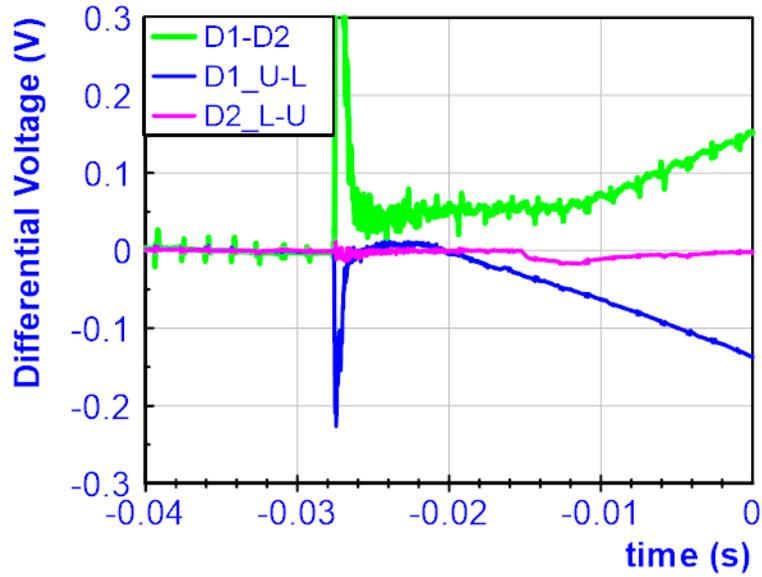
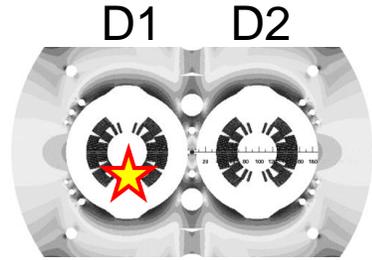
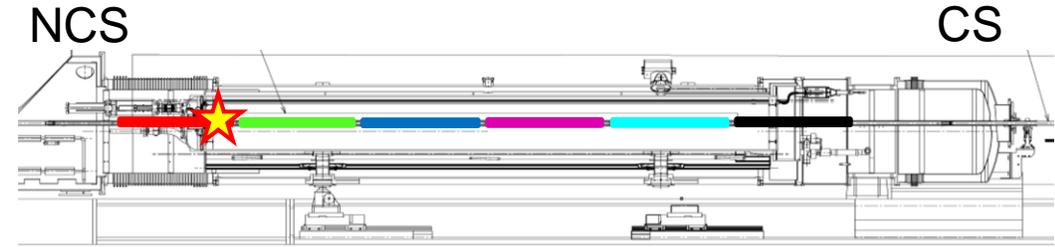
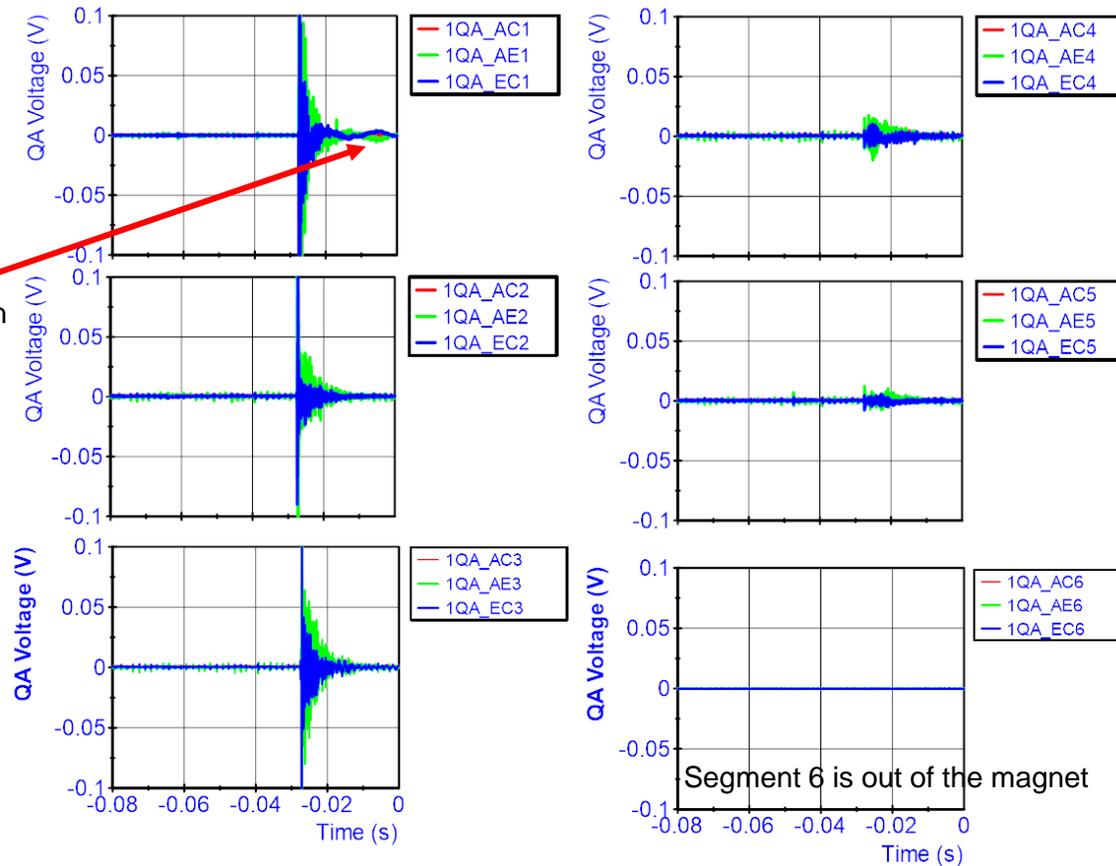
Quench 3: 9040 A @ 1.9 K

Aperture 1
Lower coil
Head non-connection side
Precursor: Mechanical origin

Quench propagation
QA 1E

Segment 6 is out of the magnet

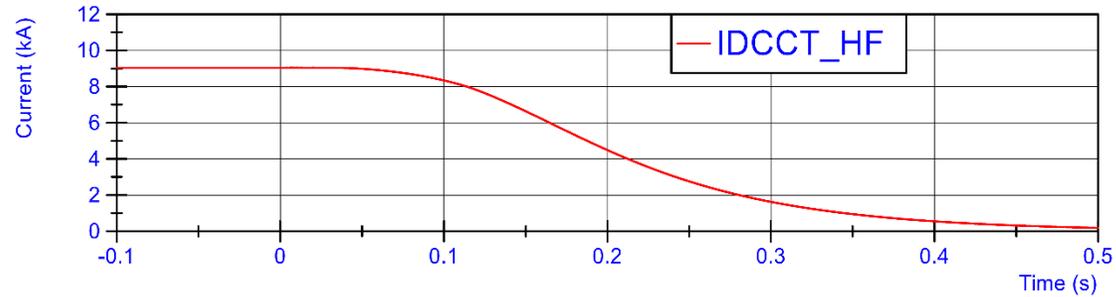
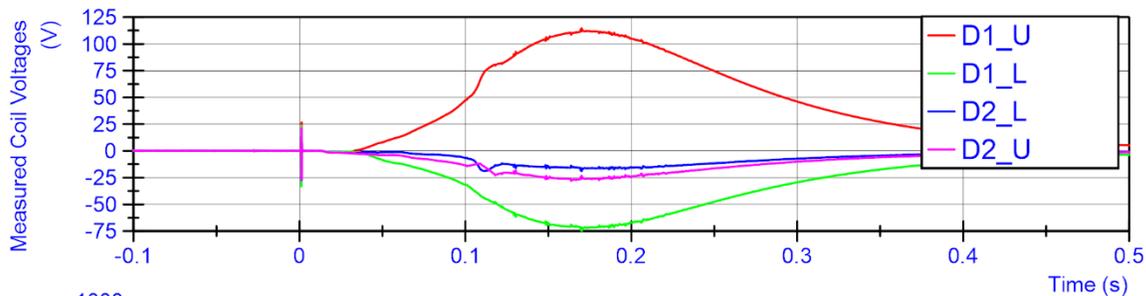
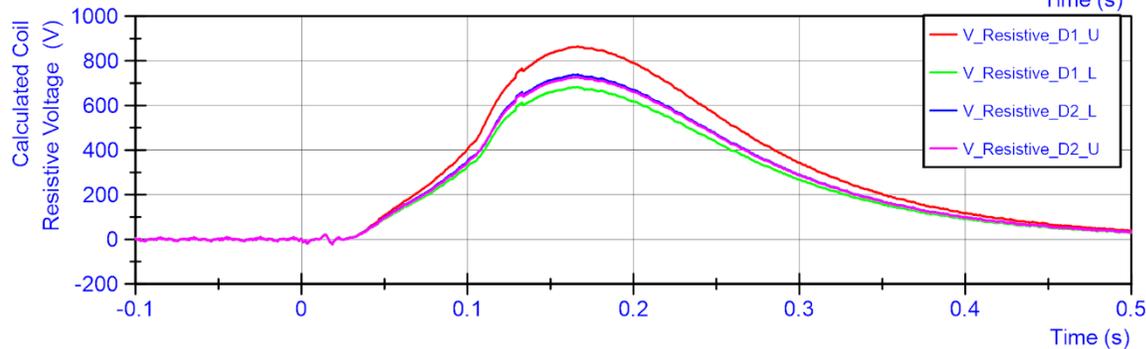
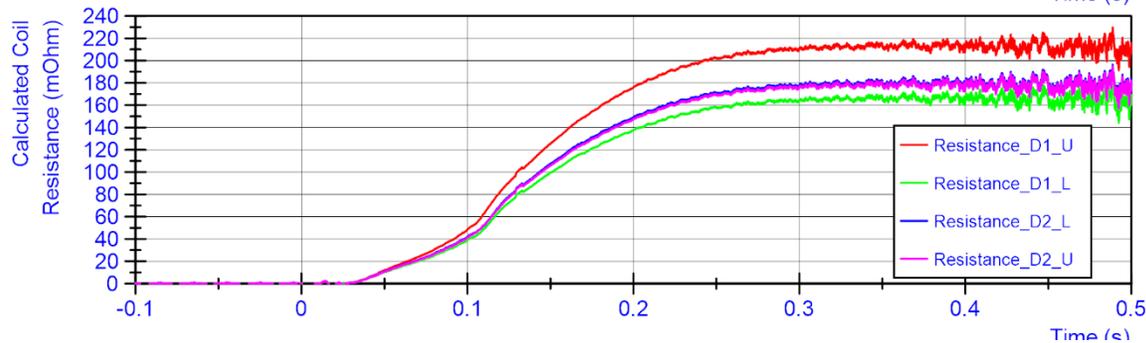
Current decay from 9 kA quench.
With the measured voltage and calculated inductive voltage, the resistive voltage can be calculated.

Consistent with R_20 K (or RRR) measurements, the resistance in coil D1_U is significantly higher than in the other coils.

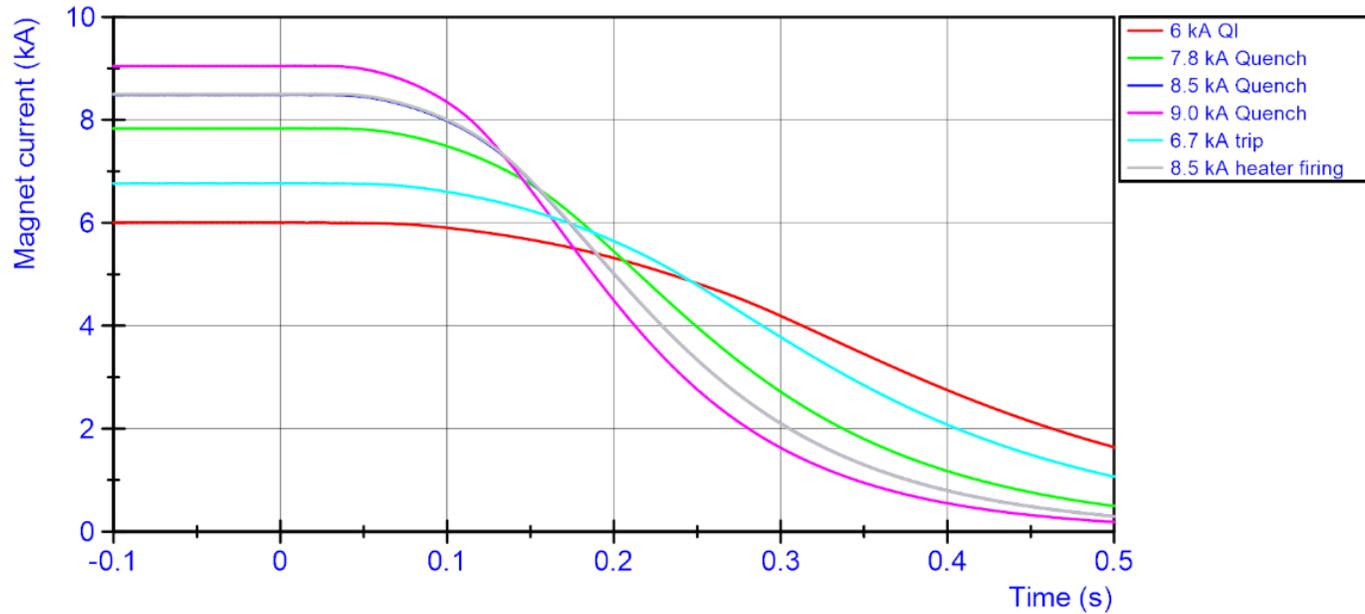
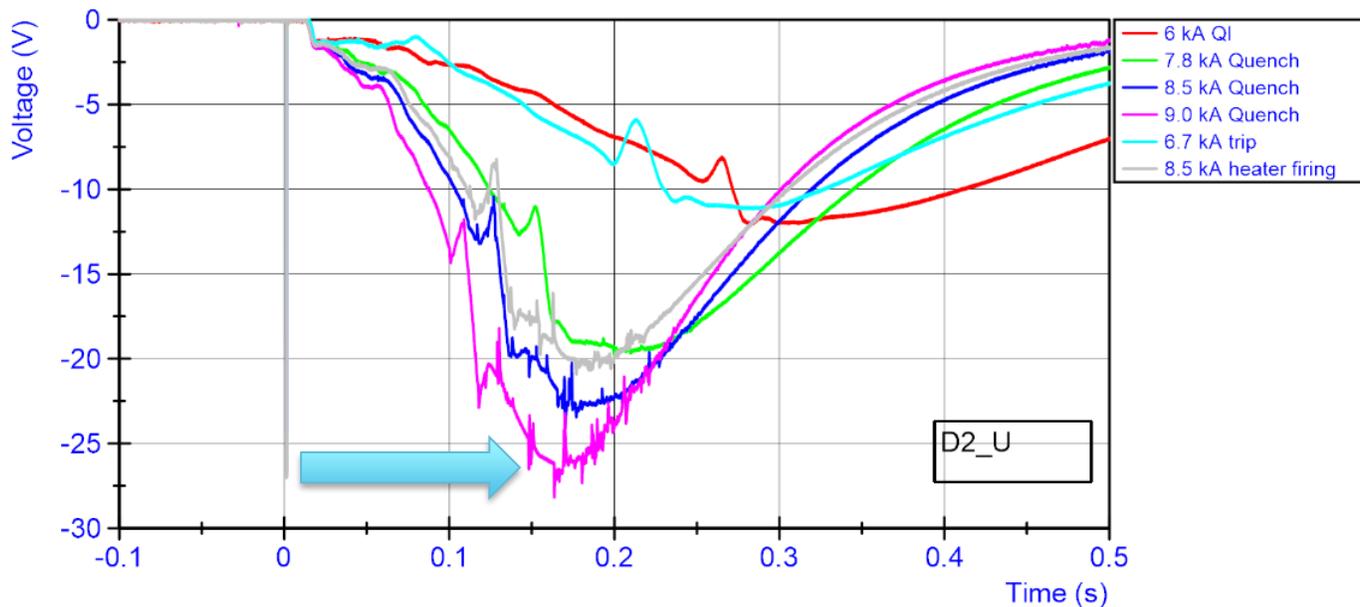
During current decay after a quench or heater firing we discovered spikes on the voltage of all coils, specifically above 8 kA.

Investigation started.

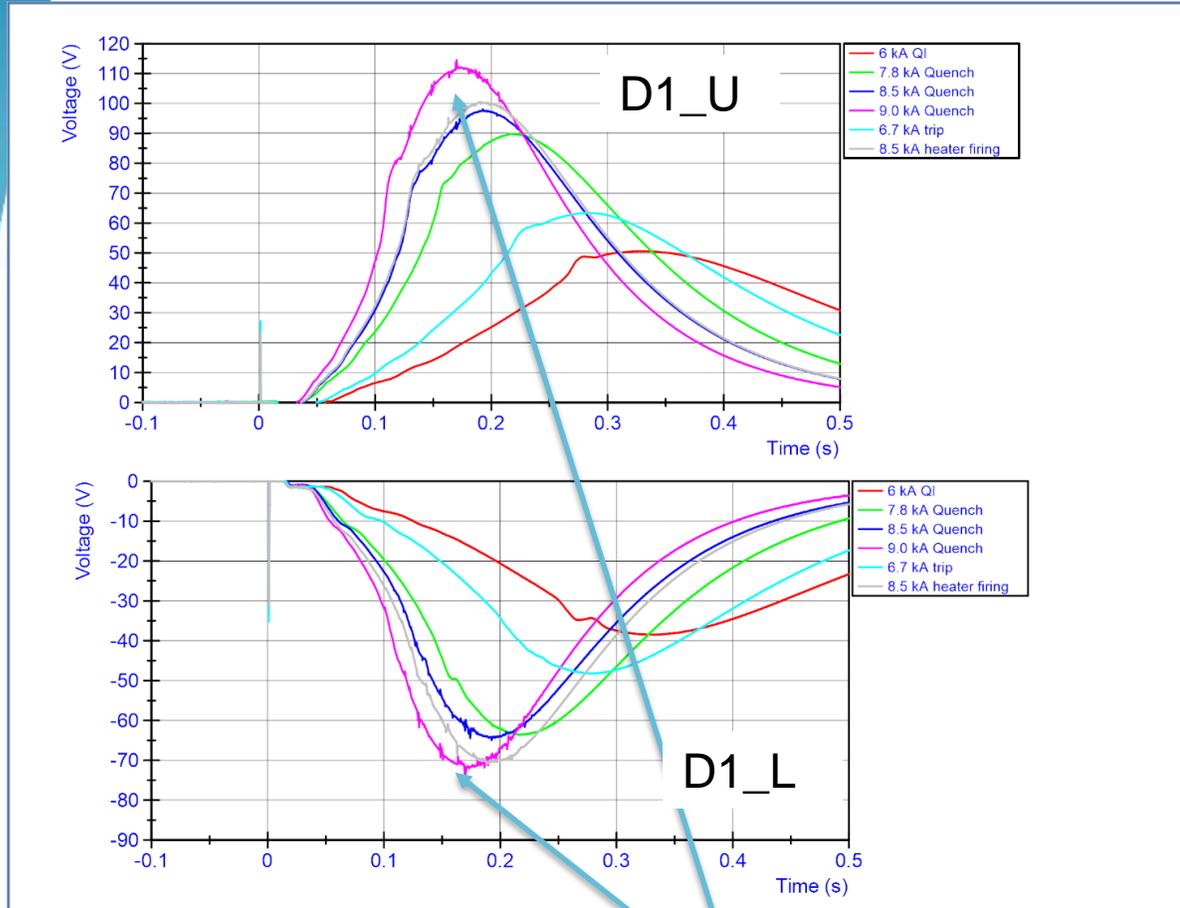
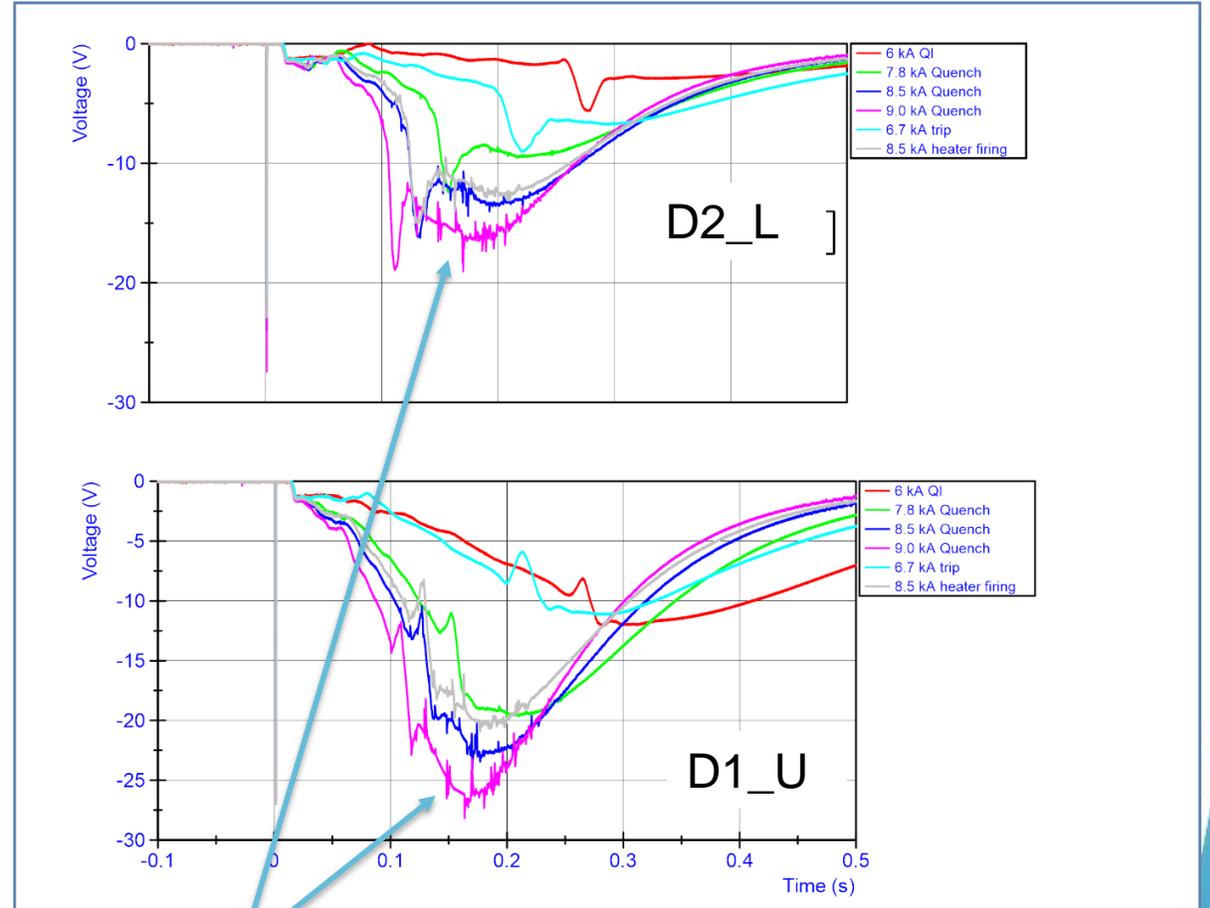
The spikes appear in all coils at the same moment.

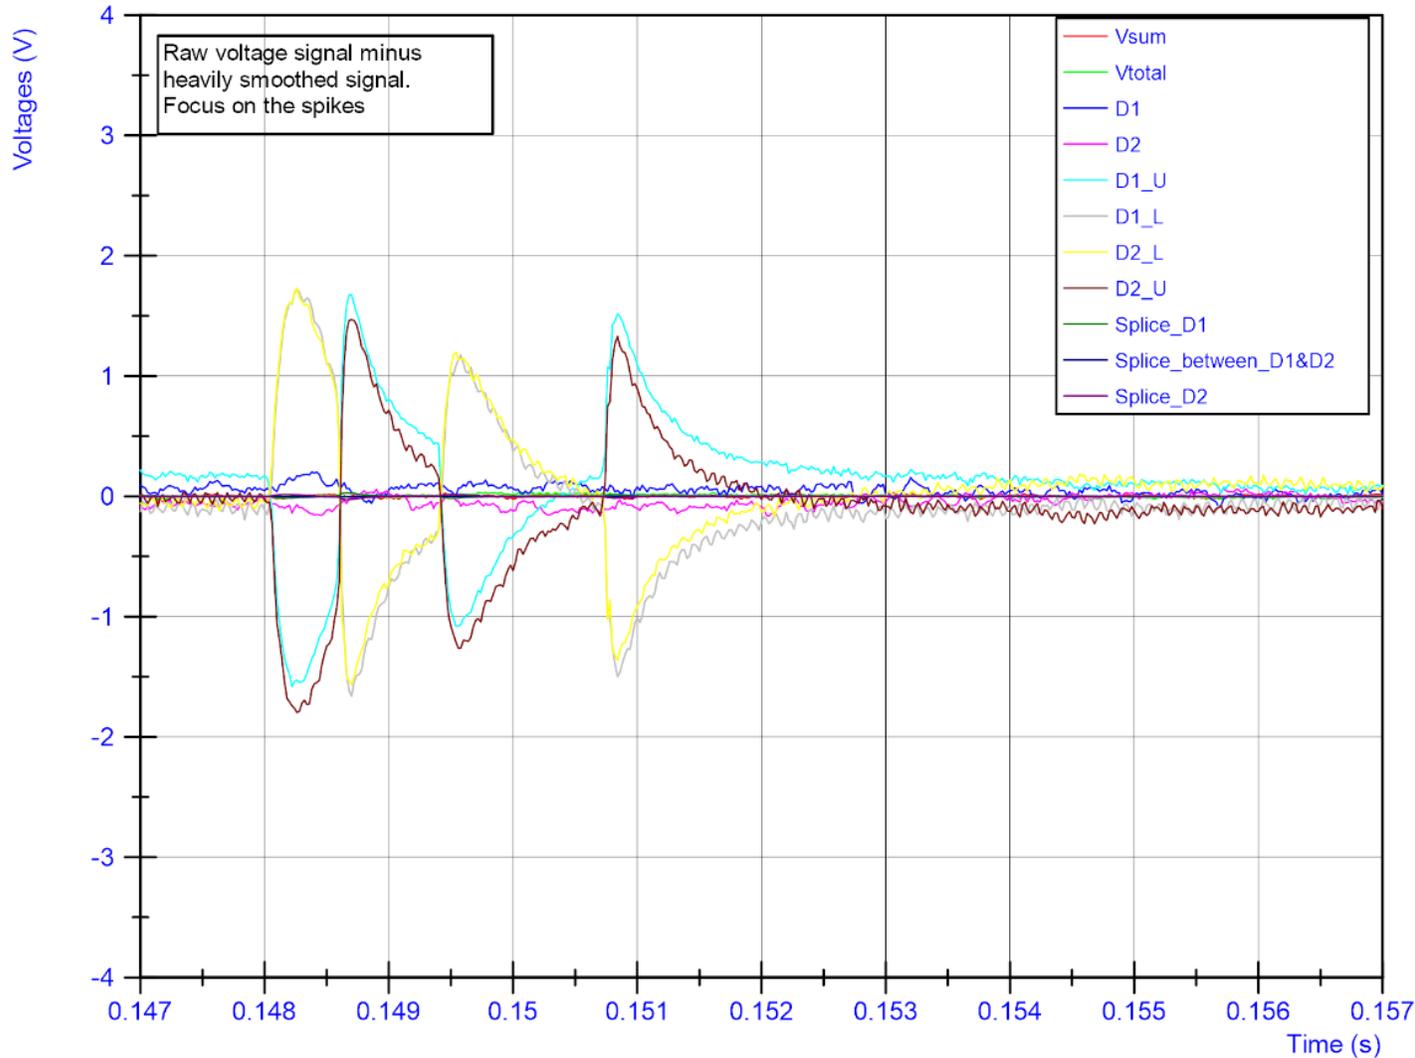
Removing roughly the quench voltage we keep only the spike voltages.

The spikes are symmetric:

D1_U and D2_U always have same sign and same amplitude.

D1_L and D2_L have the same amplitude, but opposite sign to the upper coils.

$D1_U + D1_L$ and $D2_U + D2_L$ show no spikes.

This symmetry, and the spikes appearing and disappearing give immediately the idea of an **intermittent short between the two inter-coil points**

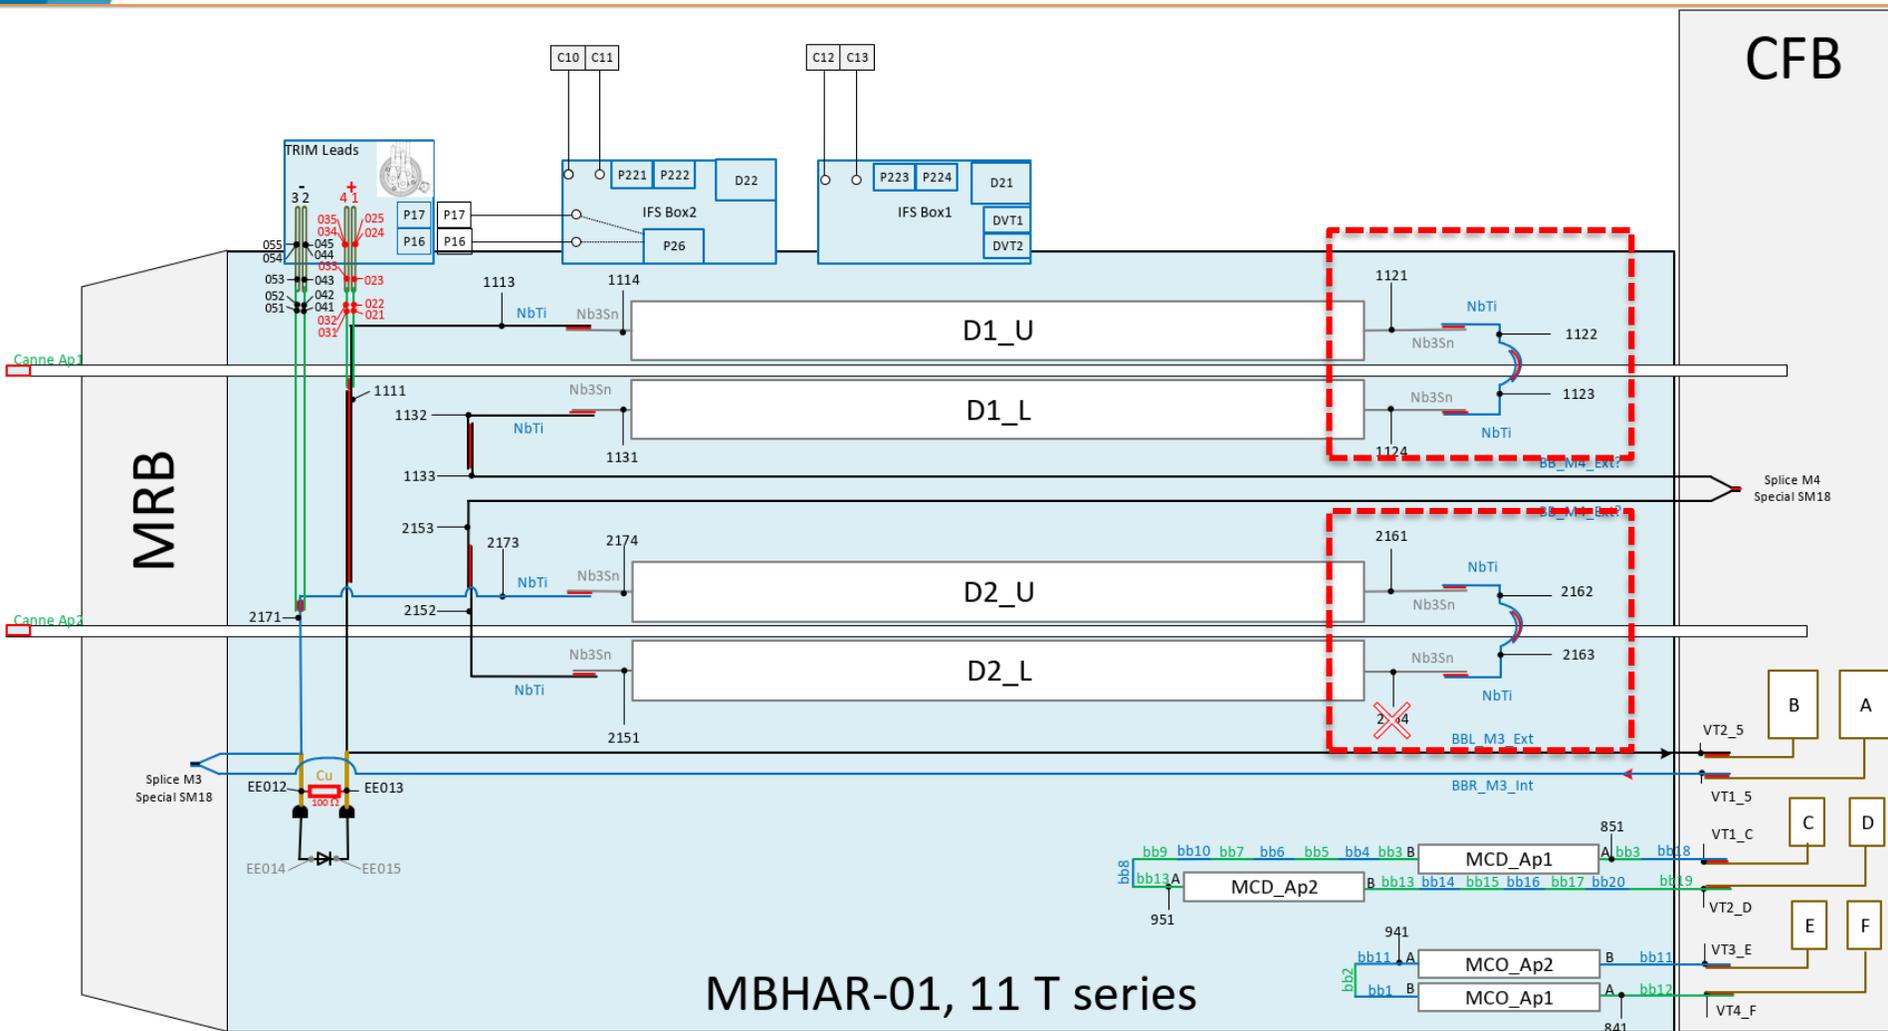
Discussion on origin of short

The analysis shows the short is between intercoil region of each aperture.

Only the wires towards and inside the capillary are physically close to each other, so they are suspected.

The suspected short is between one of the wires VT1121, VT1122, VT1123, VT1124 to one of the wires VT2161, VT2162, VT2163.

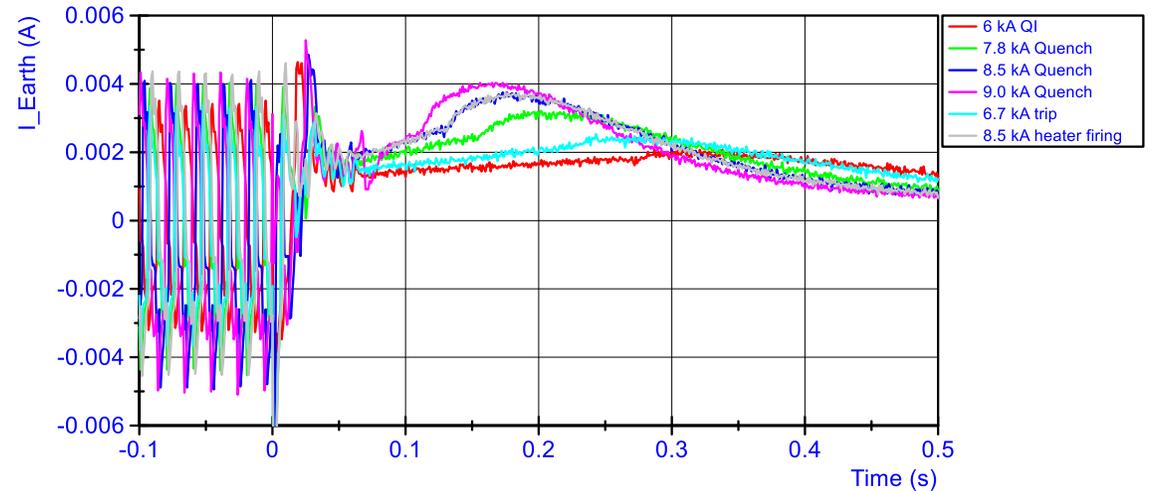
Earth current measurements shows nothing notable: no short to ground.

(note that the maximum V to ground is about 120 V during the 9 kA quench).

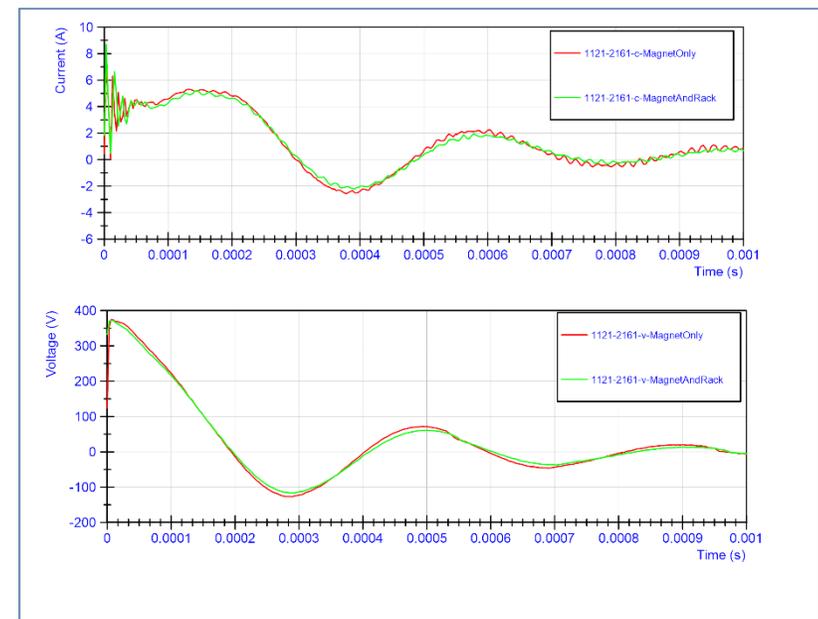
4uF Capacitive discharge up to 400 V (at 0 A in the magnet) over the suspected short did not show a sign of the short.

(Note that the maximum voltage over suspected short is 60 to 90 V during the quench).

Can we conclude that the short is not there at low current?

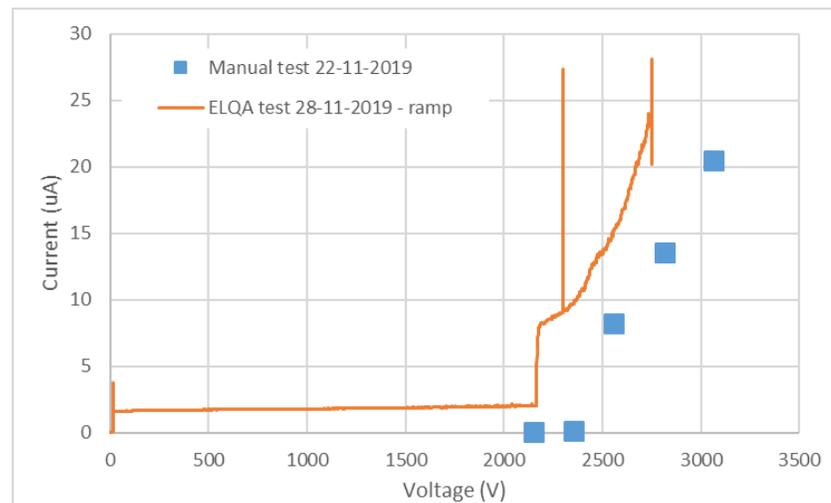
HV test before powering (22-november) failed for 3.3 kV from Coil to ground with a high (rather constant) leakage current.

Training was started and after the powering and quenches a new HV test campaign by the ELQA team was launched (November 28)

In the figure to the left, we find the same pattern in jump of the leakage current, but throughout tests the onset varied between 2 and 2.8 kV.

We will retest the test bench before christmas break (even though it was verified to 3.9 kV before the MBHA-001 test)
