ELQA tests of 11 T series
magnet

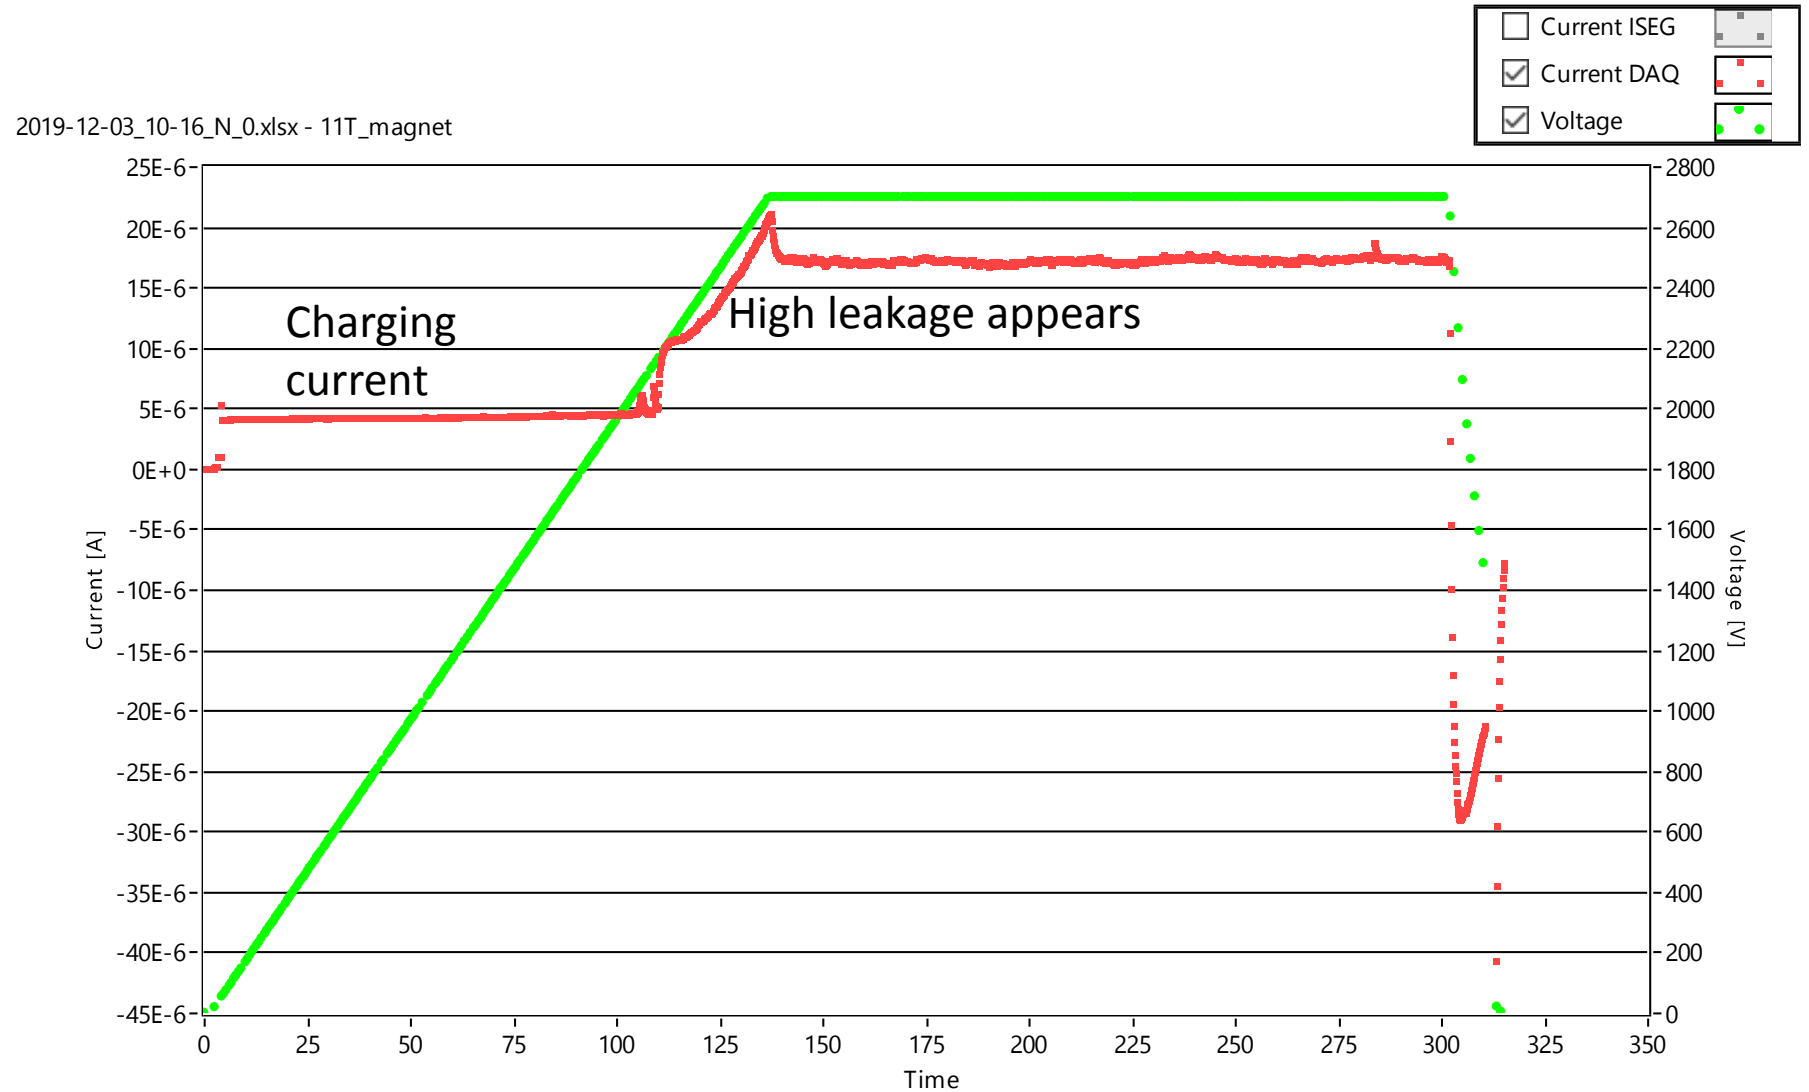
Test at 2700 V

- Voltage ramp rate 20 V/s
- Increased leakage current appeared at 2170 V

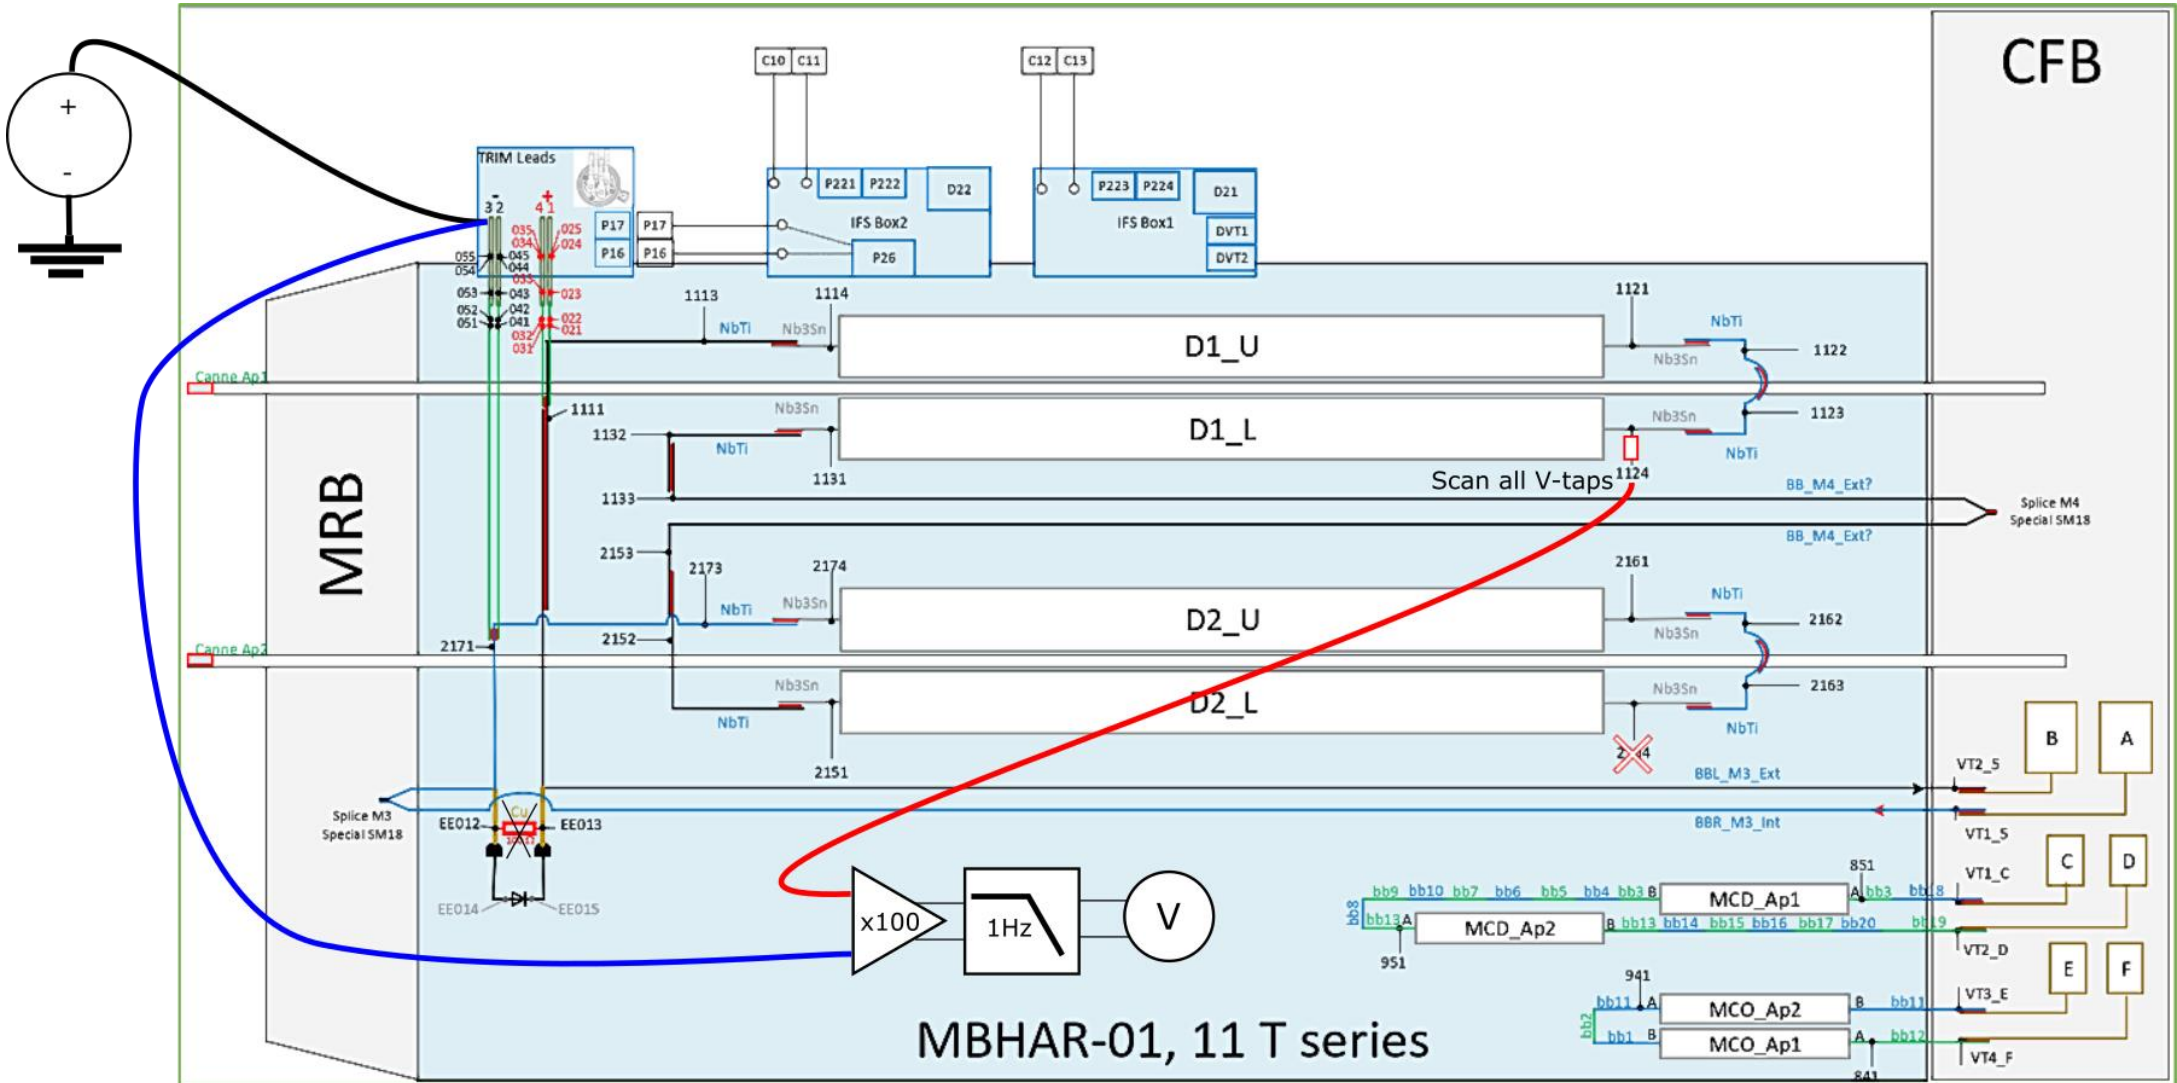
DC precision voltage measurements

- Not completely conclusive
- Not fully understood
- Grouping of V-taps observed

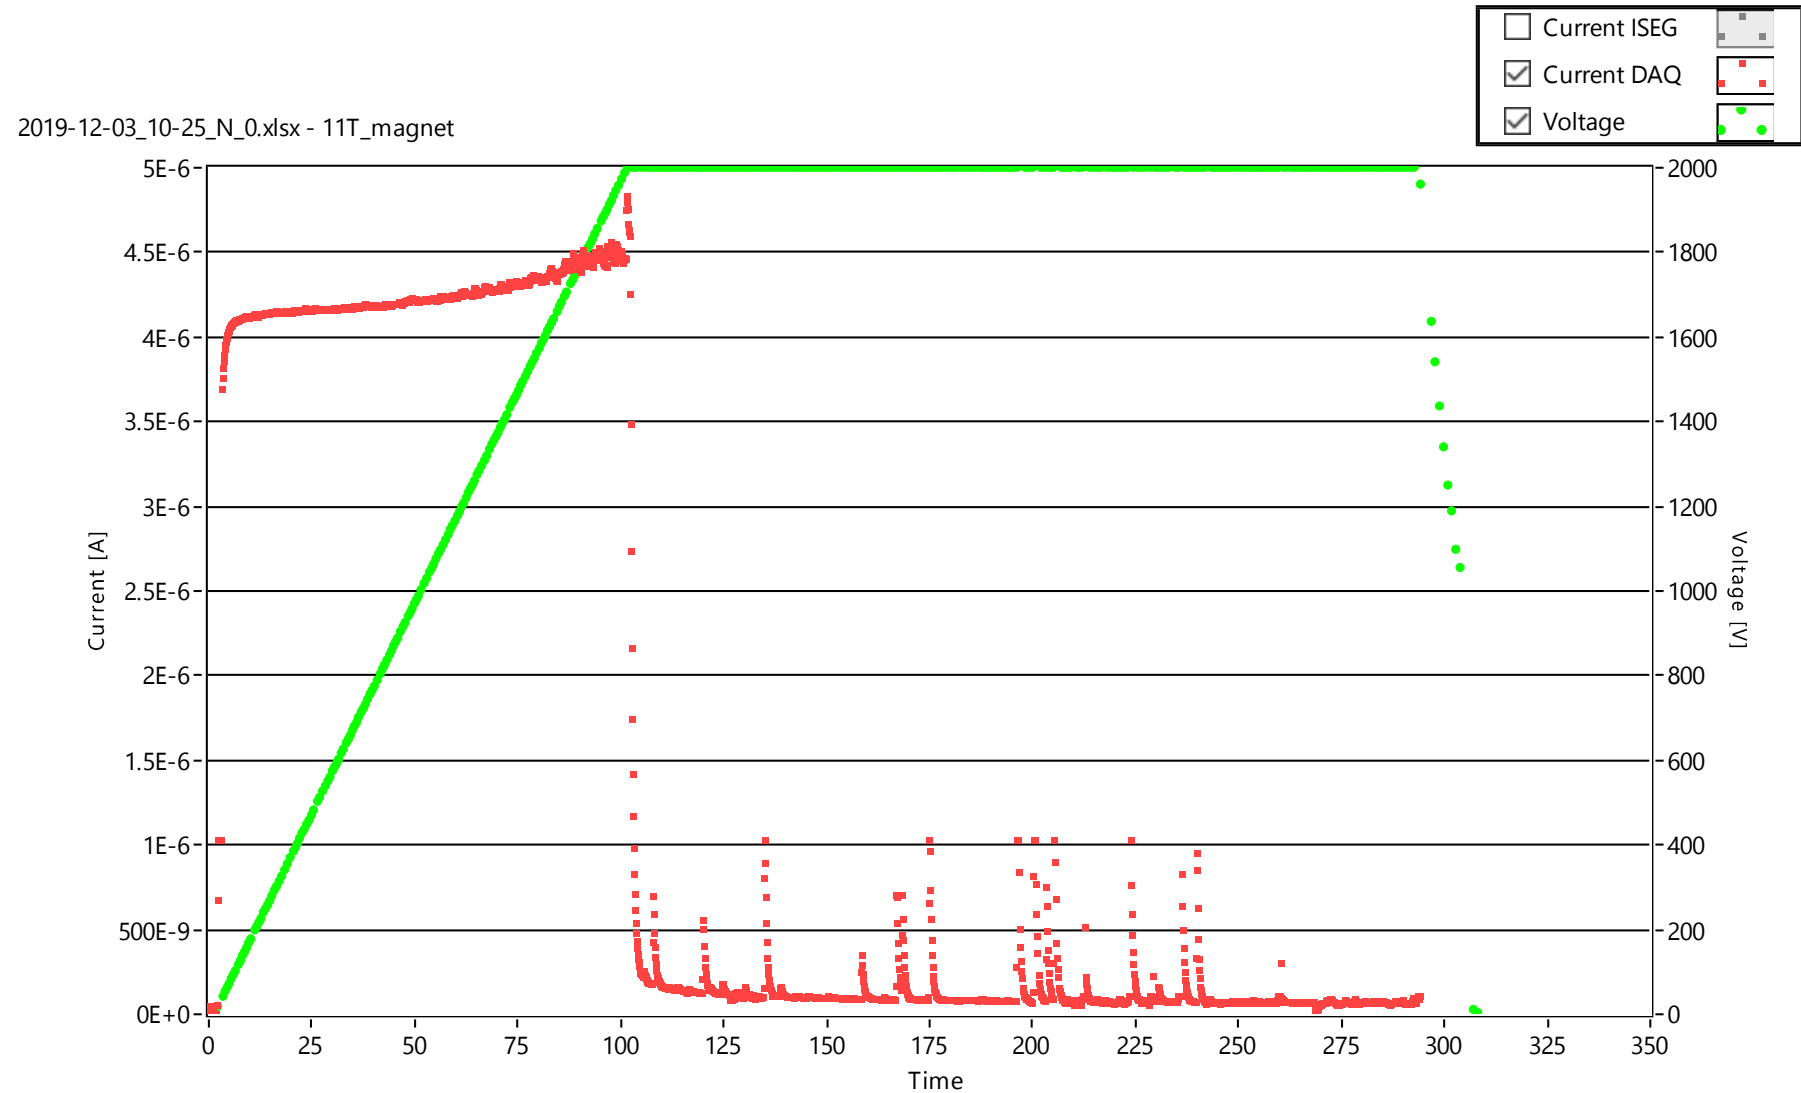
Test at 2000 V

- Partial discharge activity during the ramp and the plateau

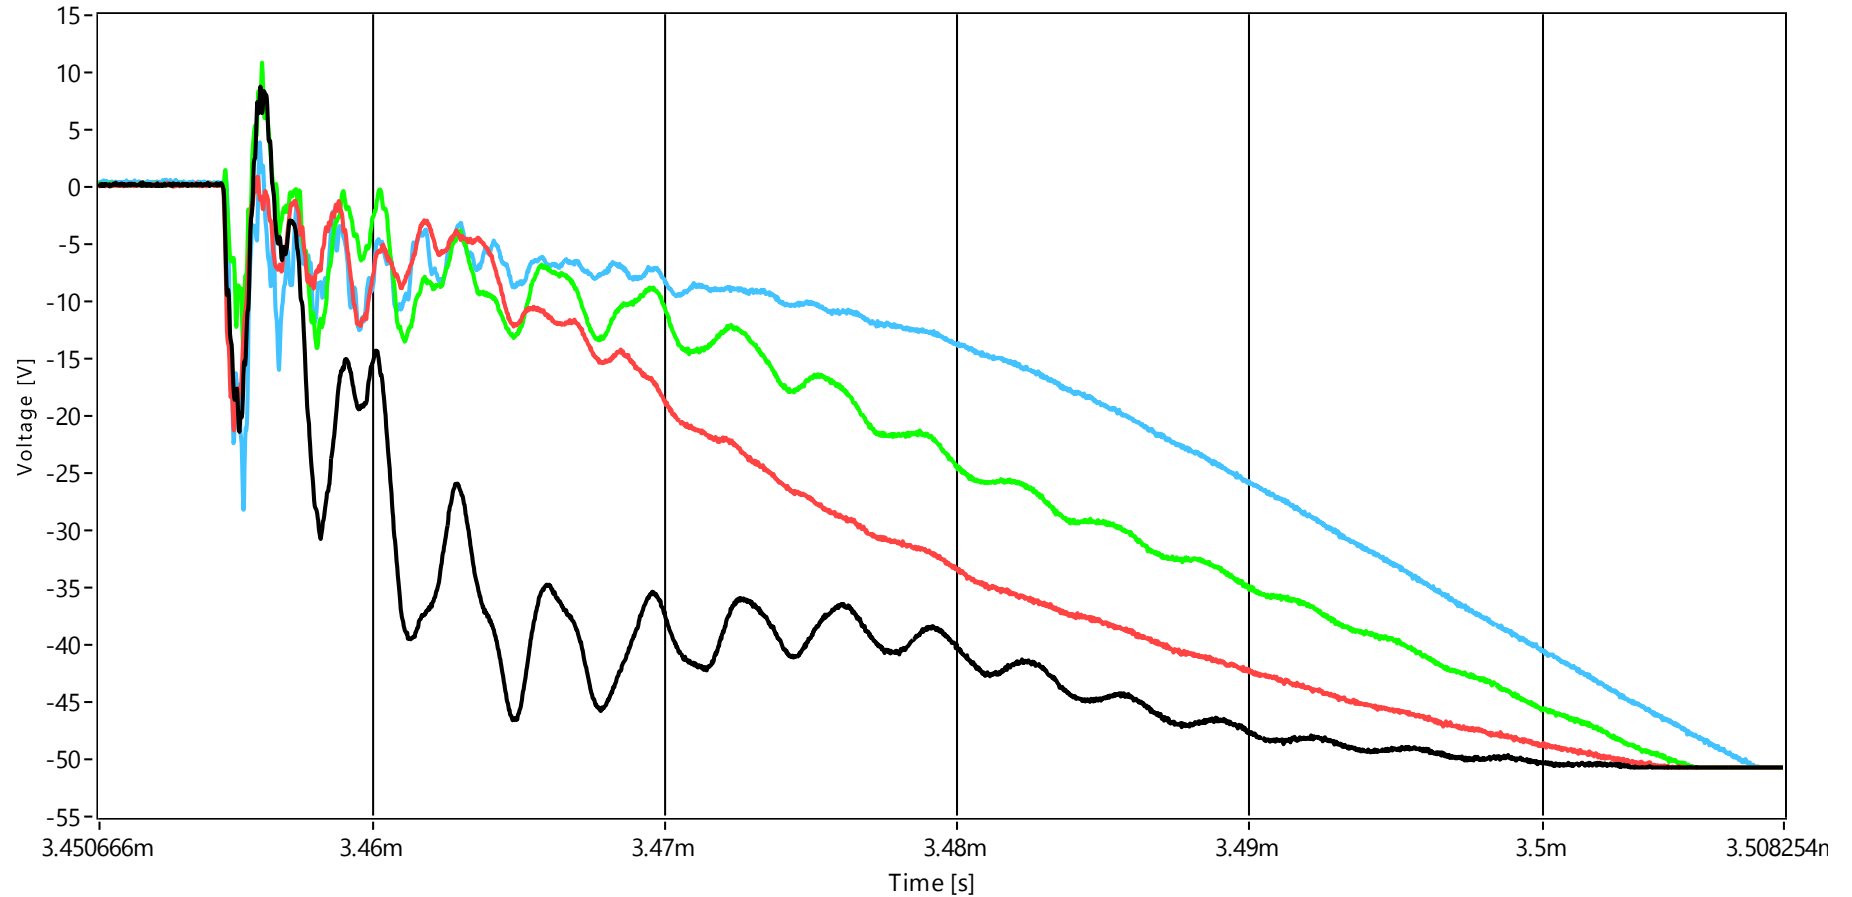
Scope data - 20191203_101021873Wfm

Short provoked at the trim lead 3, this is the expected behaviour of the circuit. The fault can be easily localised.

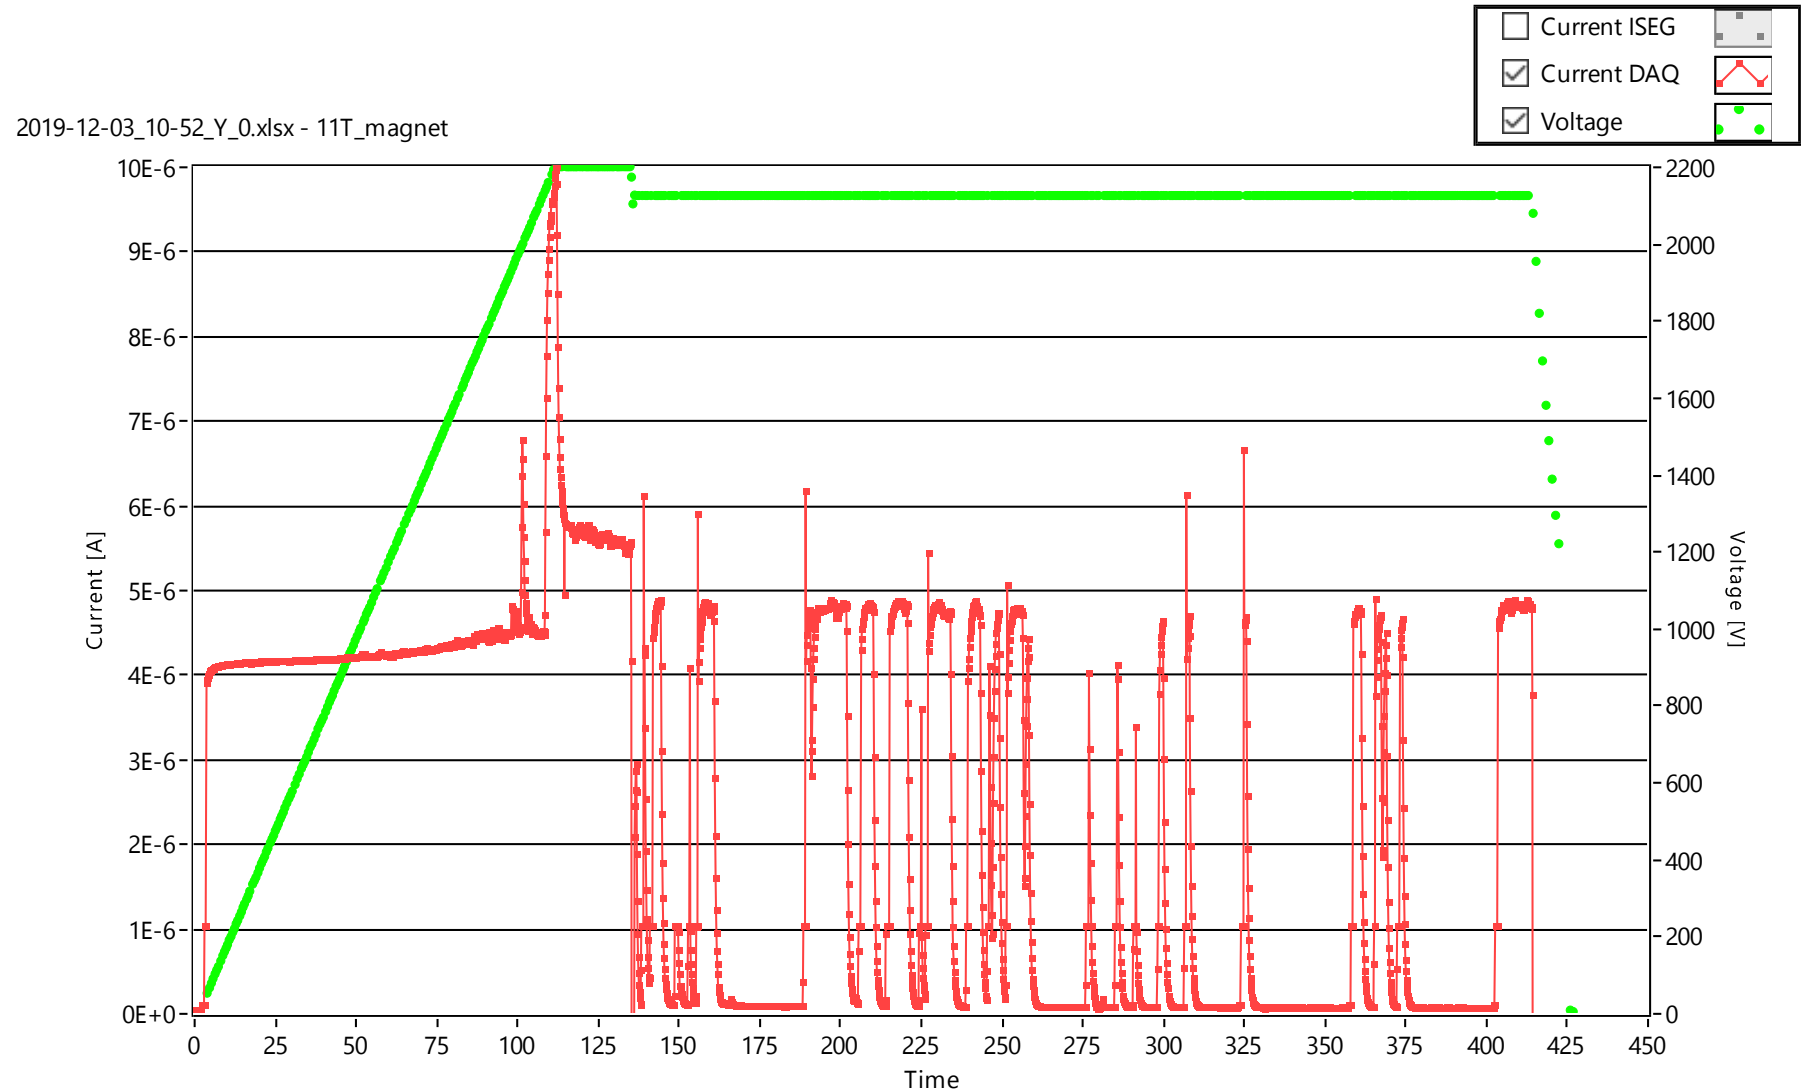
Strange activity at 2124 V

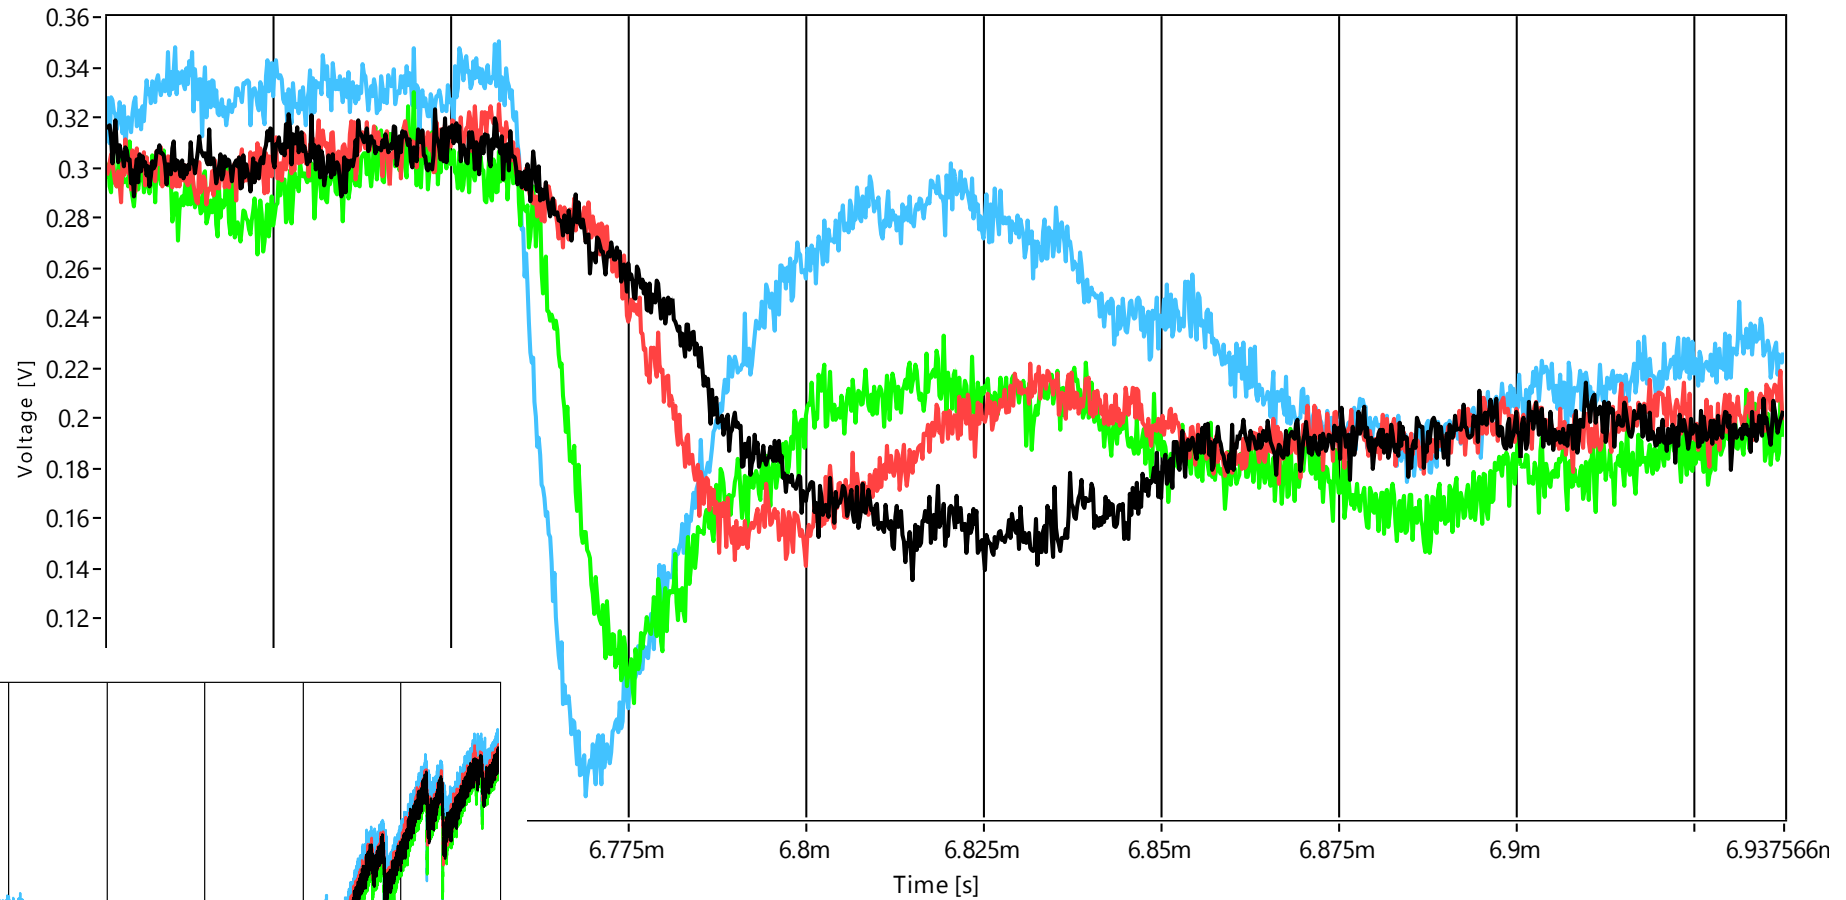
Scope data - 20191203_101642400Wfm

50 Hz noise chopped with fast transients, unknown origin, most likely external to the magnet

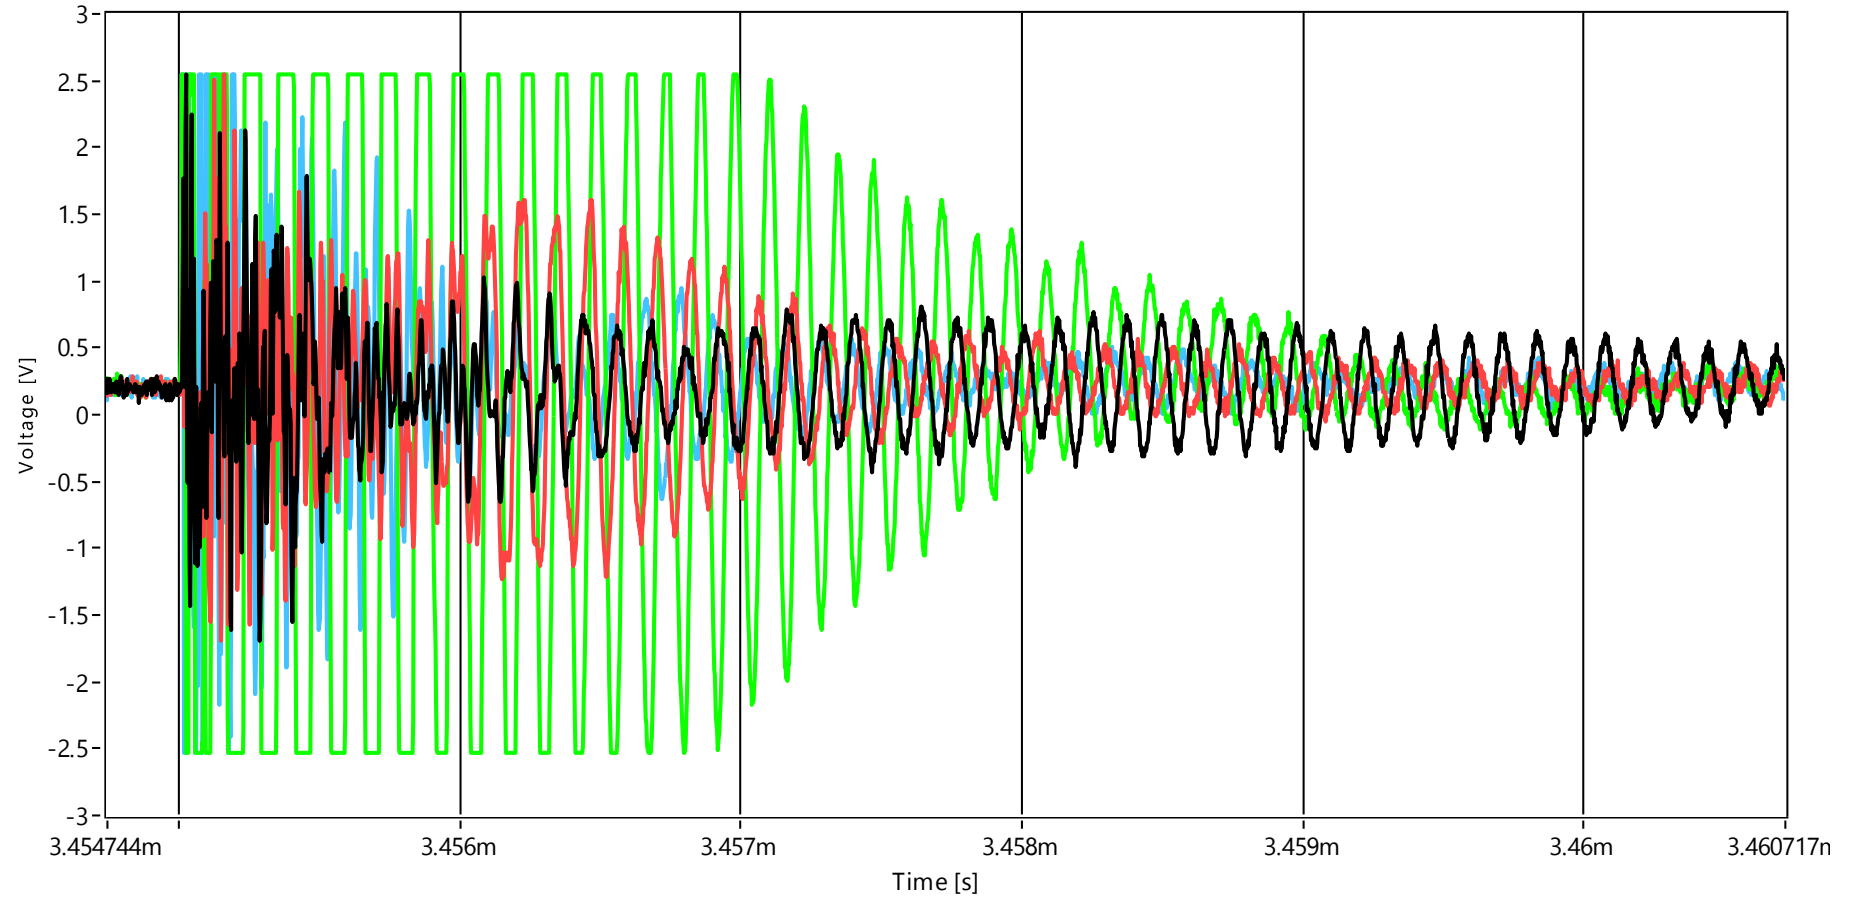
Scope data - 20191203_103533441Wfm

Fast transients,
provoked by partial
discharges.

Green curve
measured between
the coils of aperture 1

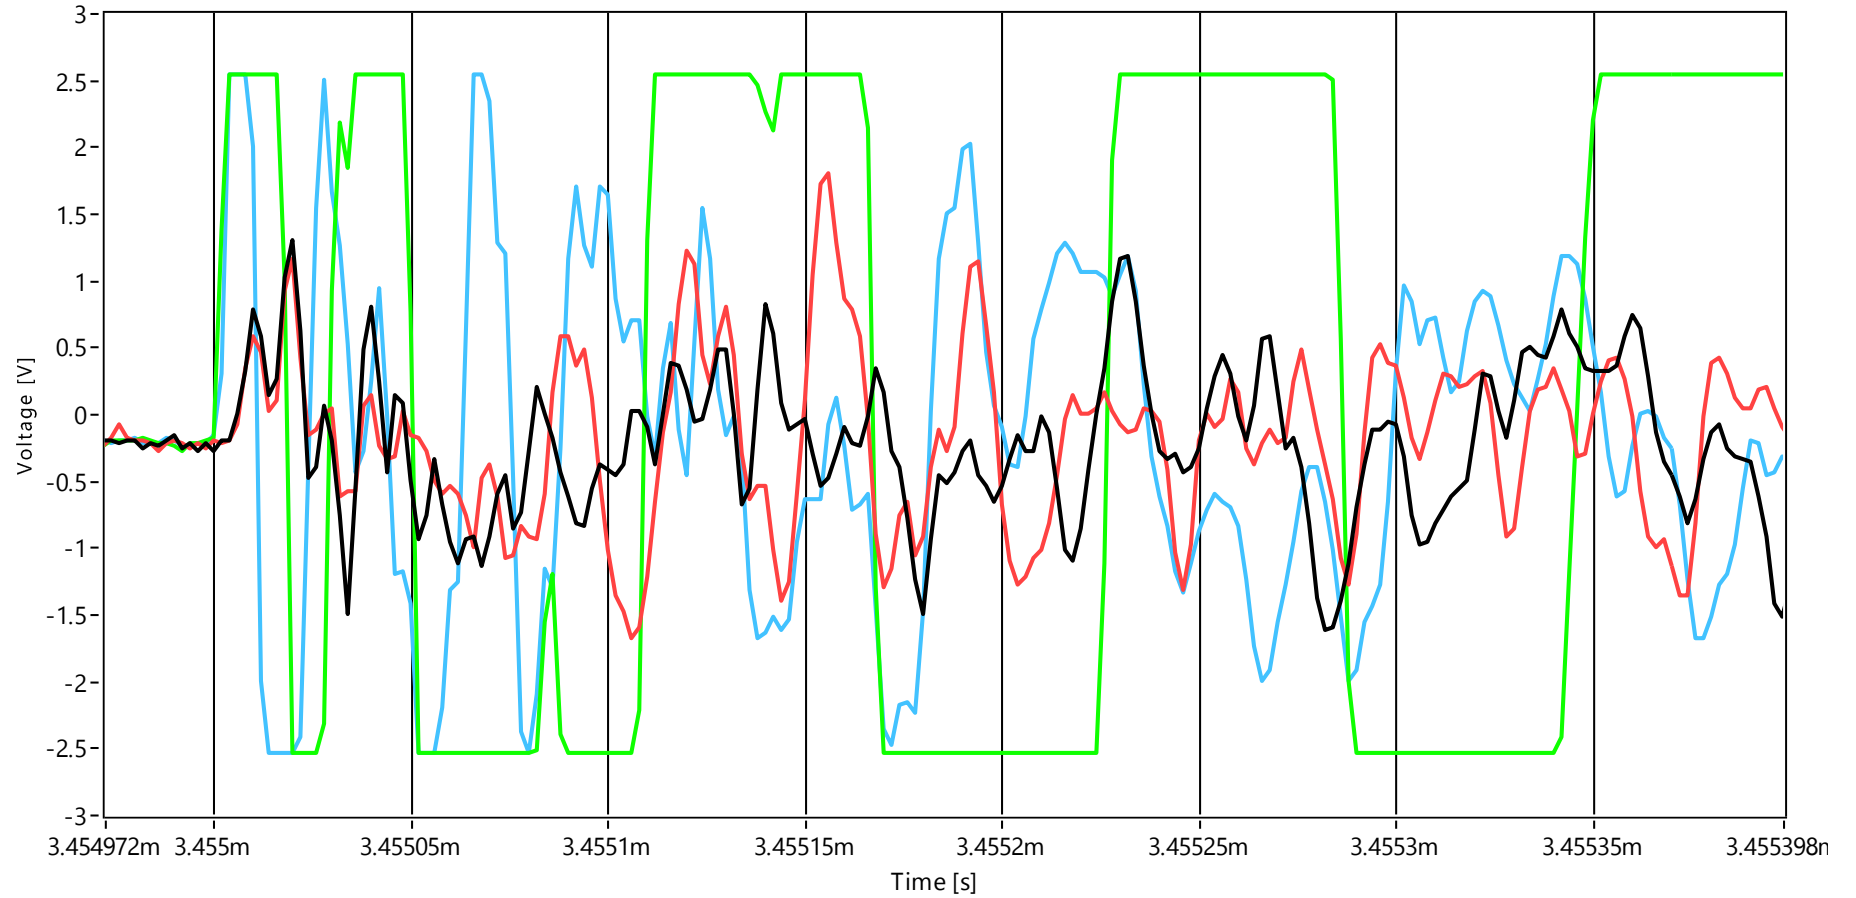
Scope data - 20191203_102828681Wfm

Fast transients,
provoked by partial
discharges.

Green curve
measured between
the coils of aperture 1

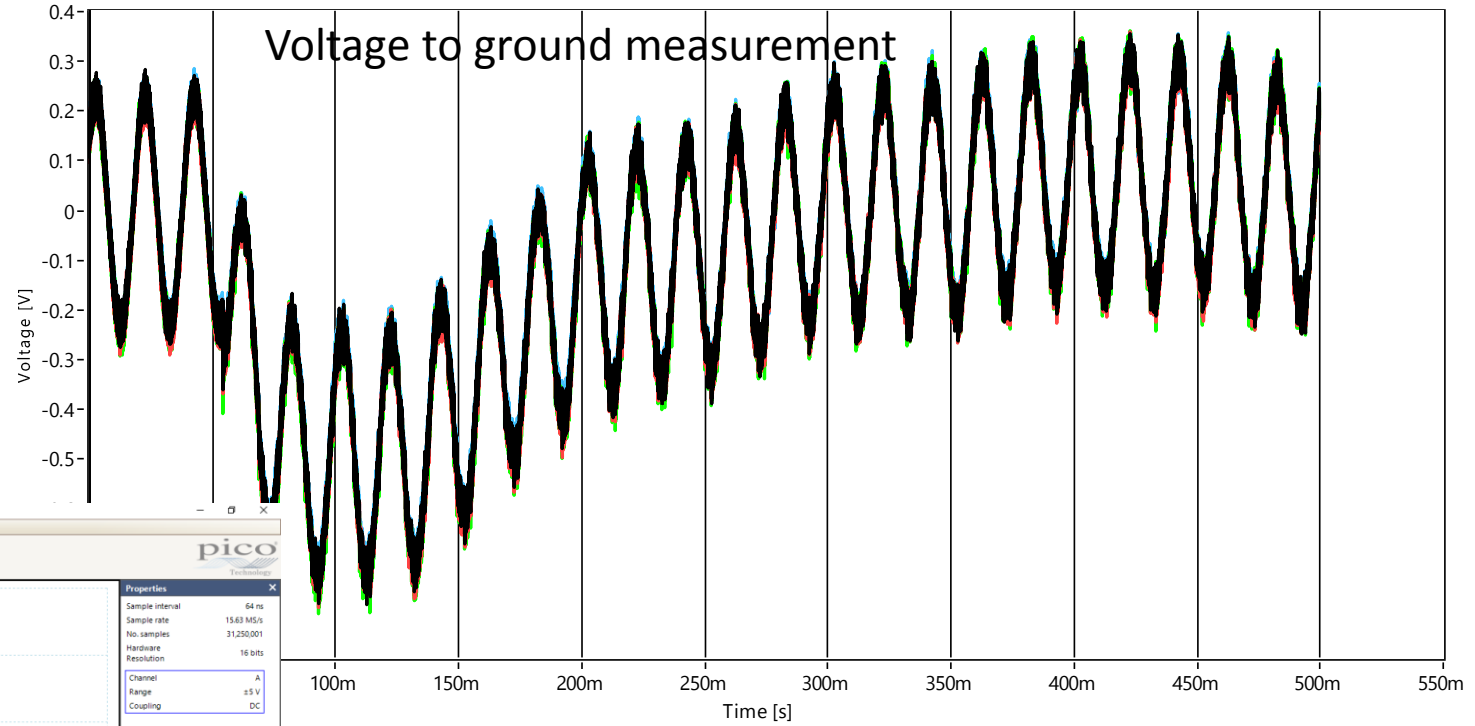
Scope data - 20191203_10533337Wfm

On-set of high leakage current is a slow process
