LMBHA001 - Electrical integrity Non-conformities at fabrication

QA.LMF 15/01/2020

11T Dipole Technical Meeting #22

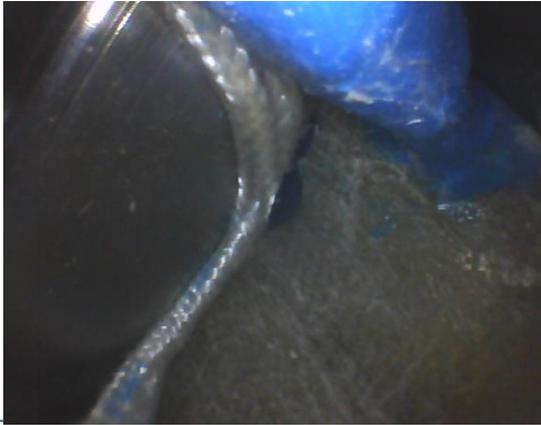
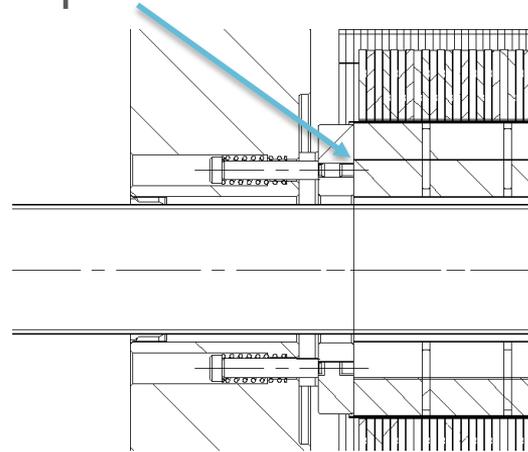
- Link: <https://edms.cern.ch/document/2226886>
- Defect detected @750V during HV tests.
- An endoscopy showed that 2 wires are damaged:
 - EE2161 is pinched between the plate and the coil's saddle

- Disposition:
 - EE2164: the wire is not replaced
 - The extremity was insulated with a polyimide tube ($\varnothing 3$) filled with Eccobond.

- The damaged glass fibre sleeve is removed and trimmed.

- A new sleeve is slid on, then glued with Eccobond

- The repairs were validated with a HV test at 3.3kV during 2min.

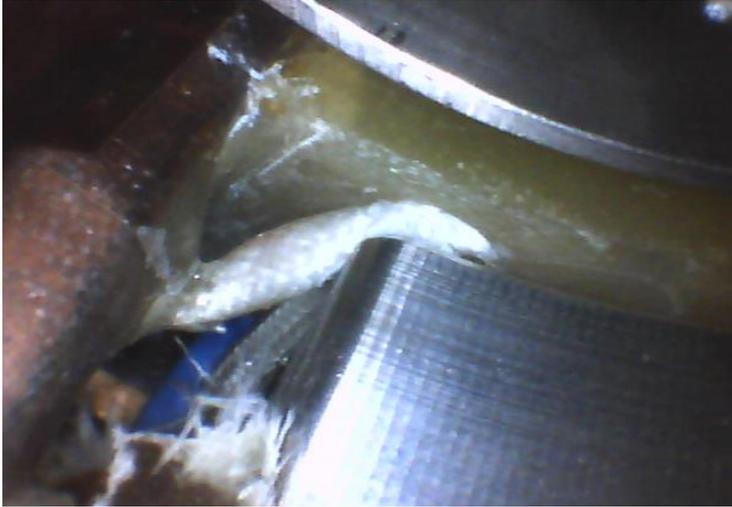
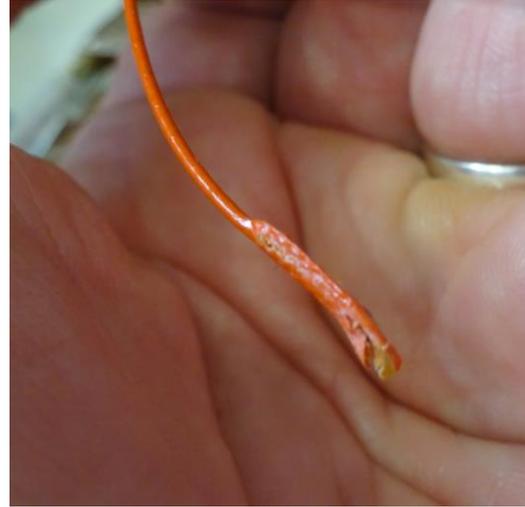
- EE2164 is pinched between the plate and the coil's saddle (wire cut)

- A 2nd polyimide tube ($\varnothing 5$) is applied over the first.

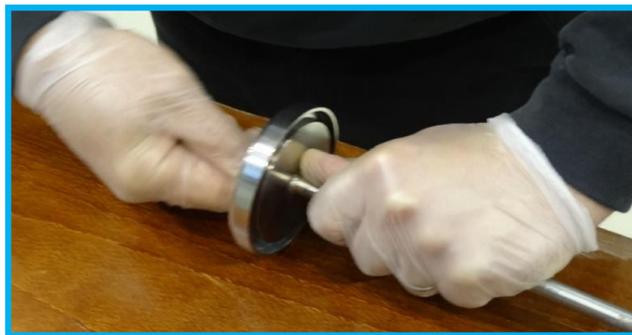
- Link: <https://edms.cern.ch/document/2263516>
- Inserting the IFS wires in the capillary tube was difficult.

- Defect detected @2000V during HV test.
- After inspection, the insulation of 3 wires was damaged because of sharp edges of the pipe at the entry point of the capillary.

- Disposition:
 - The 3 wires were repaired (as described in the IFS repair procedure <https://edms.cern.ch/document/1430439>).
 - It was agreed by the WPE to resume the electrical tests at 3.2kV to avoid a risk of a short to ground in the IFS.

- NCR2:
 - Cleaning and an inspection are added before the wires are inserted (operations 6.17 and 6.18 (<https://edms.cern.ch/document/1990289/0.2>)).
 - As requested, any NCR calling for a lower HV test level should be raised as critical and should be agreed with all stakeholders (e.g., MCF, MEB, MP3).

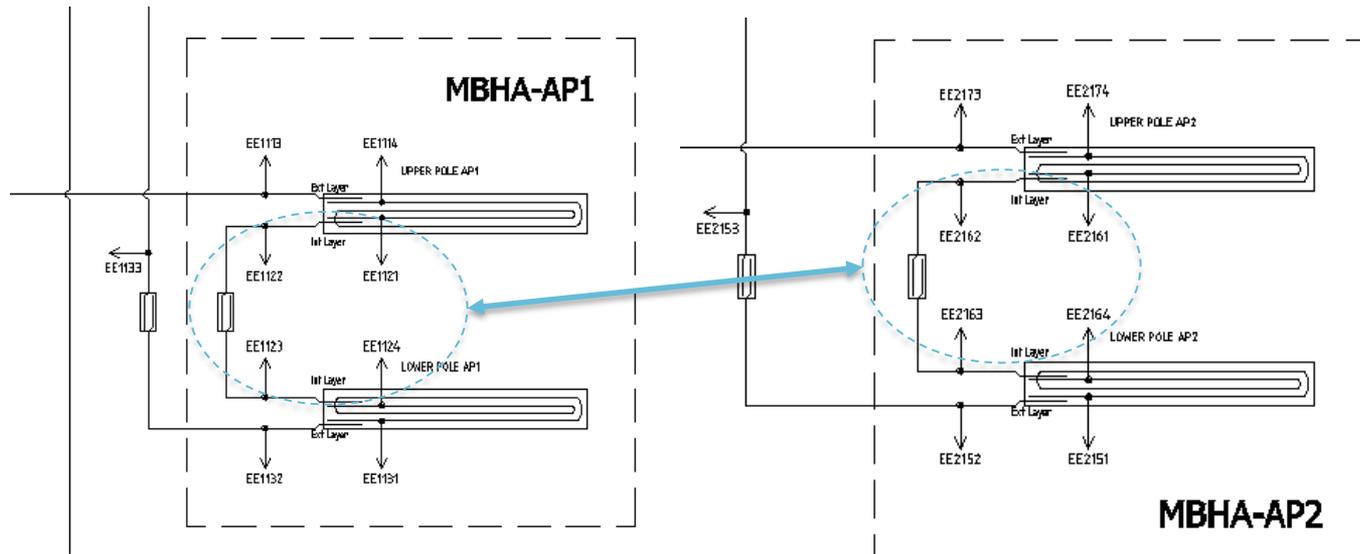
- Defect 2: In quench 2 and 3 unusual spikes were seen on the voltage signals.
 - Further investigations (EDMS 2281449): It seems most likely that wire 1121, 1122, 1123 or 1124 is touching one wire 2161, 2162 or 2163 somewhere in the bundle of wires, possibly in the capillary (EDMS 2281449).

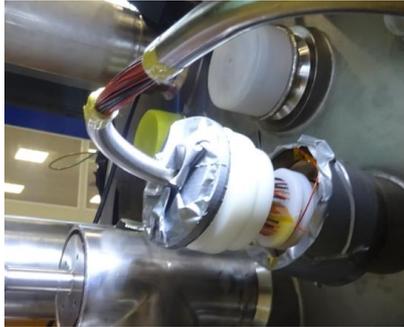
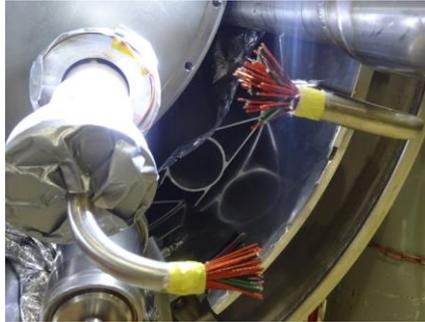
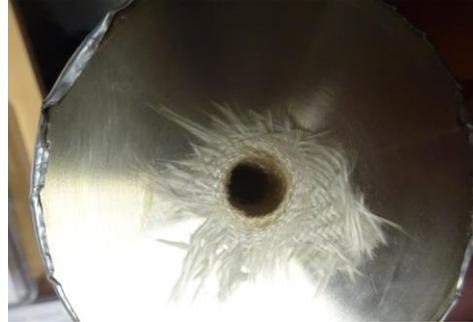
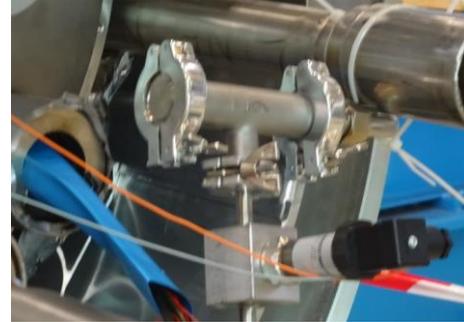
- Investigation:
 - The capillary tube is being dismantled:

- Several electrical tests were performed meanwhile under different conditions (Voltage, injection of He...). Those tests didn't reveal any defects.
- Several visual inspections were carried out:
 - Endoscopy in the flat cover,
 - Visual inspection of the wires near the cold head,
 - Visual inspection of the wires in the warm head (after cutting the cover flanges).

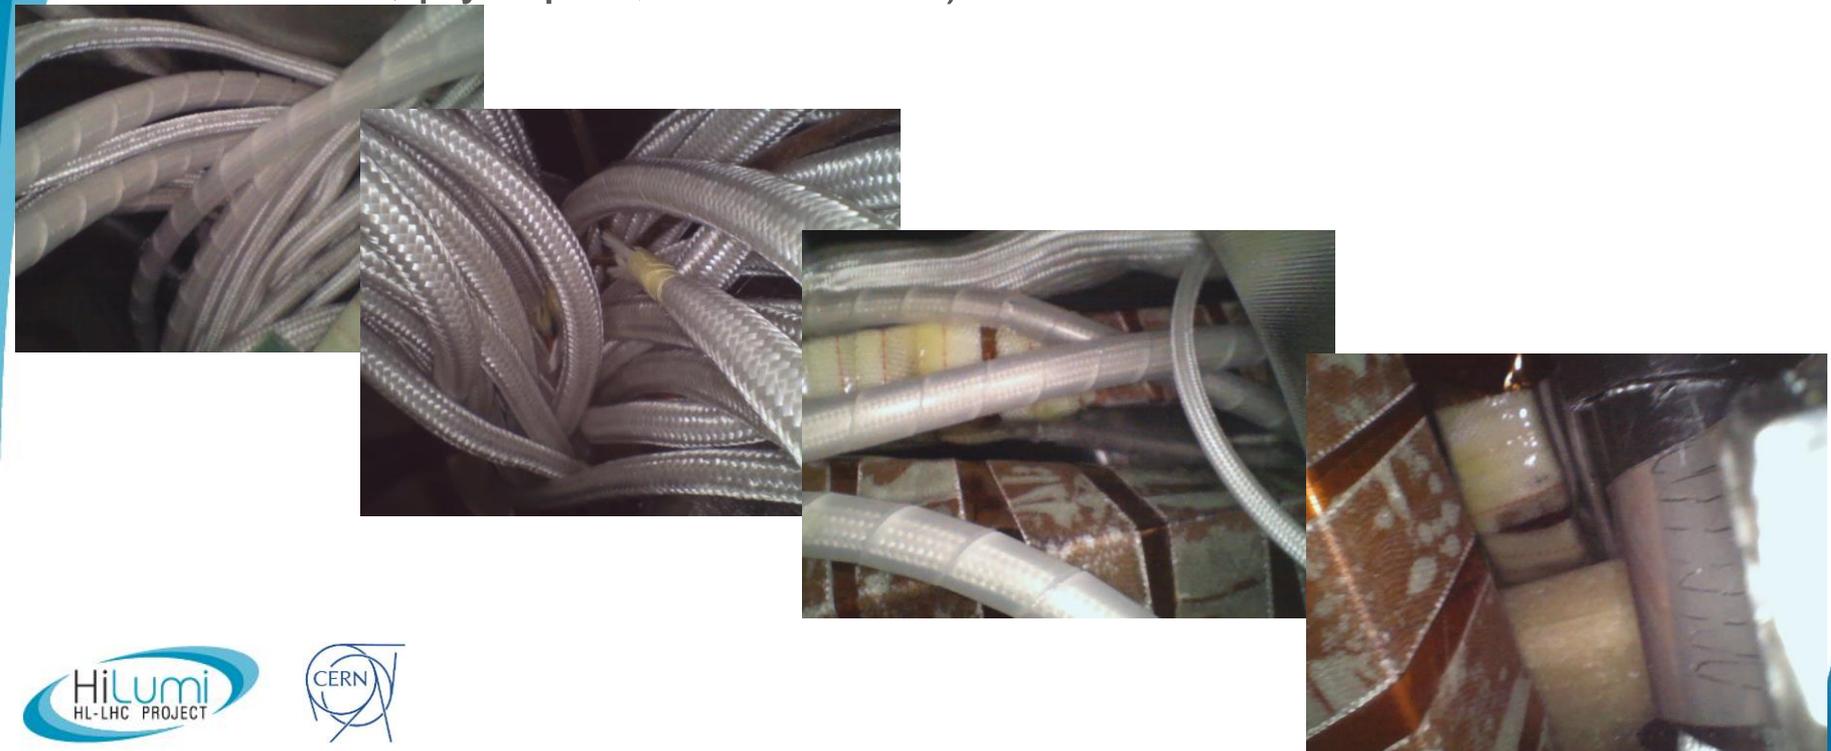
- Visual inspection:
 - Endoscopy didn't show any damage (fibreglass, heat-shrink sleeves, plyospire, insulation...).

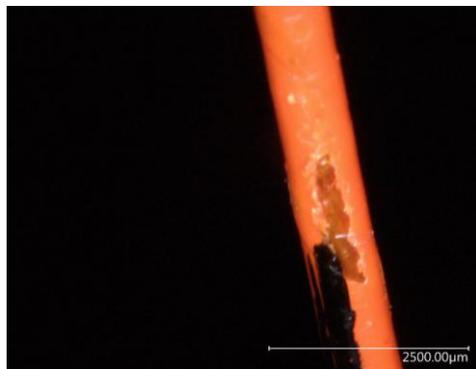
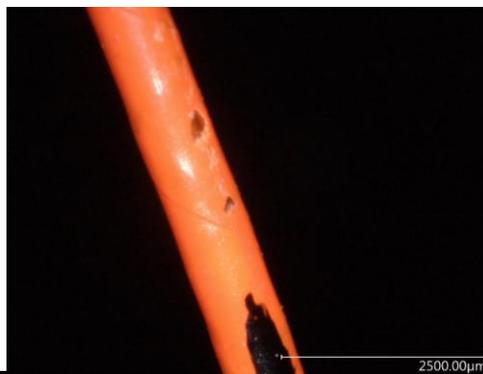
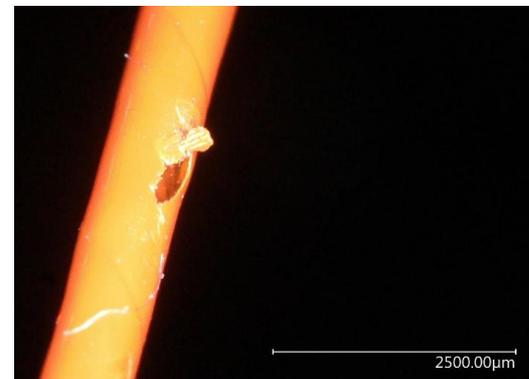
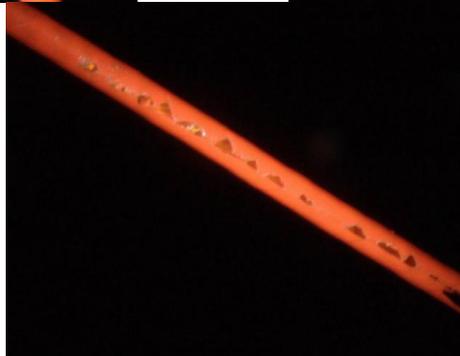
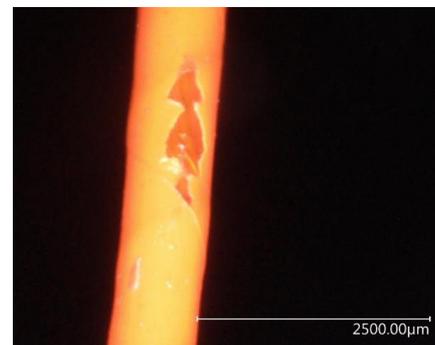
- Visual inspection of the wires near the cold head
 - Different types of defect were found:
 - External sleeve scratched (18 defects)

- In order to avoid possible damage during the cold mass manufacturing, the wires are spooled properly.
- It is now check by QA (hold point) throughout the production.

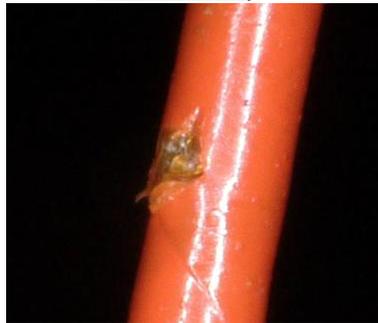
- Conductor visible (1 defect, EE1123):

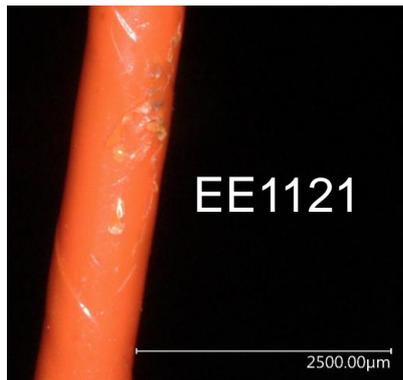
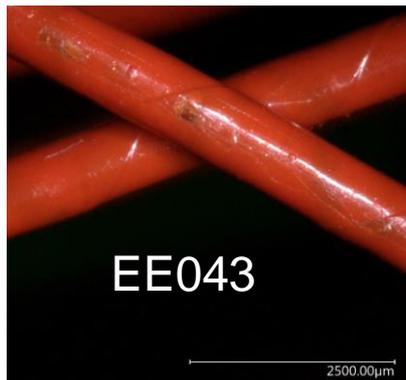
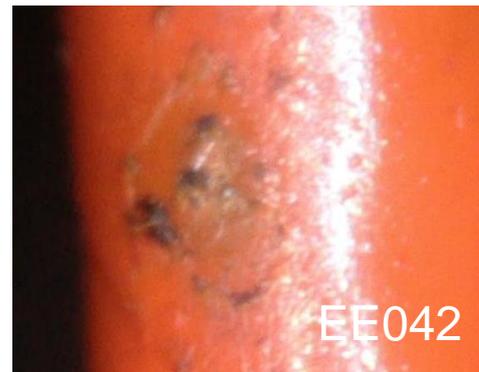
- Black stain (3 defects, EE1121, EE043 and EE042):

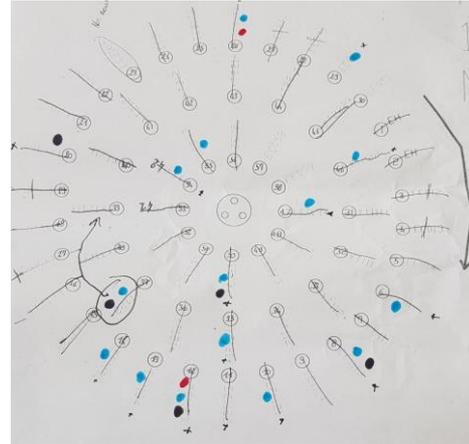
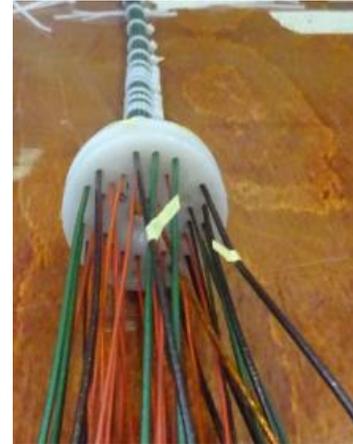
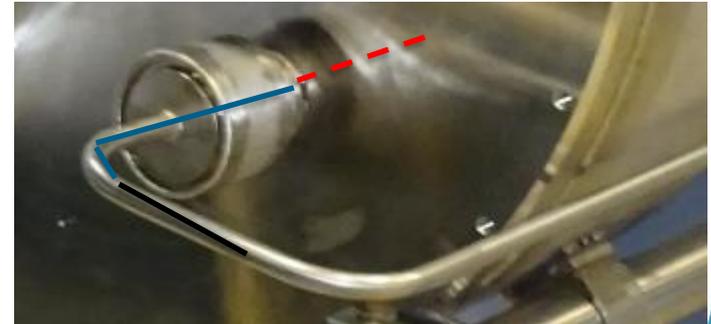
- Positions of the defects:
 - This sketch shows the arrangement of the wires in the capillary.
 - Most of the defects seem to be positioned in and before the first turn of the capillary (in blue).
 - Defects showed by black spots are at the extremity of the wires (likely caused during the IFS cutting),
- Defects showed by red spots are in under the flat cover.

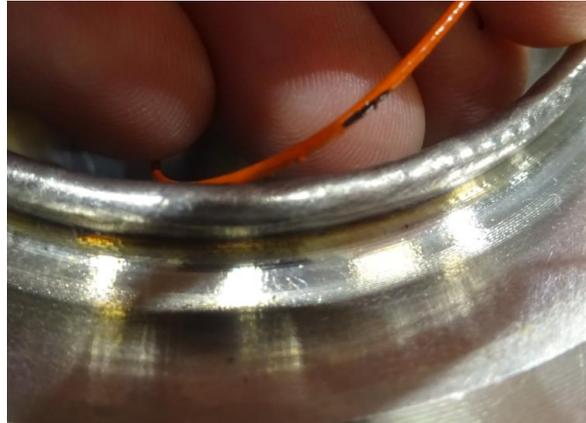
- Visual inspection of the wires near the warm head:
 - Different types of defect are found:
 - External sleeve scratched (13 defects),
 - Conductor visible (1 defect, EE021),
 - Black stain (1 defect, EE031).
 - These defects are close to the warm end (possible direct contact?)

- Therefore, extra insulation could avoid scratches caused by friction at this location (picture taken on the new IFS).

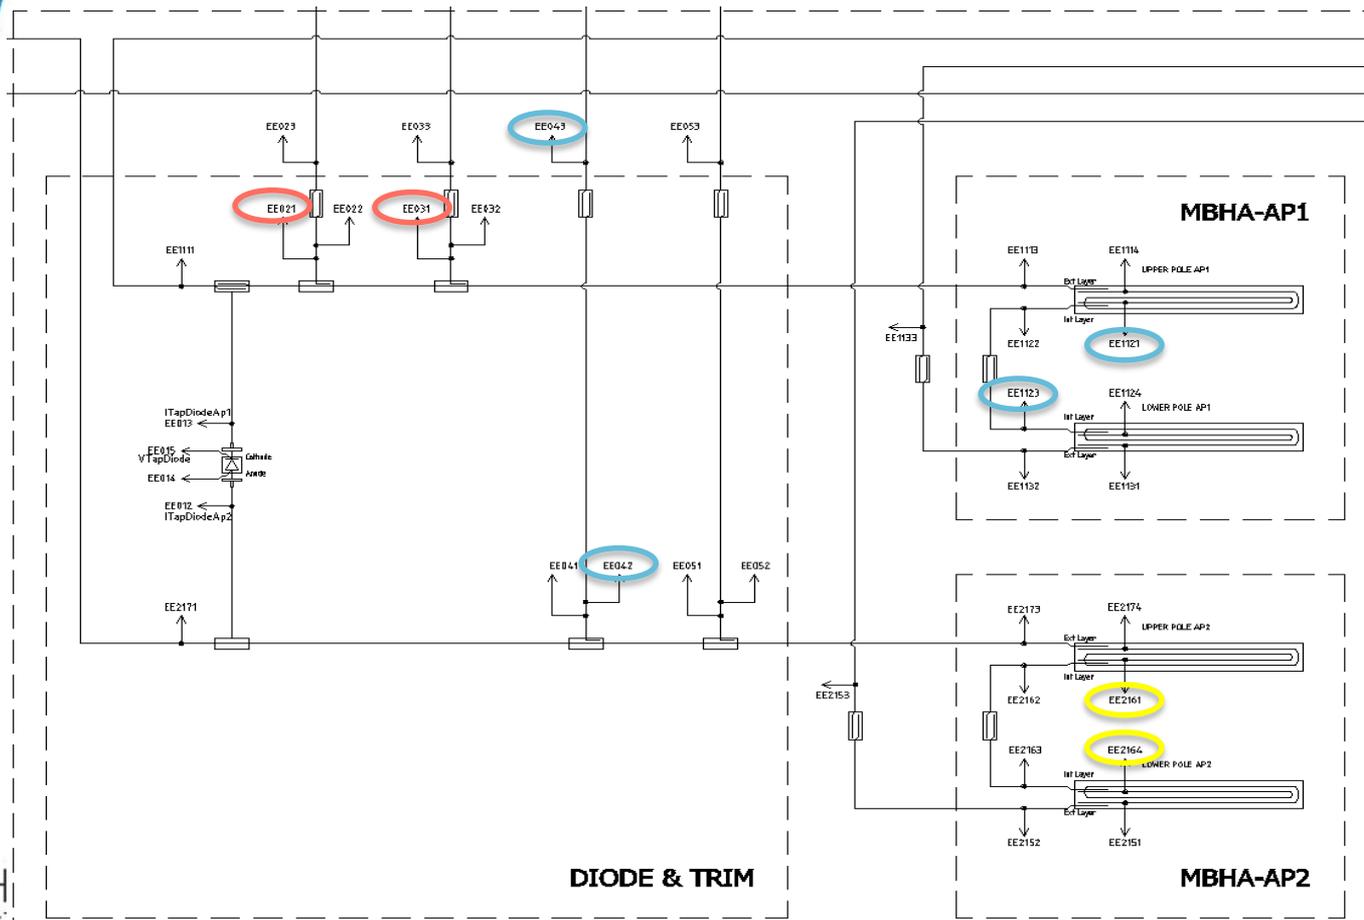
Positions of the defects (for all NCR)

Defects near bullets (NC1)
-

Defects near cold head (first turn, NC3)
-

Defects near warm head (NC3)

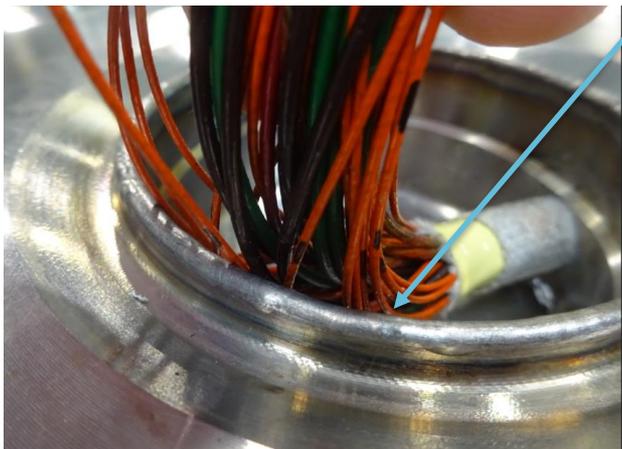
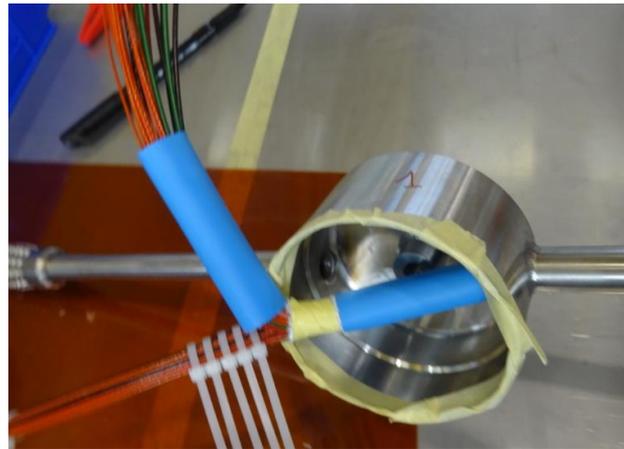
- NCR3:
 - All the defects, which have been observed, are on the wires touching the edge of the warm head.
