# Summary of ELQA measurements on LMBHA001 in SM18

Mateusz Bednarek, Jaromir Ludwin,  
Tiago Catalão da Rosa

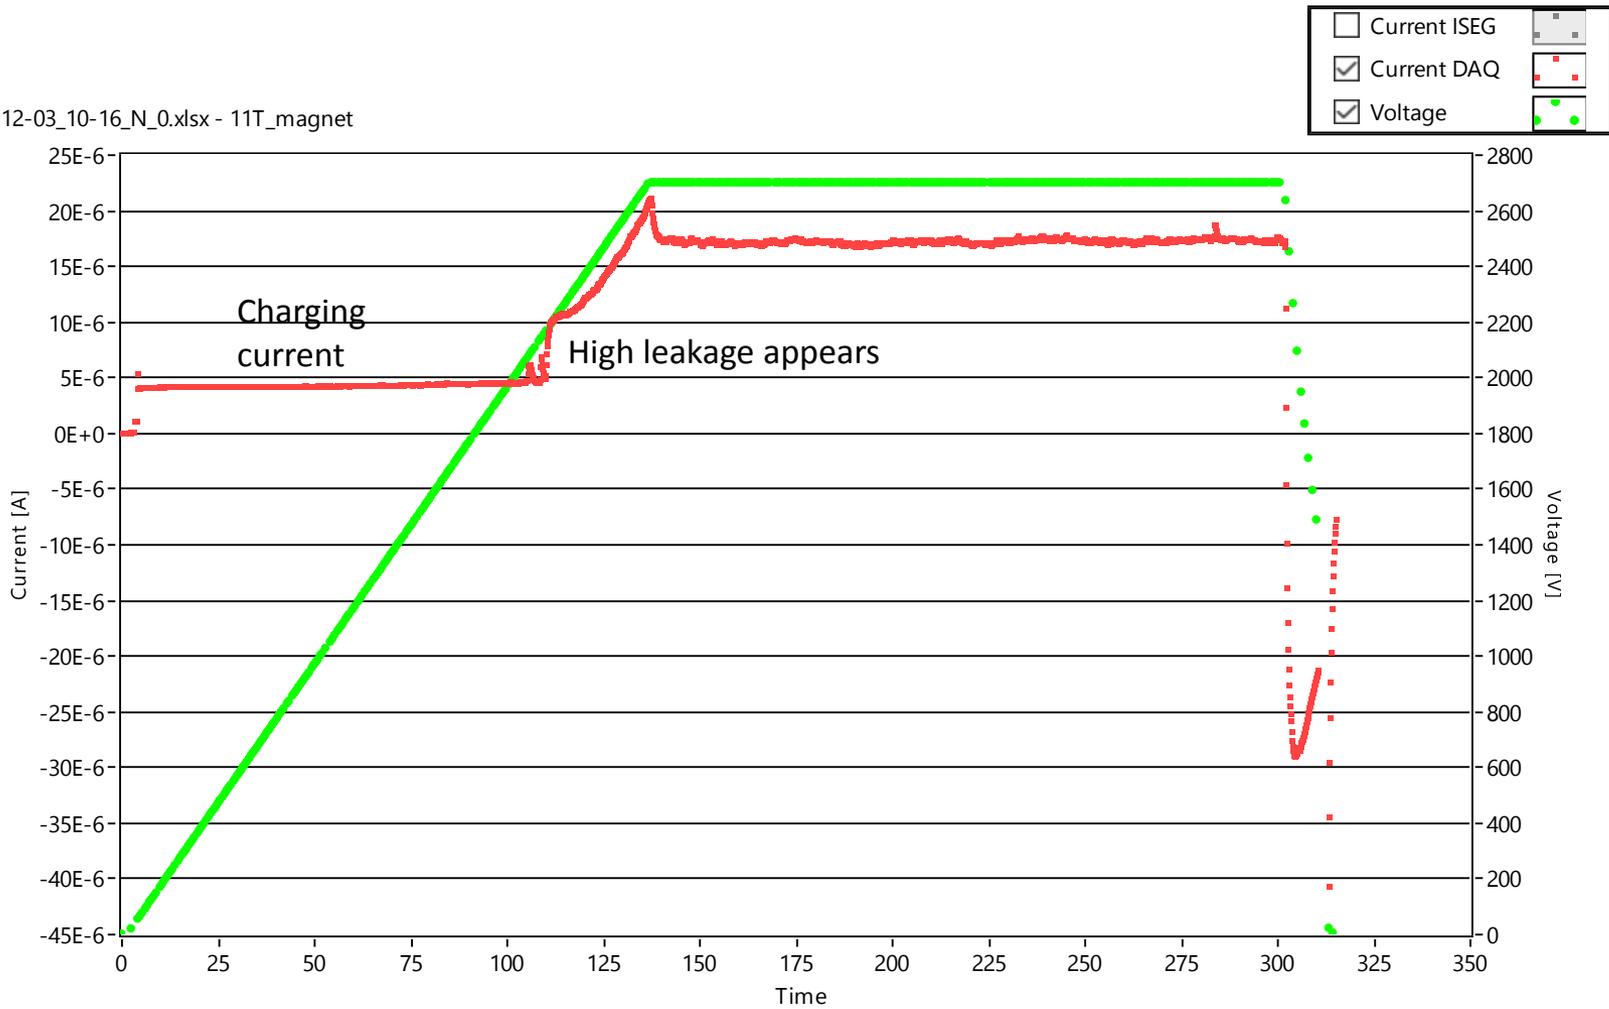
2019-12-03\_10-16\_N\_0.xlsx - 11T\_magnet

- Voltage ramp rate 20 V/s
- Increased leakage current appeared at 2170 V

- No degradation
- Random behaviour, always between 2 kV and 2.75 kV

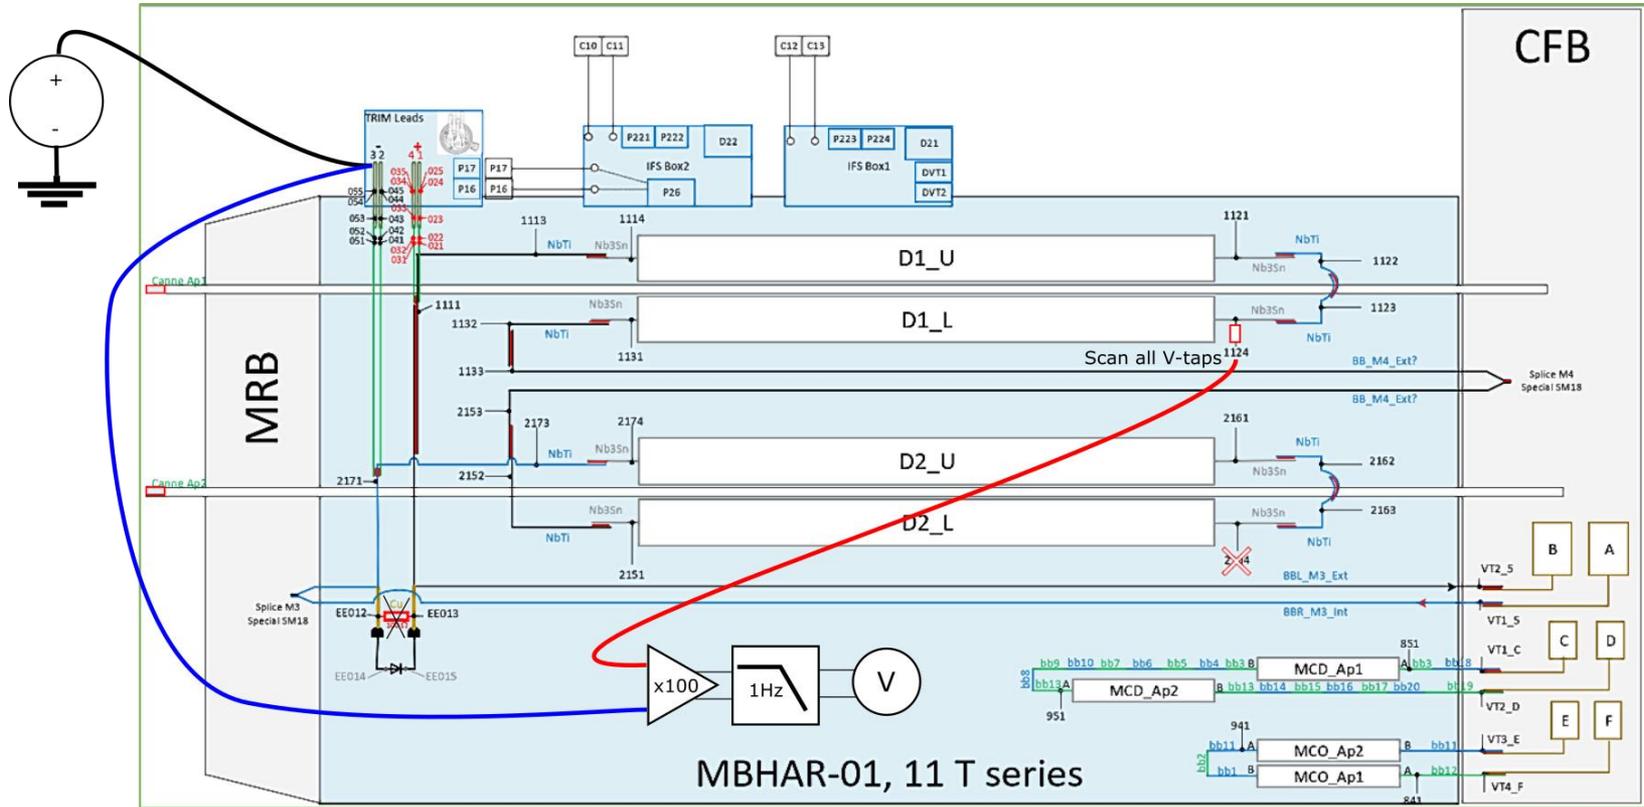
- Not completely conclusive
- Not fully understood
- Grouping of V-taps observed

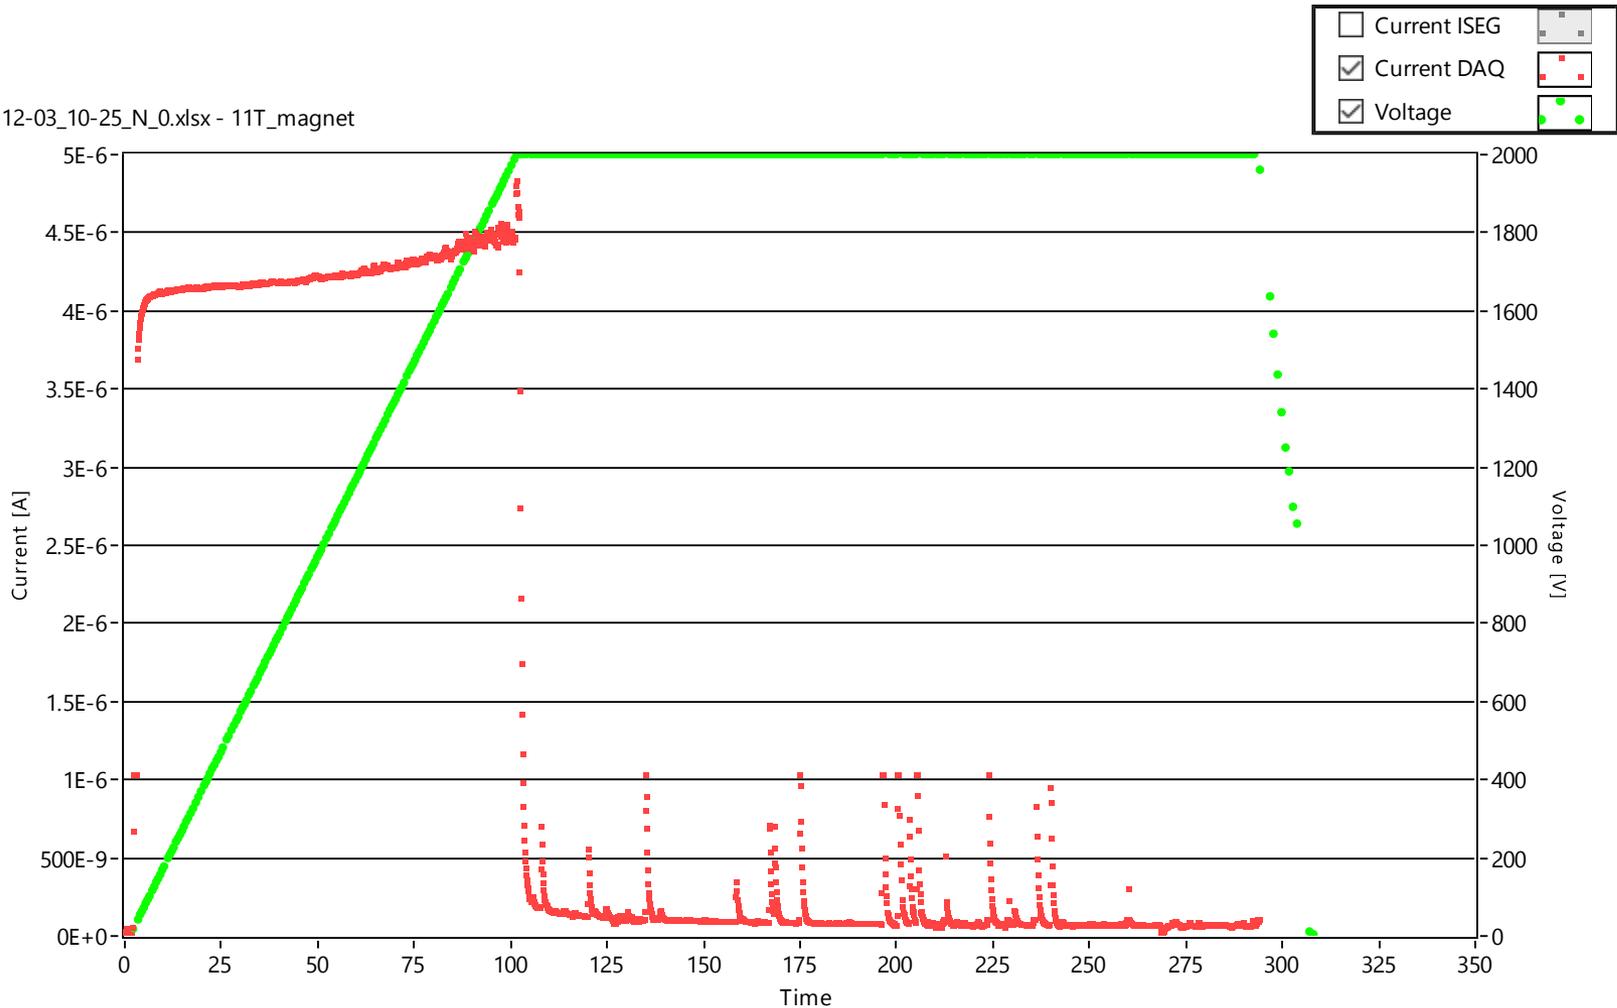
2019-12-03\_10-25\_N\_0.xlsx - 11T\_magnet

# Test at 2000 V

- Partial discharge activity during the ramp and the plateau
