# Quench Analysis

## MBHA-002

### Quick upate

### 04 Febuary 2020

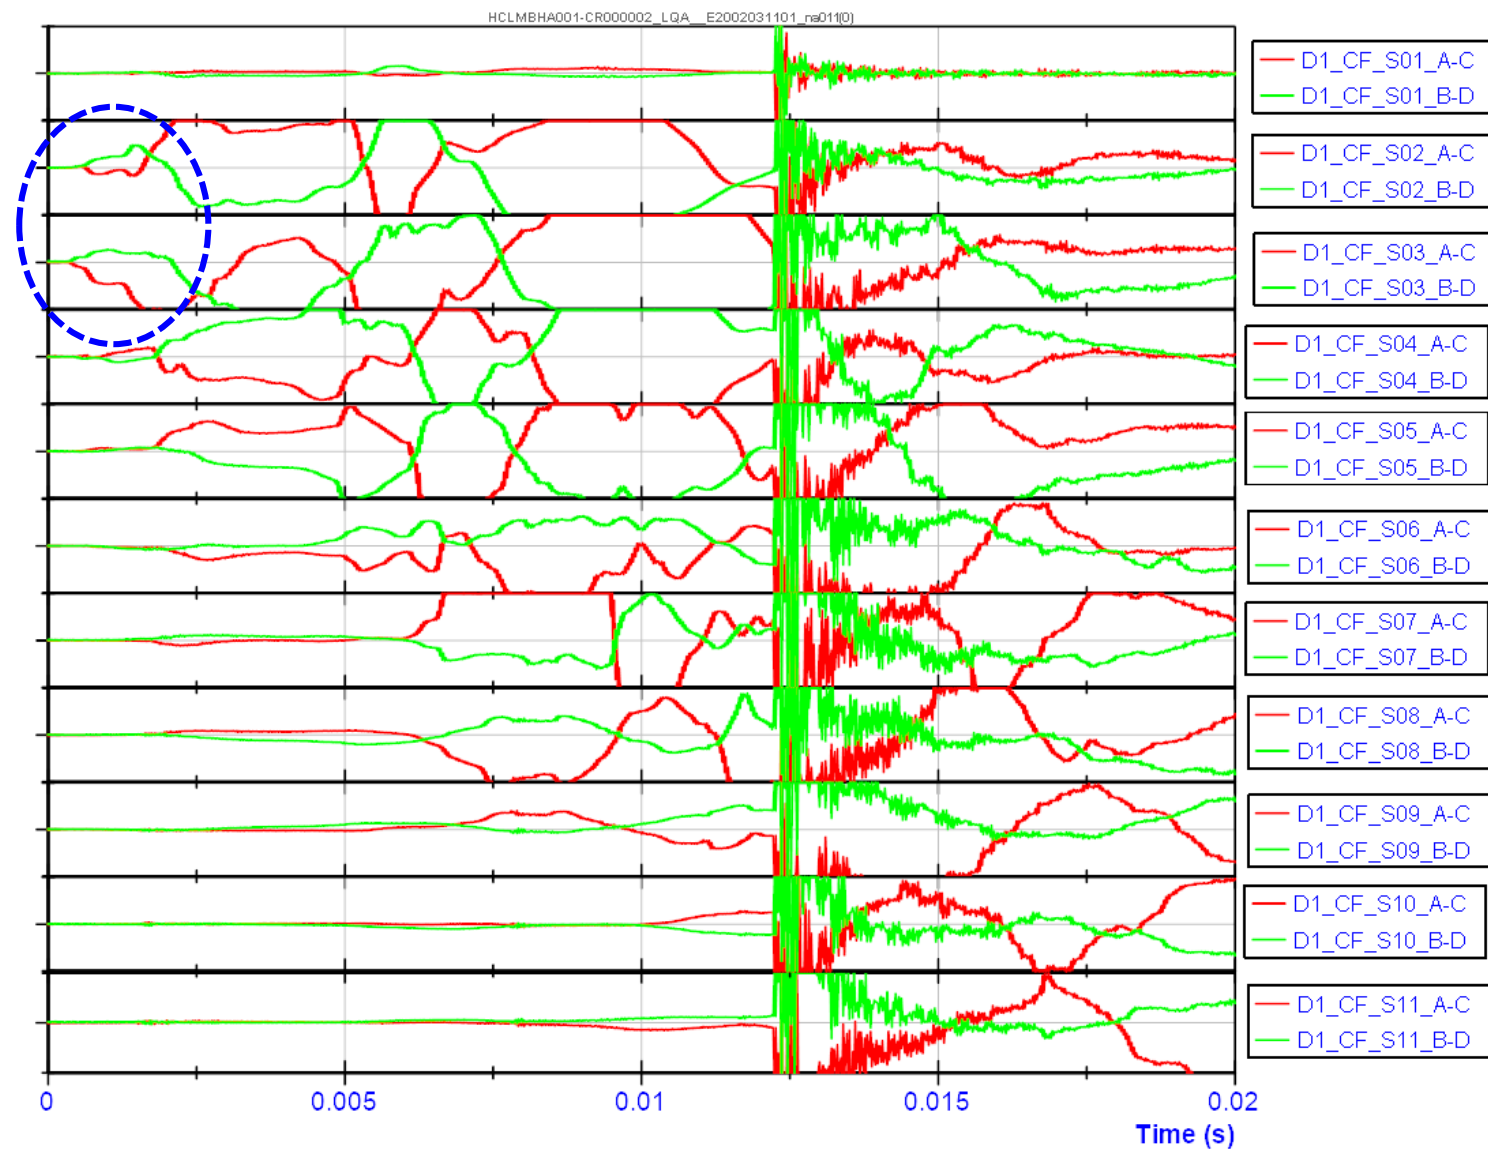
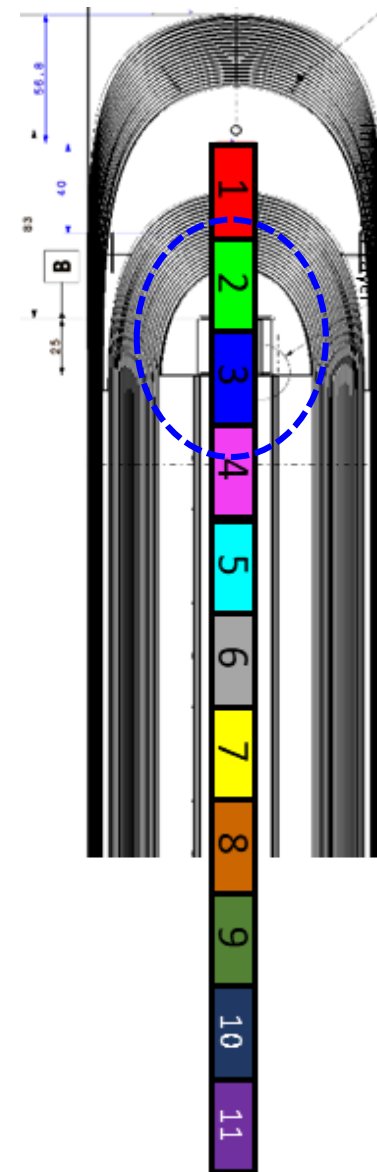
Quench 22: 10.43 kA @ 4.5 K, 50 A/s  
Abnormal propagation:

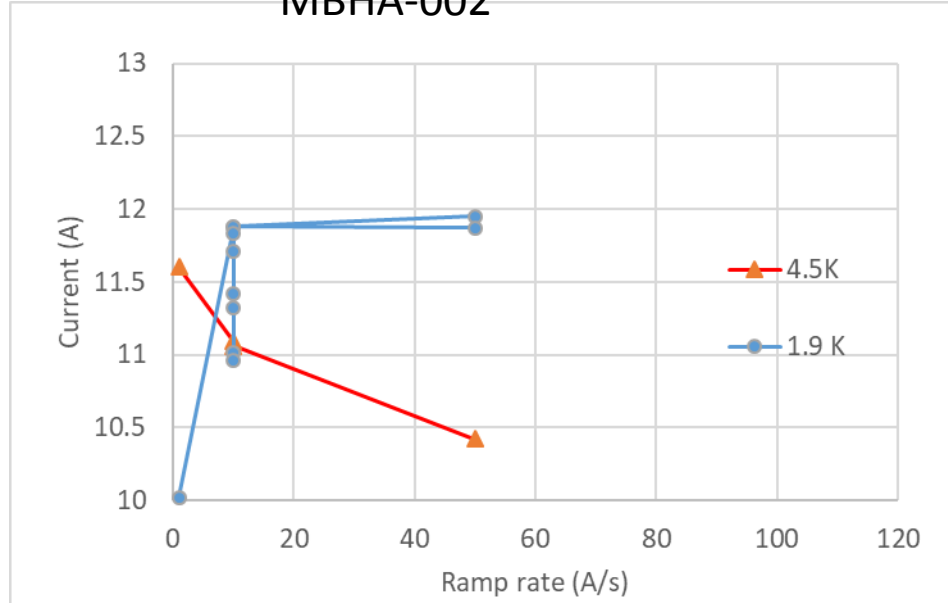
MBHA-002

Instability at 1.9 K at 10 A/s.

Reproducibility at 4.5 K at 10 A/s.

4.5 K higher ramp prate gives lower quench current

4.5 K highest quench current with very low ramp rates

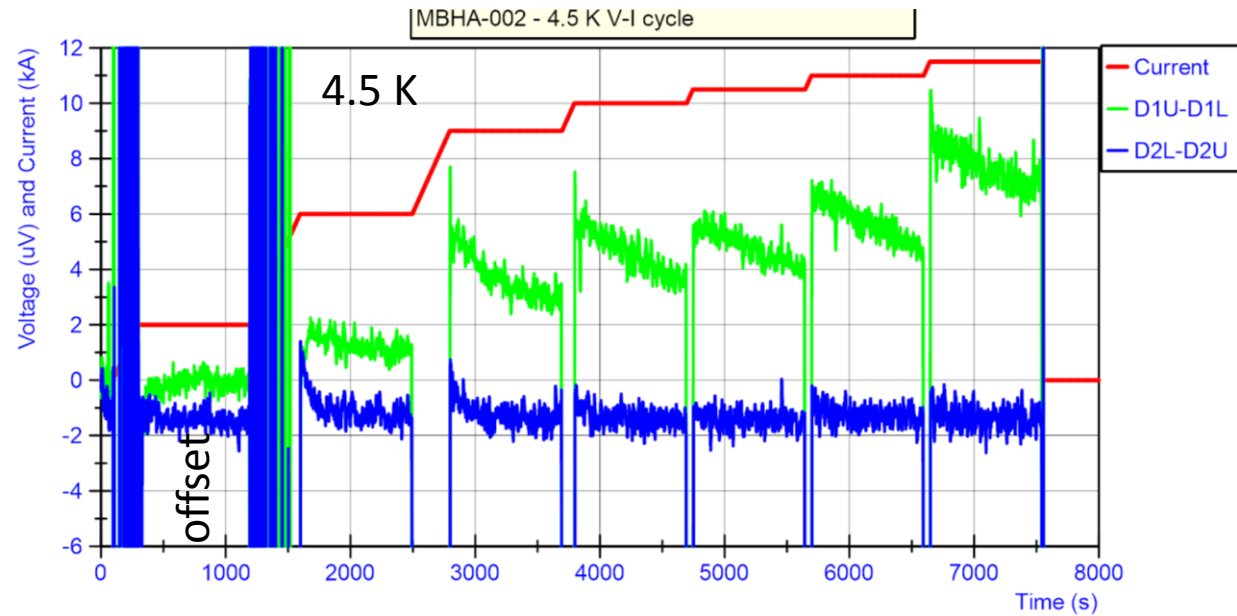
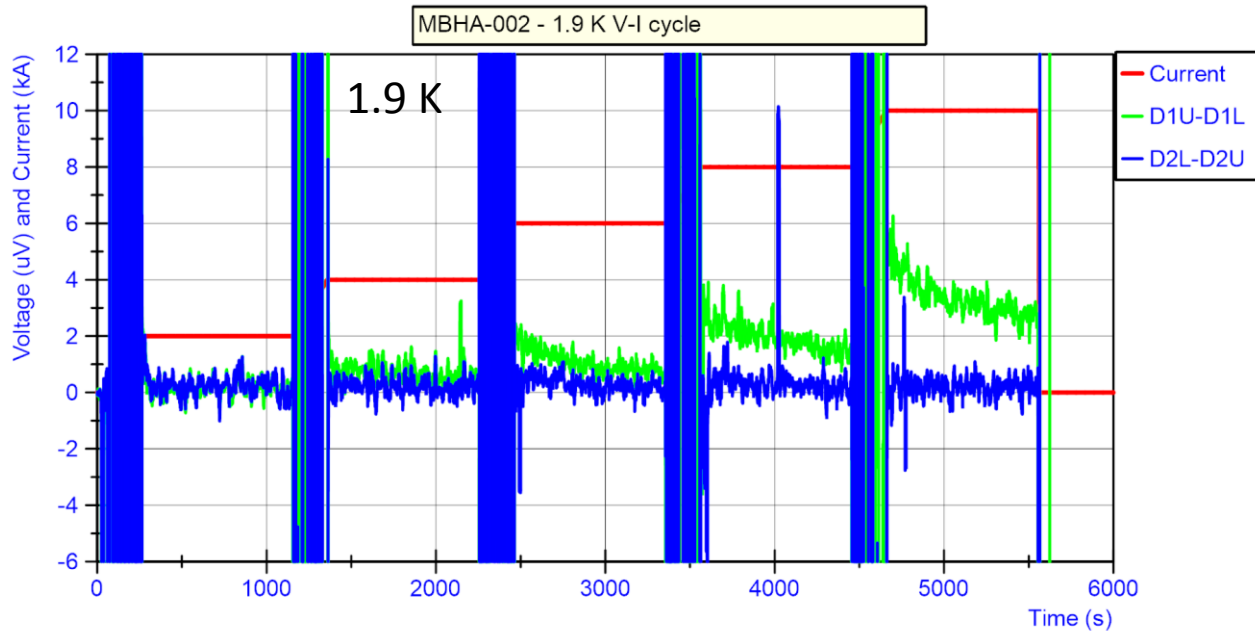
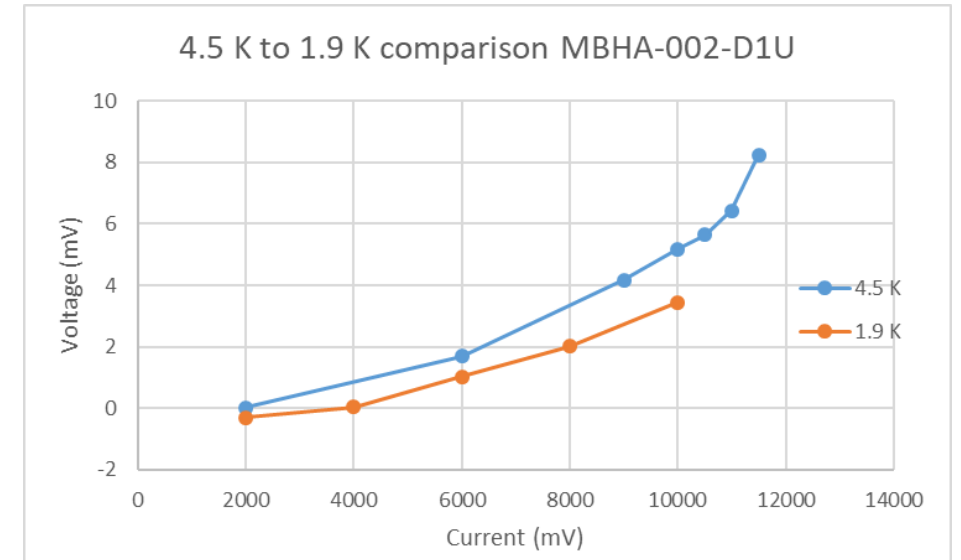
- Significant voltage buildup in voltage in coil D1U
- Voltage buildup starts from very low current of 6 kA
- Clear decay of voltage on current plateaus.
- No sign of degradation in aperture 2, nor in coil D1L

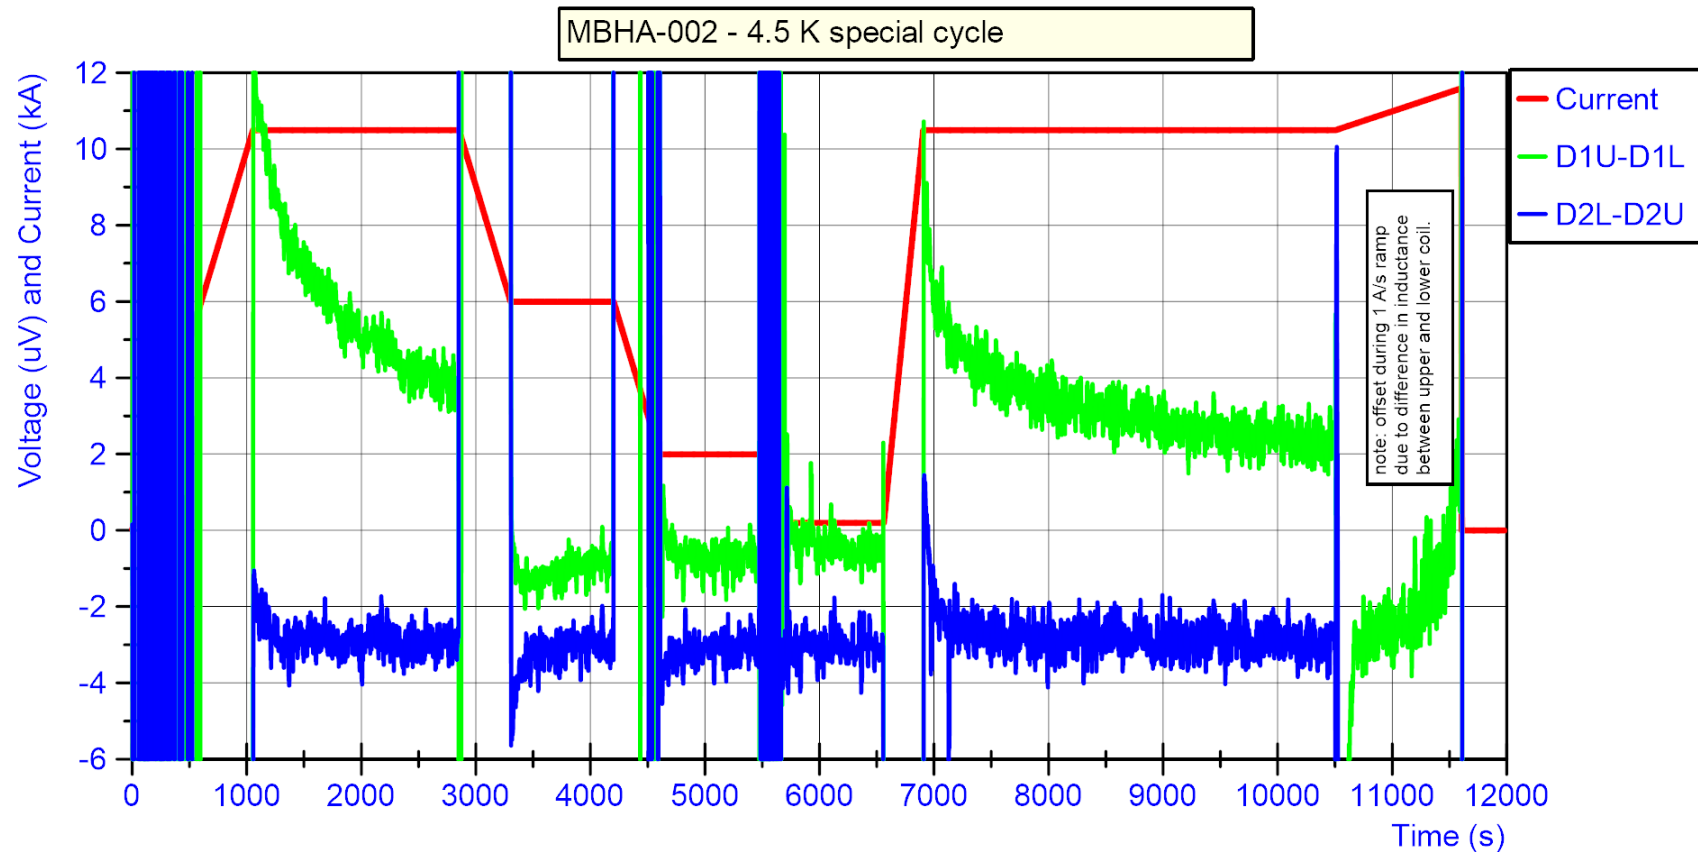
Several features:

- 10 A/s ramp straight to 10.5 kA, reaching 12 uV, showing decay time constant on 30 minutes plateau
- Ramp down to 6 kA, shows **negative voltage**
- 30 A/s ramp to 10.5 kA (lower voltage than 10 A/s ramp, this can be influenced by pre-cycles).

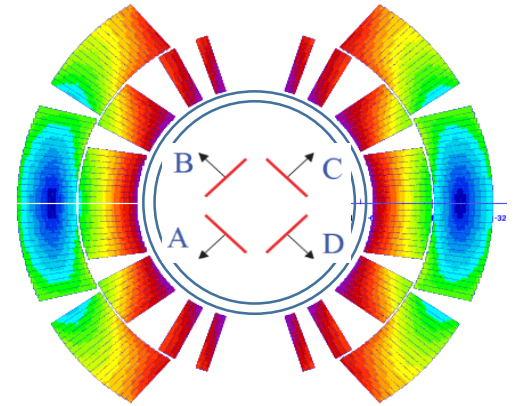
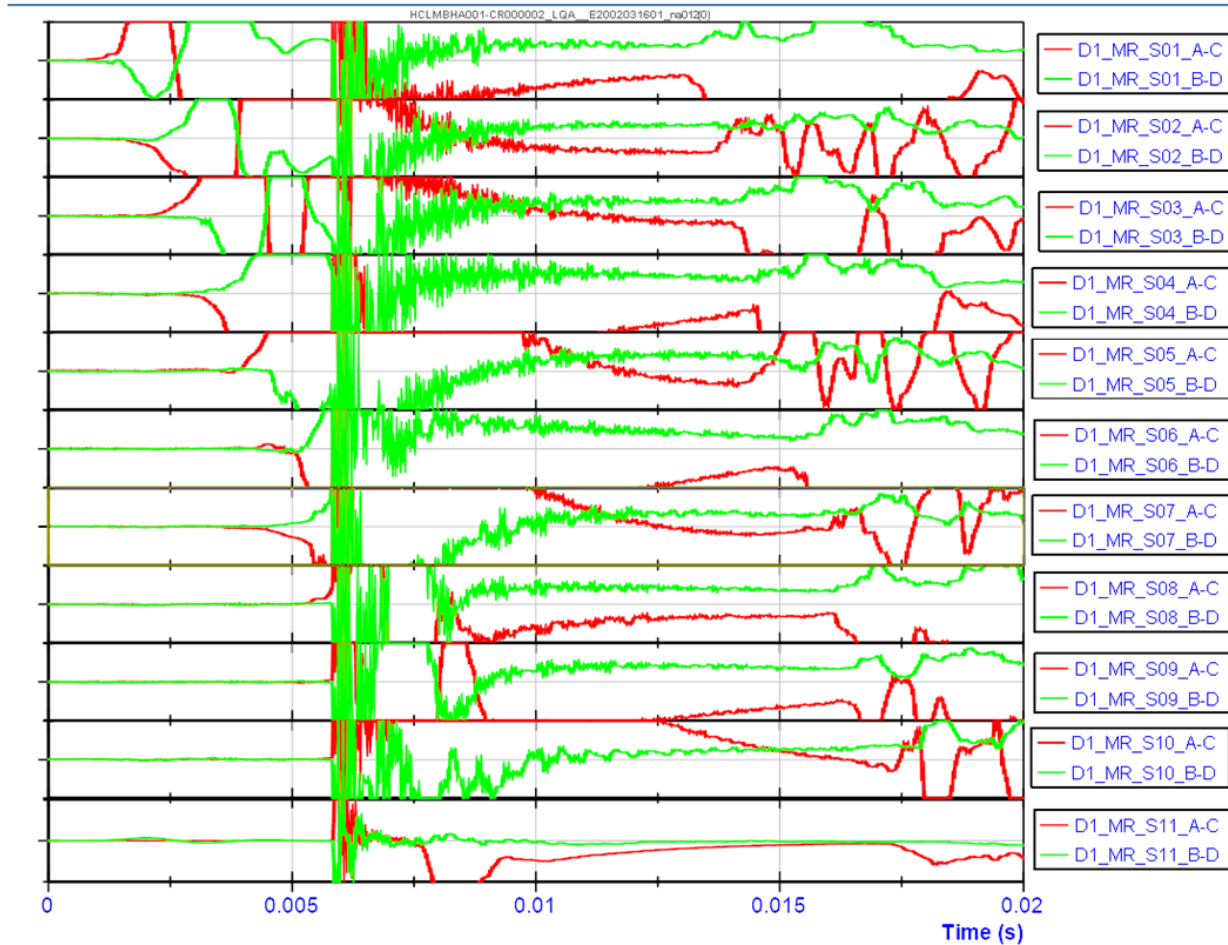
Quench 23: 11.6 kA @ 4.5 K, 1 A/s (start 1.1 meter from the head, MRB shaft inserted towards CFB end)

Abnormal propagation:

Curves A-C flip sign for most segments. (transposition pitch 100 mm, pickup coil length 40 mm)

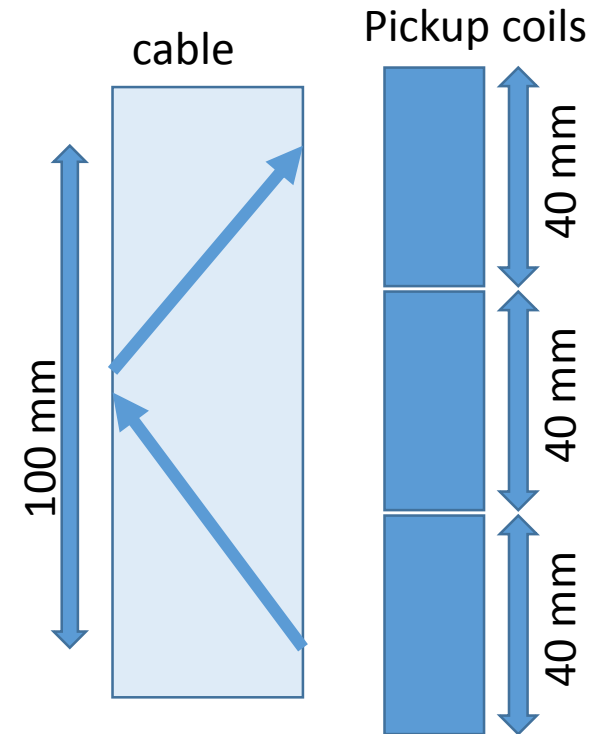
Can a quench propagate through a single strand (or a few strands)

**To check**  
Quench signal should repeat each 5 segments.

If always the same strand has propagating quench, repeatedly between quench.

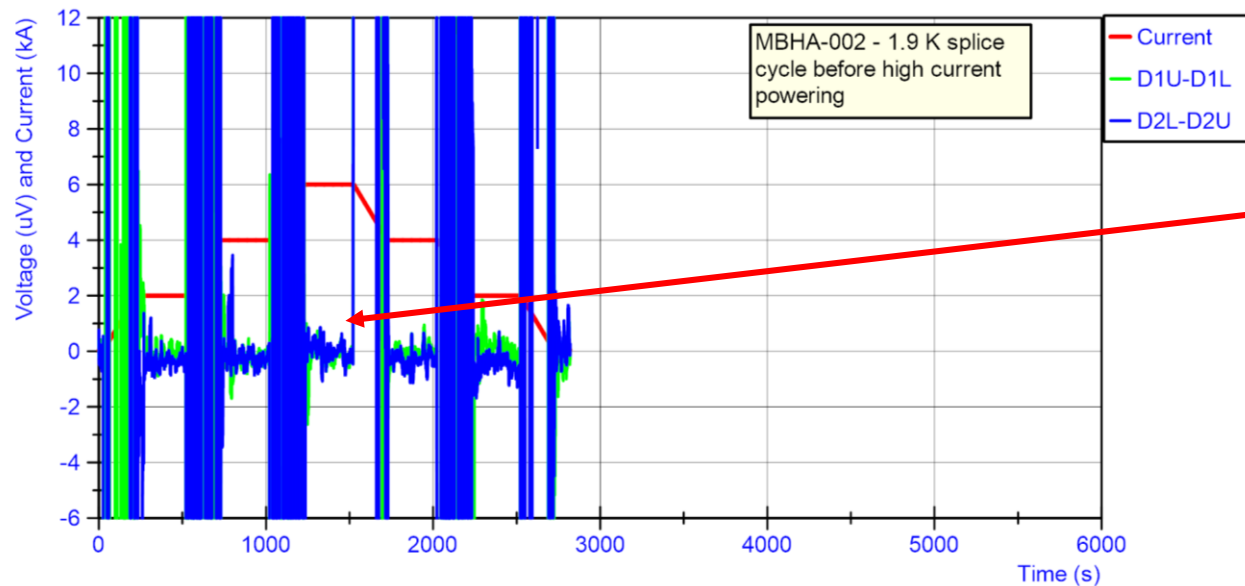
First powering to 6 kA was a splice cycle including V-I measurements.  
No sign of any voltage.

This was the first time this magnet reached 6 kA.

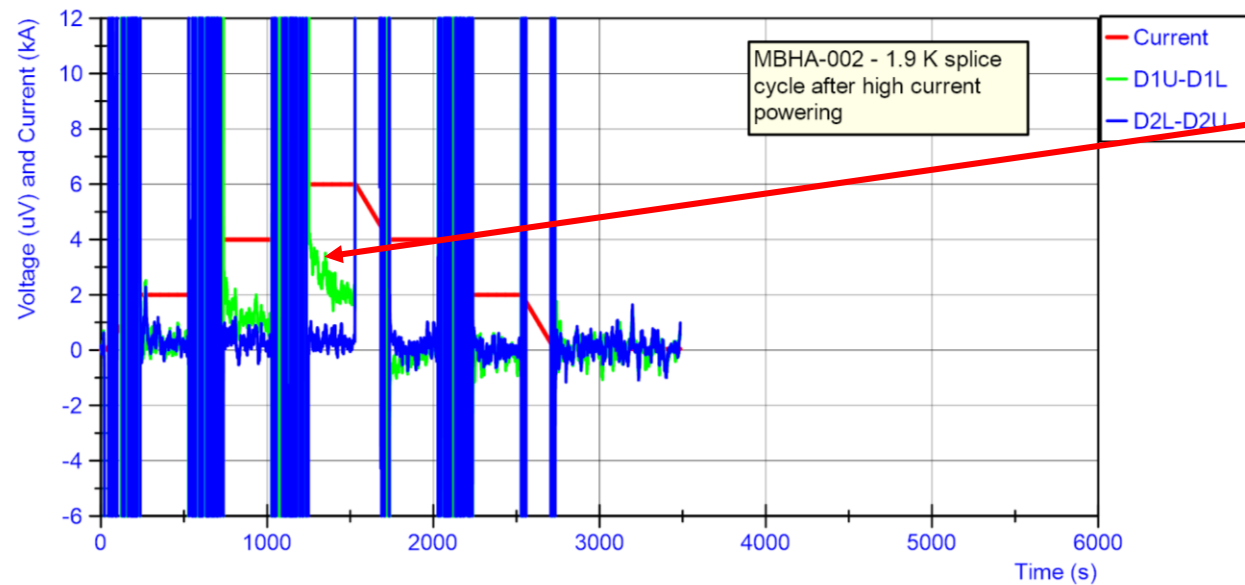
Clear voltage at 6 kA  
This was the last powering before warm up.

Conclusion: a weakness appeared, or an existing weakness degraded more during the powering/quenching.
