MBHA-002 results

Quick update

05 February 2020

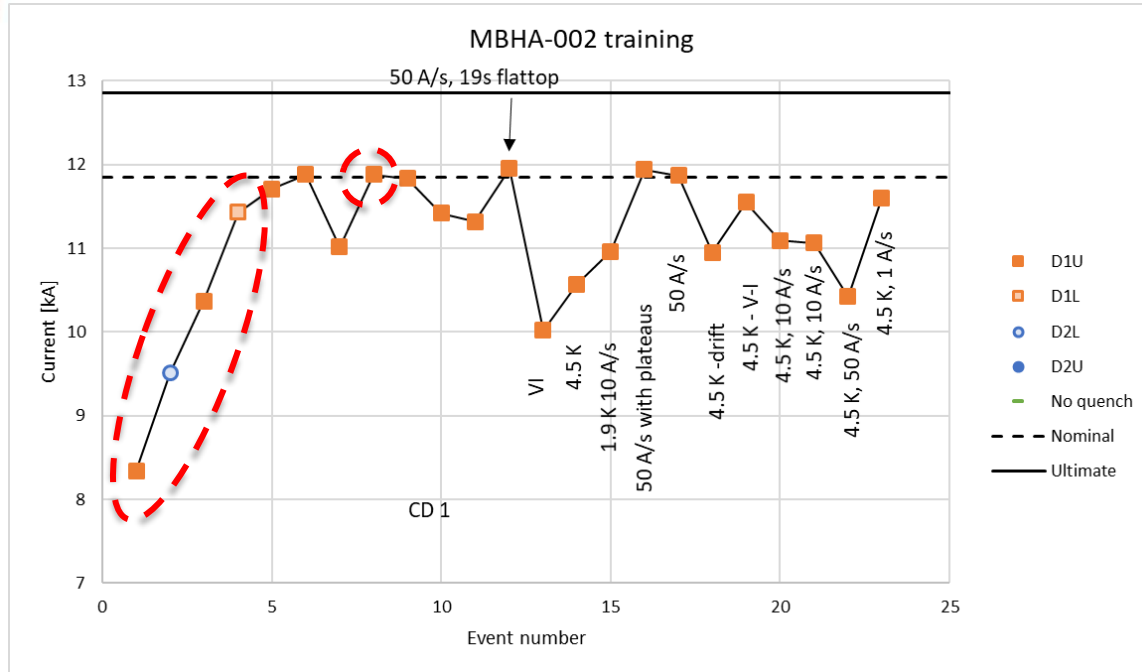
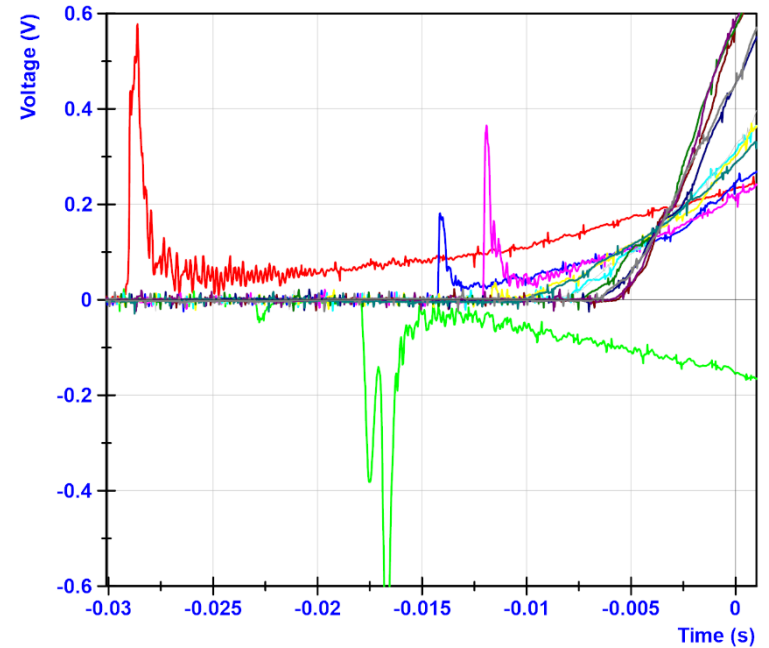
Fast training, 5 training quenches in the heads on the connection side, showing vibration precursors.

1 in D2L

1 in D1L

3 in D2U

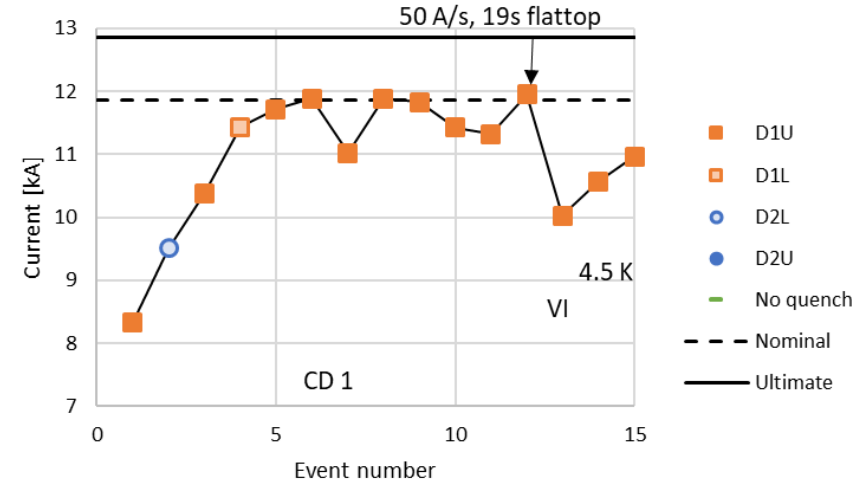
MBHA-002 training

Fast training to 11.5 kA, then showing quenches varying between 11 and 11.9 kA at 1.9 K, 10 A/s.

50 A/s reached target of 11.95 kA, but with flat top quench after 19 seconds.

V-I cycle (15 minutes at stable current of 2, 4, 6, 8 and 10 kA) quenched at 10015 A.

10.5 kA at 4.5 K

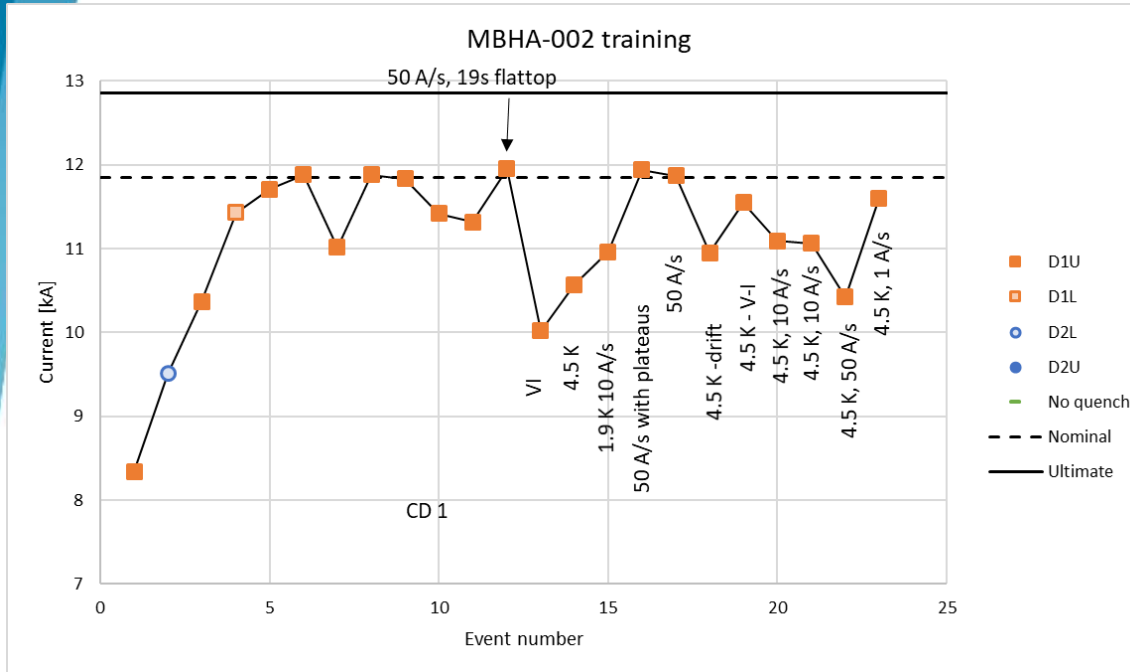
Quench history

Some issues appeared with erratic quench patterns.
Coil D1U does not show stable performance.

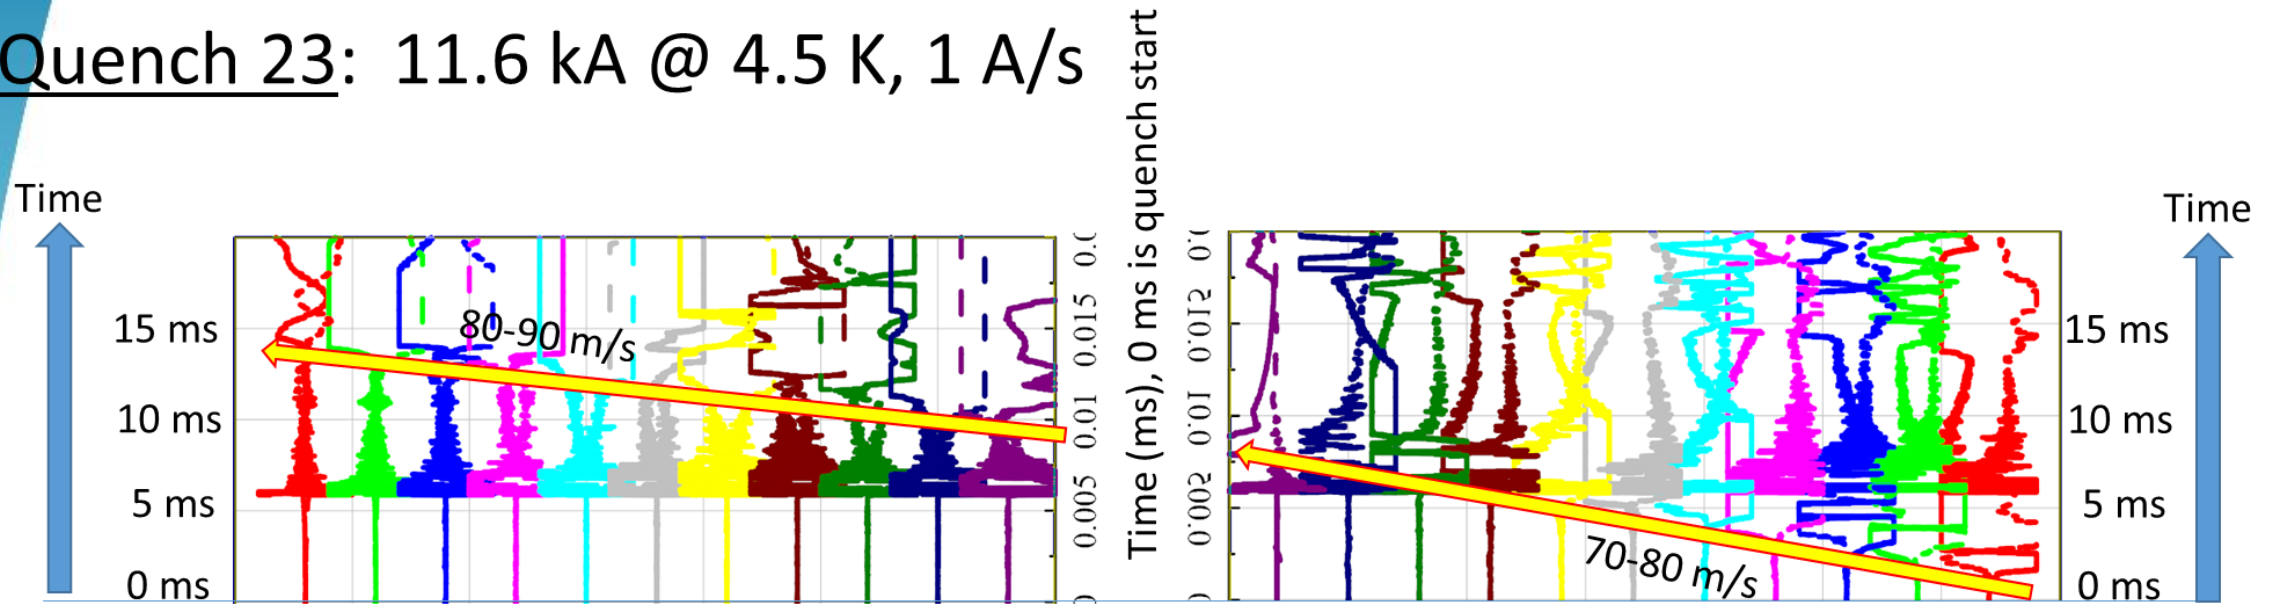
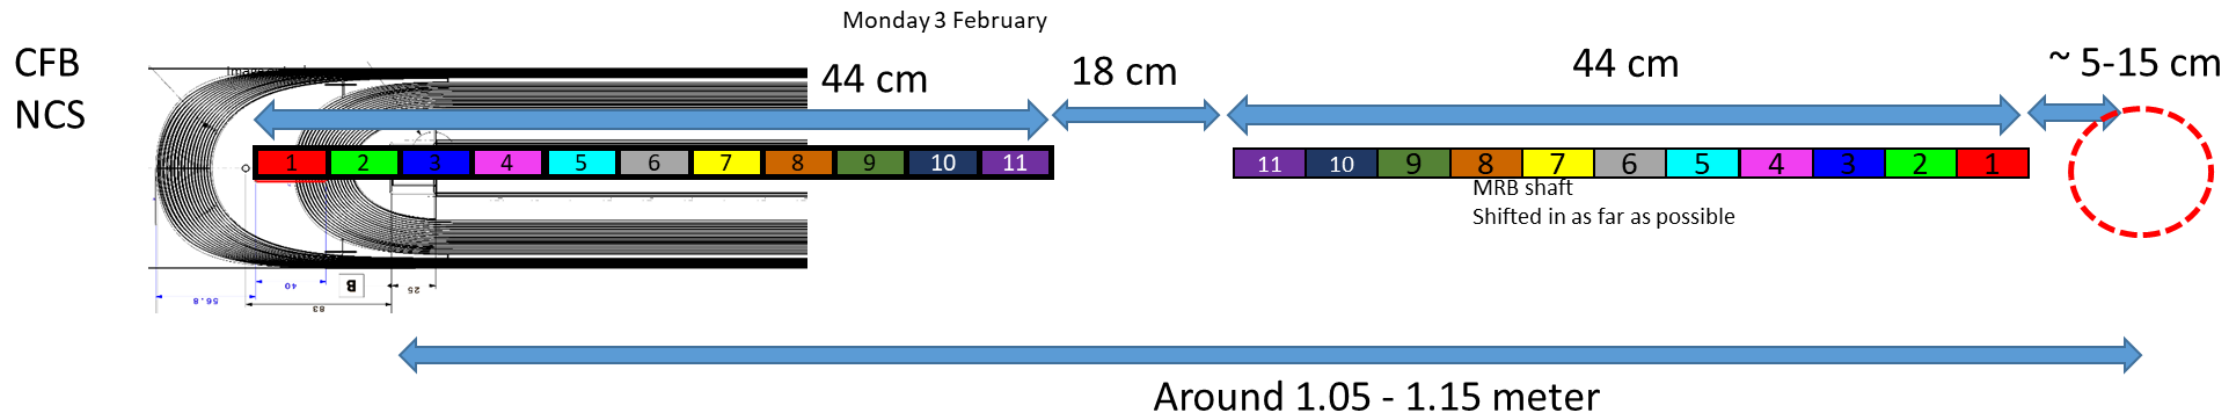
Quench 23: 11.6 kA @ 4.5 K, 1 A/s

Very fast propagation

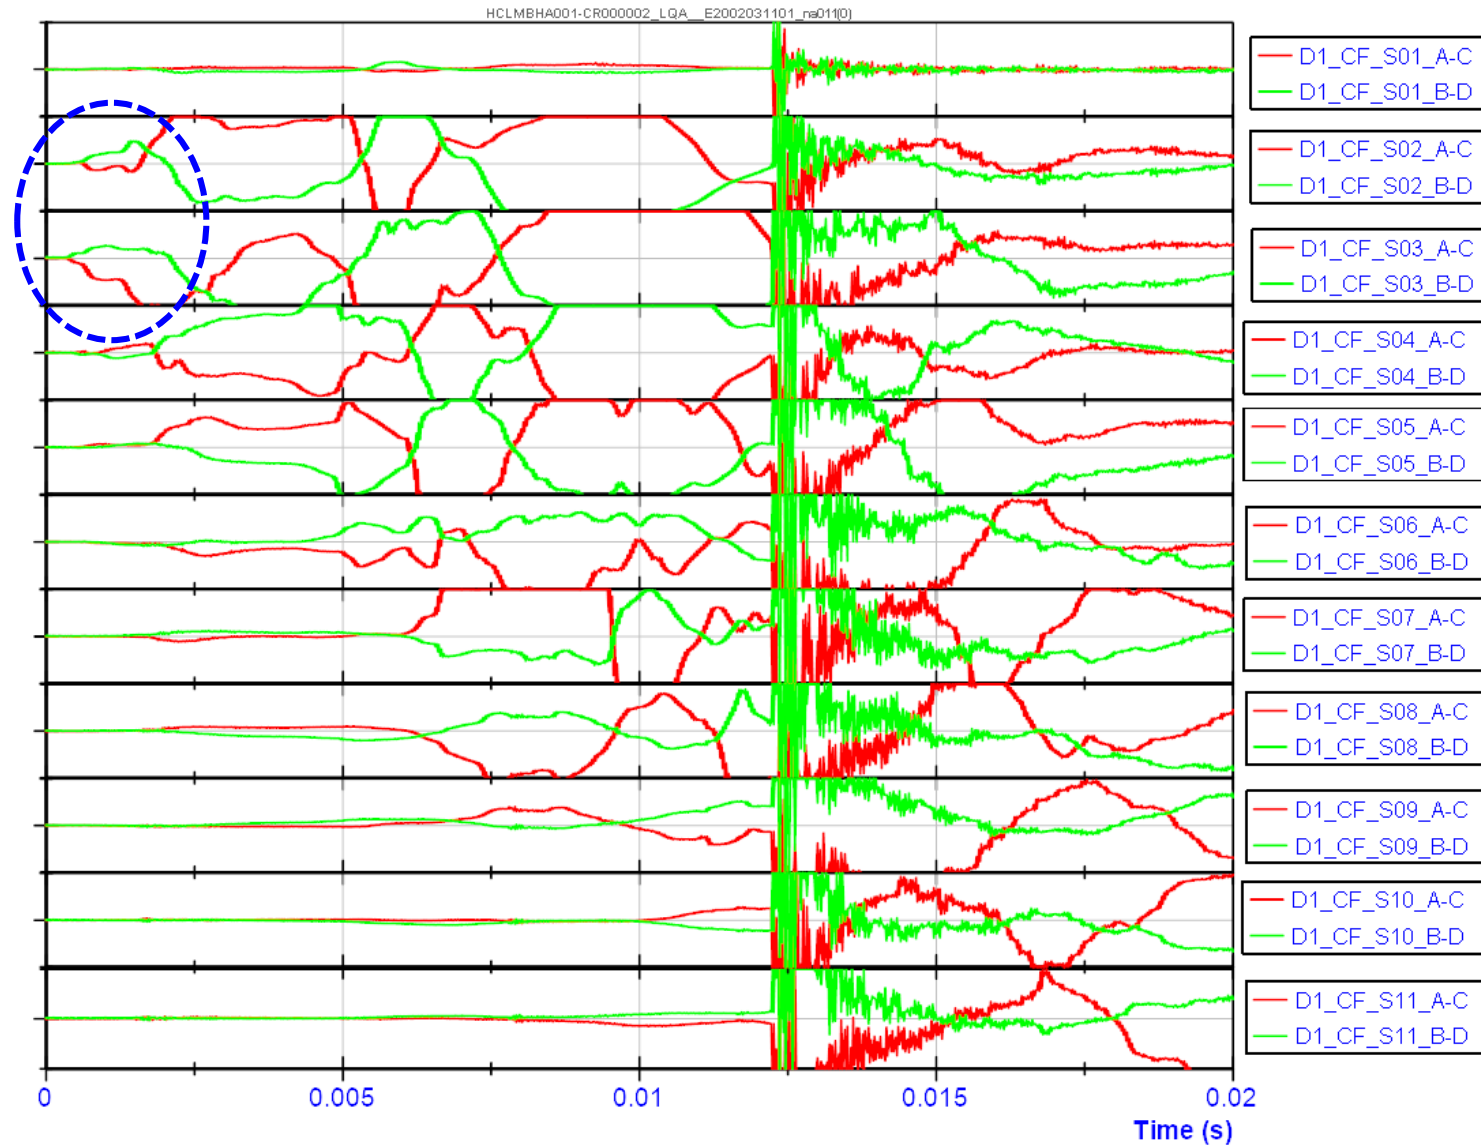
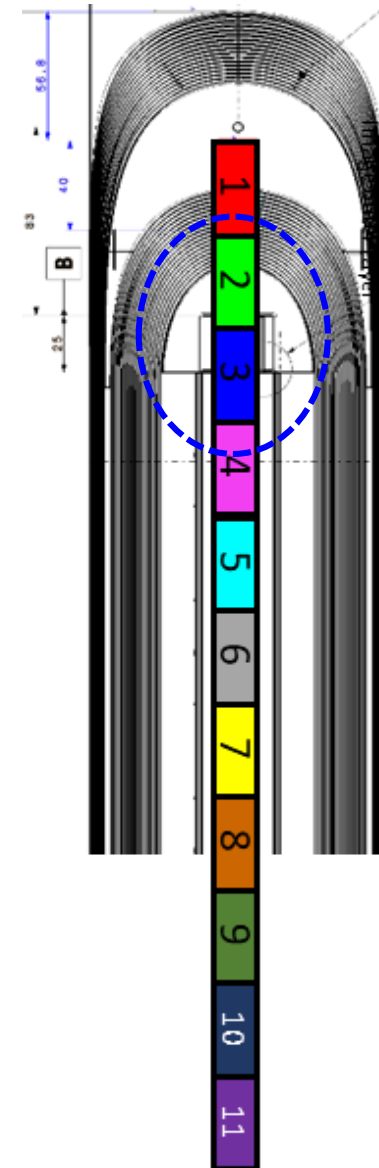
Quench 22: 10.43 kA @ 4.5 K, 50
A/s

Abnormal propagation:

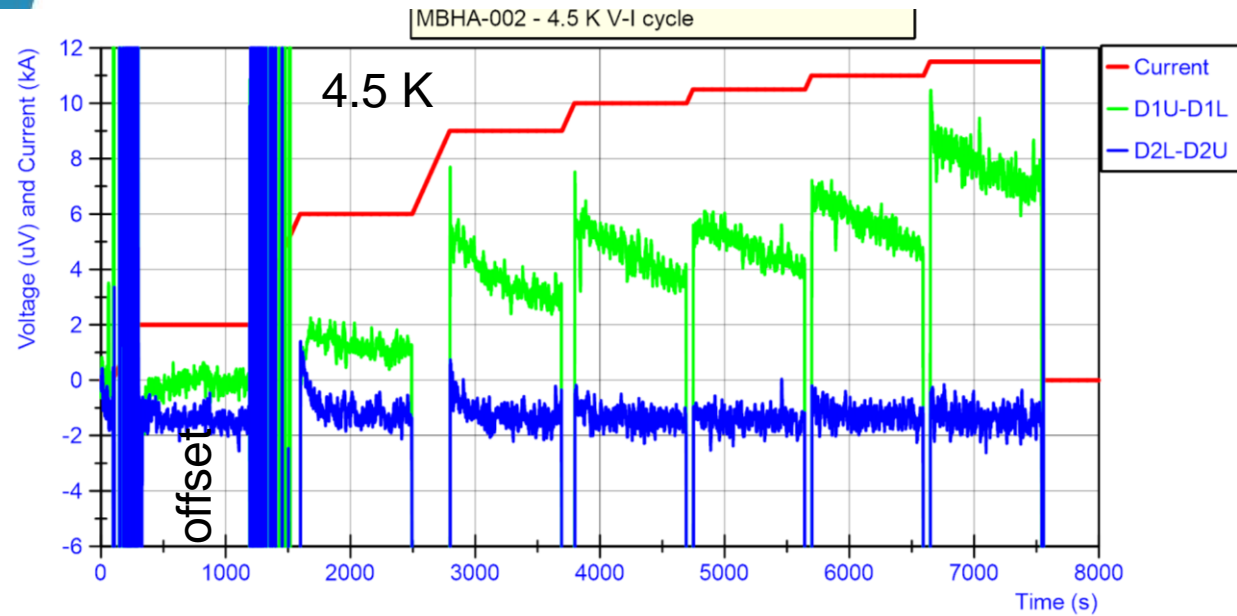
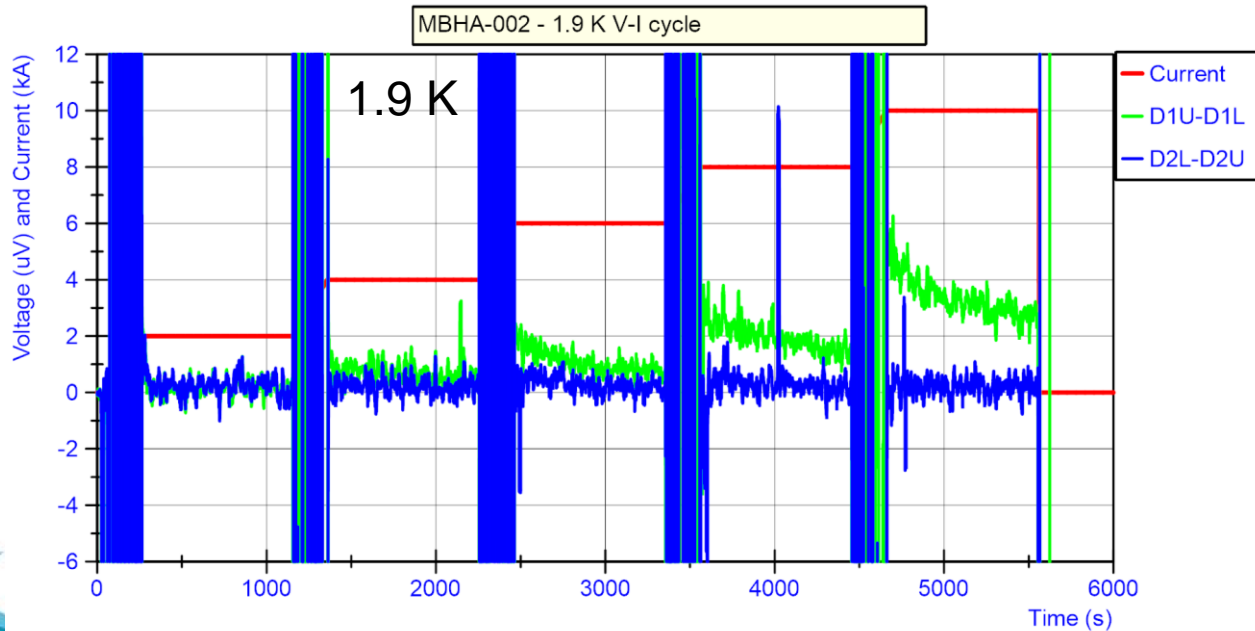
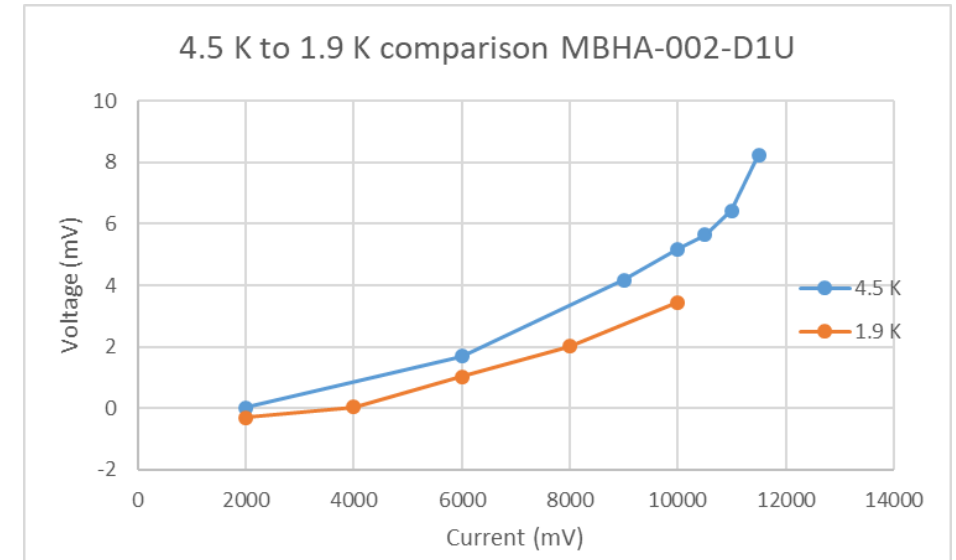
V-I measurements

- Significant voltage buildup in voltage in coil D1U
- Voltage buildup starts from very low current of 6 kA
- Clear decay of voltage on current plateaus.
- No sign of degradation in aperture 2, nor in coil D1L

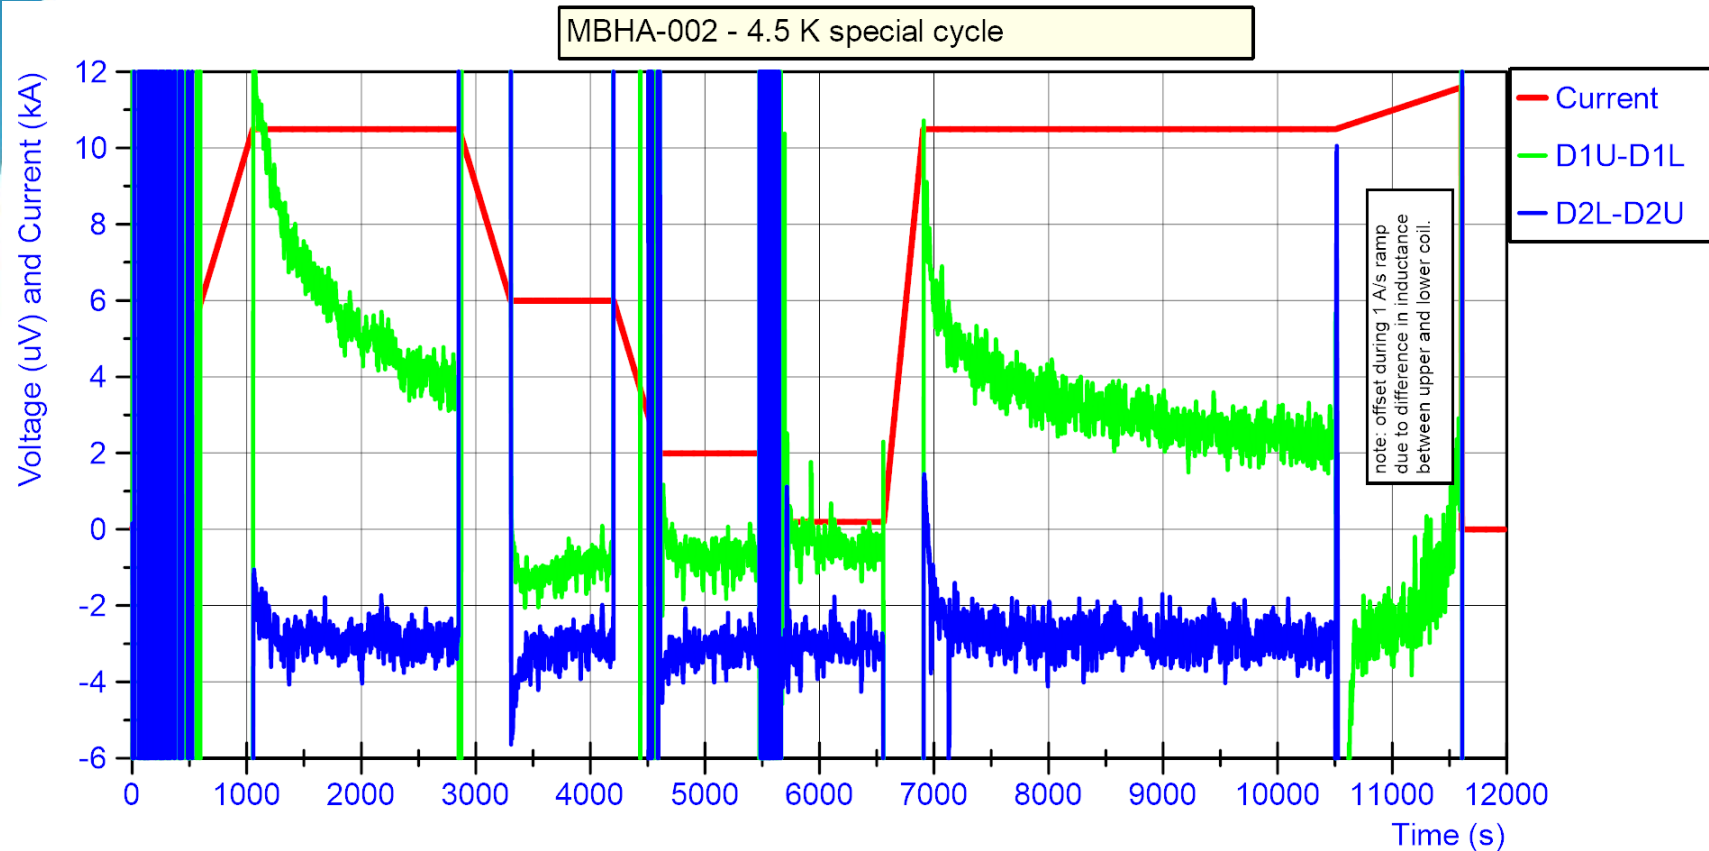
Additional V-I measurements

- 10 A/s ramp straight to 10.5 kA, reaching 12 uV, showing decay time constant on 30 minutes plateau
- Ramp down to 6 kA, shows **negative voltage**
- 30 A/s ramp to 10.5 kA (lower voltage than 10 A/s ramp, this can be influenced by pre-cycles).

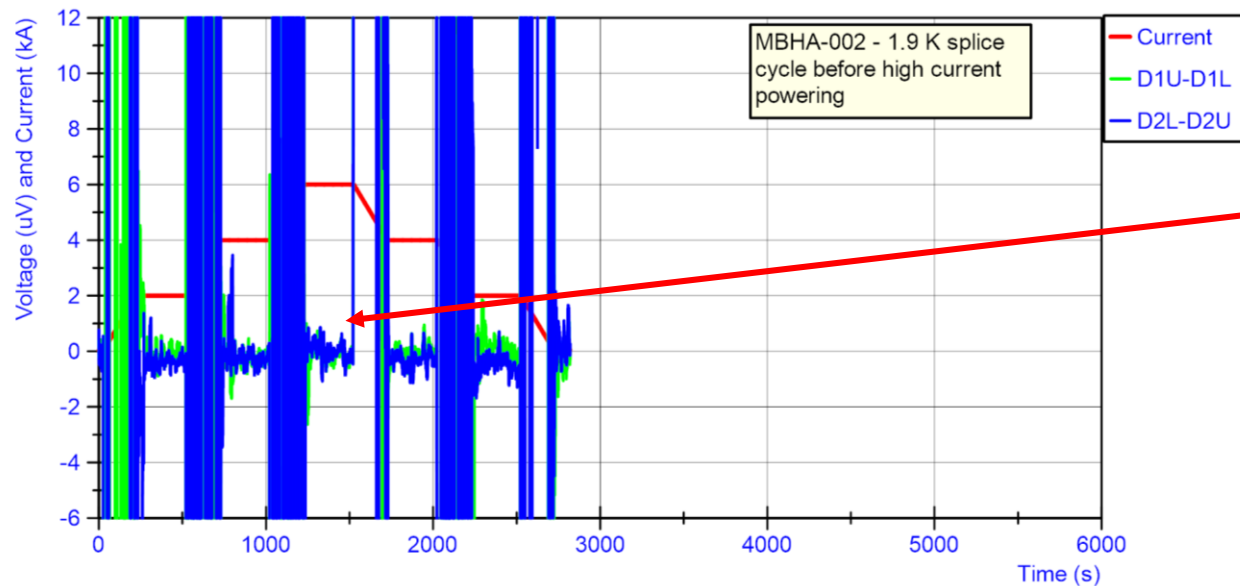
First powering to 6 kA was a splice cycle including V-I measurements.
No sign of any voltage.

This was the first time this magnet reached 6 kA.

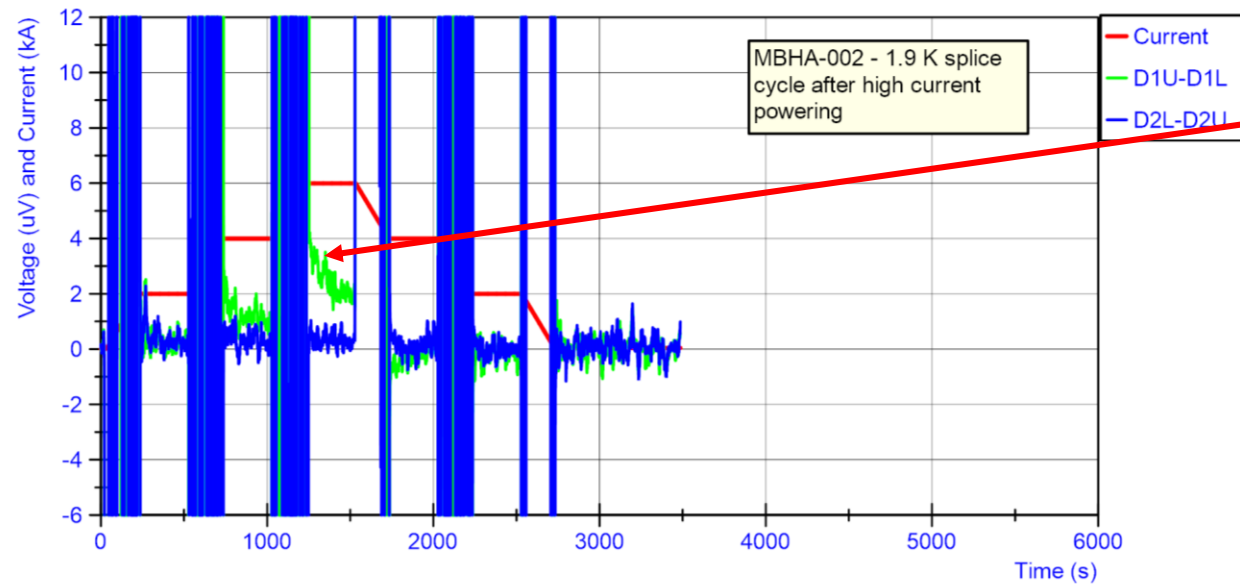
Clear voltage at 6 kA
This was the last powering before warm up.

Conclusion: a weakness appeared, or an existing weakness degraded more during the powering/quenching.

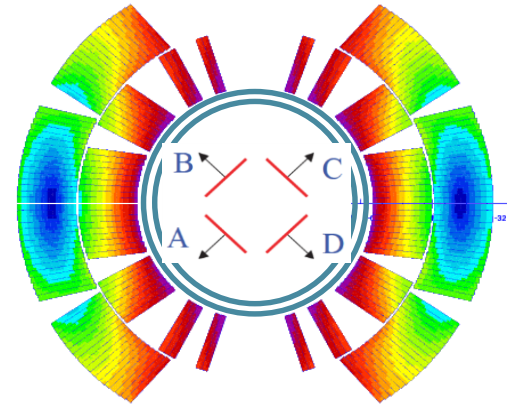
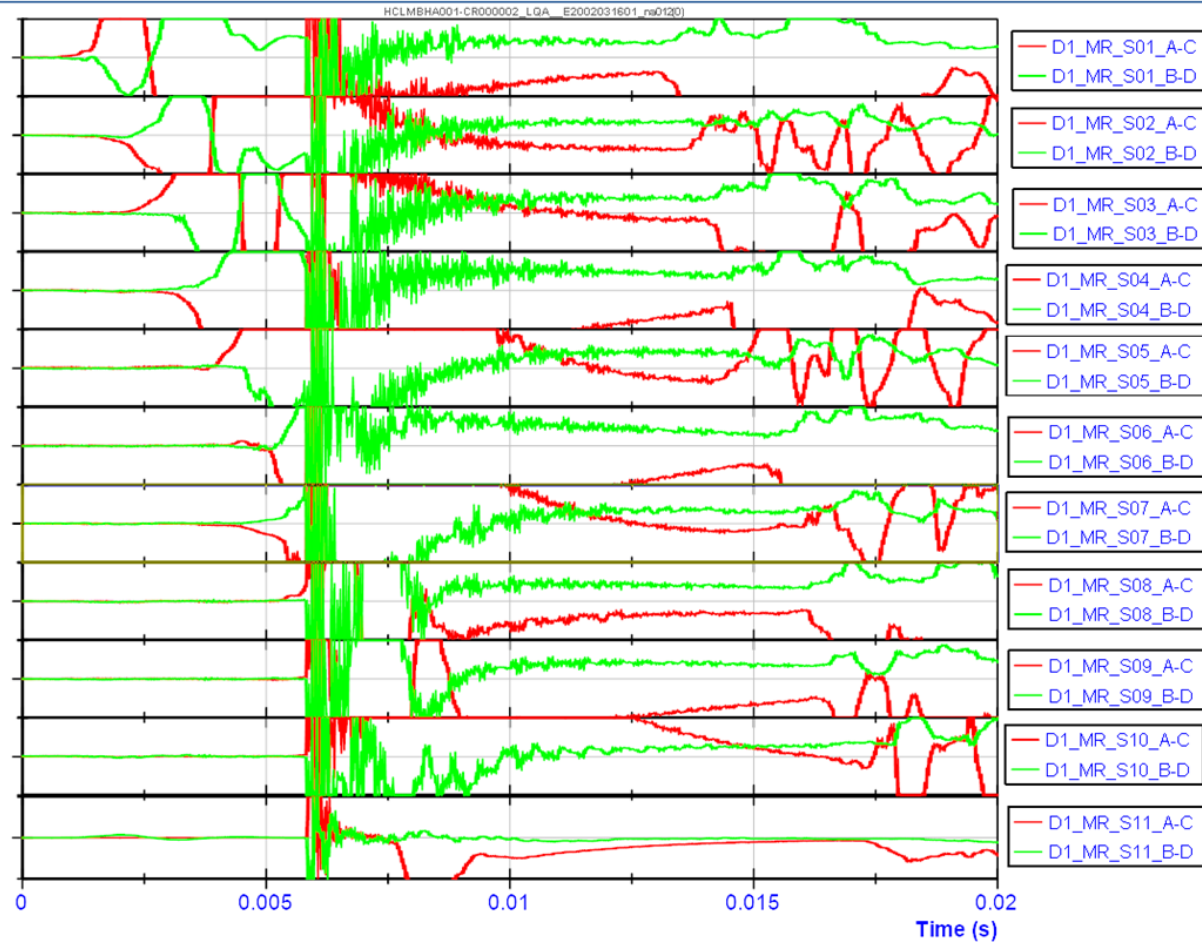
Quench 23: 11.6 kA @ 4.5 K, 1 A/s (start 1.1 meter from the head, MRB shaft inserted towards CFB end)

Abnormal propagation:

Curves A-C flip sign for most segments. (transposition pitch 100 mm, pickup coil length 40 mm)

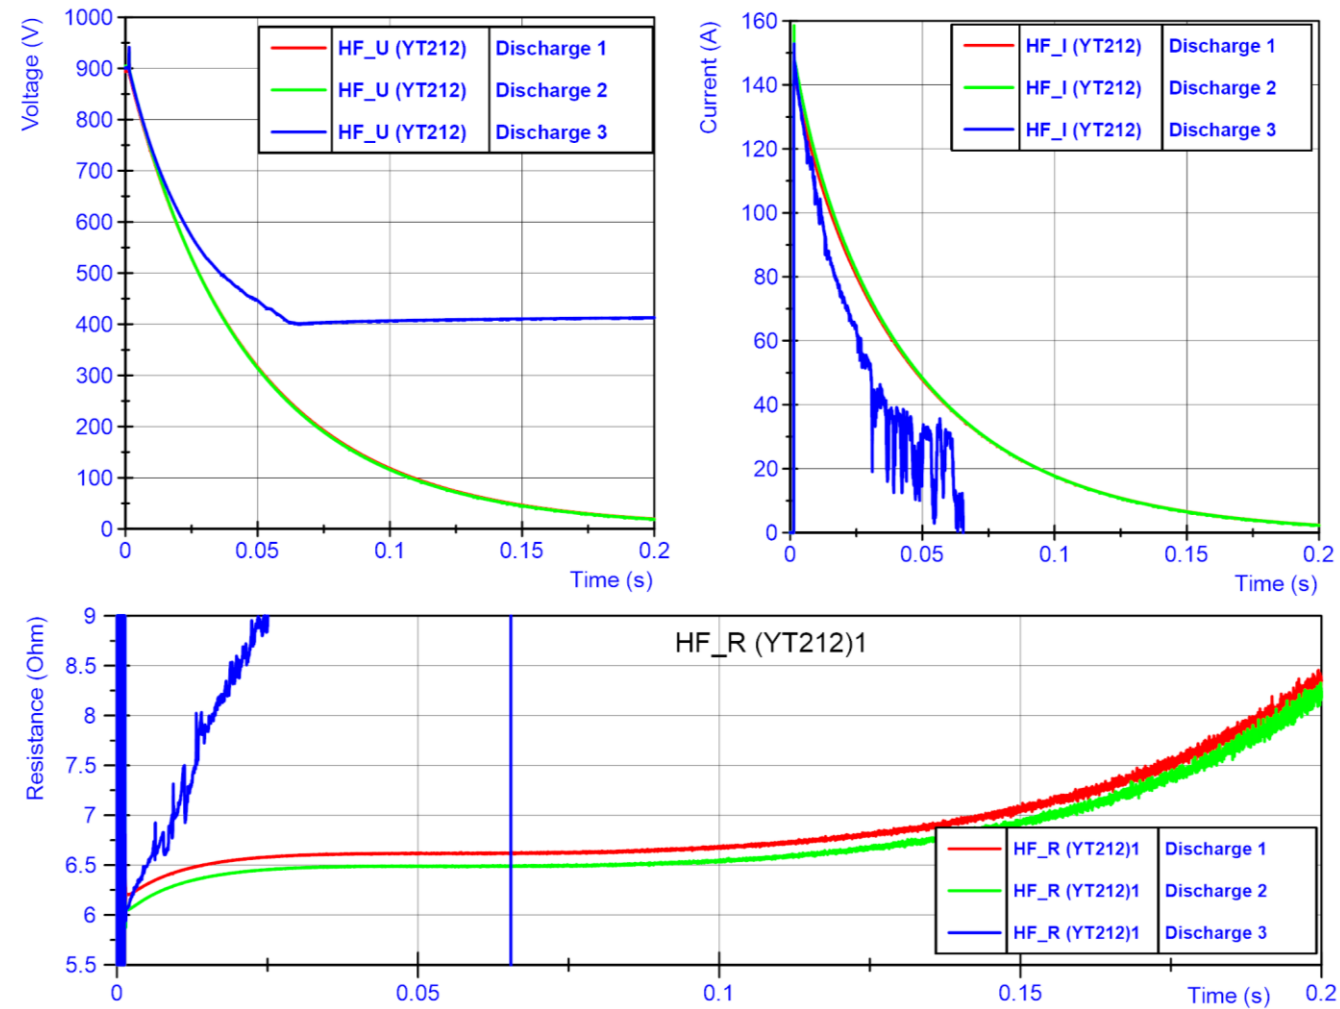
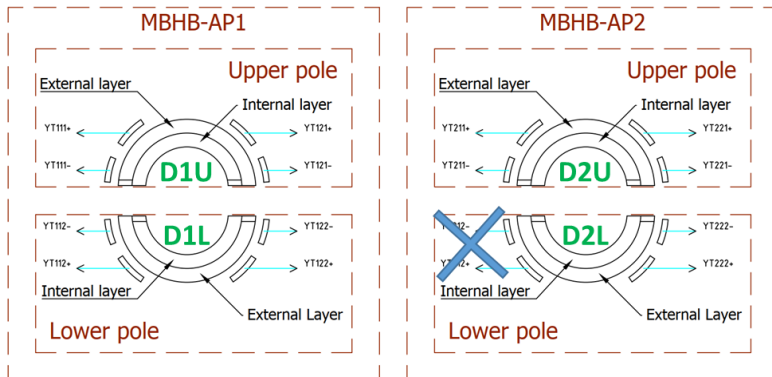
MBHA-002 Quench heater failure

Quench Heater circuit failed in the 3rd heater firing.

- No sign of weakness in discharge 1 and 2.
- Circuit now shows an open loop. Identified with reflectrometry to be about 5 ± 1 m from the IFS box.
- HV insulation test from this heater circuit to coil and ground OK at 1 kV after failure, so test continued with 7 out of 8 QHs.
- First heater to fail in 11T magnet (including models)

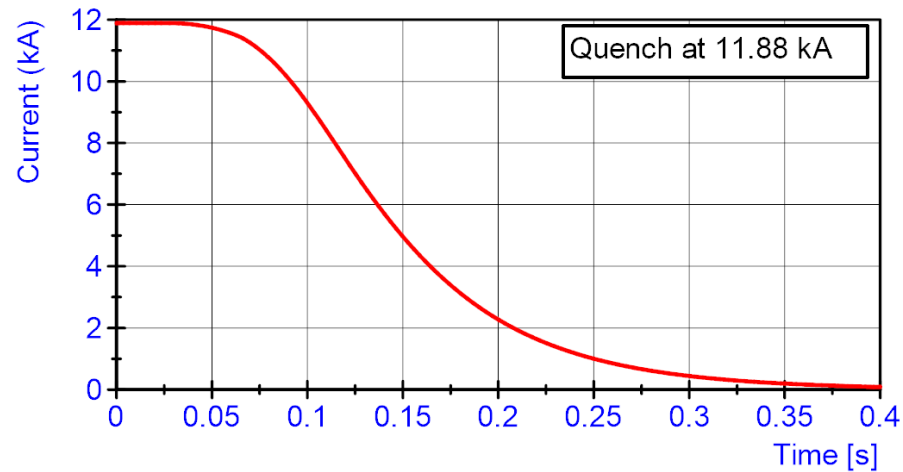
Voltage imbalance following quench

MBHA-002 training was performed with 7 out of 8 heaters. The failed heater was in coil D2_L (aperture 2, lower coil)

This leads to a voltage imbalance: in coil D2_L we measure -460 V, while in other coils we measure 130 to 190 V.

This imbalance plays a role in the discussion for the HV insulation test levels.

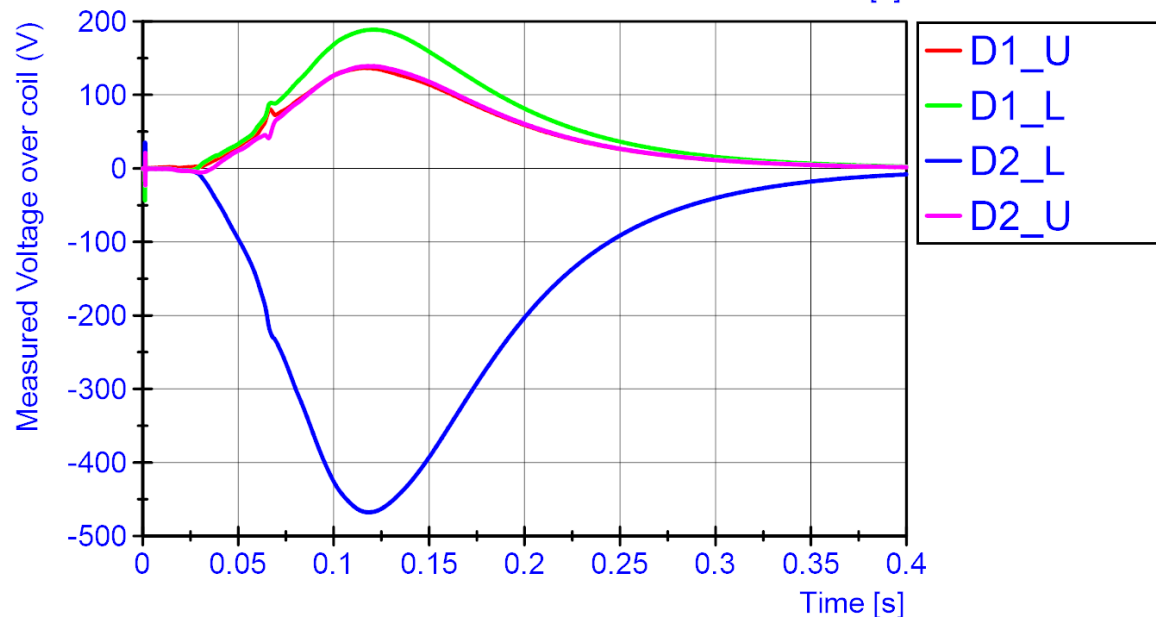
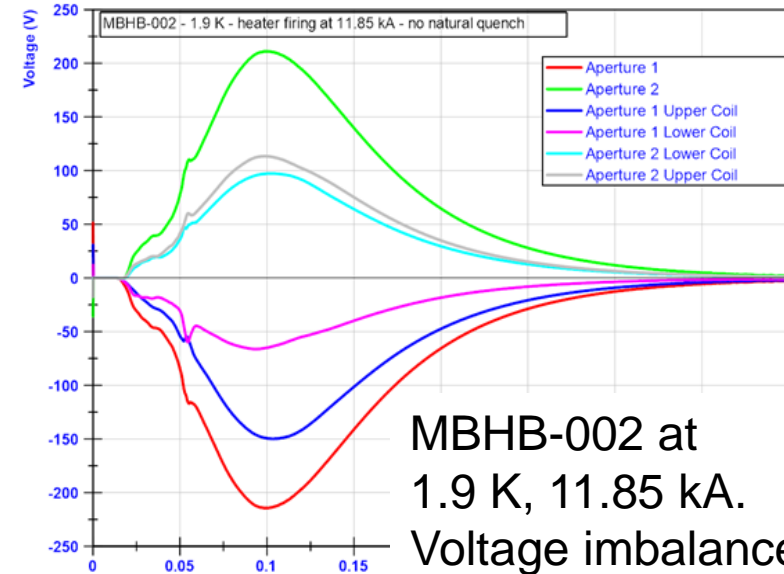
MBHB-002 at
1.9 K, 11.85 kA.

Voltage imbalance caused by
RRR and Cu content variation.
