CBM GEM Muon detector assembly and discussion on the opto-coupler based HV system

Anand Kumar Dubey

VECC, Kolkata

Opto Coupler Scheme for biasing triple GEMs in the trapezoidal module

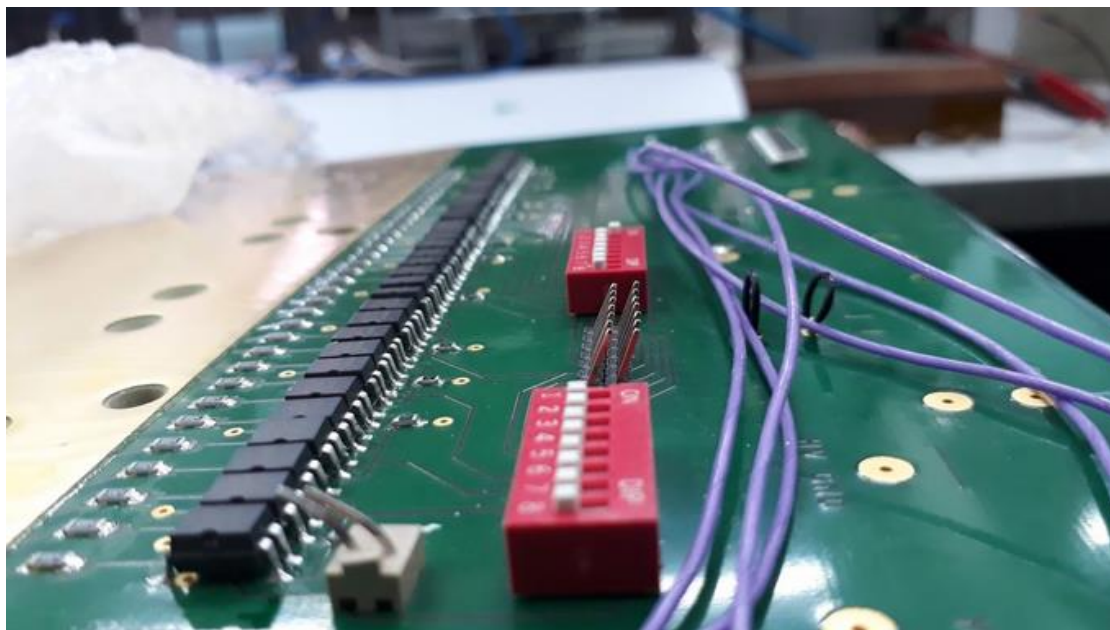
- The modules took good data for the entire run period.
- However, one observation :
- There was occasional **elink-loss at high GEM voltages – also called as link-break problem.** (4600 or higher)
- It was attributed to some spikes coming from the detector.
- The situation worsened with high intensity beams, the system could not remain stable for more than few minutes.
-
- But there were several occasions where the detector handled 4900 V upto one hour without any link-break

The Optocouplers as soldered on the drift PCB

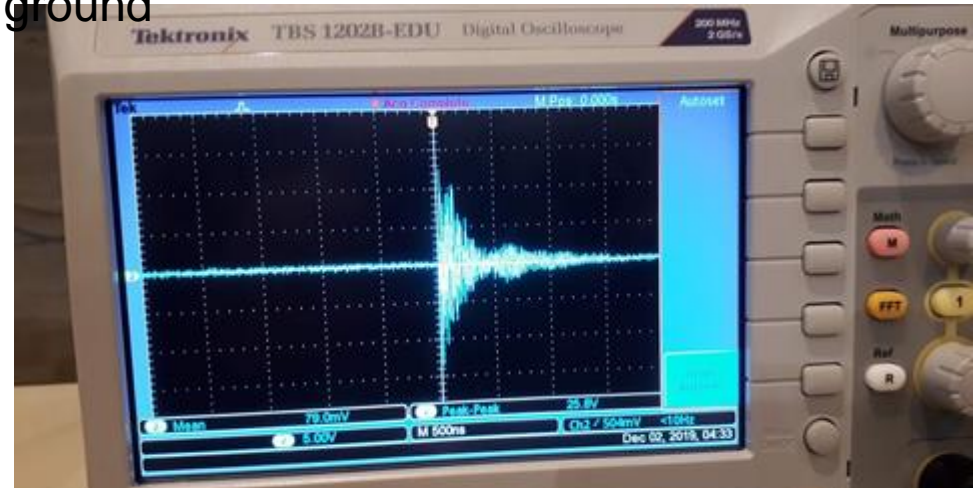
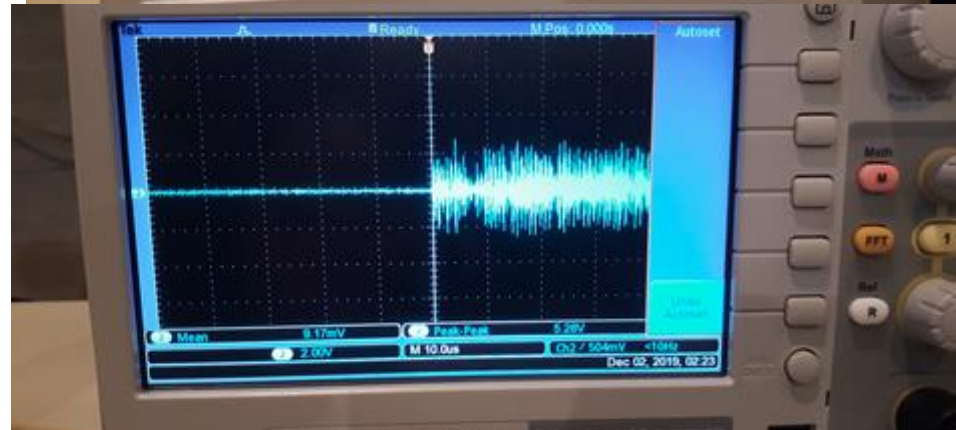
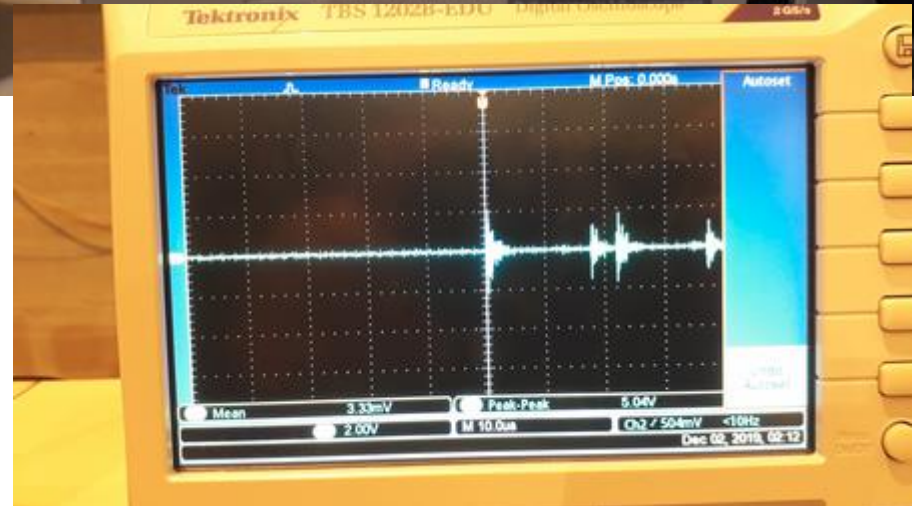
Investigation into the layout to identify any leaky path

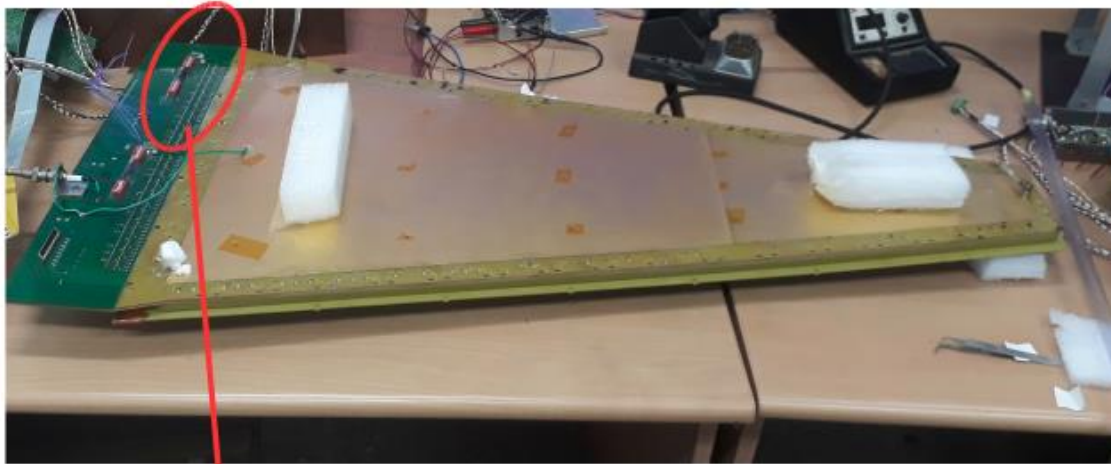
Occasional to Frequent spikes seen on the scope

-- frequent at higher humidities.

On replacing the opto-couplers with simple SMD resistors, the system ran smoothly without any link break for several hours at 4900V.

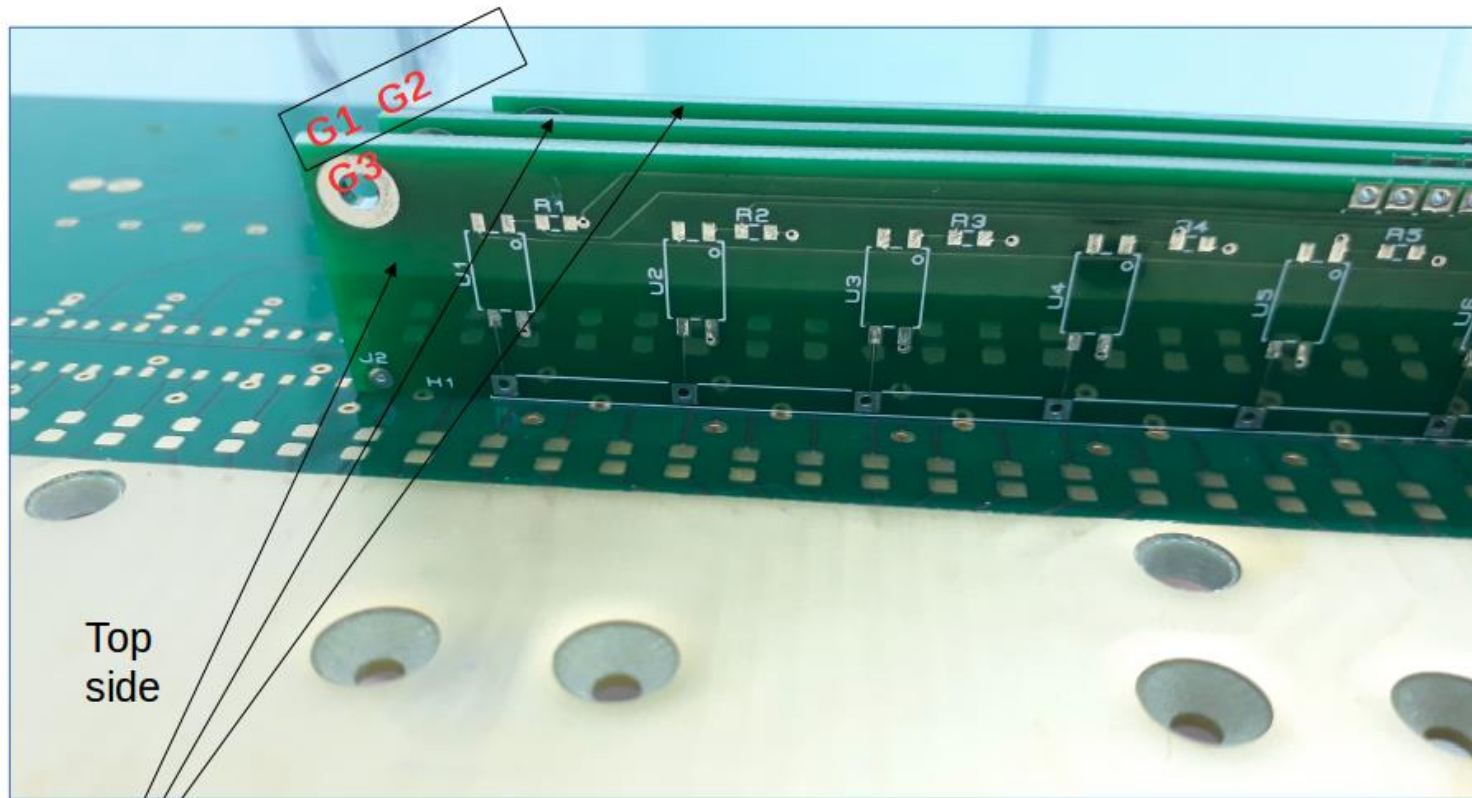
too close proximity of the optocouplers of GEM1, GEM2 and GEM3.

**PCB arrived
On 06-07-
2020**

Can we increase the separation ?
-- we make use of three separate planes, where the optocouplers will be mounted.

The optocouplers will be mounted on three different planes, and the extra pads and the PTHs on the present Drift PCB will be scraped off.

If this arrangement is successful, the drift PCB will be modified.

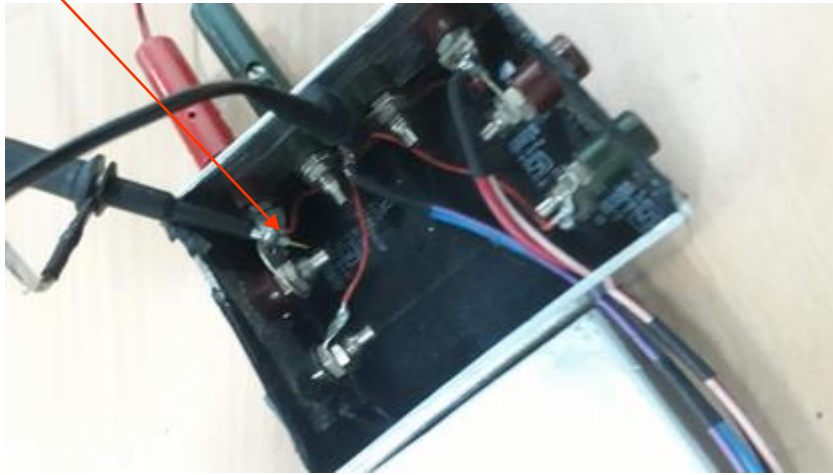
Position of the probe
for sensing the spikes -
- at the optocoupler- LV
point.

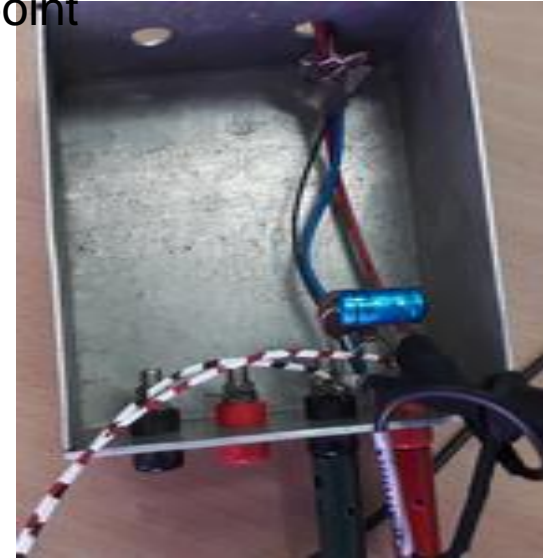
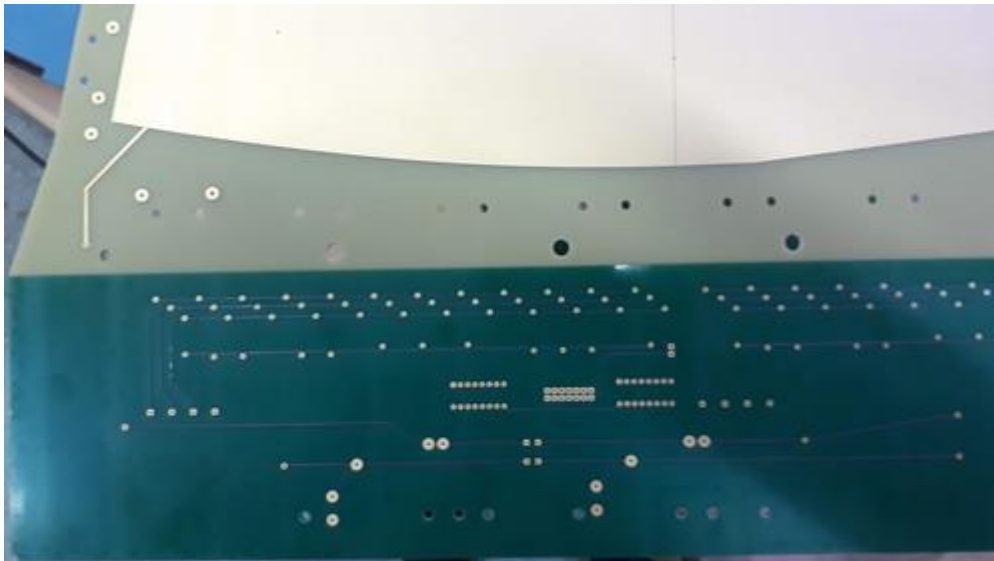
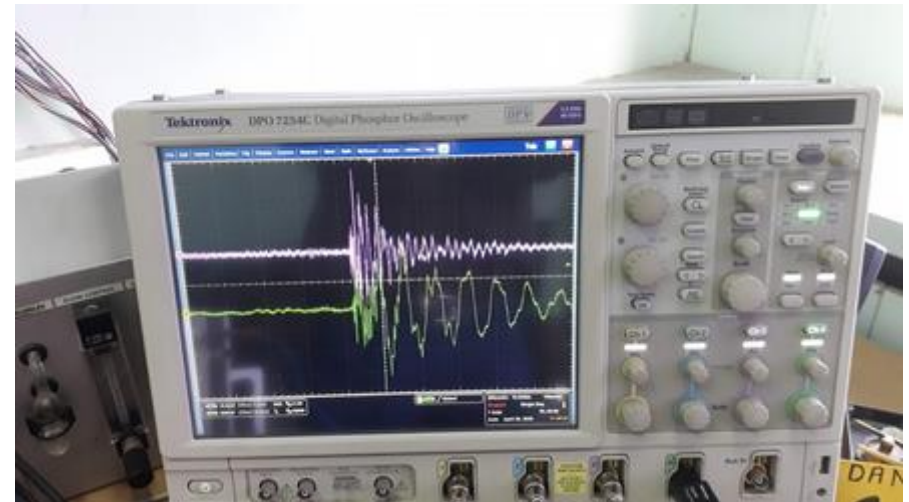
Filters introduced at LV
point

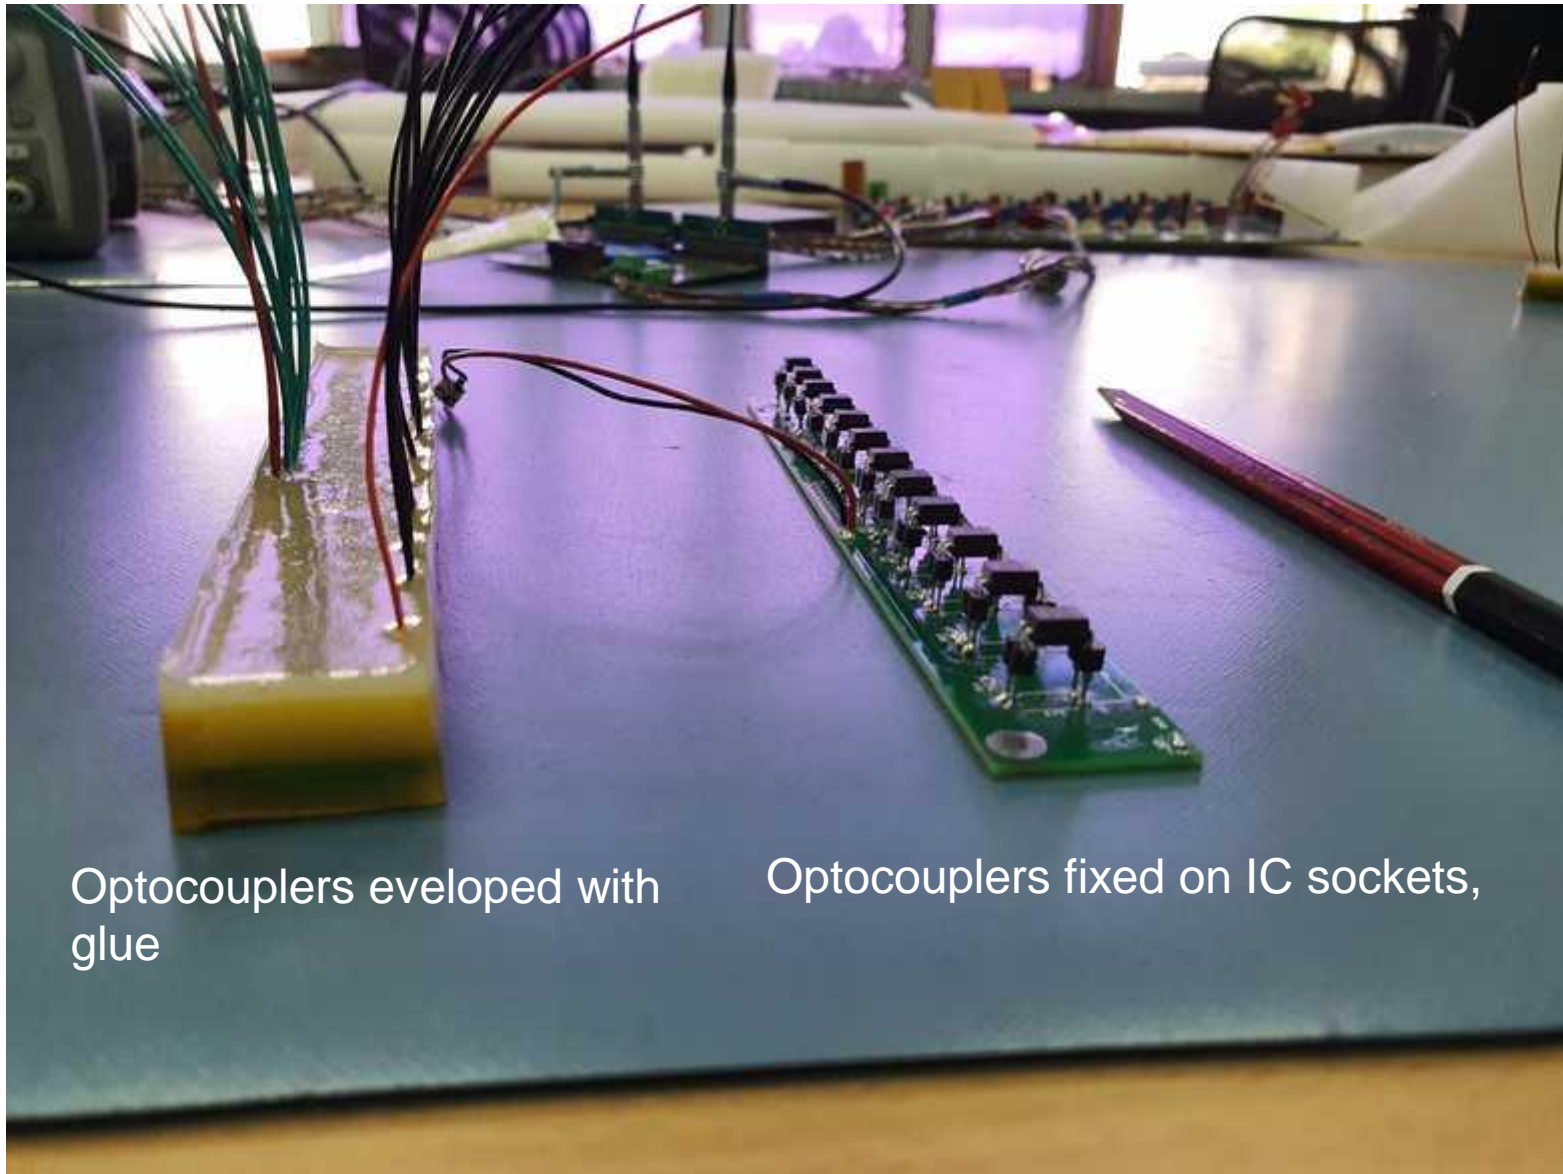
Optocouplers enveloped with glue

Optocouplers fixed on IC sockets,

Those fixed on IC-sockets were found to be relatively more stable under HV

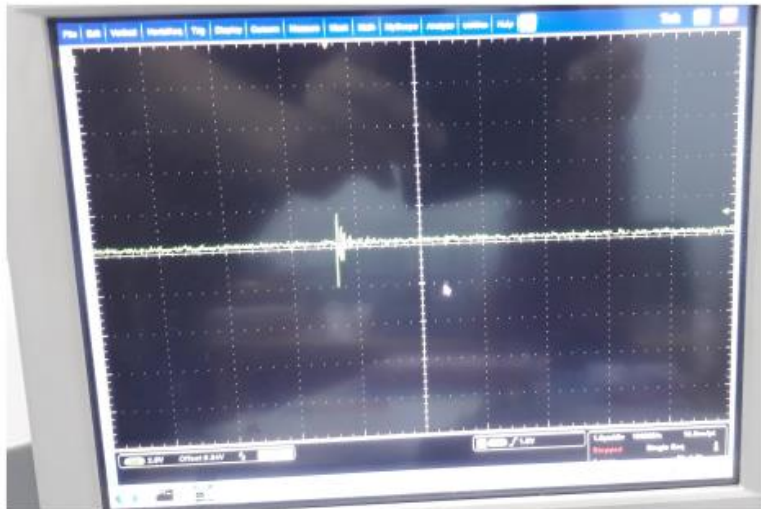
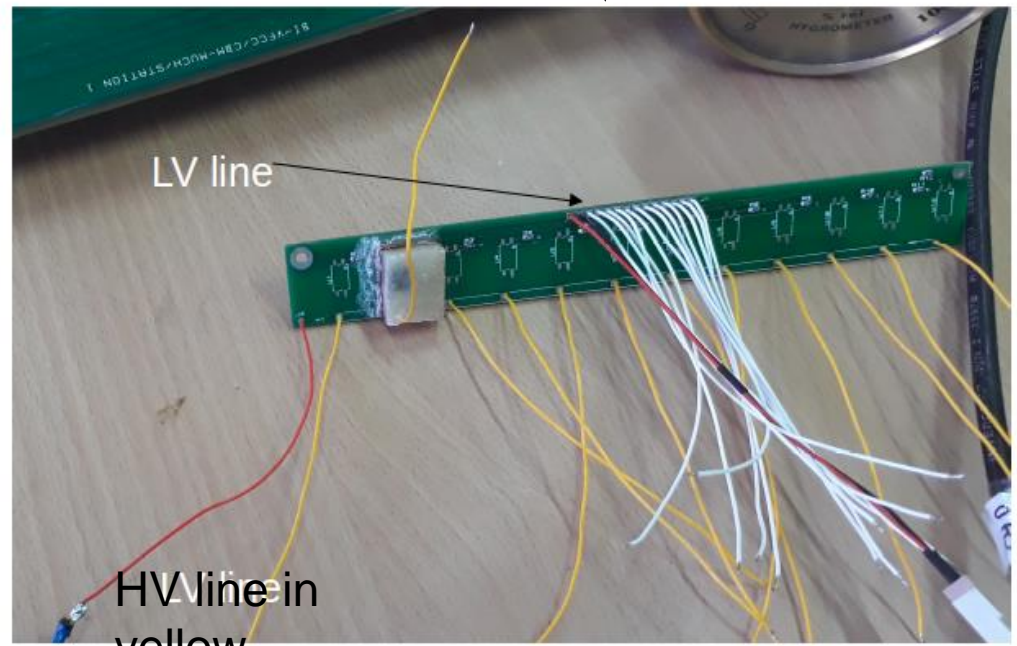
← Without glue-
cover
With glue-cover

Testing with
Single OptoCouplers

Spikes still observed, just that they are now mostly confined to ~4V, as Compared to occasional 20 V, with 12 optoc

Some cleaning procedure incomplete,
Discussion ongoing with Rui
