CMS Pixel

New Layer 1 and other Upgrades to the current Tracker during LS 2

Klaas Padeken

On Behalf of the CMS Collaboration

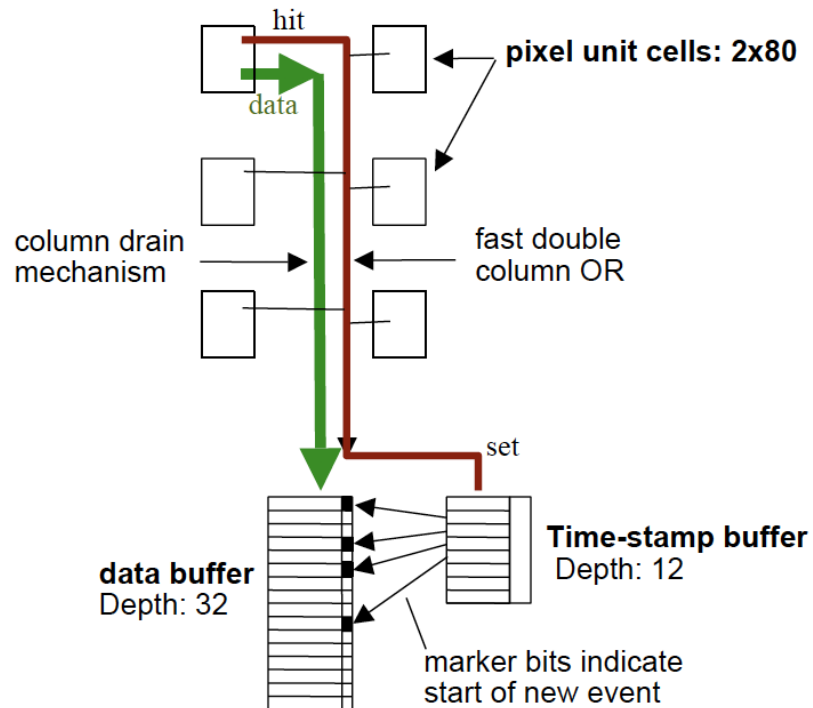
sketch of a double column

The hits are stored in the chip periphery:
timestamp – in the time-stamp buffer
data – in the data buffer.

Due to a glitch the synchronisation between
time and data was lost.

This could be solved in the new PROC600.

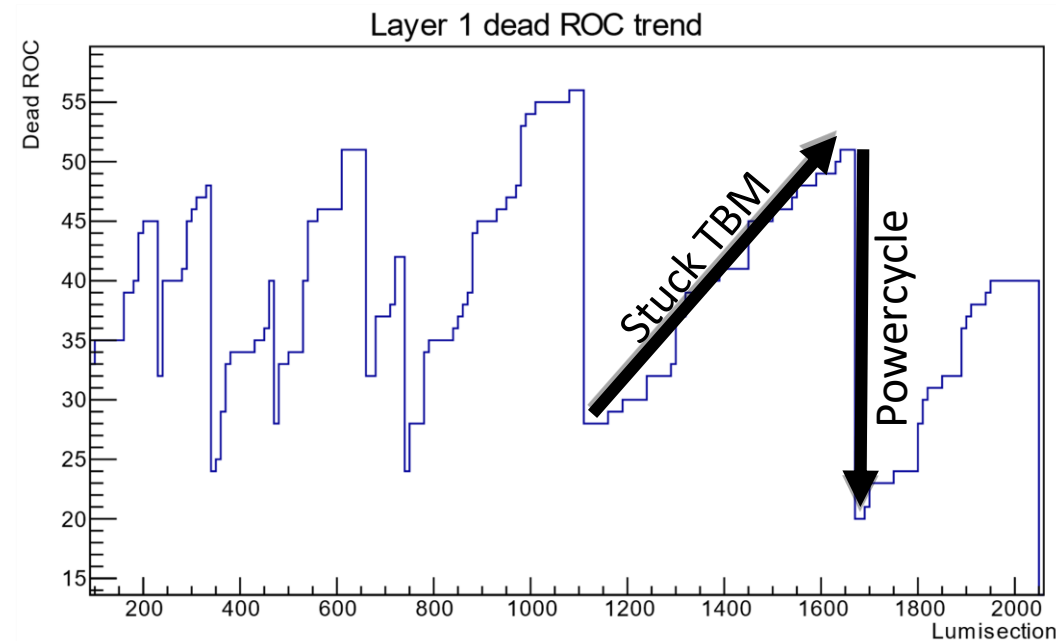
Run 303838 Sep. 2017

- The TBM can get stuck in one state
- Lose data from one core
- No way to reset except to **powercycle**

SEU rate during 2018: $\sim 3/100 \text{ pb}^{-1}$

- **New TBM for Layer 1 fixes this issue**
- **Reset of the TBM possible in new version (for Layer 1)**

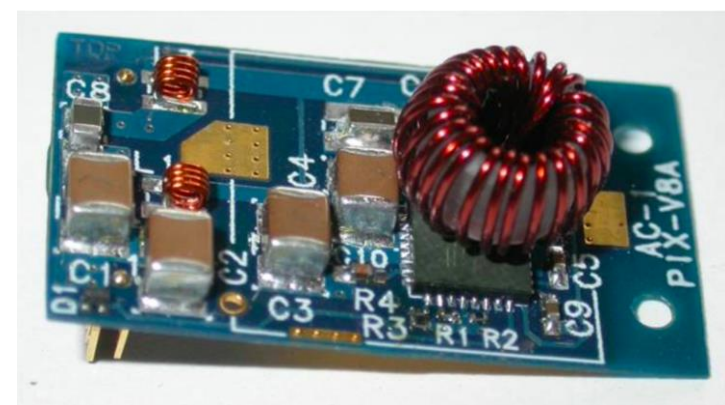
How do DCDCs break?:

If the DCDC is **irradiated** and **disabled** -> a **current** can be **amplified** and **break** the DCDC

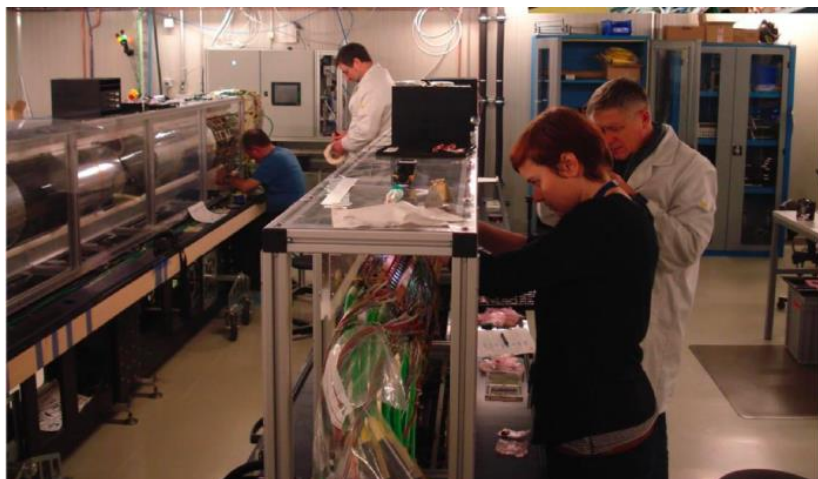
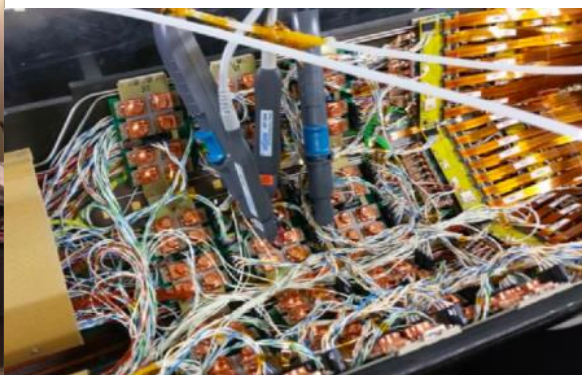
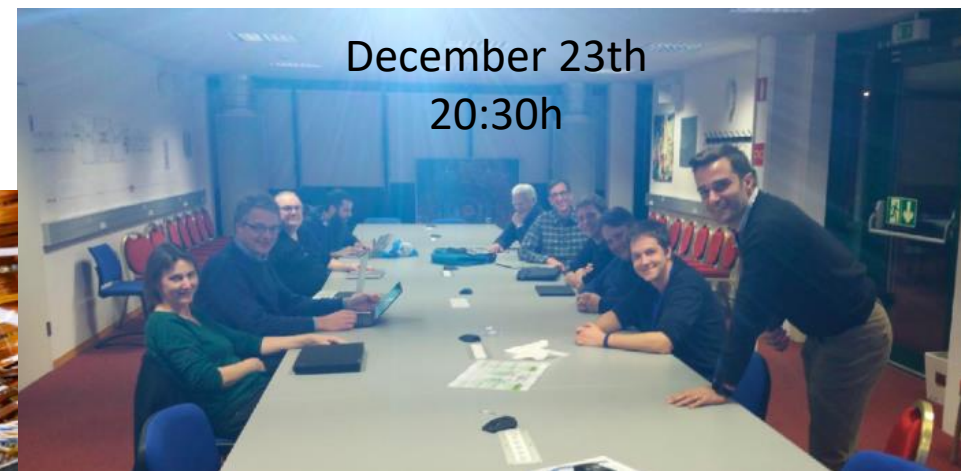
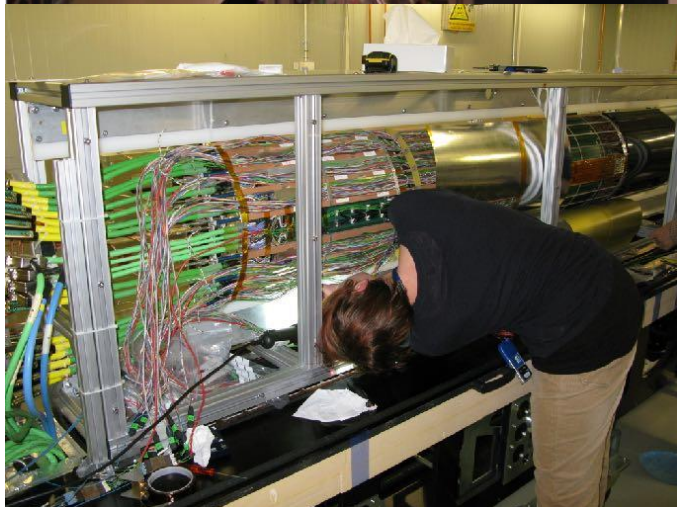
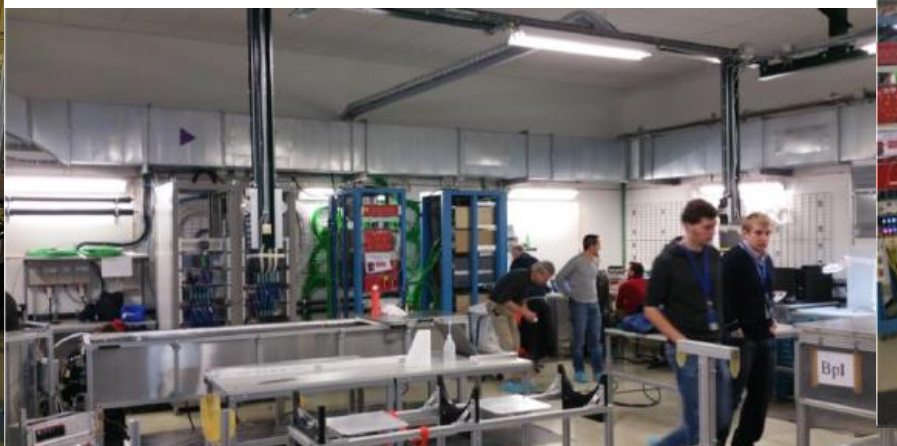
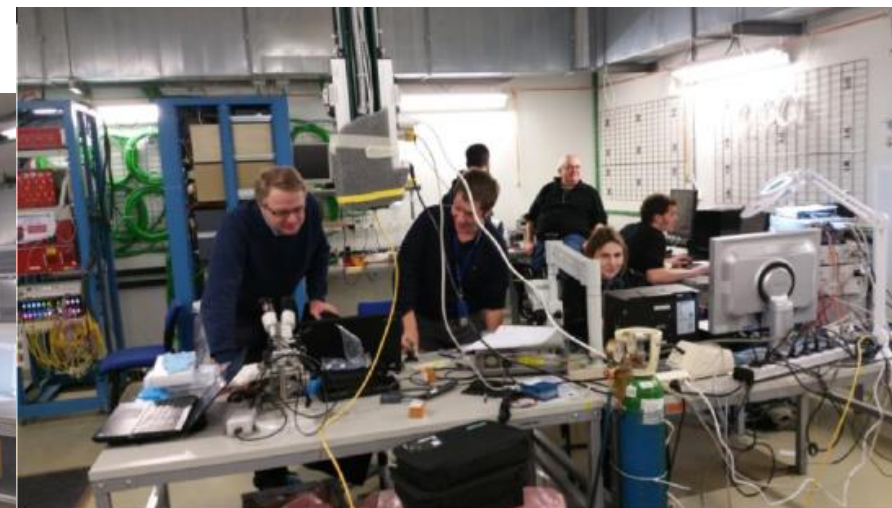
Broken
DCDC
Converter

Detector Extracted, Replaced all DCDC
with bigger fuse, problem not
yet understood

Problem reproduced in
the lab (IRAD,X-ray),
reason understood

- We ran 2018 without using the DCDC converters to cut the power to the modules
- Powercycling needed for the stuck TMBs
- Reduced the supply voltage to 9V
- Use powersupplies to powercycle between beam
- The turn on current of the modules is very high
 - We did have to disable a few DCDCs in order to turn on the detector/powercycle the powersupplies --> **none broke in 2018**

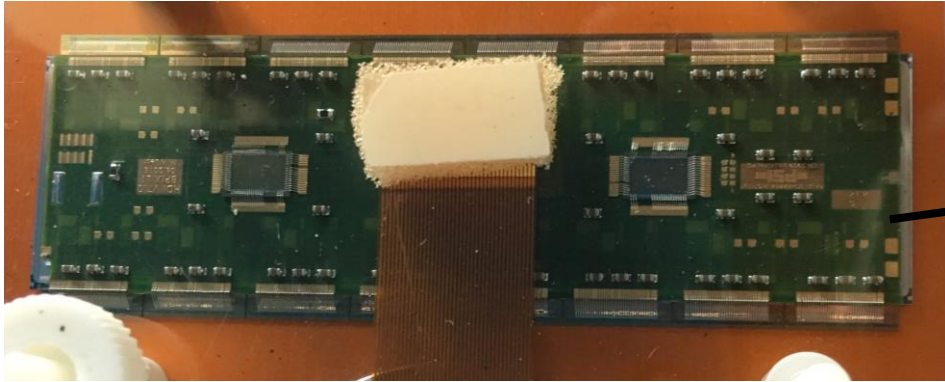
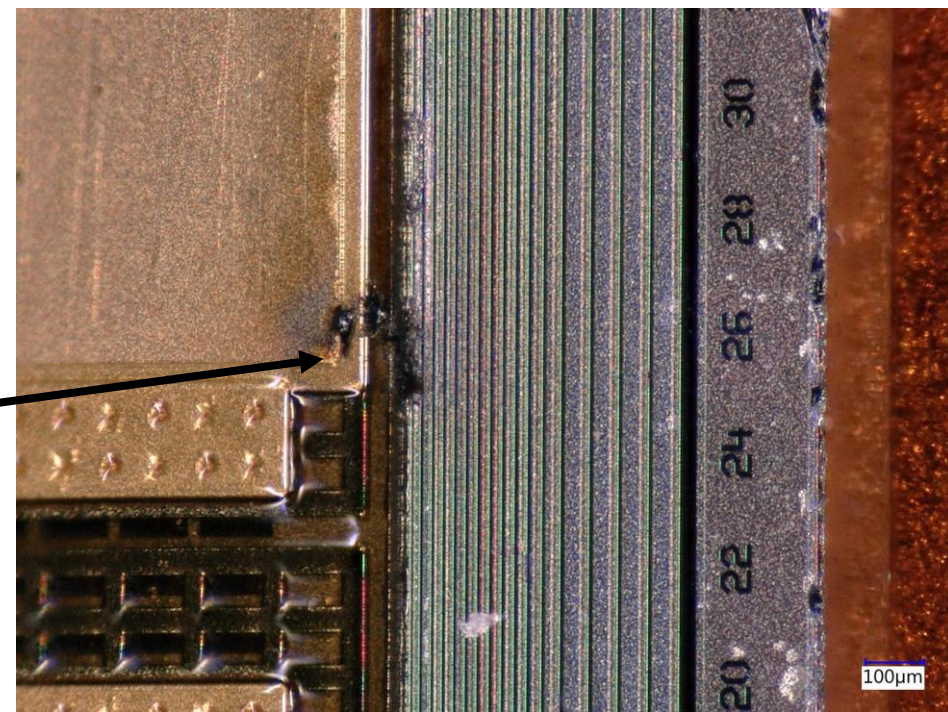
HV problems

Damages due to HV on and LV off

The edge of the L1 HDI was not covering the sensor enough, so a HV spark to pad ground could damage the module.

For the new L1 the HDI boarder was **increased** to cover the guard rings completely.

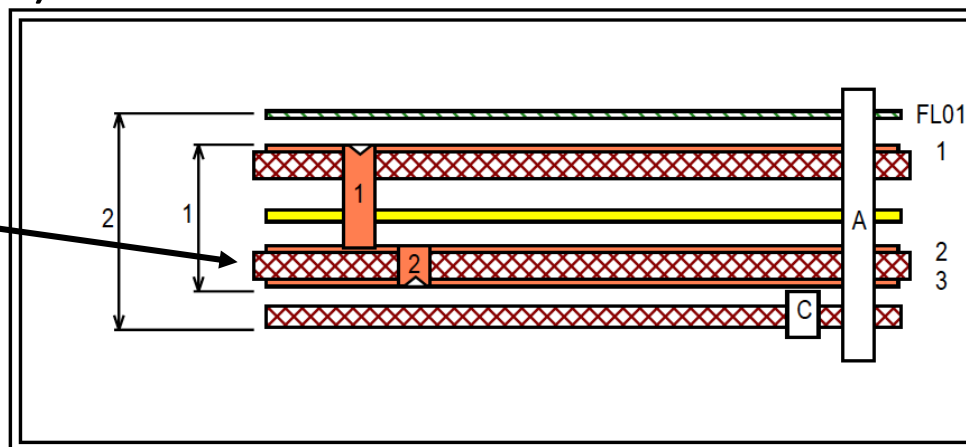
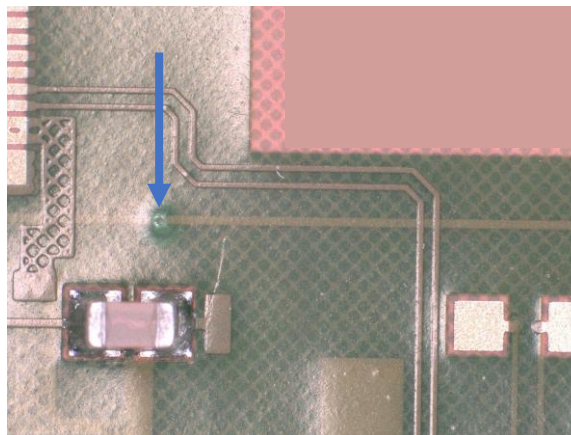
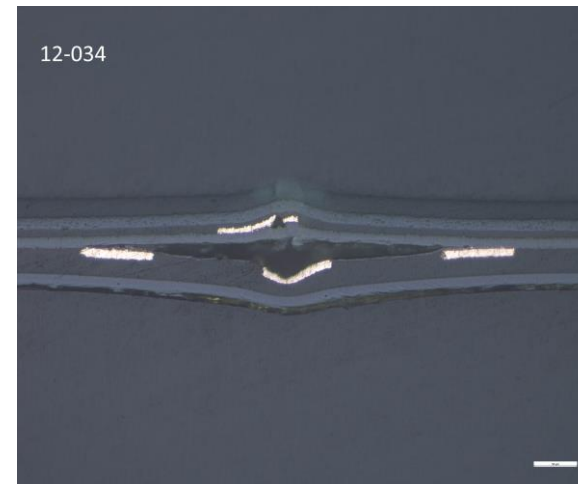
(other) HV problems

On testing the new HDIs at 1100V (800V maximum in the detector originally designed for 600V) a short occurred

Further test showed that you can break any HDI if you try. Humidity probably has an effect (or opening the test box)

- **New HDI** without a ground grid around the HV line
- No problems observed for long testing at 1100V

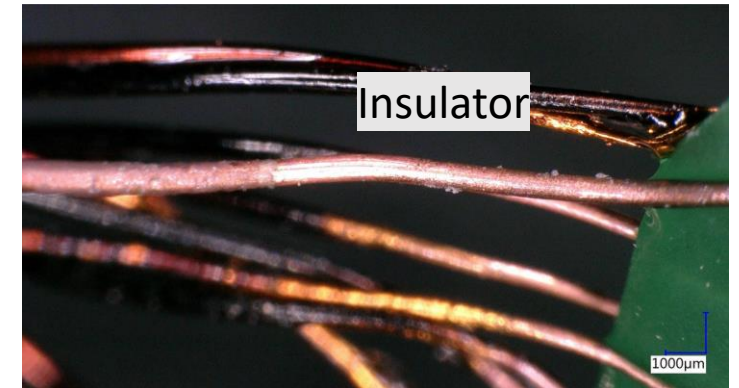
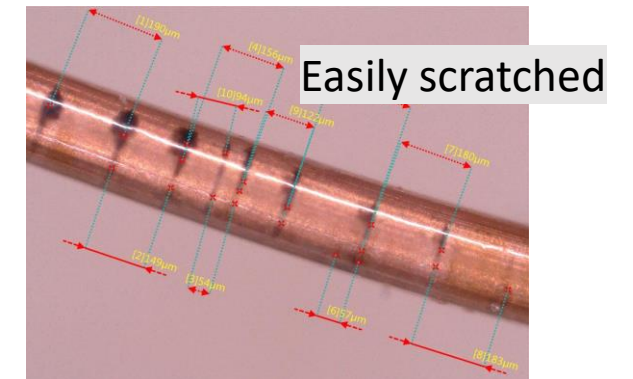
(and one more) HV Problem

- New module cables showed HV problems:
 - Insulator was stripped to far back
 - PEEK insulation was too susceptible for mechanical damage
- New thicker PEEK insulation solved both issues

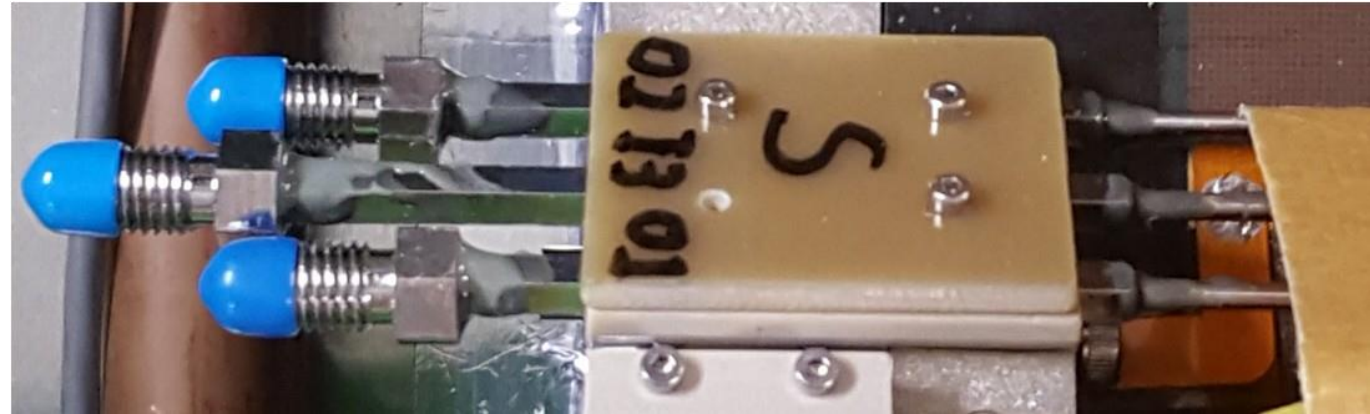
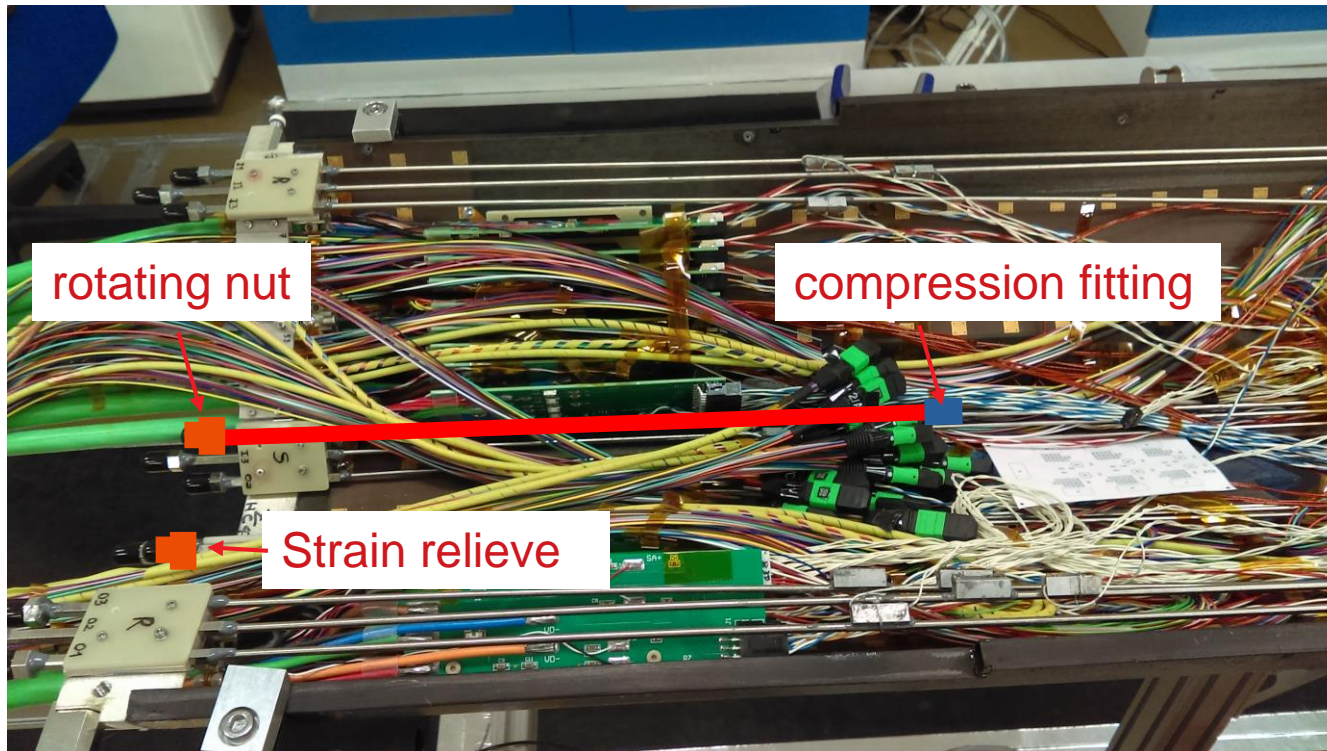
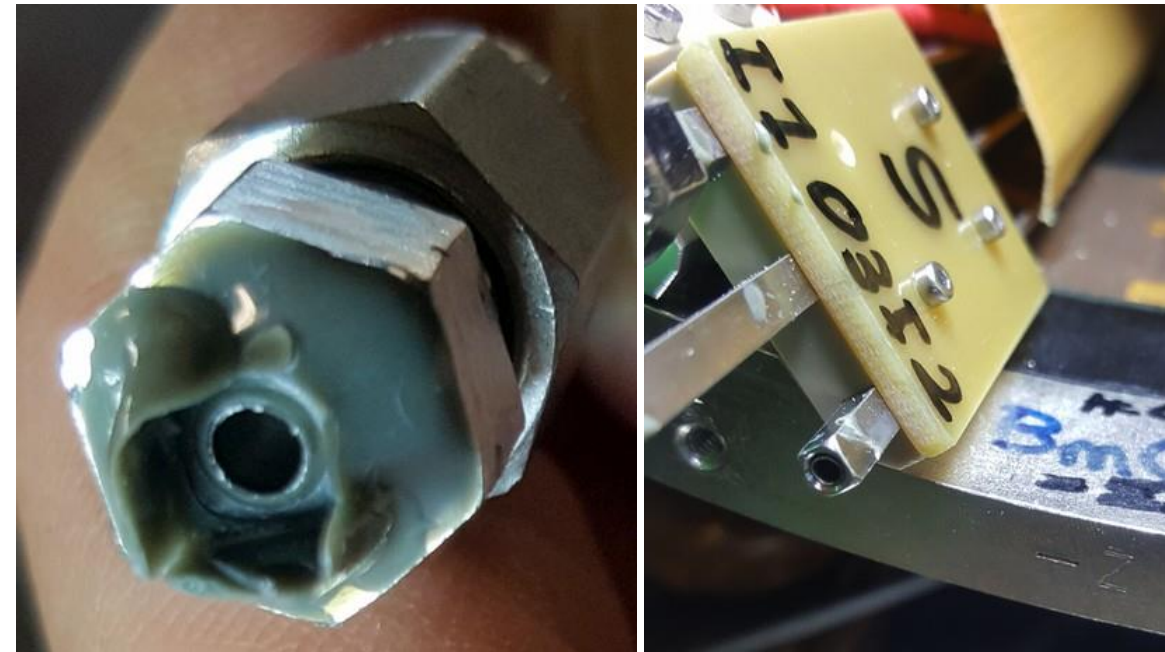
FPix cooling

- Fixed nut directly welded to 120 μm thick pipe
- Minimal mechanical torque needed to break off the nut
- Glue was meant to reduce the mechanical stress.

- Add a strain relieve to the end flange (for non broken pipes)

- Add a larger 1/8" (3.18mm) tube to the 2.4mm tube
- Connection done with a (custom) VCR fitting
- Which solution will be used on how many pipes will be decided during the repair works

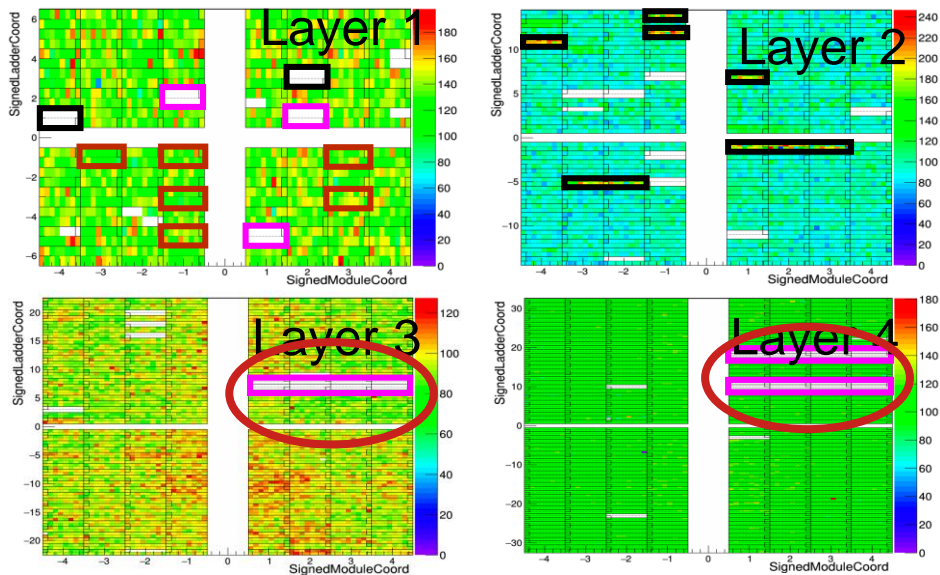
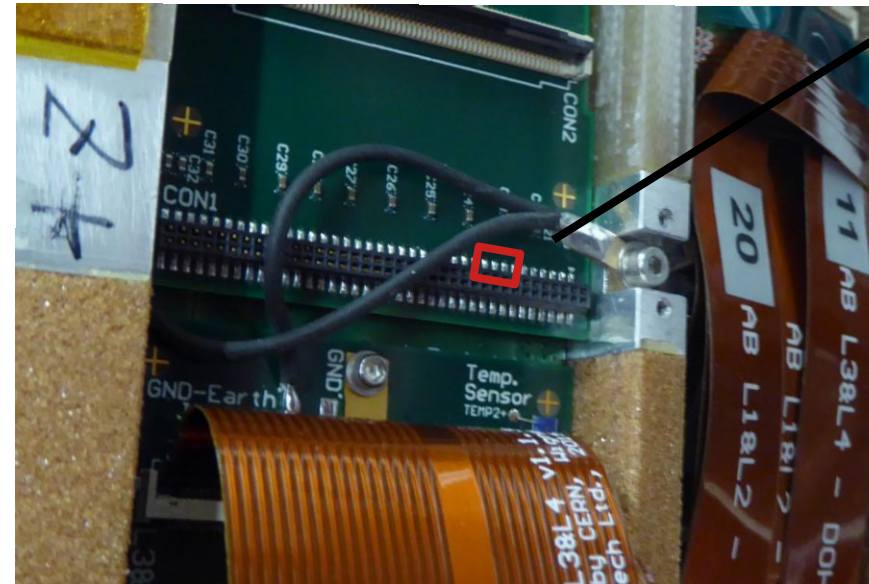
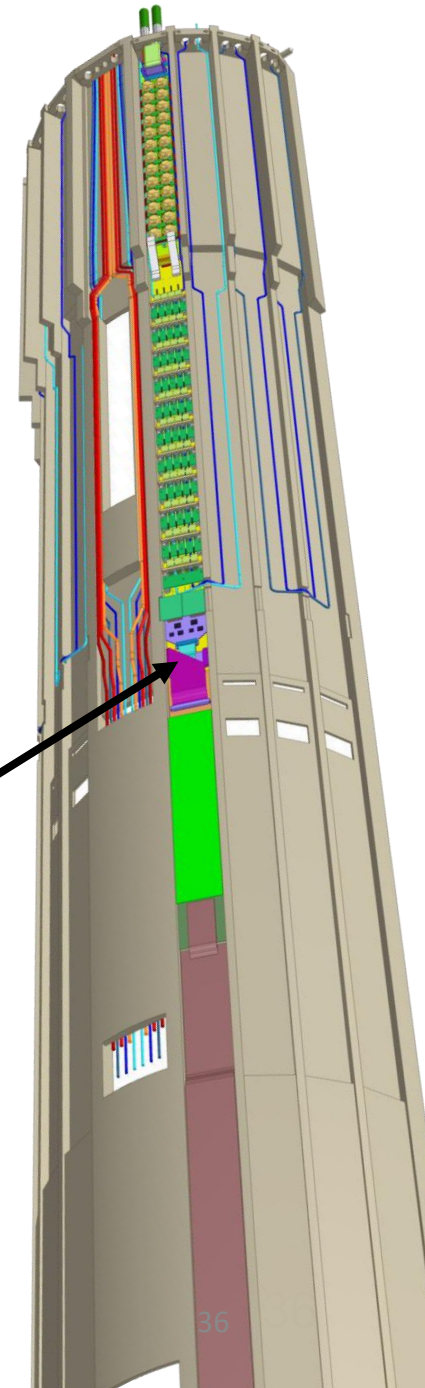
Connection problems

- Two LV lines were disconnected during operations in 2018
- To avoid damages, the HV was shut of (full sectors)
- The problem was in the connection between two boards
- A better mechanical support is planned
