# Linac4 RFQ issues

Suitbert Ramberger

10 June 2020

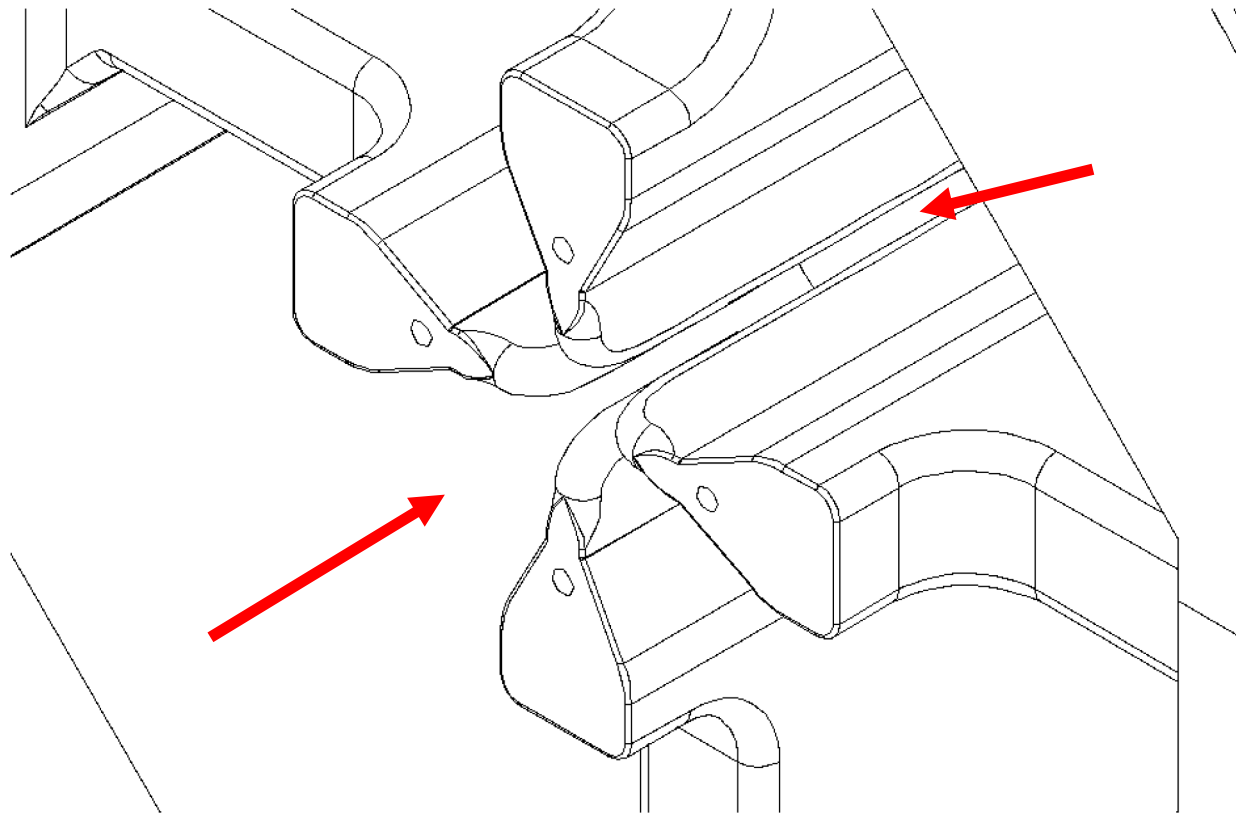
# L4 RFQ vane front face

- **Found damage on front face & start of the RFQ vanes**
- **Beware: endoscopy images can be misleading**
- **The analysis is based on more images than shown**

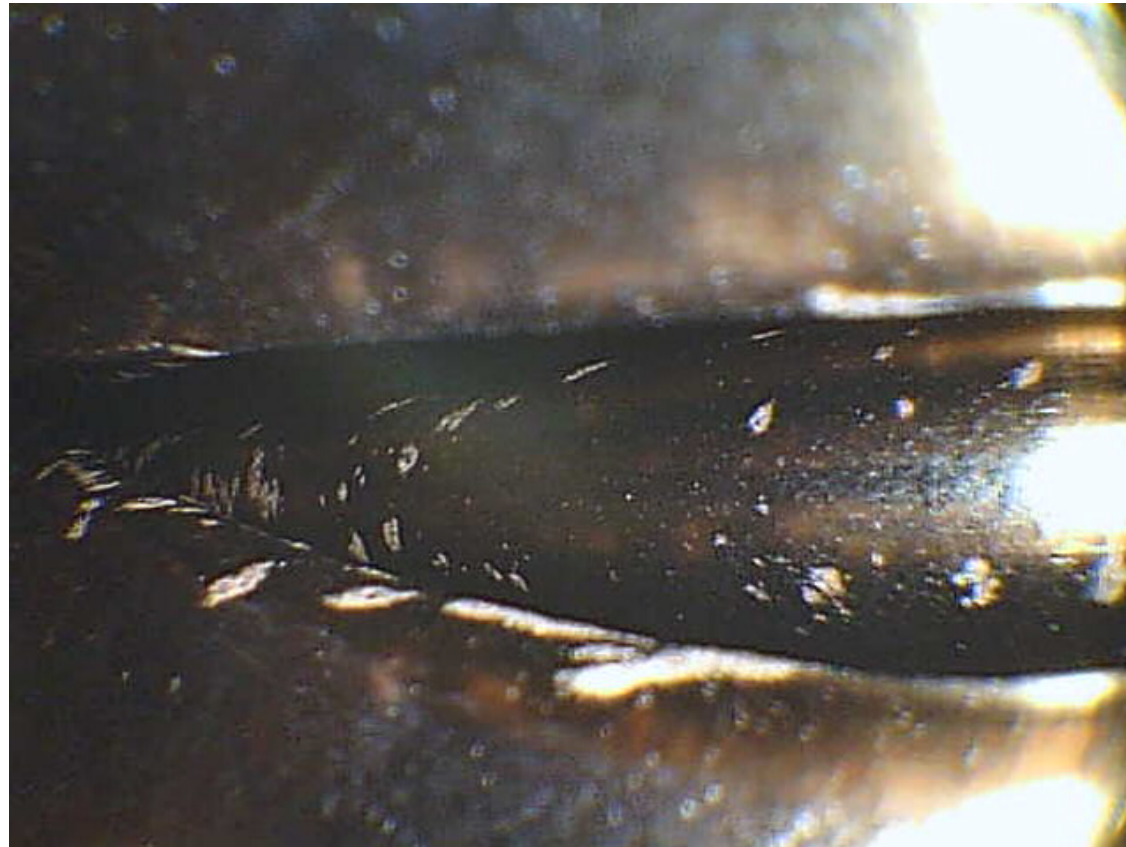
# Breakdown craters

- **Found usual craters all along the RFQ vanes**
- **Craters are a typical signature of breakdowns**
- **Breakdowns are part of conditioning of a structure**

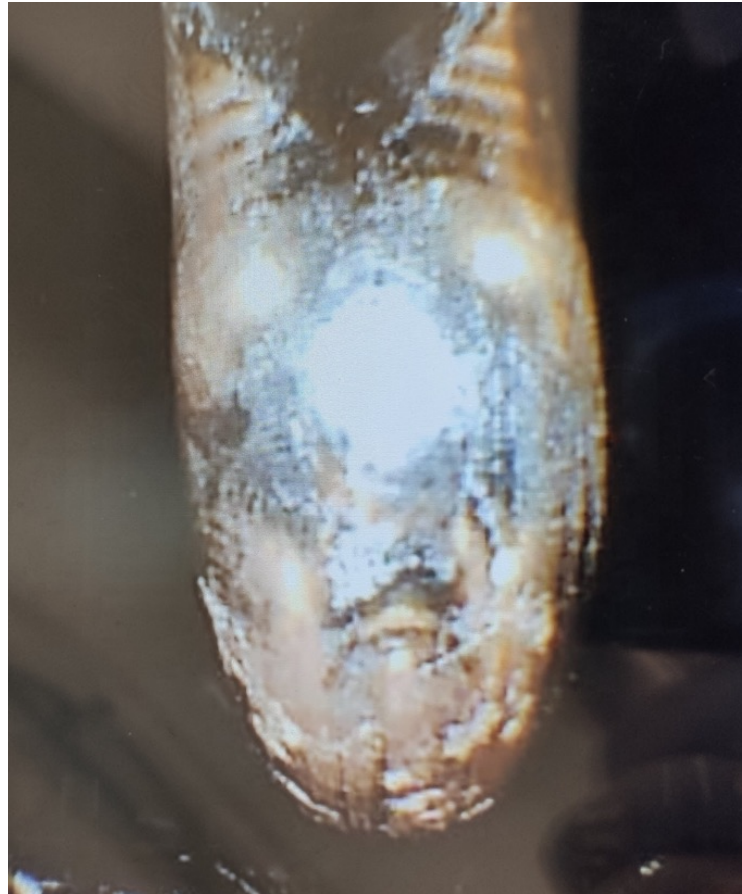
# Vane front face damage

- **Damage on the surface layer of front face – first ideas**
- **Appears to be beam induced**
- **Superficial hydrogen implantation in Cu  $>10^{18}$ ions/cm<sup>2</sup>**
- **No hydride formation in copper, instead H-bubbles**
- **Literature: blistering & exfoliation by heat deposition**

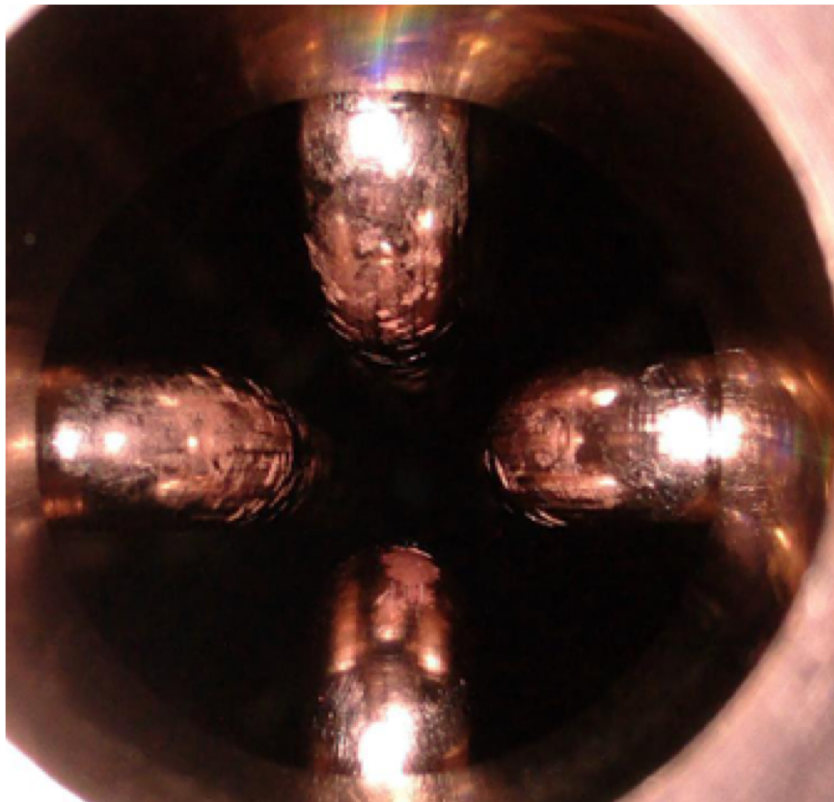
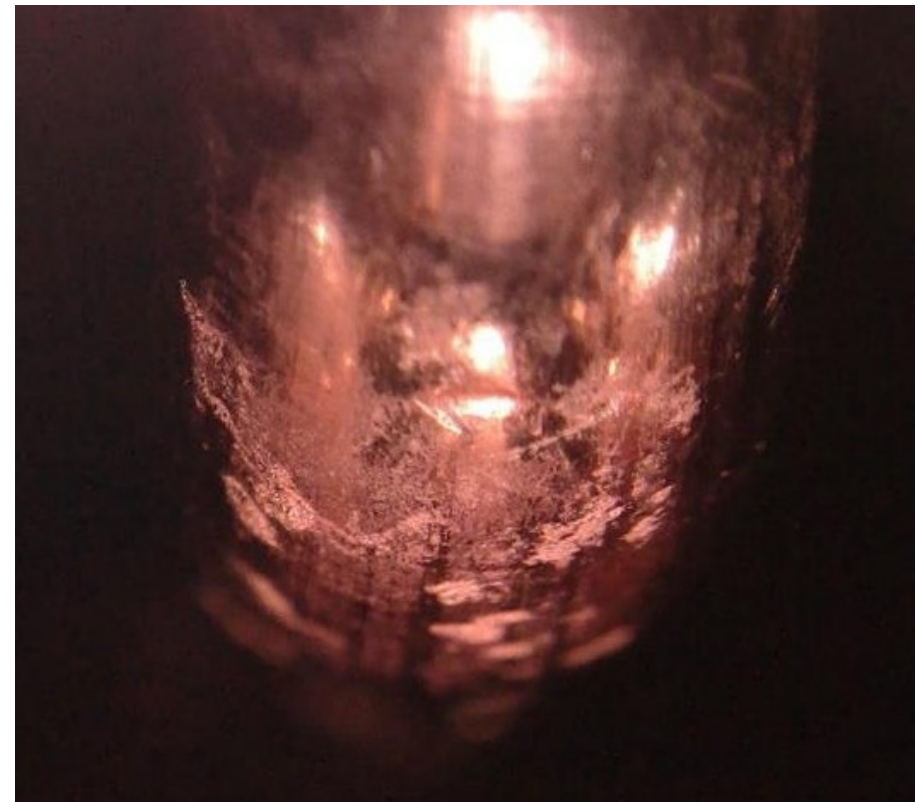
# Linac4 RFQ – Inspection 11.02.2020

- Solenoid removal, pictures taken by normal camera:
- Presumed damage turns out to be mostly variations in surface texture
- No profound features were found
- Surface profile could not be measured
- Aperture of opening too small to use hand held laser metrology devices
- Space is tight for the installation of a laser measurement head with XY table
- Copper surfaces have strong reflections
- 3d endoscope had major issues with surface texture
  - AI image reconstruction in the visible freq. range has similar shortcomings as our eyes.

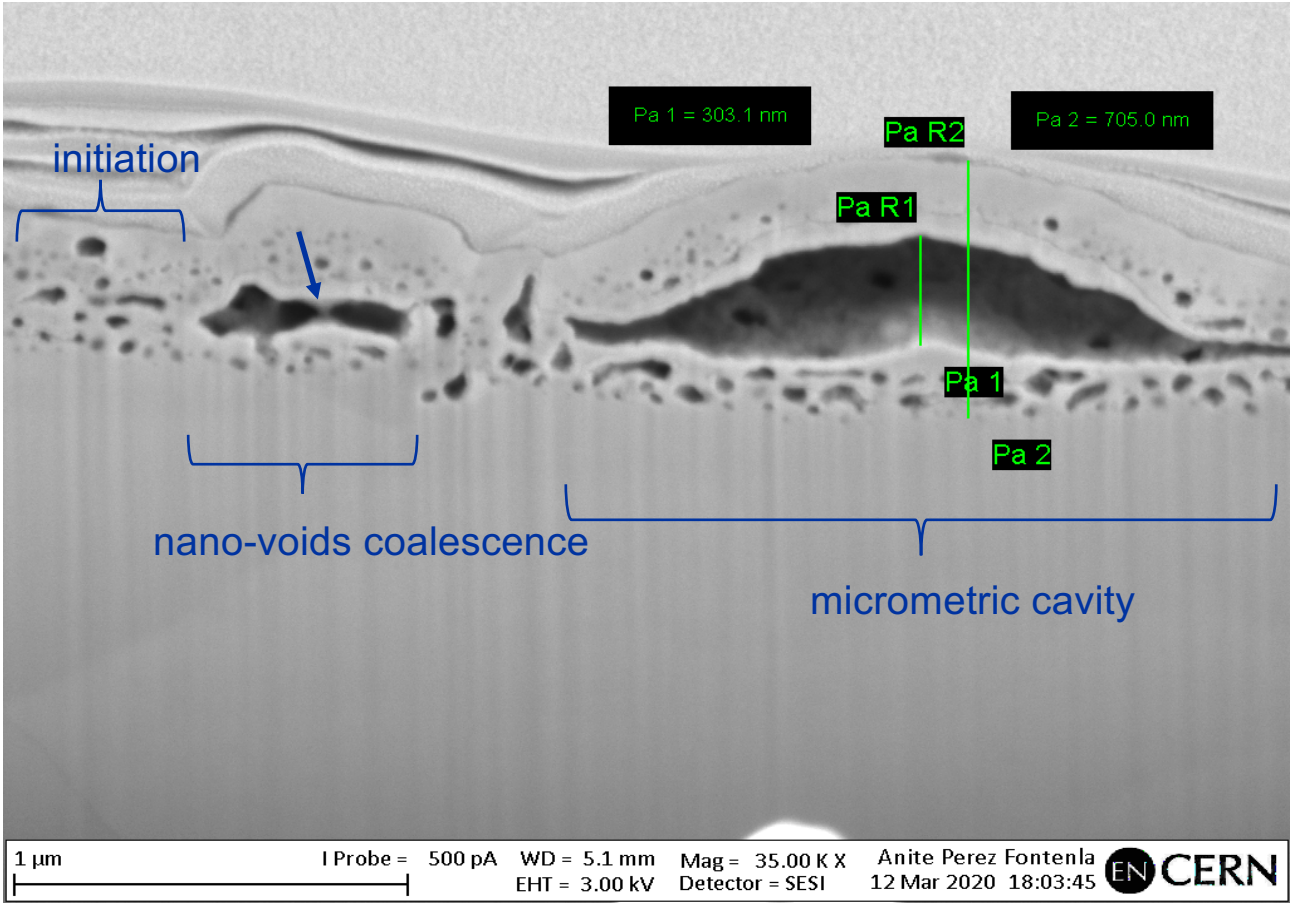
# Spongy copper layer

- Changes in surface roughness with micron-sized features
- Little hydrogen cavities under every bump in the surface
- Spongy material areas going 400nm into the surface
- The Bragg peak at the proton implantation energies is expected at 200nm
- Areas w/o coloration have 400nm of perturbed non-spongy structure
  - Probably due to material production
- The material is not representative for the RFQ – more beam tests required
- More care will need to be taken to reproduce the situation on the RFQ
