UPS network perturbations in SX2

Vincent Chareyre

EN-EL-SN

ALICE Technical Coordination Meeting

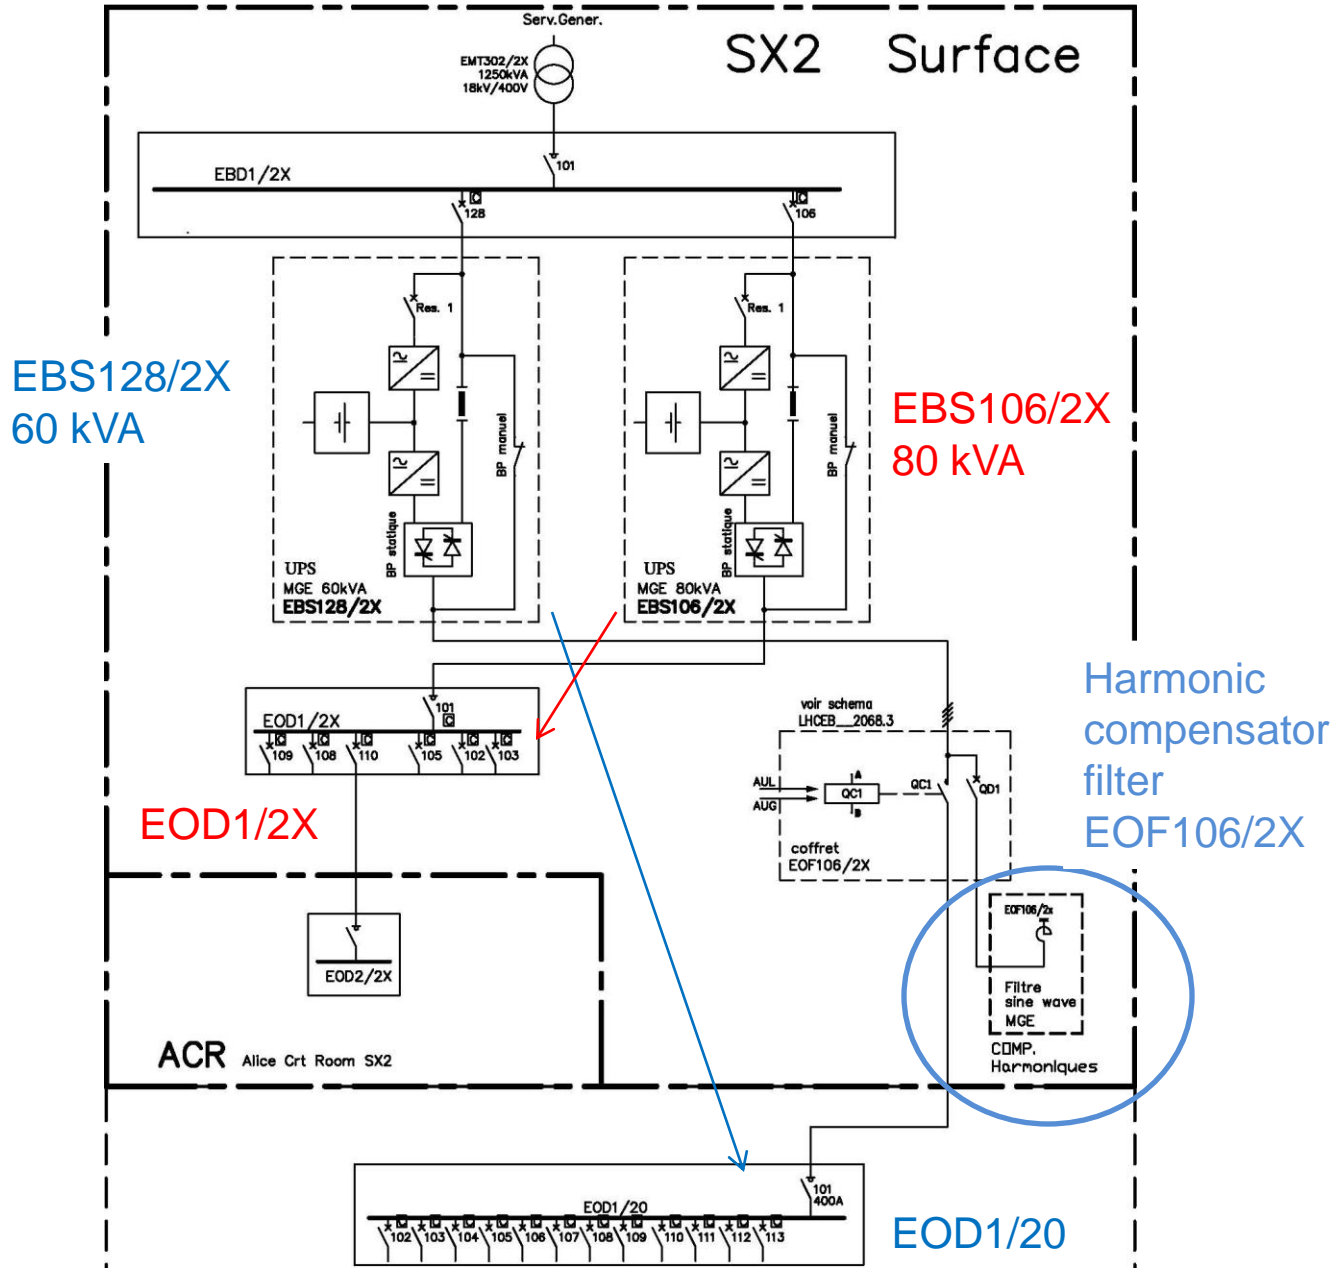
Current electrical distribution

- New distribution:
 - UPS EBS106/2X (80 kVA) powers EOD1/2X
 - UPS EBS128/2X (60 kVA) powers EOD1/20
- Both UPSs loaded at around 70%
- EN-EL recommendation: current phase balancing!
- Both switchboards generate high rate of current harmonics
THDI around 23% rejected on UPS
- THDI significantly reduced by compensation filter
- Exact reason for having a filter on the UPS 80 kVA: unknown!
- Decision to keep the filter attached to EOD1/20 in order to avoid overloading the UPS 60 kVA

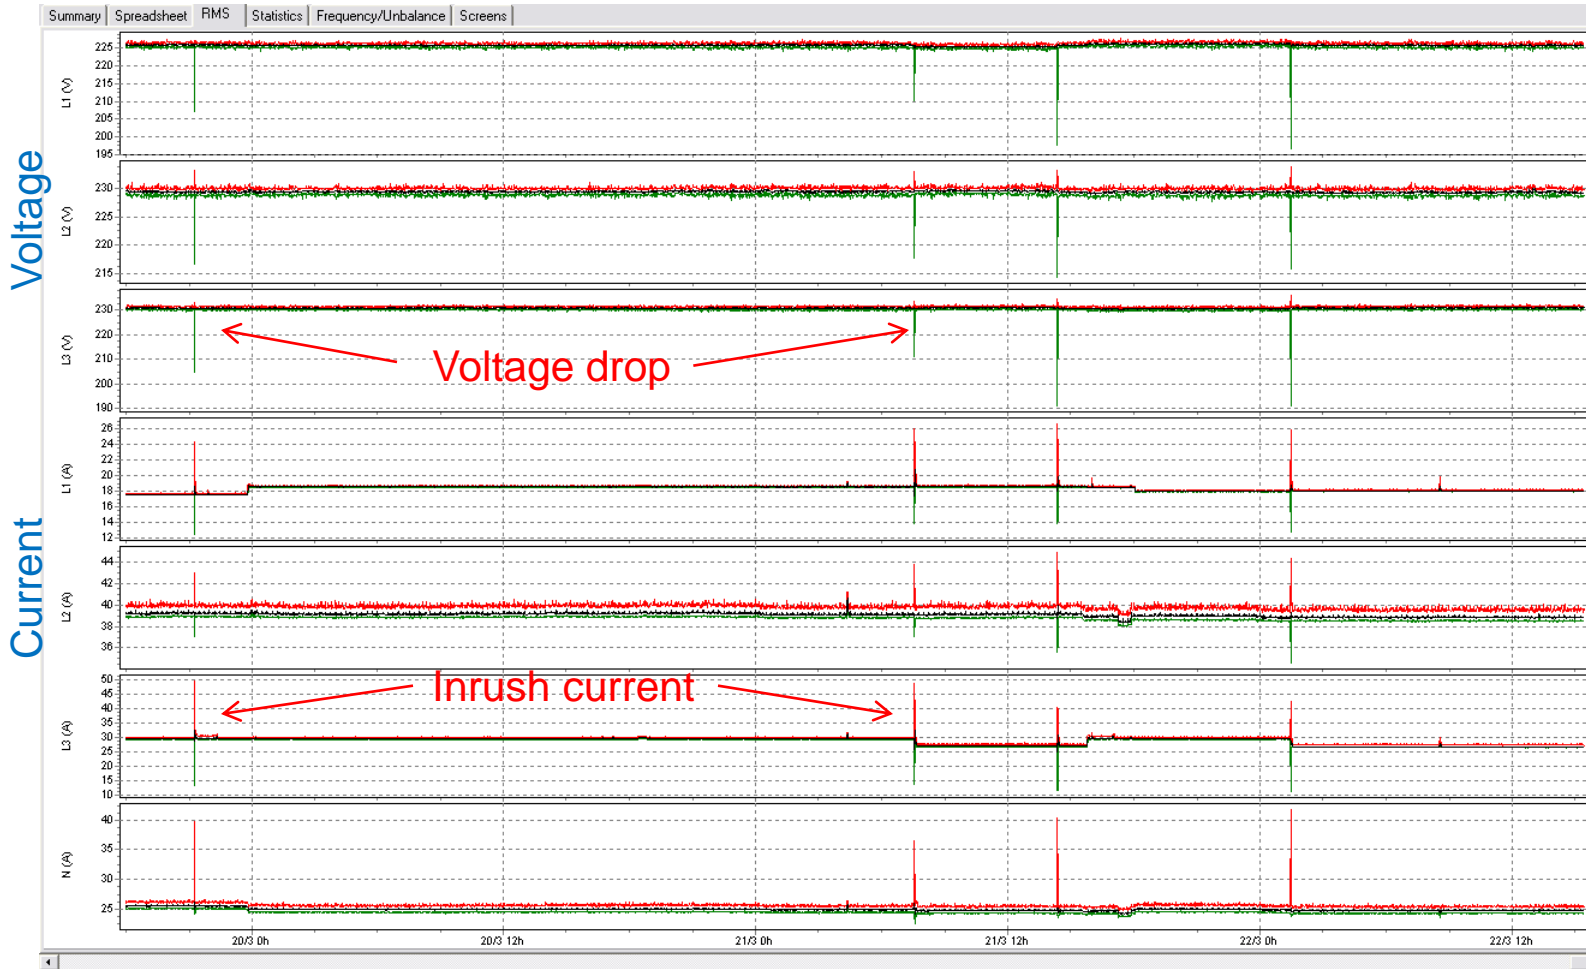
- Power network analyzer connected on the feeder EOD102/2X

- One example: 4 events over one week-end!

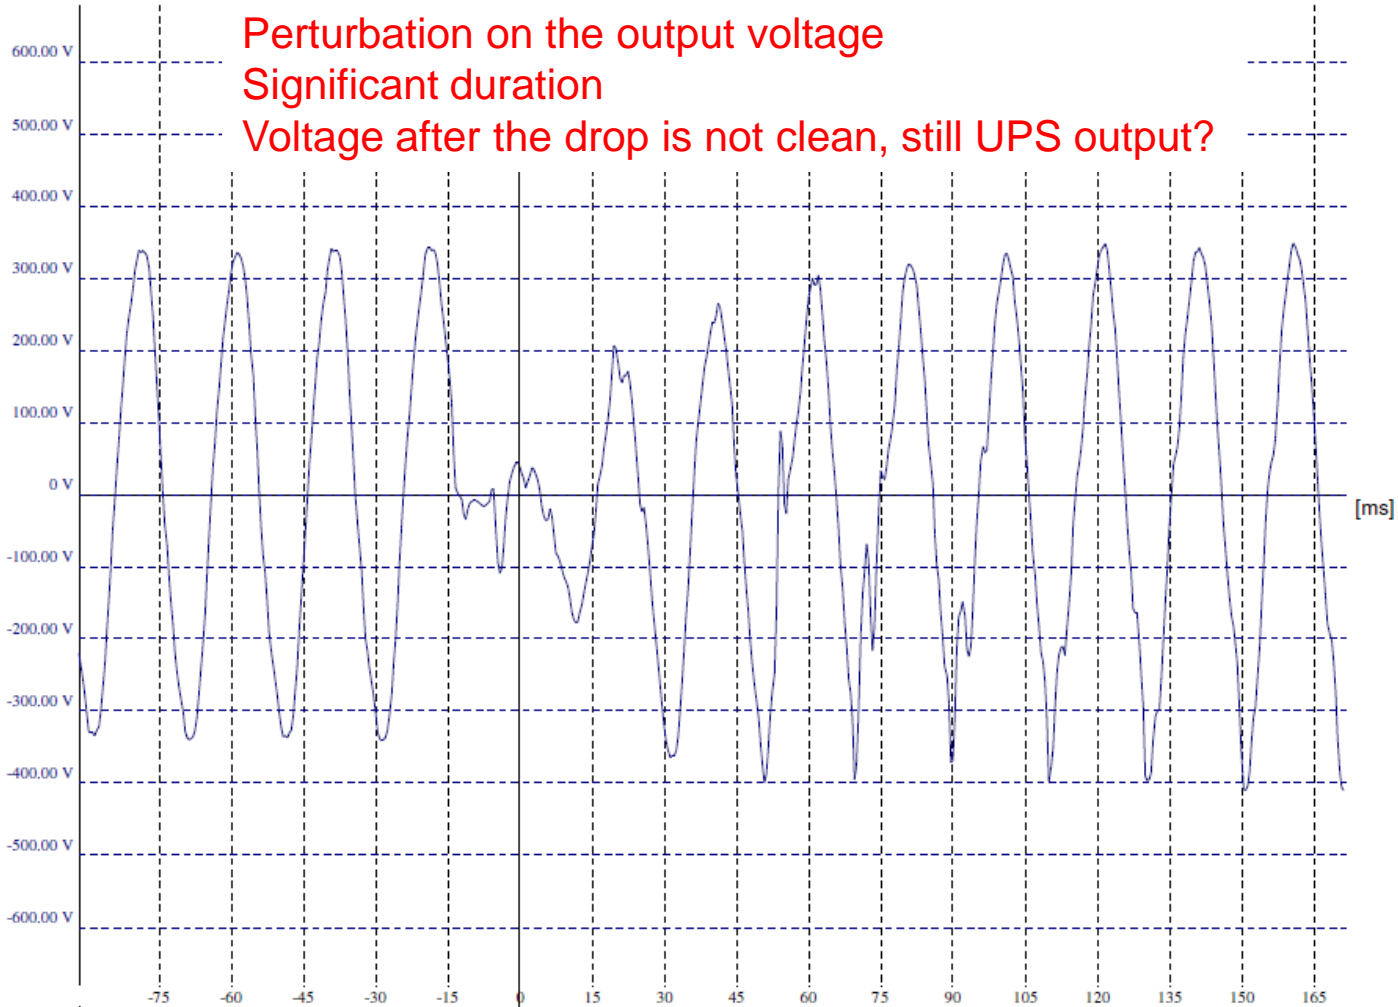
UC 2

- Voltage on EOD1/2X recorded by perturbation analyzer at point 2

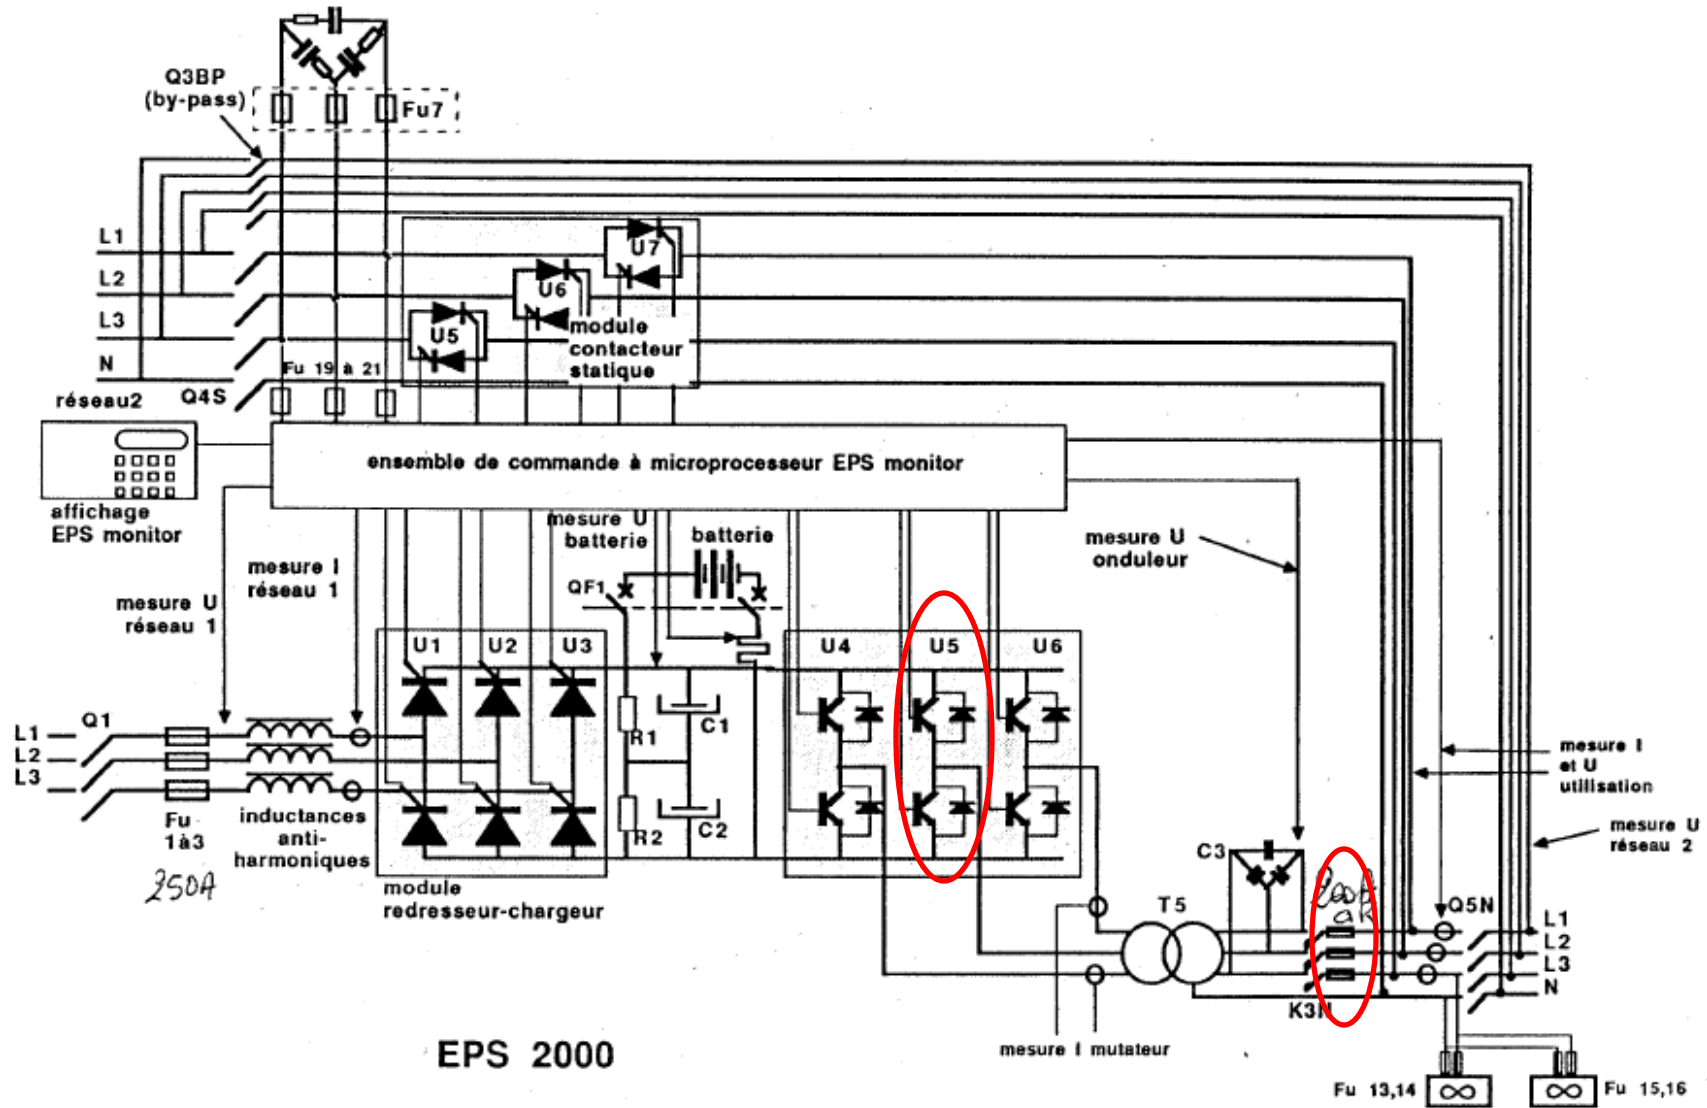
- CCC phone call on Saturday 27 March 2010, alarms from EBS106/2X
- **UPS OFF, output fuses 1 and 3 melted, loads on static by-pass**
- No power cut of the loads according to ALICE control room
- Request of MGE UPS Systems intervention
 - Change of fuses on phases L1 and L3
 - UPS switch on not loaded, EOD1/2X switched to manual by-pass
 - UPS OFF, output fuses 1 and 2 melted, inverter #2 broken down
 - Change of the inverter and fuses
 - **UPS restarted, tests OK, EOD1/2X switched back to UPS**
- According to MGE UPS Systems:
 - Failure not related to previous perturbations
 - Inverter may have been overstressed by inrush currents generated by loads. No switch to static by-pass since the limitation mask was enabled.

- Internal failure of the UPS

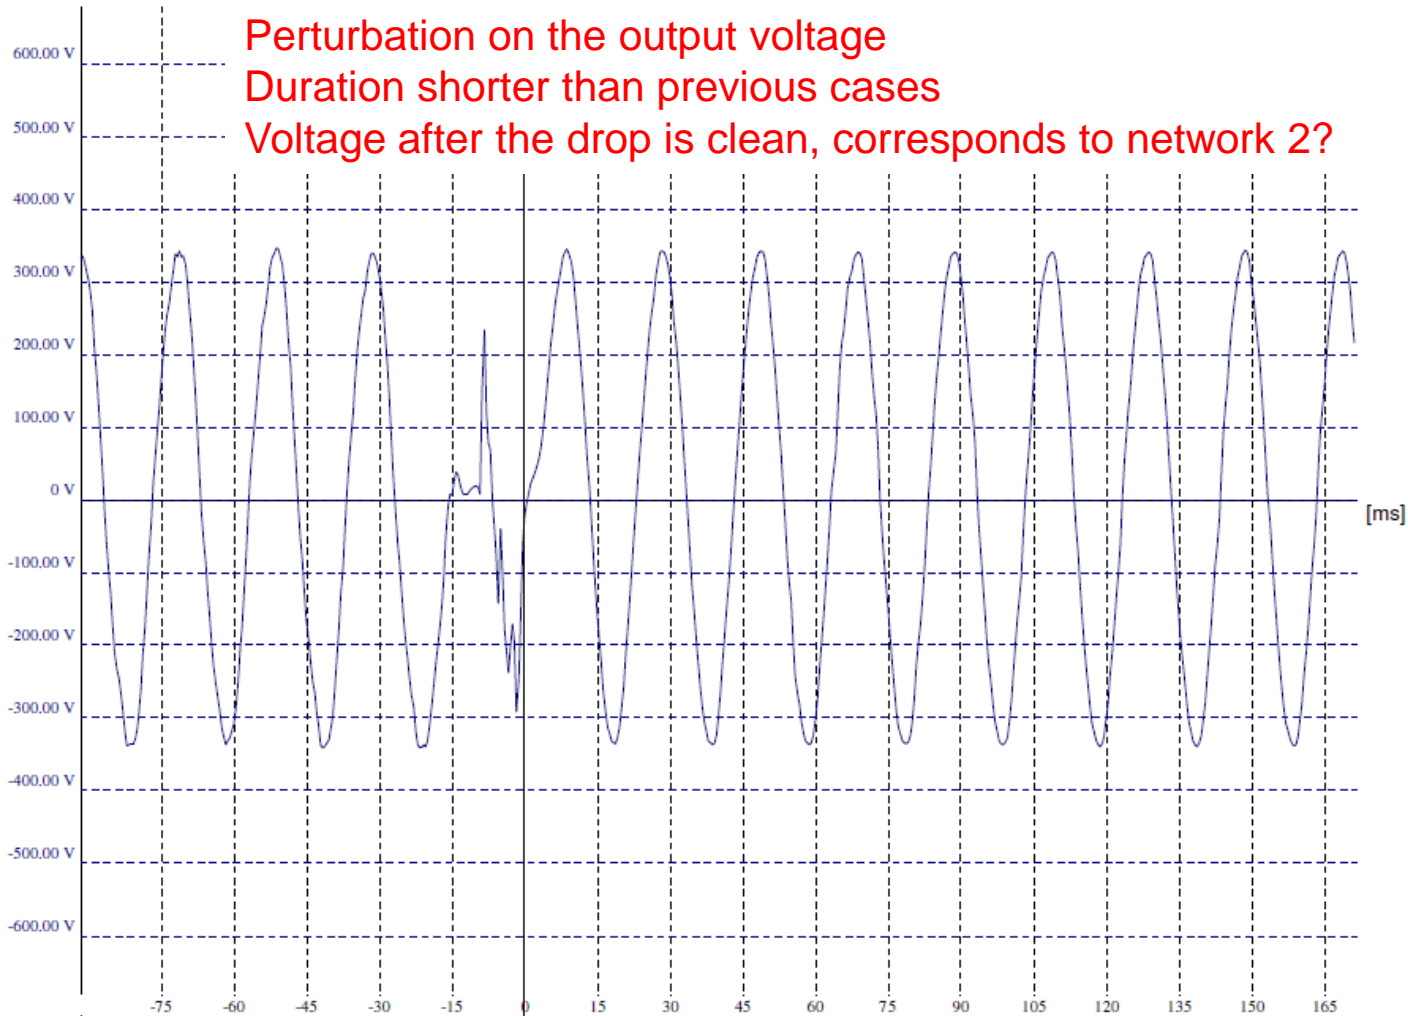
UC 2

- Voltage on EOD1/2X recorded by perturbation analyzer at point 2

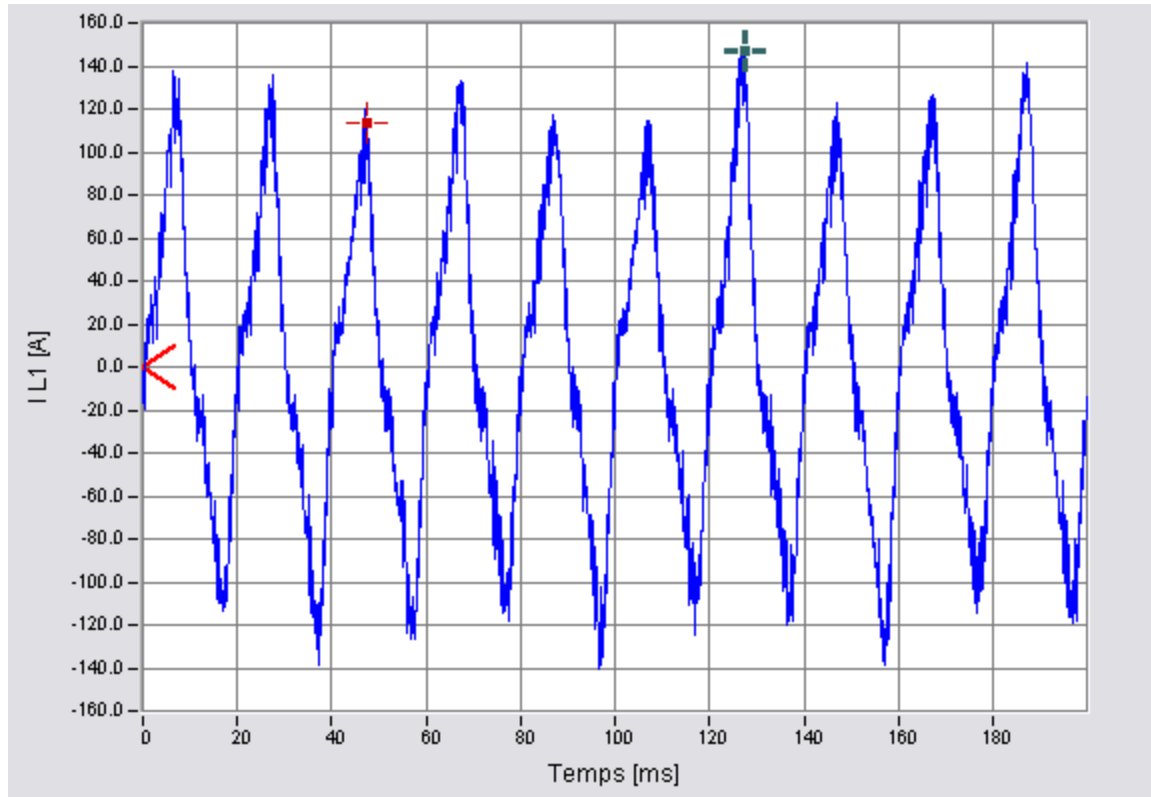
- No perturbation detected since 27 March 2010
- Both UPS have the same configuration with limitation mask disabled
- Current measured with a precise power network analyzer

- Maximum peak current measured during 2 weeks: 193 A (< 245 A)
