Results from MQXFBP1 cold tests

Meeting on MQXFBP2 assembly, 11-08-2020

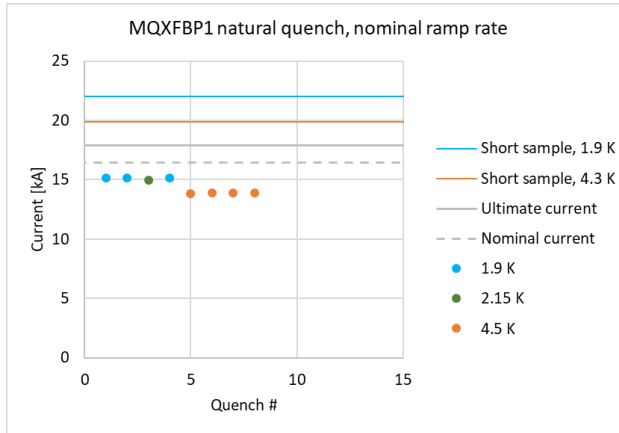
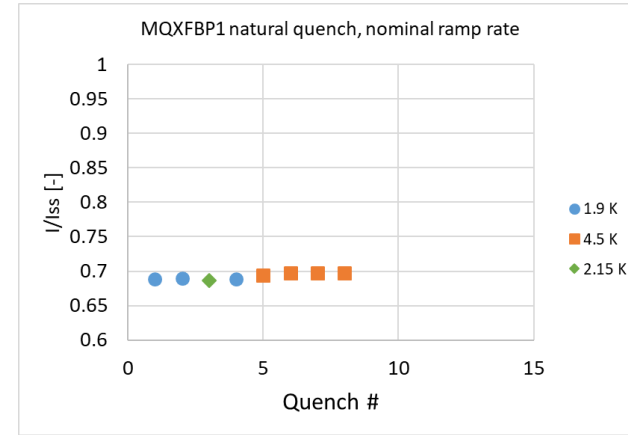
- Powering started at 1.9 K at nominal 20 A/s ramp rate.
- No “training quenches” for the magnet up to 15.2 kA
- All quenches go to a coil limitation at around 69 to 70 % of I_{ss} both at 1.9 K as at 4.5 K.

All quenches at 20 A/s were in the center of the magnet, straight pole turn segment in coil 108 (pole 3), see later slides.

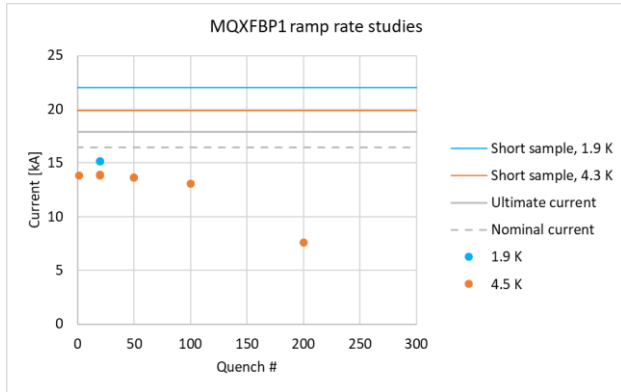
- “Normal” ramp rate behavior at 4.5 K
- Up to 20 A/s: Quench in EE3126-EE3113
- 50 and 100 A/s: Quench in EE3126-EE3113
- 200 A/s: Quench in EE3113-EE3112

- All quenches in Pole 3 (coil 108)
- None of the quenches show a pre-cursor.

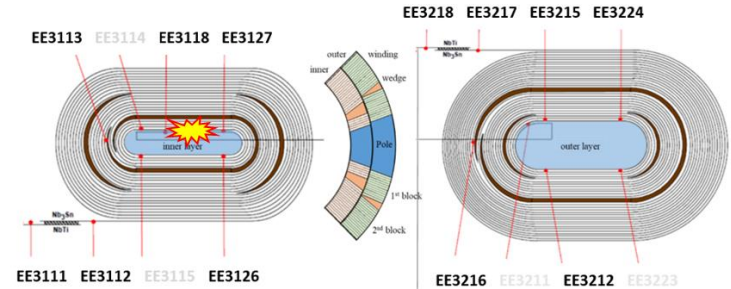
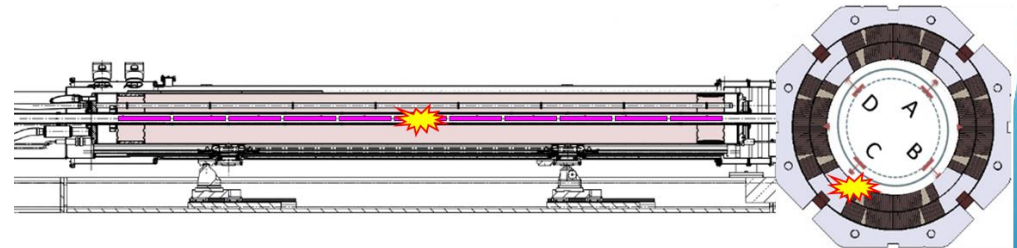
P3
Coil 108

Quench location:

Vtaps: P3, EE3118-EE3127

Inner layer pole turn

Straight segment.

QA: segment 5 (covering the magnetic center ± 30 cm)

By moving the 5 cm short quench antenna to the quench location, we could localize it to the magnetic center ± 30 cm

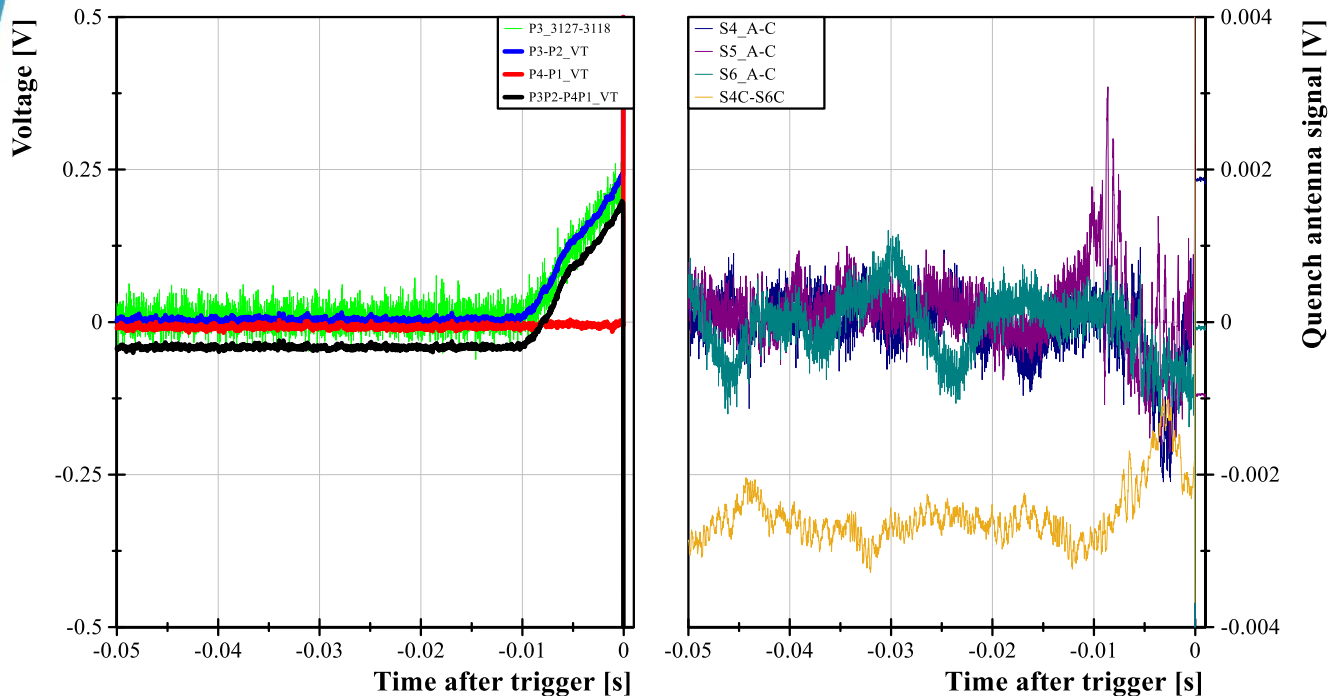
Example of quench signals for a 20 A/s quench

- Voltage build up seems normal
- Propagation velocity is about 15 m/s, which is with normal range.
- Quench Antenna data analysis and data treatment is undergoing optimization, but is clear enough for quench localization.

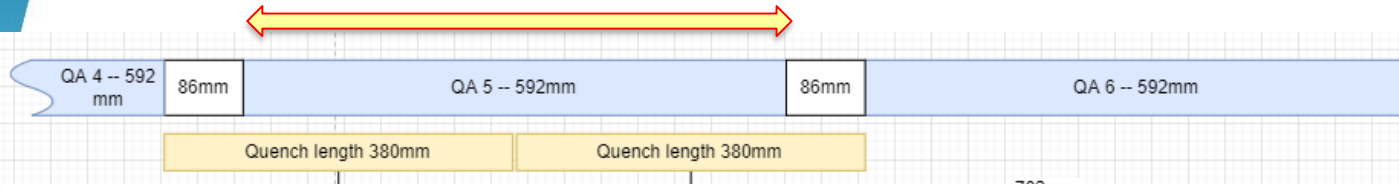
Quench in QA5,
not in 4 or 6

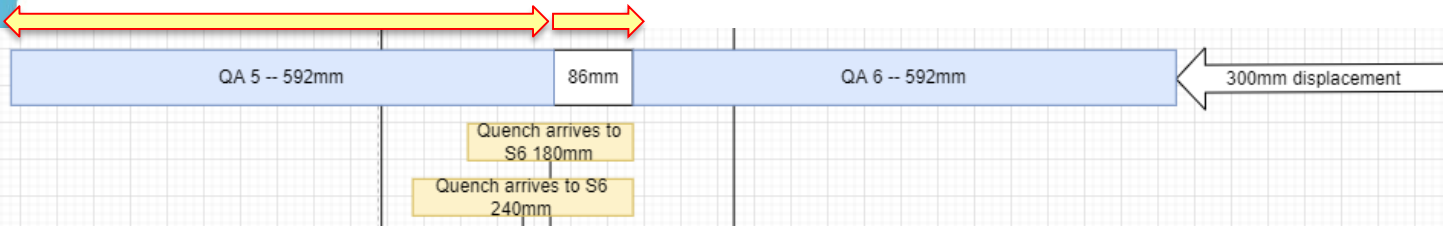
Quench in QA5
possibly going in
QA6 after 8 ms. (9
cm)

Signals seen in
CF1 to CF4 from
the start but
difficult to interpret.

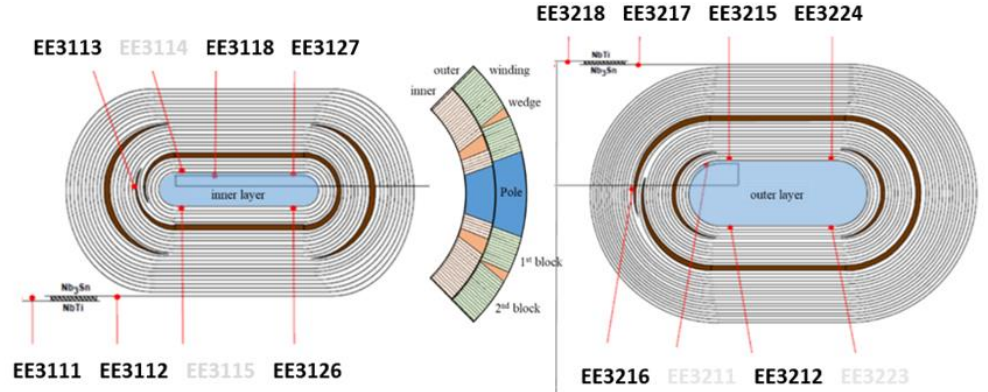
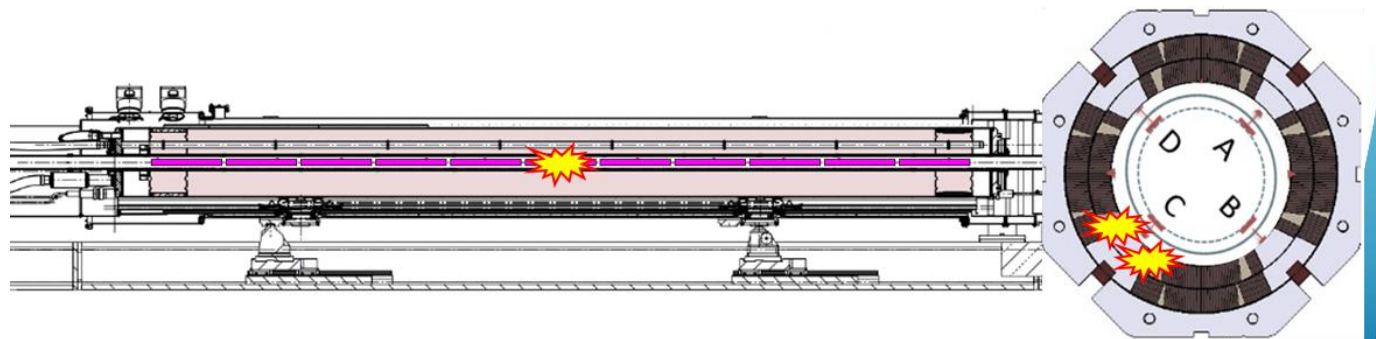
P3
Coil 108

- Vtaps: P3, EE3126-EE3113

Half of the pole turn +

About 5 of the first block seen from pole

QA: segment 5 (covering the magnetic center ± 30 cm)

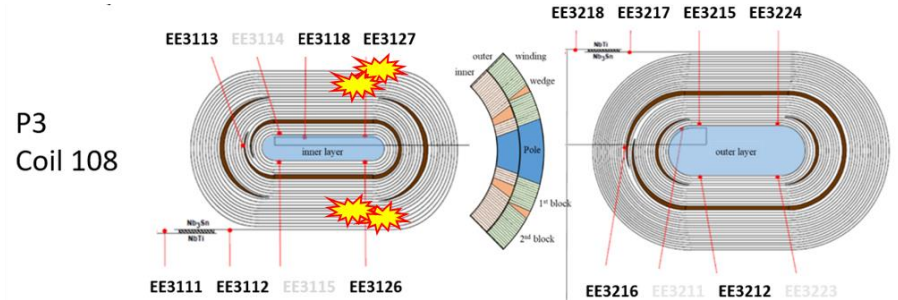
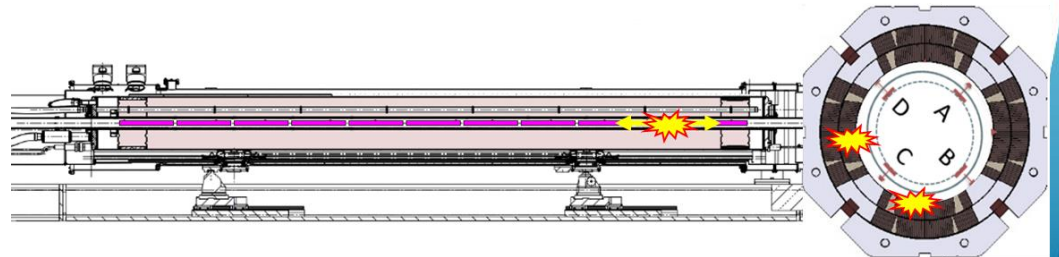
- Vtaps: P3, EE3113-EE3112

Multiturn (excluding first block from pole)

QA: Segment 9 (40 to 100 cm from the head)

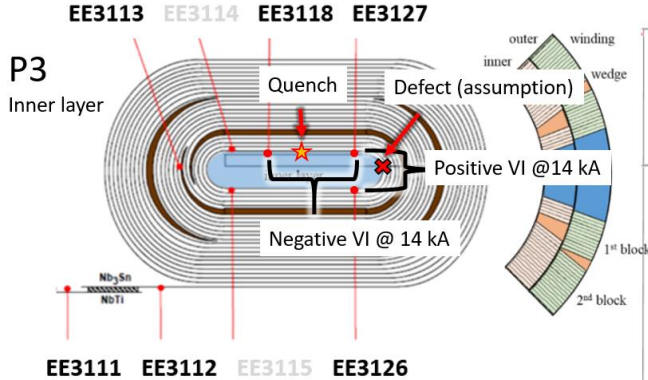
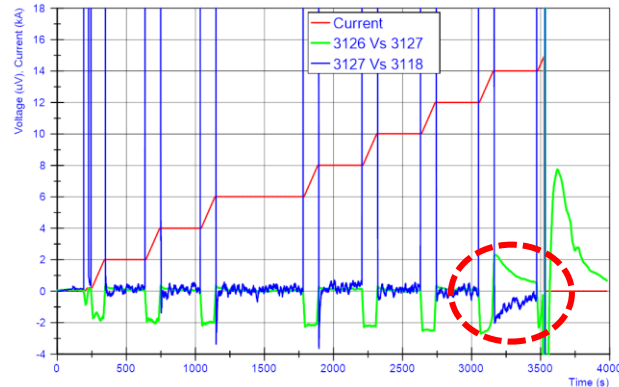
Anomalous voltage signals during the VI measurement at 14 kA plateau

Positive decaying voltage in the head (3126-3127)

Negative decaying voltage in the straight section (3127-3118), quench at 14.96 kA

- Decaying voltage points to degradation in one or a few strands.
- Negative voltage can only occur in a segment neighboring a degradation.
- Is under further investigation.
