3-cathode system 6-way cross

31.07.2020

Revolver magnet test remarks

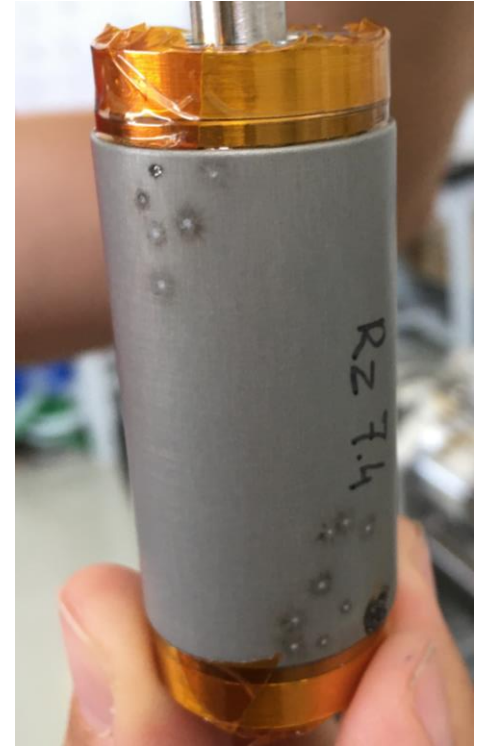
- First test did not ignite for wrong magnetic assembly.
- It then ignited but had arcs: not properly anodized (not same color of strips of single magnet).
- We asked to have it machined to remove 0.2mm OD, to add some kapton tape around.
- We noticed (not considered) that the magnet assembly is floating, therefore to be properly grounded. We had arcs between thermocouple (floating) and chamber.
- In 2 weeks time, I will come bsack for 1-2 days with Alban for first coating.
