LTB untighten screws issue

2020-08-11

Facilities Operation Meeting (FOM) 2020 #7

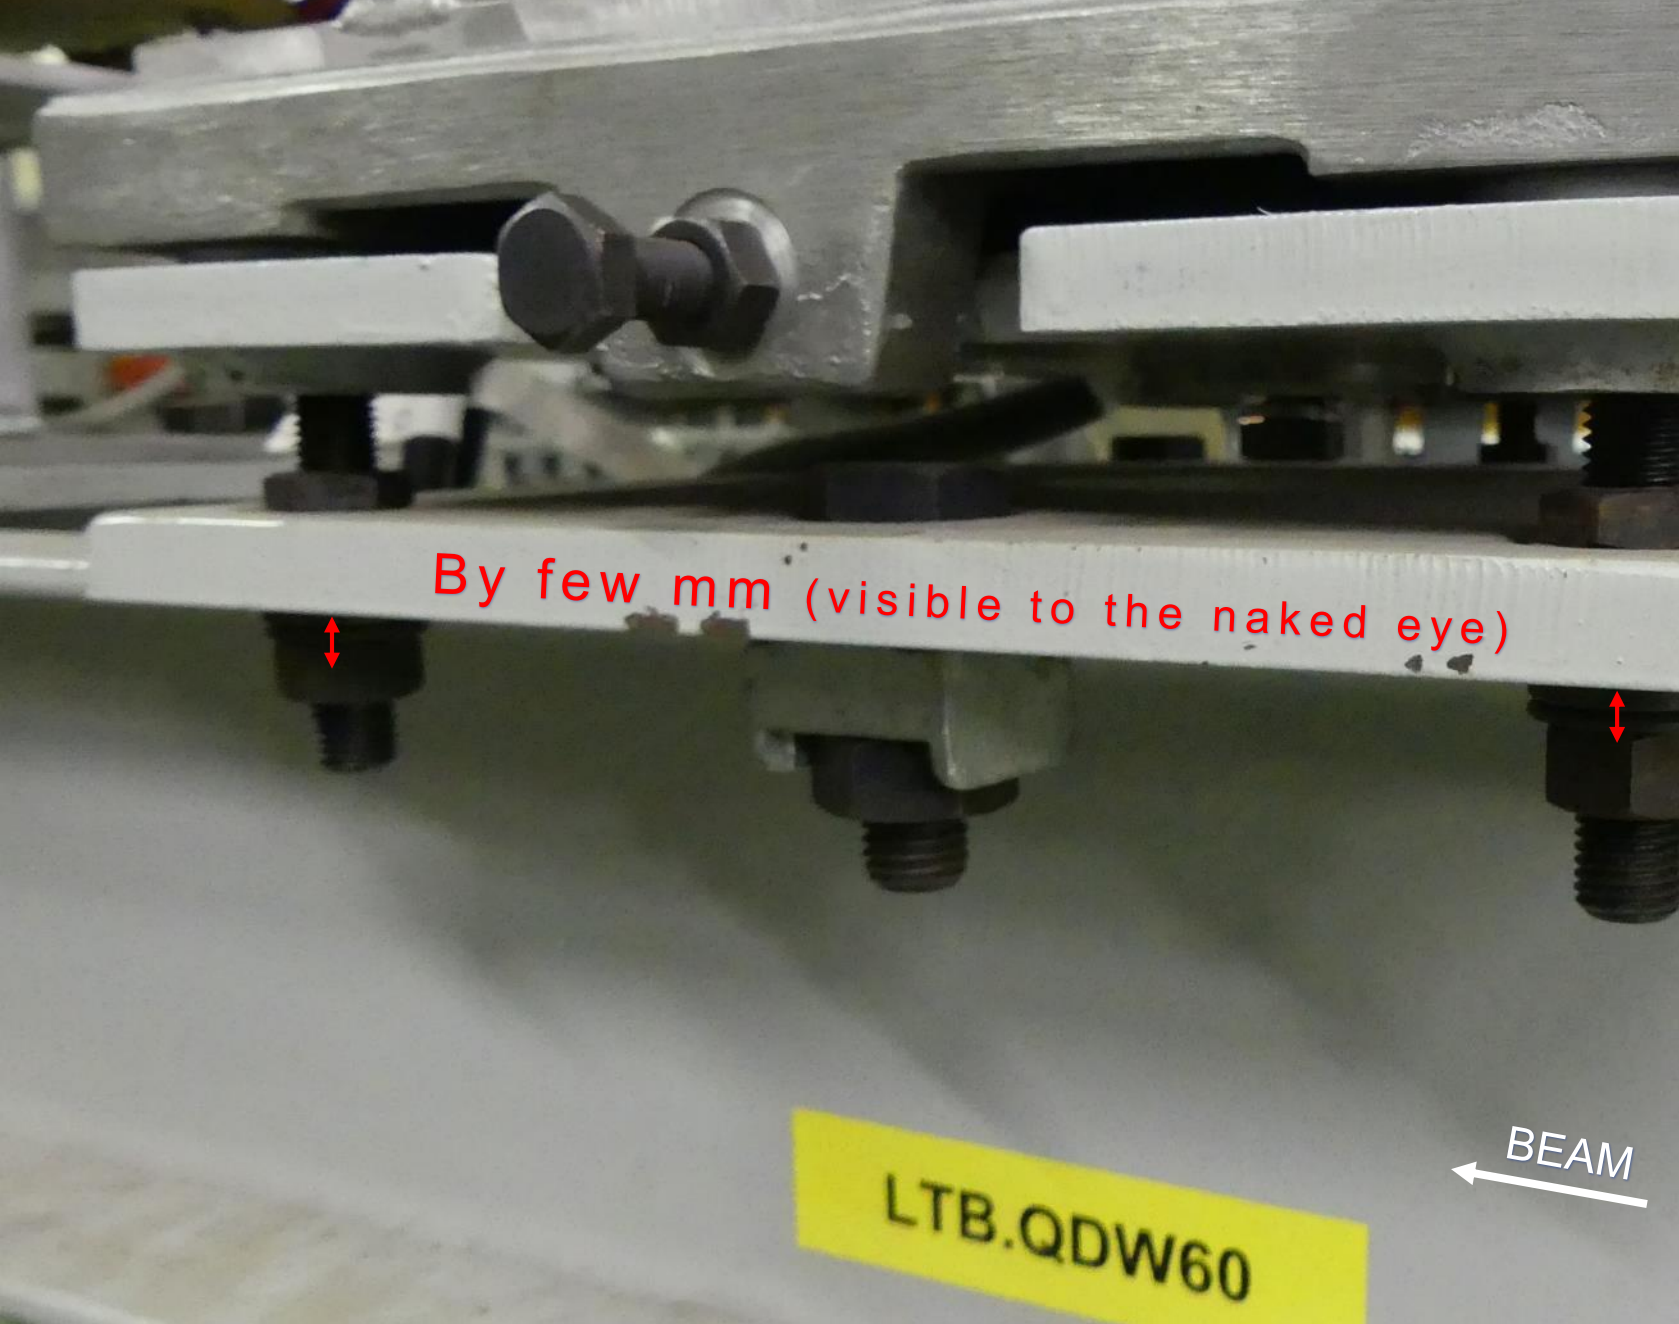
- LTB smoothing under vacuum (week 30)
- Roll angle out of tolerance (up to -11mrad , i.e. $11000\% \times T$)
- Vertical adjustment screws **untighten**
- Concerned components:
 - QNO40
 - QNO50
 - **QNO60**
 - BPM30

i.e. at least
one out of two
