TDIS alignment findings and next actions

Marco Calviani, David Carbajo Perez, Inigo Lamas Garcia, Antonio Perillo Marcone,
Regis Seidenbinder

2020/08/31 ([Indico link](#))

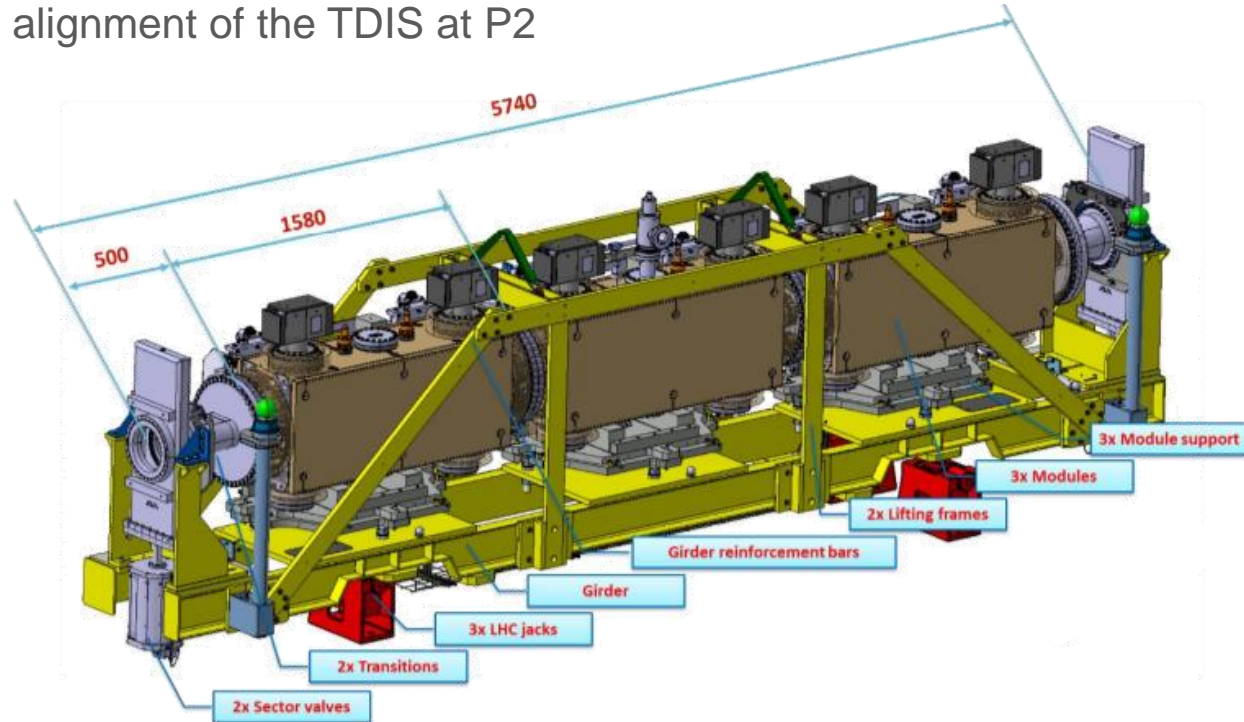
- TDIS P2 – alignment non-conformities (NCR: [EDMS 2407349](#))
- On the 17/08 the survey team found the jacks' stroke ($\pm 10\text{mm}$) was insufficient to allow a correct alignment of the TDIS at P2

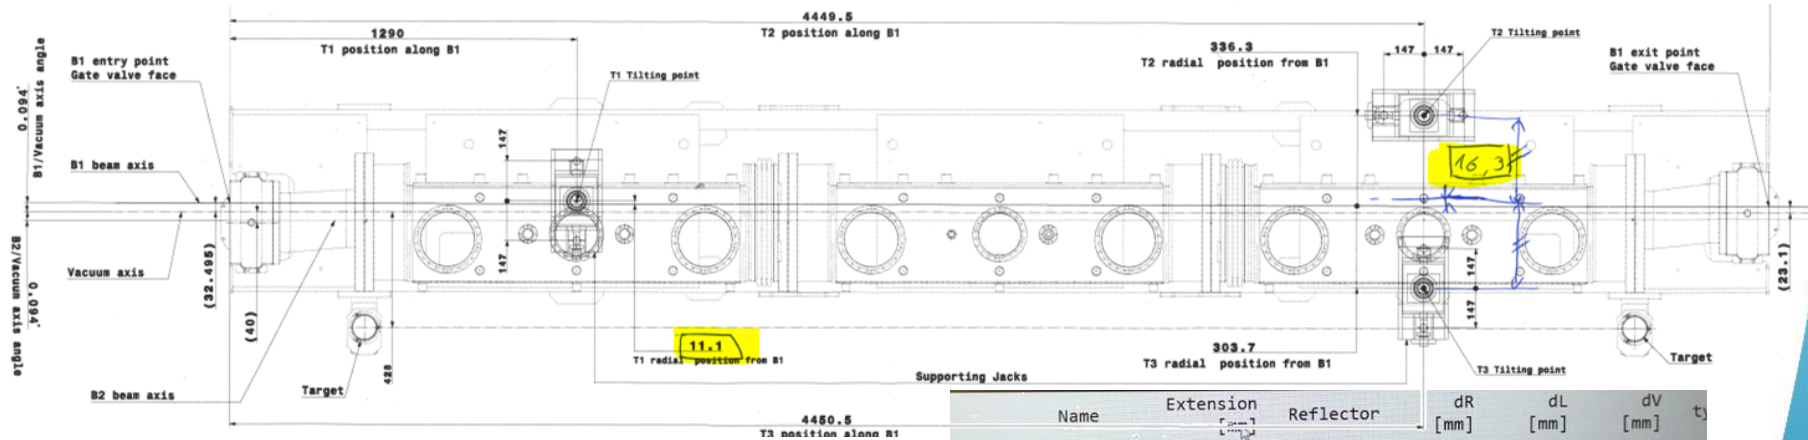
- TDIS P2 – alignment non-conformities (NCR: [EDMS 2407349](#))
- Jacks' end-stops were reached (towards passage side) but the TDIS was between 10mm (upstream side) and 15mm (downstream) away from the its target position

Name	Extension [mm]	Reflector	dR [mm]	dL [mm]	dv [mm]	tj
LHC.NID.4L2-06.	0.00	RRR1.5_1	-	-	-	No
LHC.NID.4L2-05.	0.00	RRR1.5_1	-	-	-	No
LHC.NID.4L2-04.	0.00	RRR1.5_1	-	-	-	No
LHC.TDIS.A4L2.E	0.00	RRR1.5_1	-10.16	1.81	0.34	Q
LHC.TDIS.A4L2.S	0.00	RRR1.5_1	-15.31	1.80	-0.13	Q
LHC.NID.4L2-03.	0.00	RRR1.5_1	-	-	-	No
LHC.NID.4L2-02.	0.00	RRR1.5_1	-	-	-	No
LHC.NID.4L2-01.	0.00	RRR1.5_1	-	-	-	No

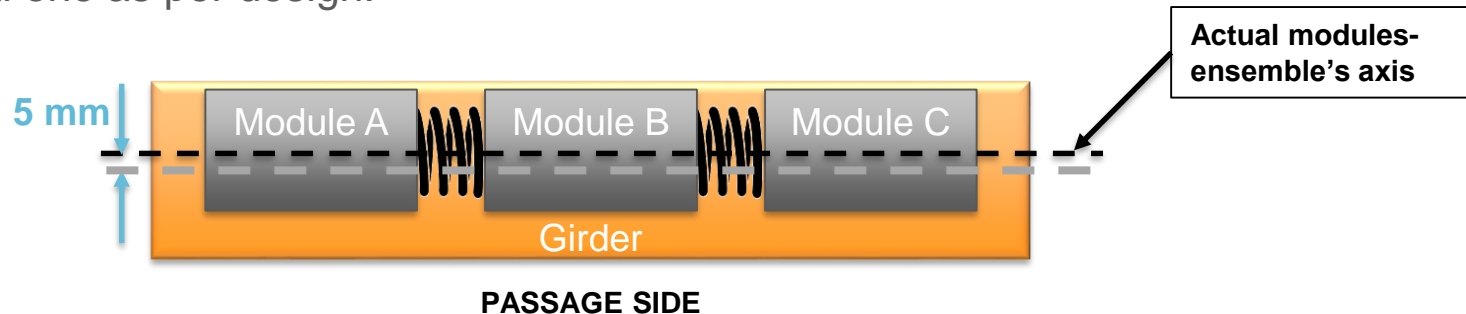
- TDIS P2 – alignment non-conformities (NCR: [EDMS 2407349](#))
- Data analysis revealed the 3 modules were not correctly aligned with respect to the girder. At present there is a **5mm-offset** between the 3-modules-ensemble's axis and its theoretical one as per design:

- However, even if the modules were correctly positioned it would not suffice to reach the required position => **Another issue must underlie** (jacks misalignment? incorrect references taken for alignment? actual Integration geometry not matching design?)
