LIU BWS. Mechanics

Dmitry Gudkov, William Andreatza
BE-BI-ML

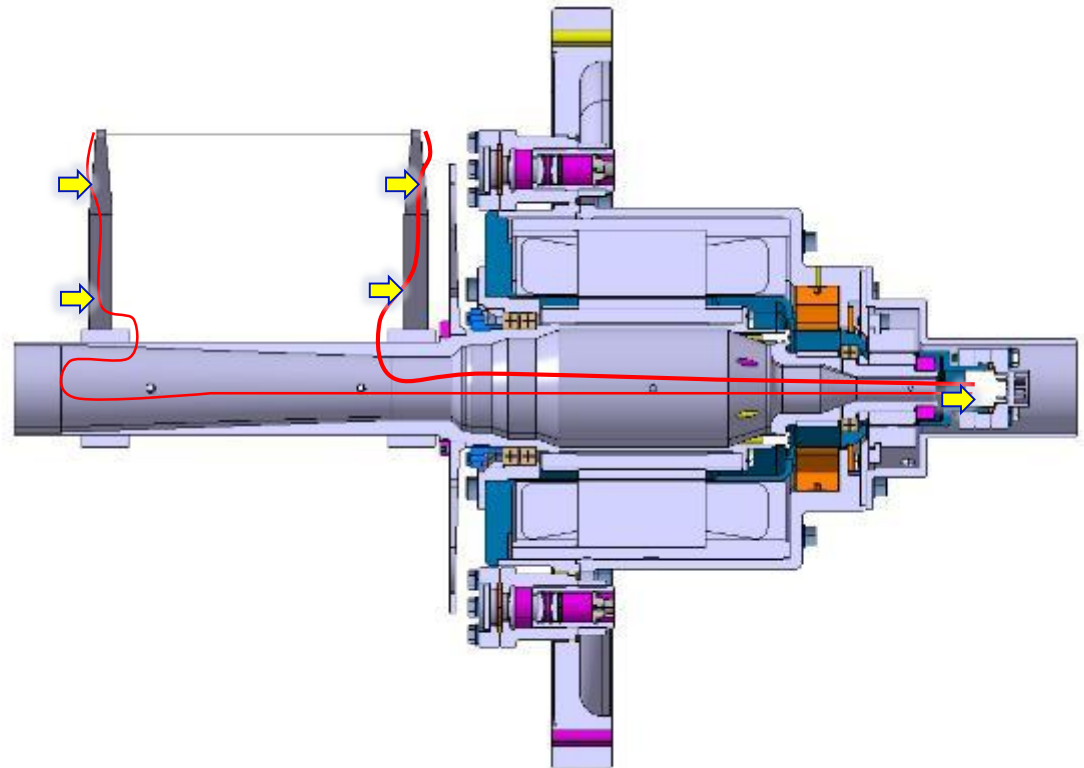
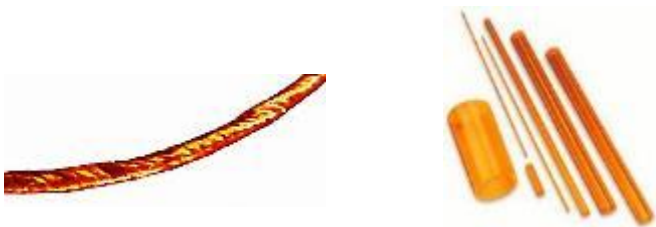
- We have identified all locations where insulation damage is possible
- The cables used in series scanners are not suitable for dynamic applications

3 cables (wrapped, for use in motion) have been ordered from 2 suppliers:

1. **KAP-BAND-L-AWG28 and KAP-BAND-L-AWG24 (Vacom)**
2. **301-KAPM-075 (Allectra)**

- These cables will be tested on one of our lab scanners
- The problematic locations will be protected by a Kapton sleeves (approved by TE-VSC)
