Leak in TT2

Jose A. Ferreira (TE-VSC)

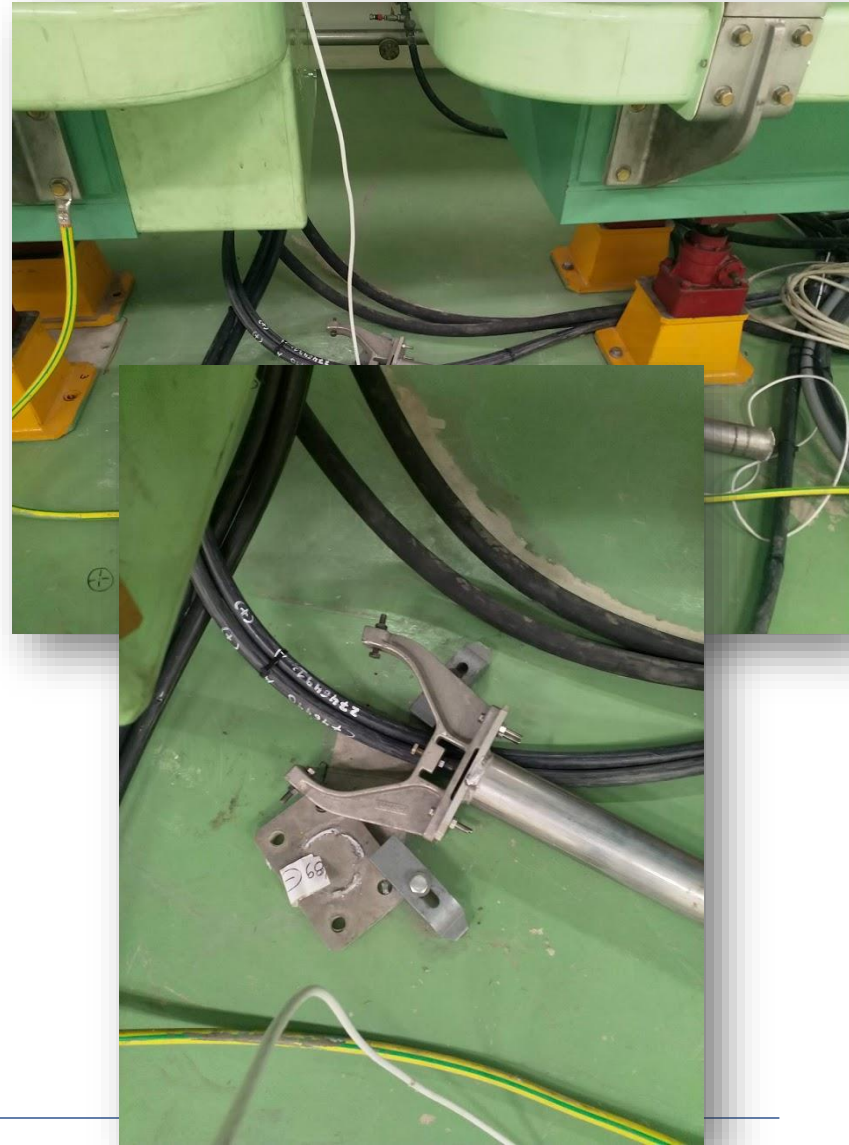
- Failure of support between BHZ.377 and BHZ378
- The fall of the support created a sudden movement on the other side of the chamber
- 3 bellows affected by the movement
- Very poor welding of the support to the plate.

- ❑ Replace the 3 damaged bellows
- ❑ Spare bellows localized and tested. Fixed DN160CF flanges available, 2x rotatable DN160CF also available
- ❑ Some chambers undocumented → Drawing production started
- ❑ Discussions with workshop to be started on Monday (chambers beginning of next week t.b.c.)
- ❑ No major issue for Hardware Commissioning.
