Feedback from W48

MACHINE STATUS: *4th/5 weeks of the BOOSTER COLD-CHECKOUT – 2nd & last week of Magnet Covers Consolidation (W47/48)*

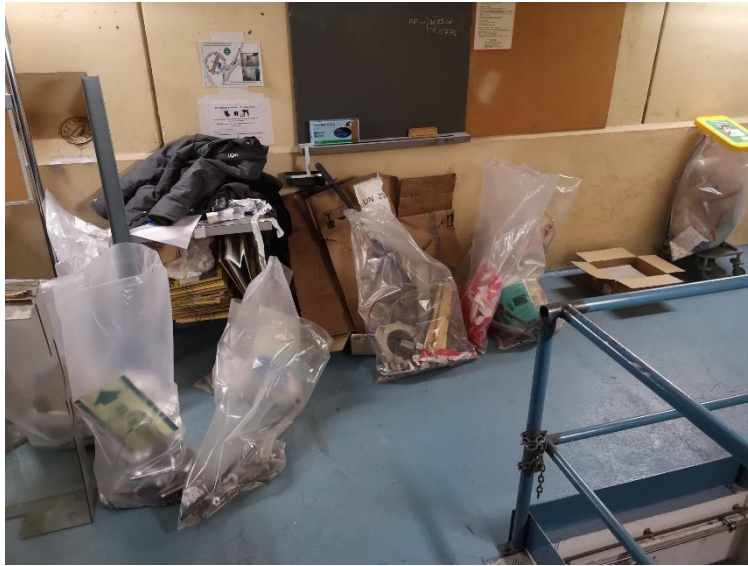
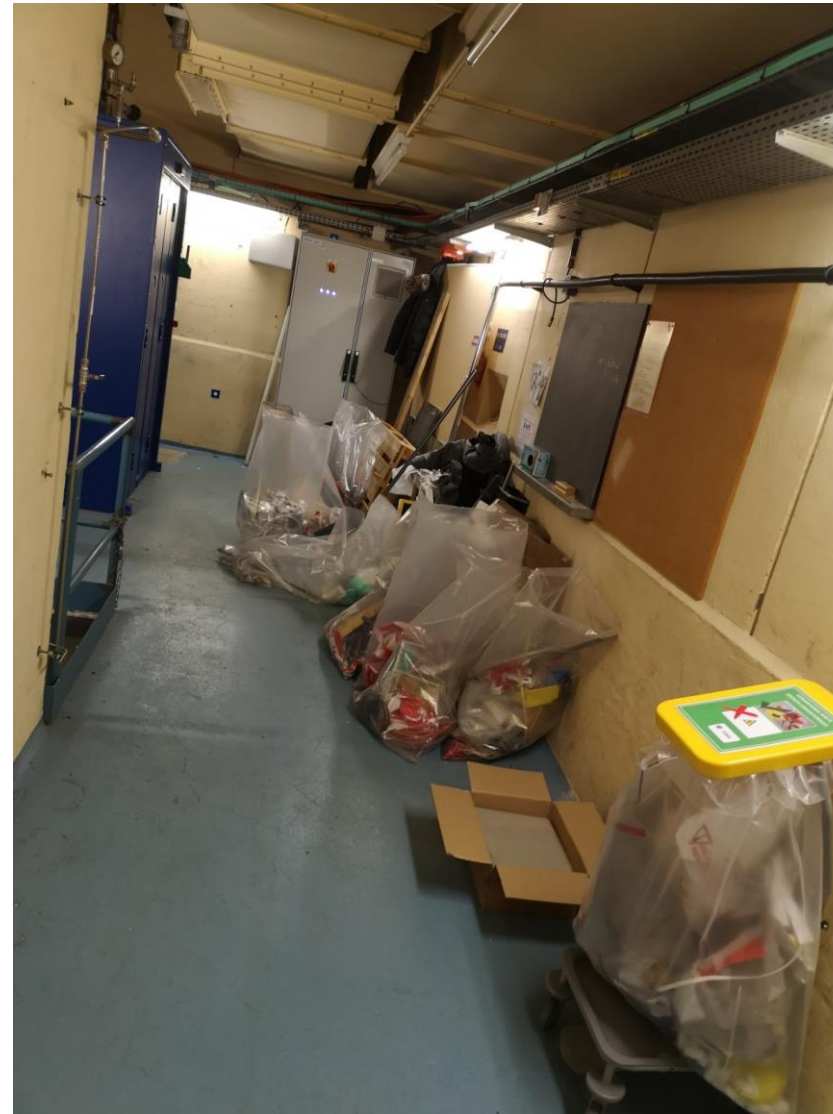
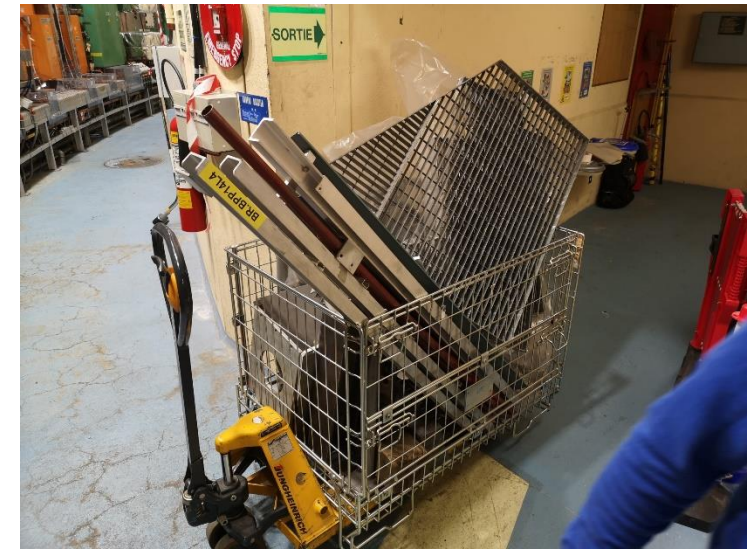
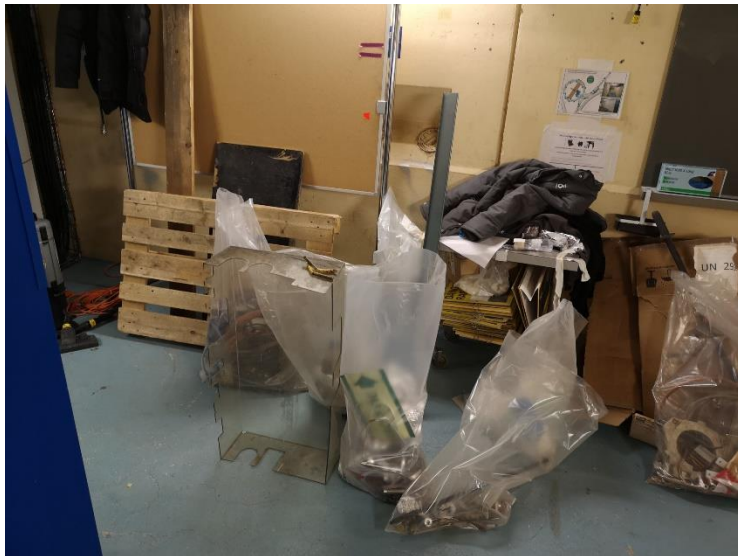
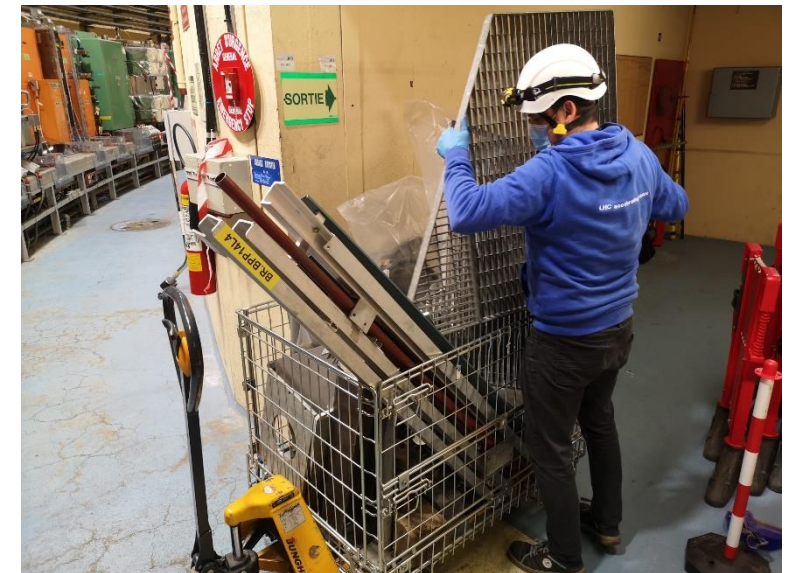
Back-up Slide: HSE-RP + SMB + BE-OP + EN-ACE machine visit and cleaning

- The cleanliness of the Booster (see back-up slide)
- The Booster Auxiliary circuits will be unlock out as from Tuesday 01/12;
- POPS-B Main Transformer plate forgotten → will be reassembled on Monday and Tuesday, the unlock out will follow.
