Request for a change of the PSB 4L1-R2 wire scanner

Ray VENESS / BE-BI

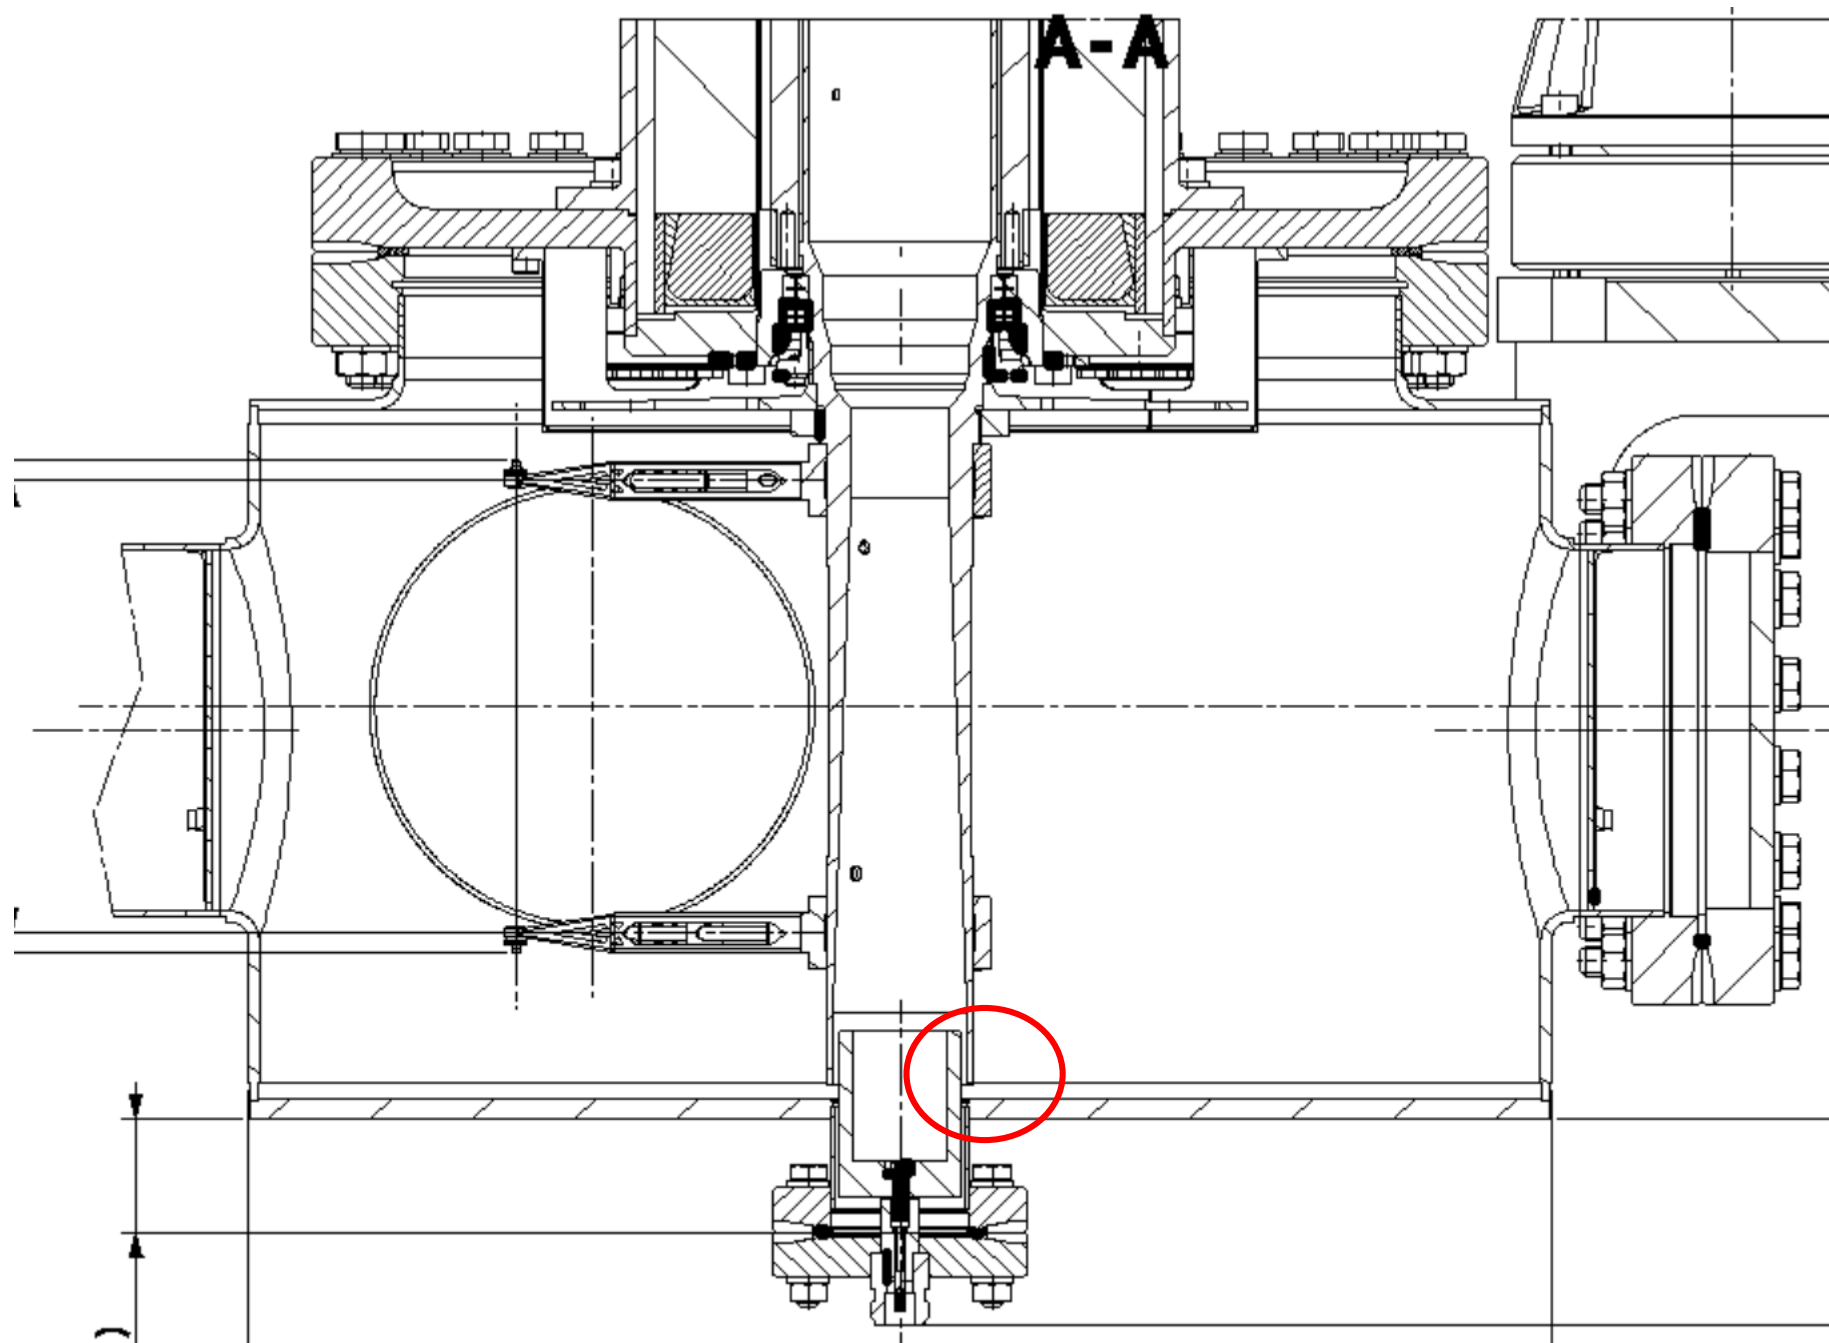
- It has now been determined that there is a design/fabrication dimensional error in this one vacuum tank
 - The error is just large enough that the deflection of the tank under vacuum ($\sim 0.4\text{mm}$) will block the scanner shaft against the tank wall, but not so large as to prevent the instrument seal from closing normally

- This means that the problem only appears when the scanner is under vacuum. This has been verified by venting the sector and operating at atmospheric pressure – the error is systematically repeatable

- Replace the scanner and tank assembly
 - Fortunately a spare scanner tank was produced for all variants and this exists for the PSB-H design. This spare tank is conforming to requirements and has been re-cleaned and prepared

- Ad-hoc meeting yesterday with OP, VSC plus other discussions has converged on a proposal for a **vacuum intervention on Tuesday 5th Jan 2021**
 - The complete assembly of tank + scanner will be removed and replaced with the spares, then re-surveyed. This intervention (not including vacuum recovery) will take less than 1 day.
