G. Lenoir, K. Puthran, C. Barth, F. Wolf, J. Fleiter, A. Ballarino
European Organization for Nuclear Research (CERN), Geneva, Switzerland

The accelerator magnets for the High Luminosity upgrade of the Large Hadron Collider (HL-LHC) use Nb₃Sn conductor to achieve in-field performance exceeding Nb-Ti based technologies. To sustain Lorentz forces during operation, a pre-compression is applied to the conductor during the fabrication of the magnet. This can lead to an irreversible degradation due to the mechanical sensitivity of the Nb₃Sn material.

The impact of the pre-compression is investigated using a reacted double-stack of Rutherford cables.

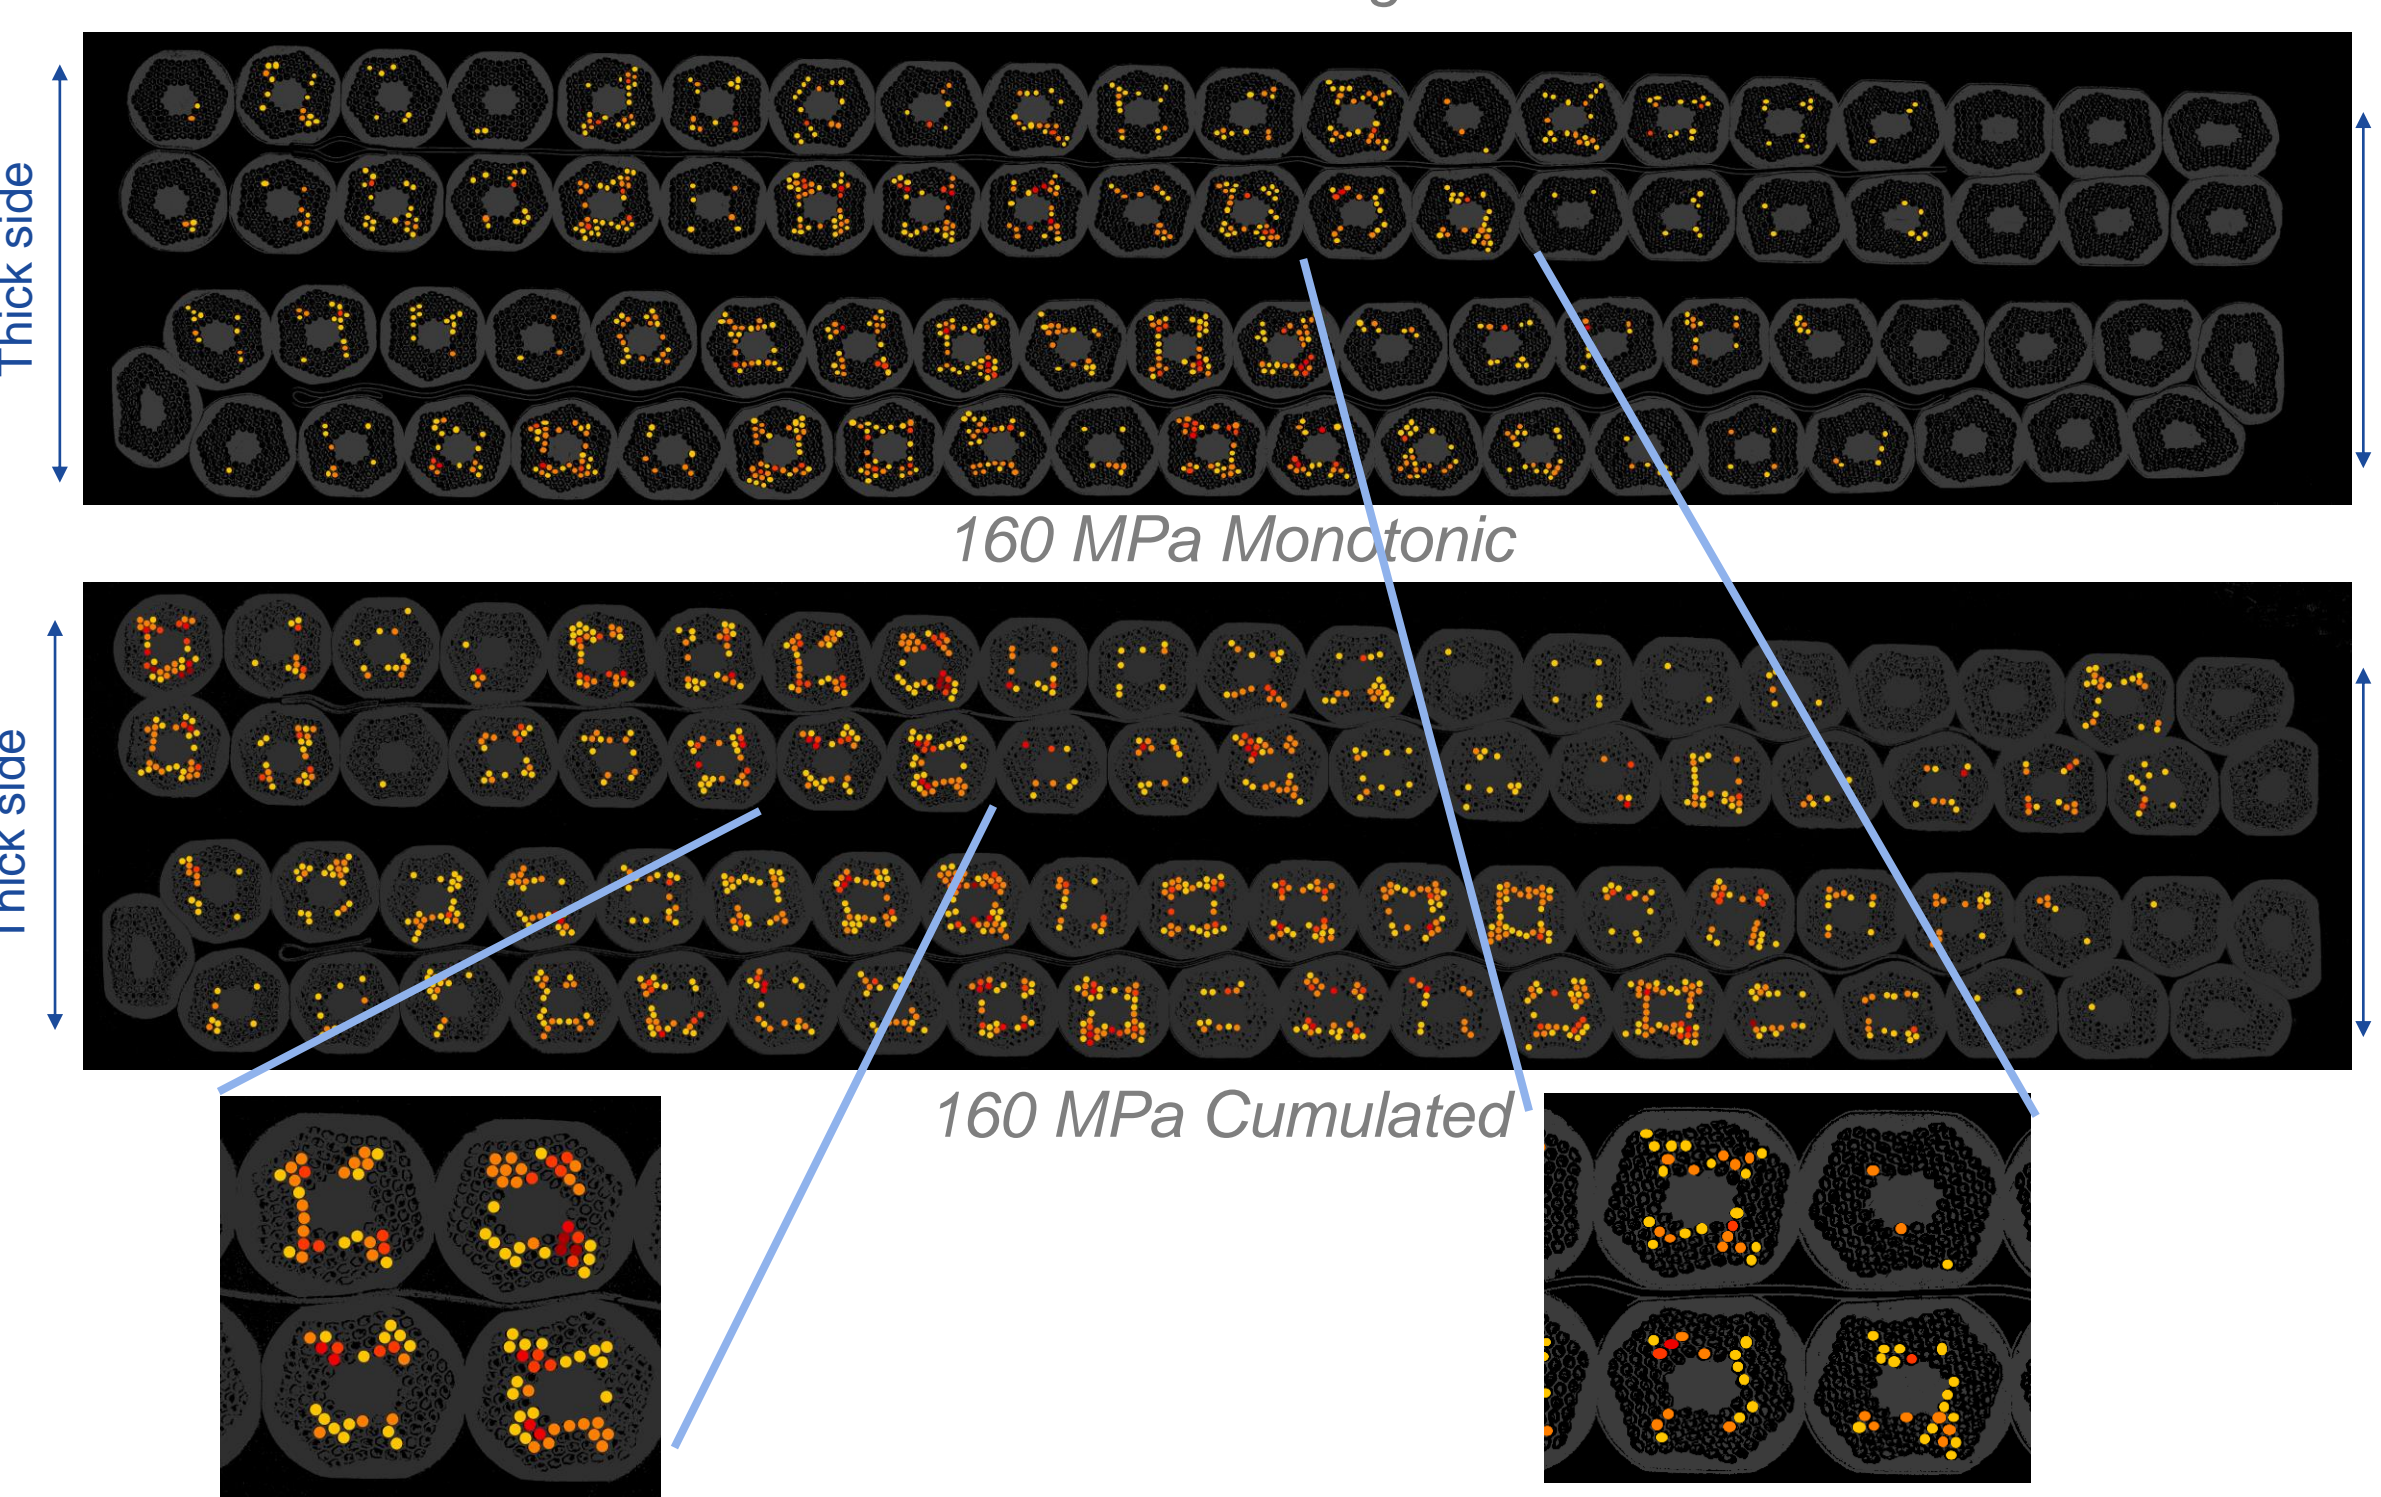
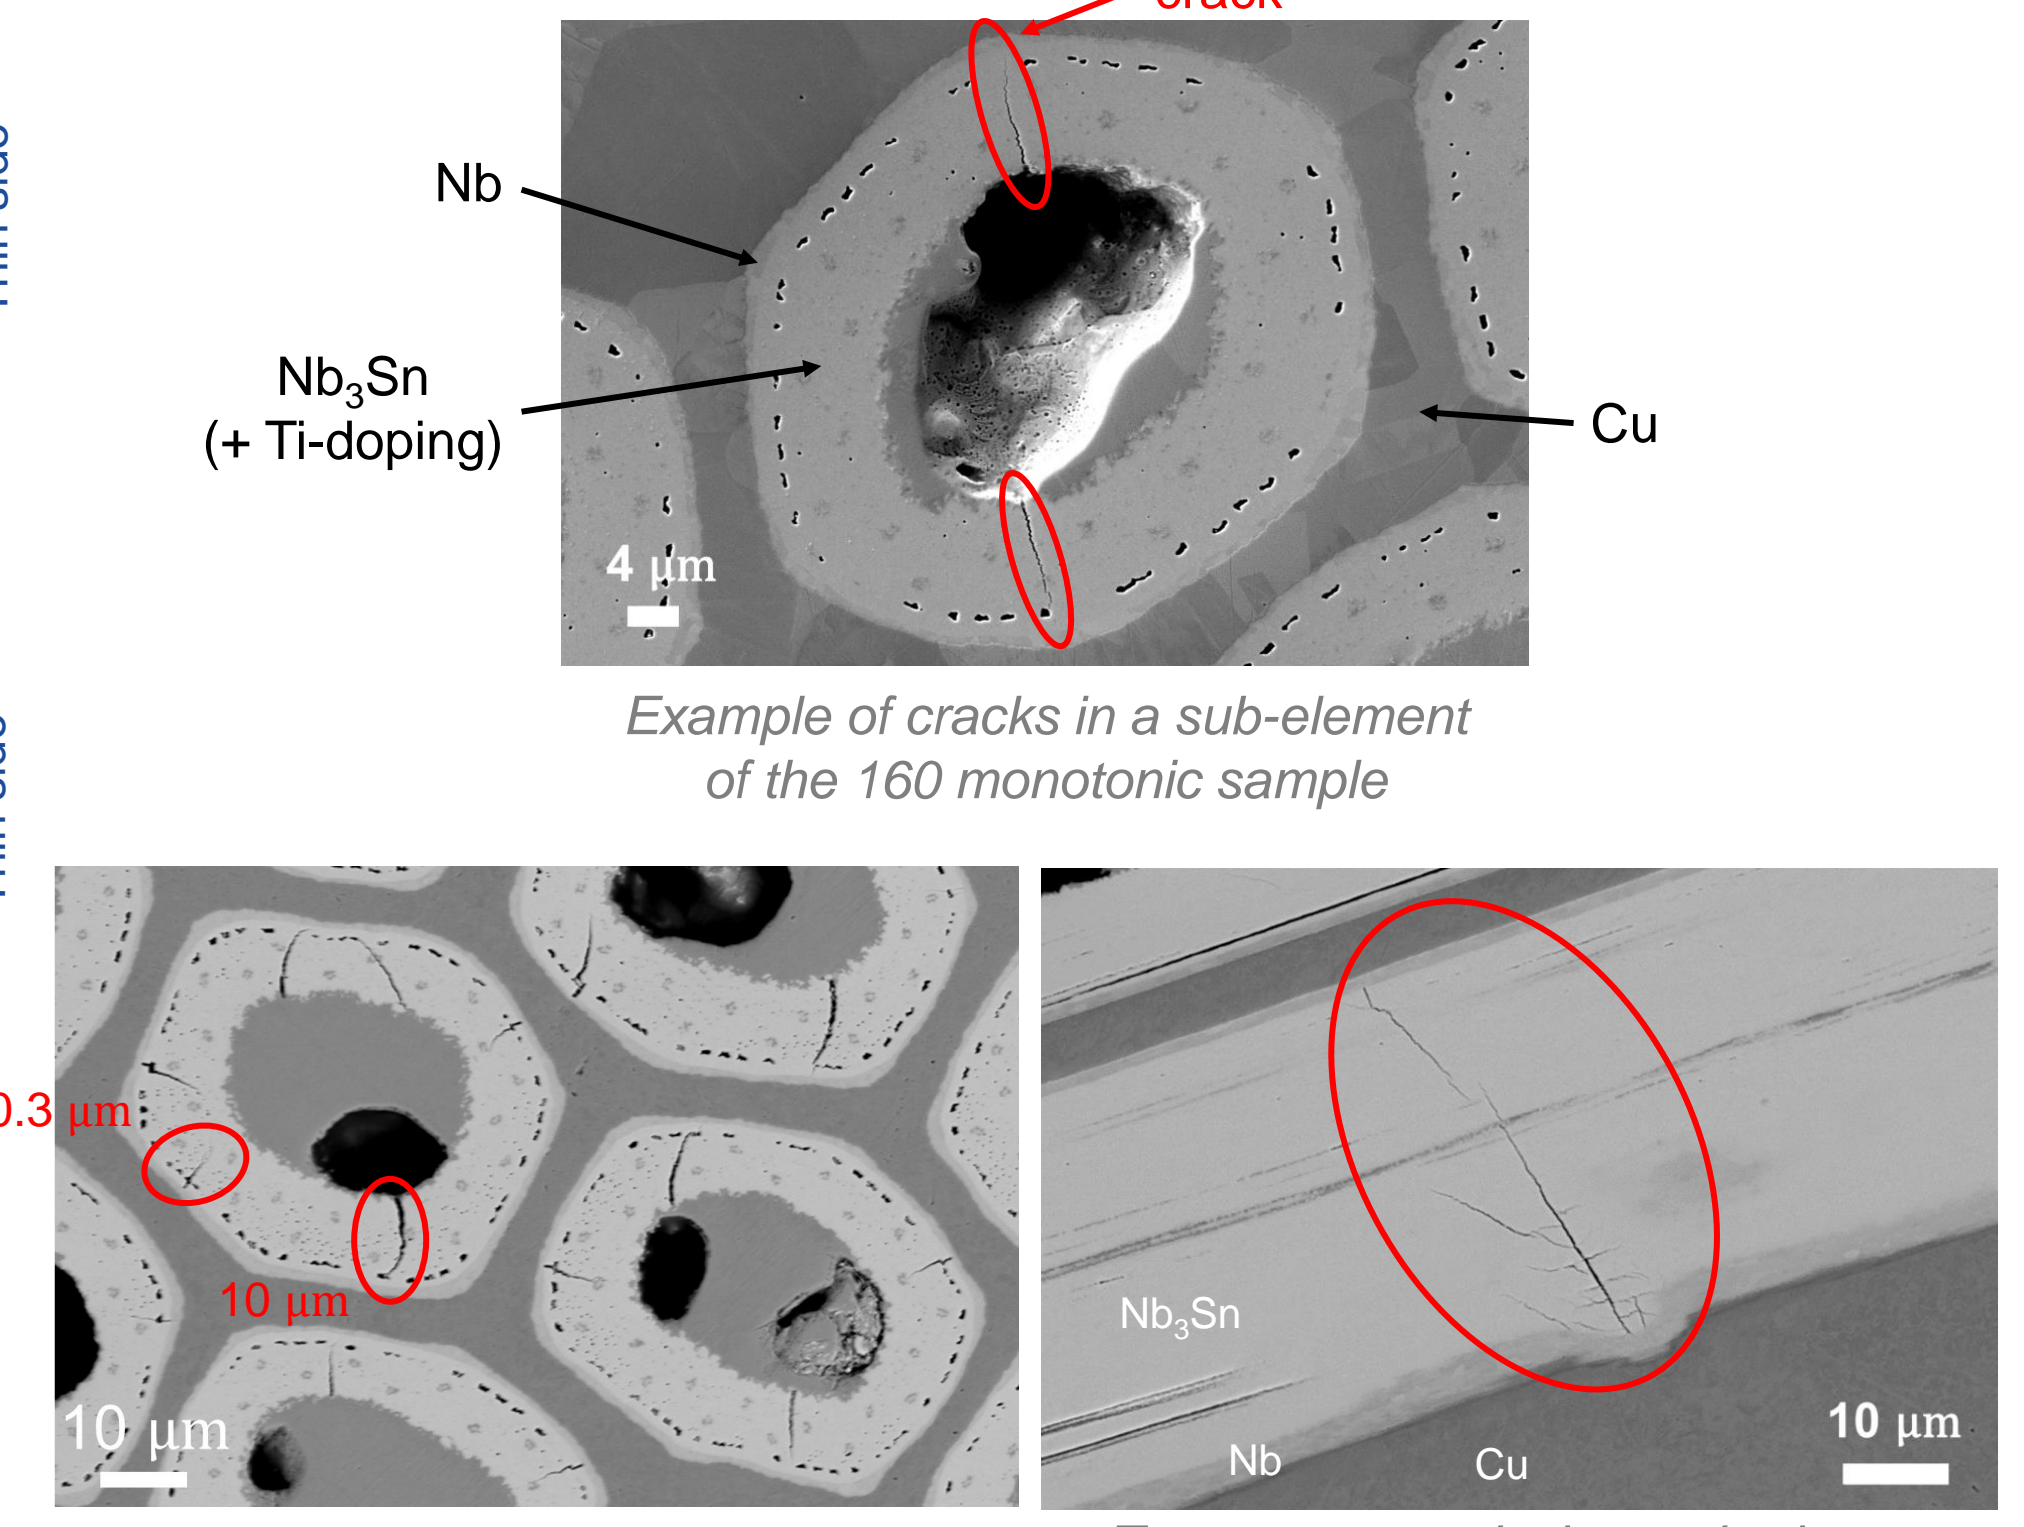
Comparison of the crack distribution of the 160 MPa monotonic and cumulated samples.
 ↳ Crack density is more important in the cumulated sample.
 ↳ Center of stack is mainly damaged.
 ↳ Thin side is less damaged than thick side.

- Results & conclusions
 - All samples show cracks, even the lowest one: 160 MPa Monotonic.
 - Density of cracks more important in cumulated loaded samples than monotonic one.

- Damage in cables localized mainly in center, thin side less damaged than thick side.
 - non-inverted configuration (can be confirmed by comparison with inverted configuration analysis).

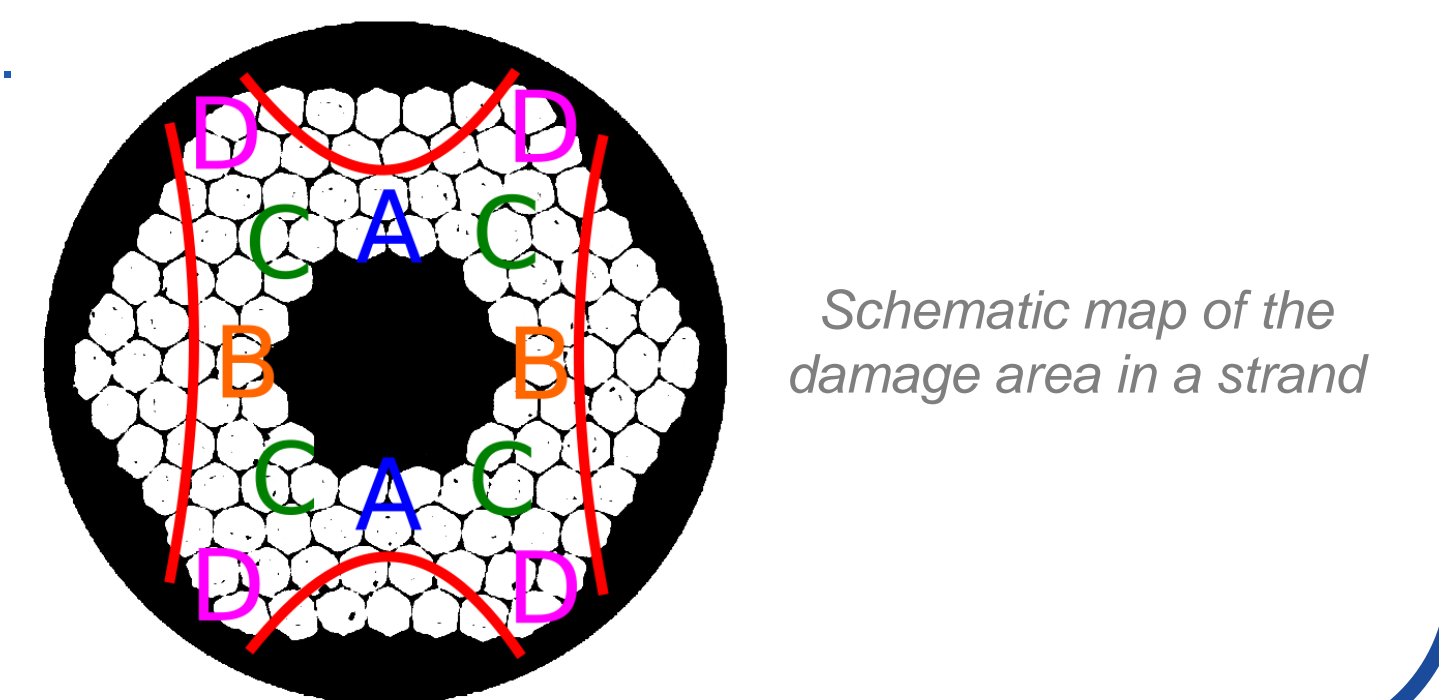
- Pattern of cracks in sub-element:
 - Cracks are localized in the 45° planes from loading direction.
 - Damage sub-elements orientation does not vary wrt. the rotation of the hexagon structure.

- Majority of the cracks oriented // to loading direction (vertical).
 - Horizontal cracks appear in severely damage sub-elements localized in zone C.
 - In strands with less damage (1 to 10 sub-elements affected) cracks localized in A,B & C.

- As cracks density ↑, localized in C.
 - Heavily damage strands, zone D is reached and multiple cracks

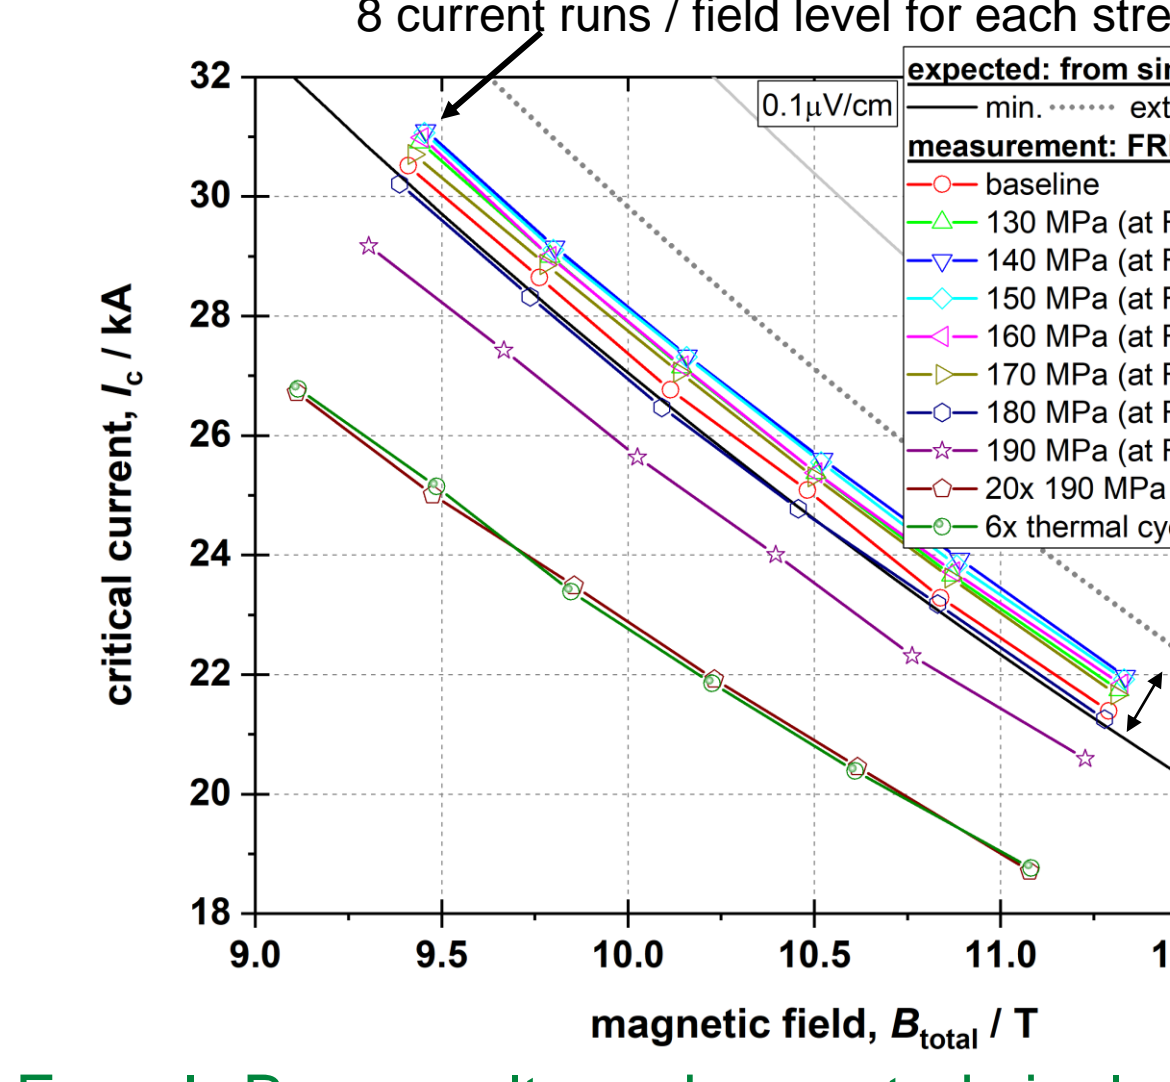
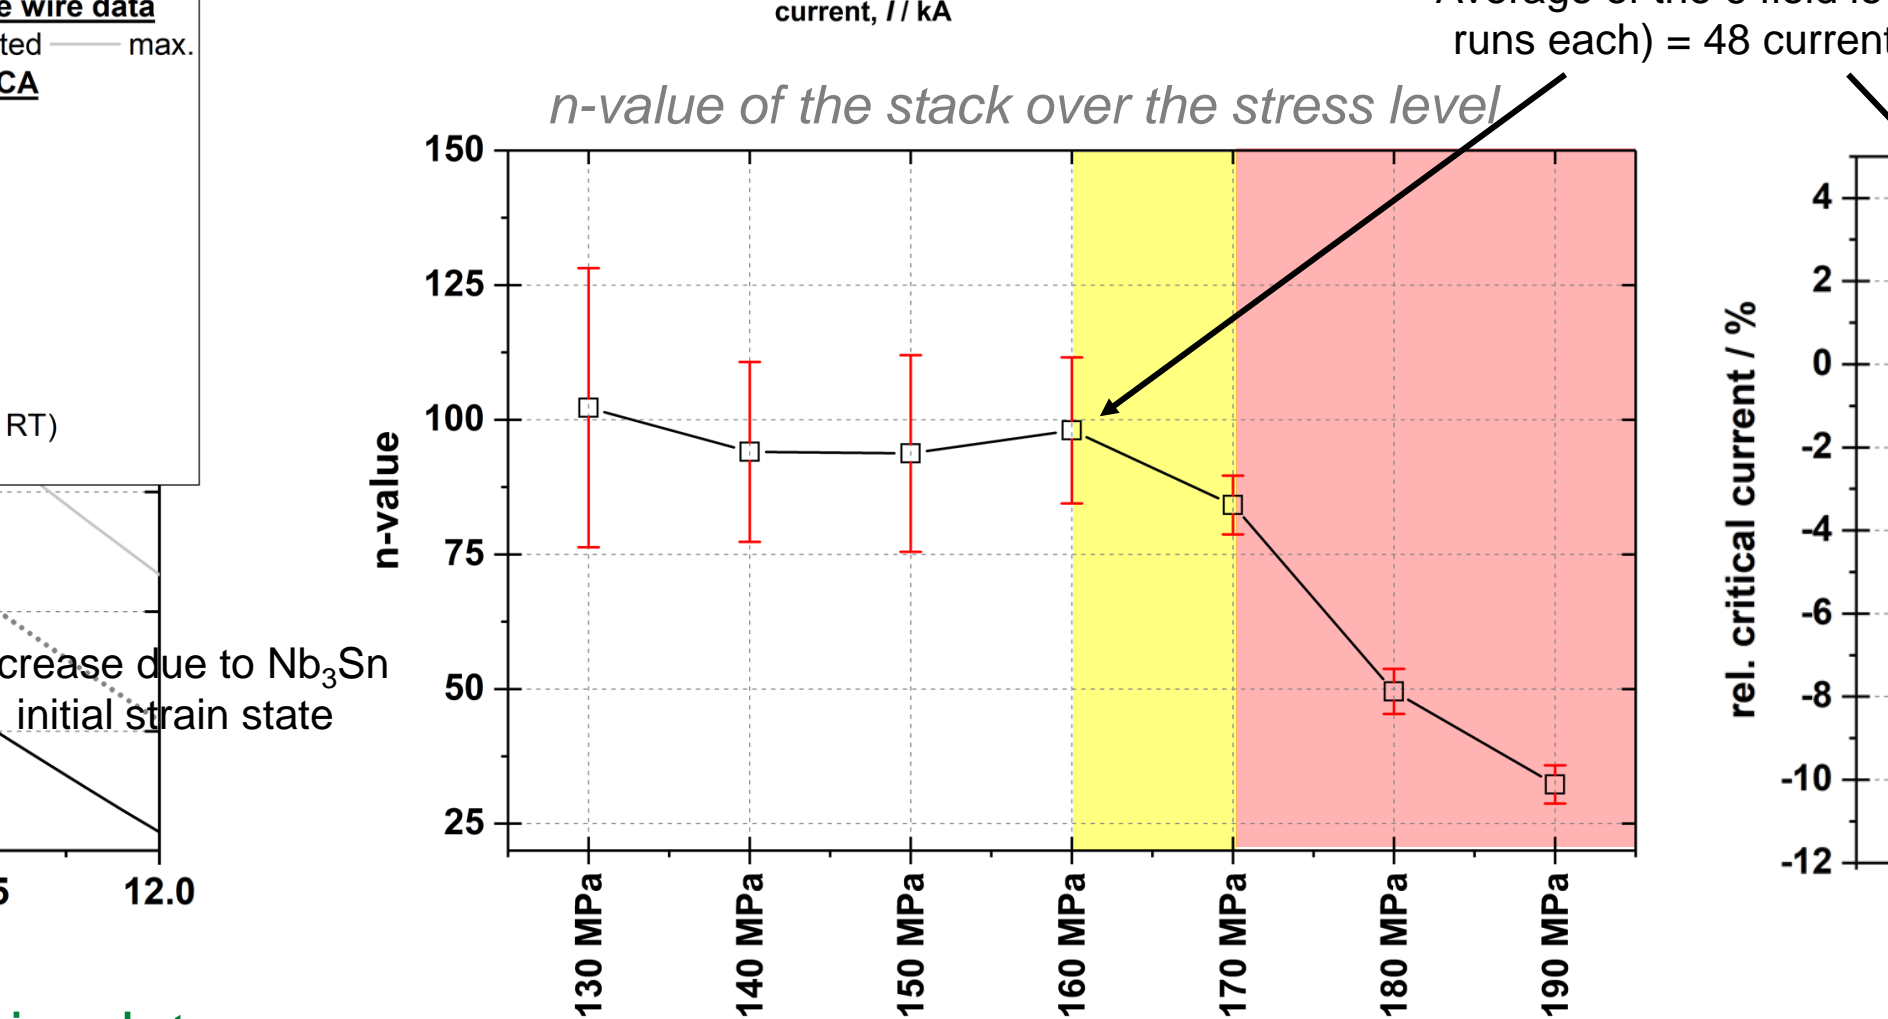
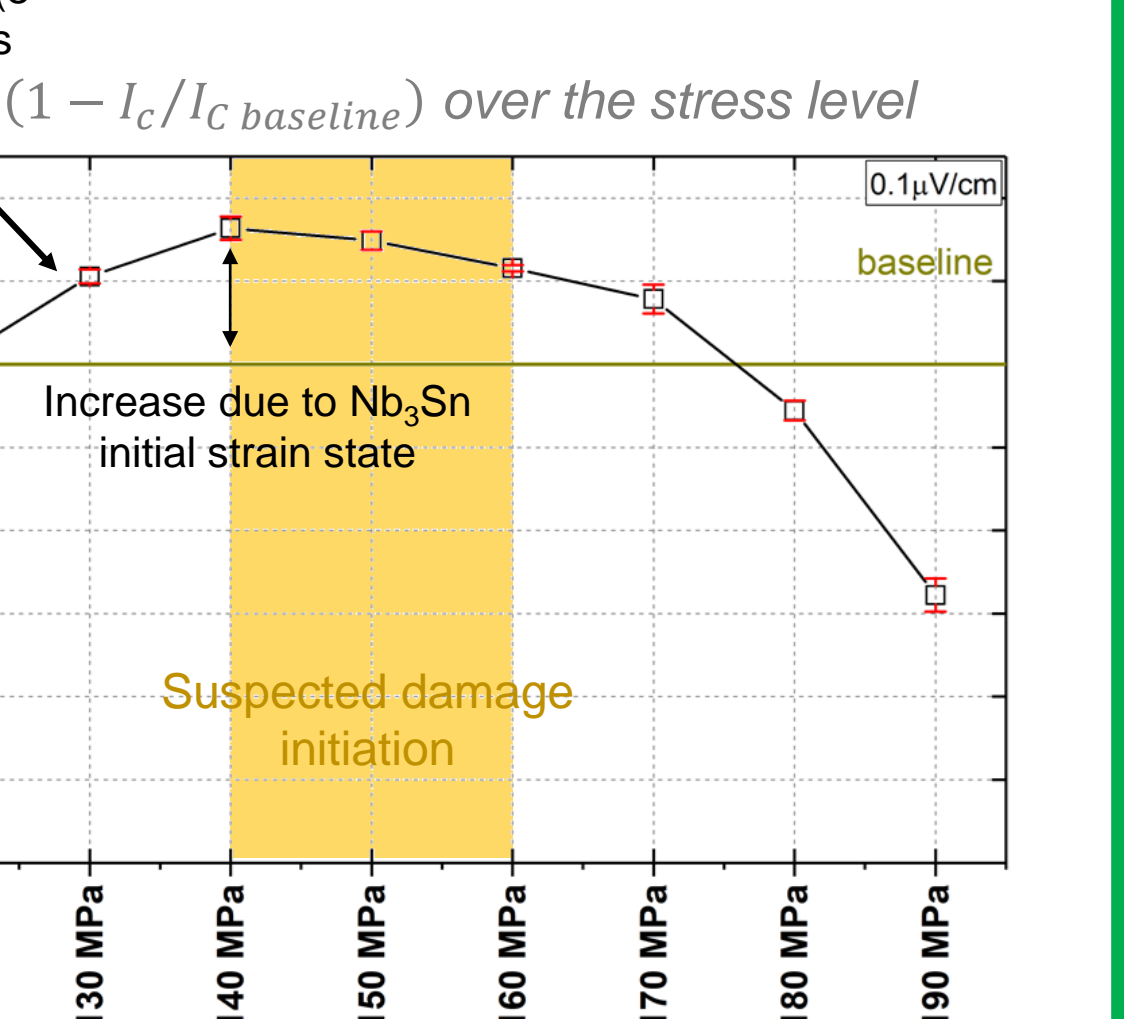
Results

From I_c-B_{total} results and expected single wire data
 ↳ Baseline: I_c just within expected range,
 ↳ ≤170 MPa: within expectations,
 ↳ ≥180 MPa: below expectations,
 ↳ Mechanical cycles - 20x190 MPa ~16.5% < baseline,
 ↳ Thermal cycles: 5x 77 K & 1x 4.2 K: no effect BUT performed after severe degradation.

From n-value results:
 ↳ 160 MPa-170 MPa: reduction ⇒ degradation,
 ↳ From 170 MPa: cable irreversibly damaged.

From I_c degradation & damage analysis:
 ↳ Degradation appears before 160 Mpa FOR A NON-INVERTED CONFIGURATION.
 ↳ Impact of damage initiated in early stress level not visible on electrical measurements.
