Special Technical Meeting on the 11T Dipole QH-Trace to Wire Jointing

Introduction

CERN – Virtual room <https://indico.cern.ch/event/978144/> – 2020.11.27

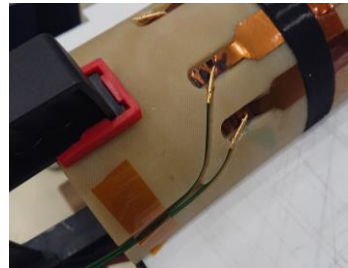
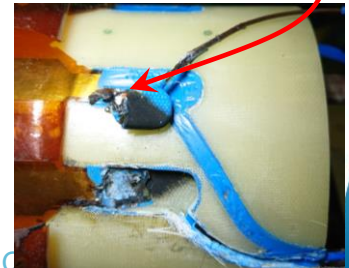
- There have been QH failures during the cold tests of two 11T dipole magnets:
 - One in the magnet S3 (LMBHA-002) tested in Jan./Feb. 2020
 - Another one in the magnet S4 (LMBHB-003) tested in Sept./Oct. 2020
- Till then, none of the 40 connections of the coils equipped with impregnated QHs (10 series coils) had shown any issue
- Whereas, 2 out of 32 connections of the coils equipped with external QHs (8 series coils) have failed in open loop
- As to S3, reflectometry, and later on visual inspection of the coil, have pointed to the QH-trace to wire jointing, as shown on the picture below
- S4 is not yet dismantled but reflectometry is pointing to the same location

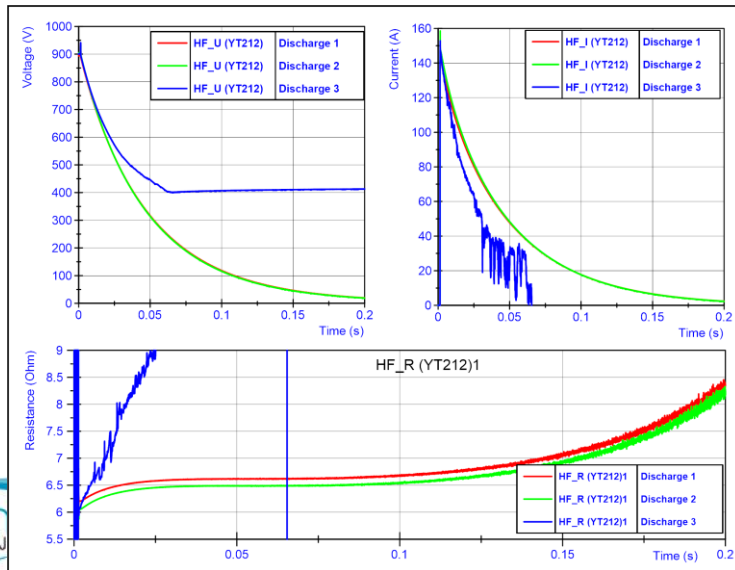
- Case of the magnet **S3**, coil **C14**, **D2-Lo**
 - At RT, in production, 4 discharge tests are made, 1 after collaring, 3 during CM construction (400 V, 80 A)
 - Failure at 3rd QH firing during reception tests at cold** prior to powering (900 V, 150 A)
 - Circuit YT-212
 - No sign of degradation during the first 2 discharges
 - NCR EDMS [2311125](#)

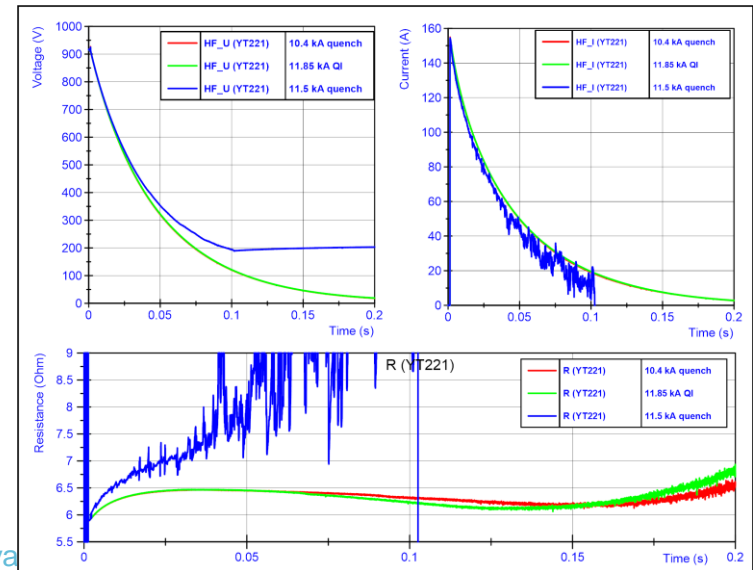
- Case of the magnet **S4**, coil **C17**, **D2-Up**
 - At RT, in production, 4 discharge tests are made, 1 after collaring, 3 during CM construction (400 V, 80 A)
 - Failure at 12th QH firing at cold**
 - Circuit YT-221
 - No sign of degradation during the previous discharges
 - NCR EDMS [2423242](#)
