Soldering tests of quench heaters (QH) Computed tomography (CT) imaging and metallurgical investigations

Mariusz Jedrychowski - Mickaël Crouvizier – Mickaël Meyer/Mechanical & Materials Engineering group, EN-MME-MM

Post-mortem analysis CR14

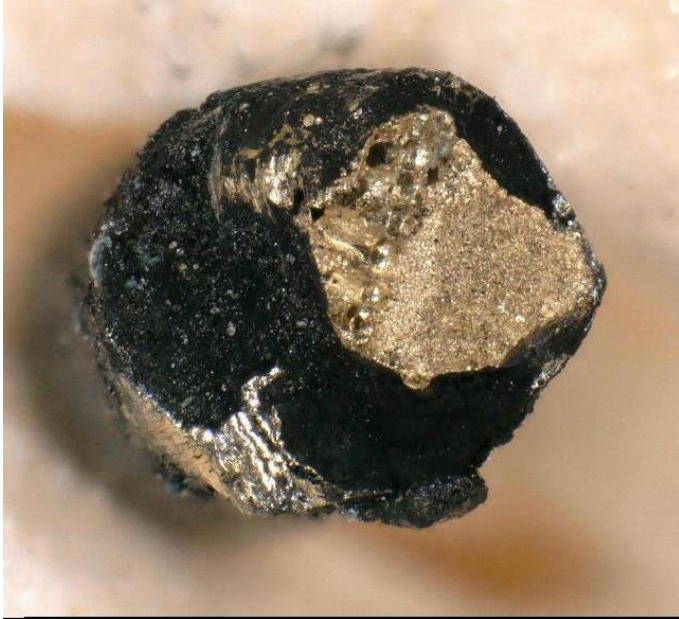
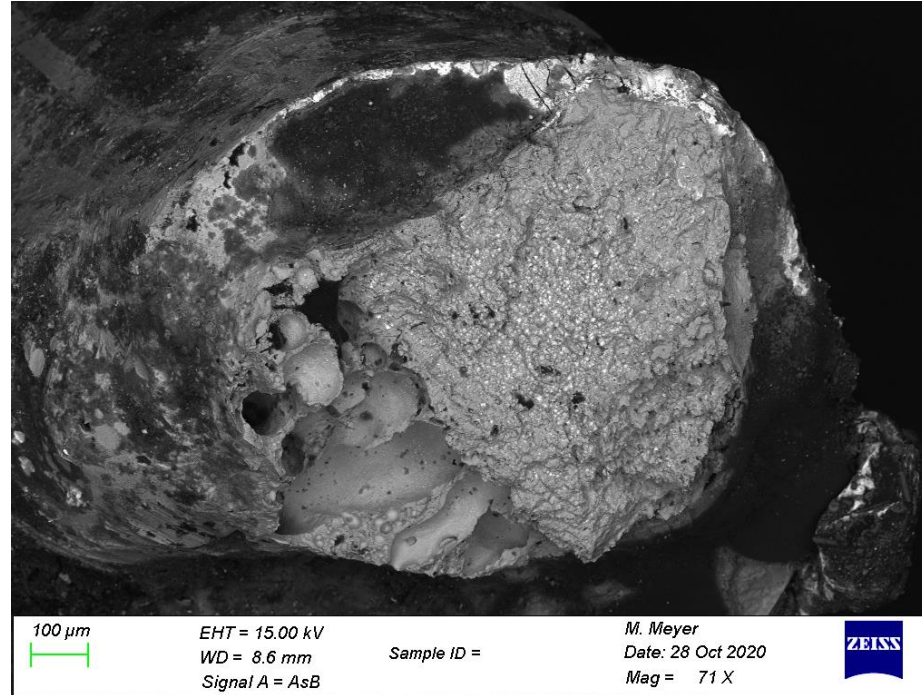
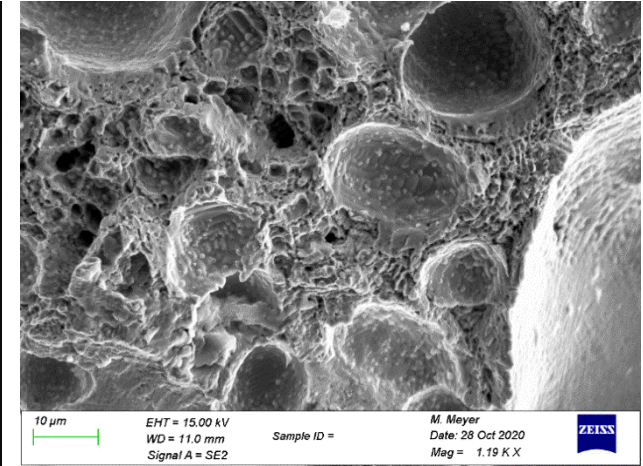
Reduced observable section → A significant part of the connector is missing
On the remaining observable section: indications of porosities, burnt organic compounds and mechanical tearing.

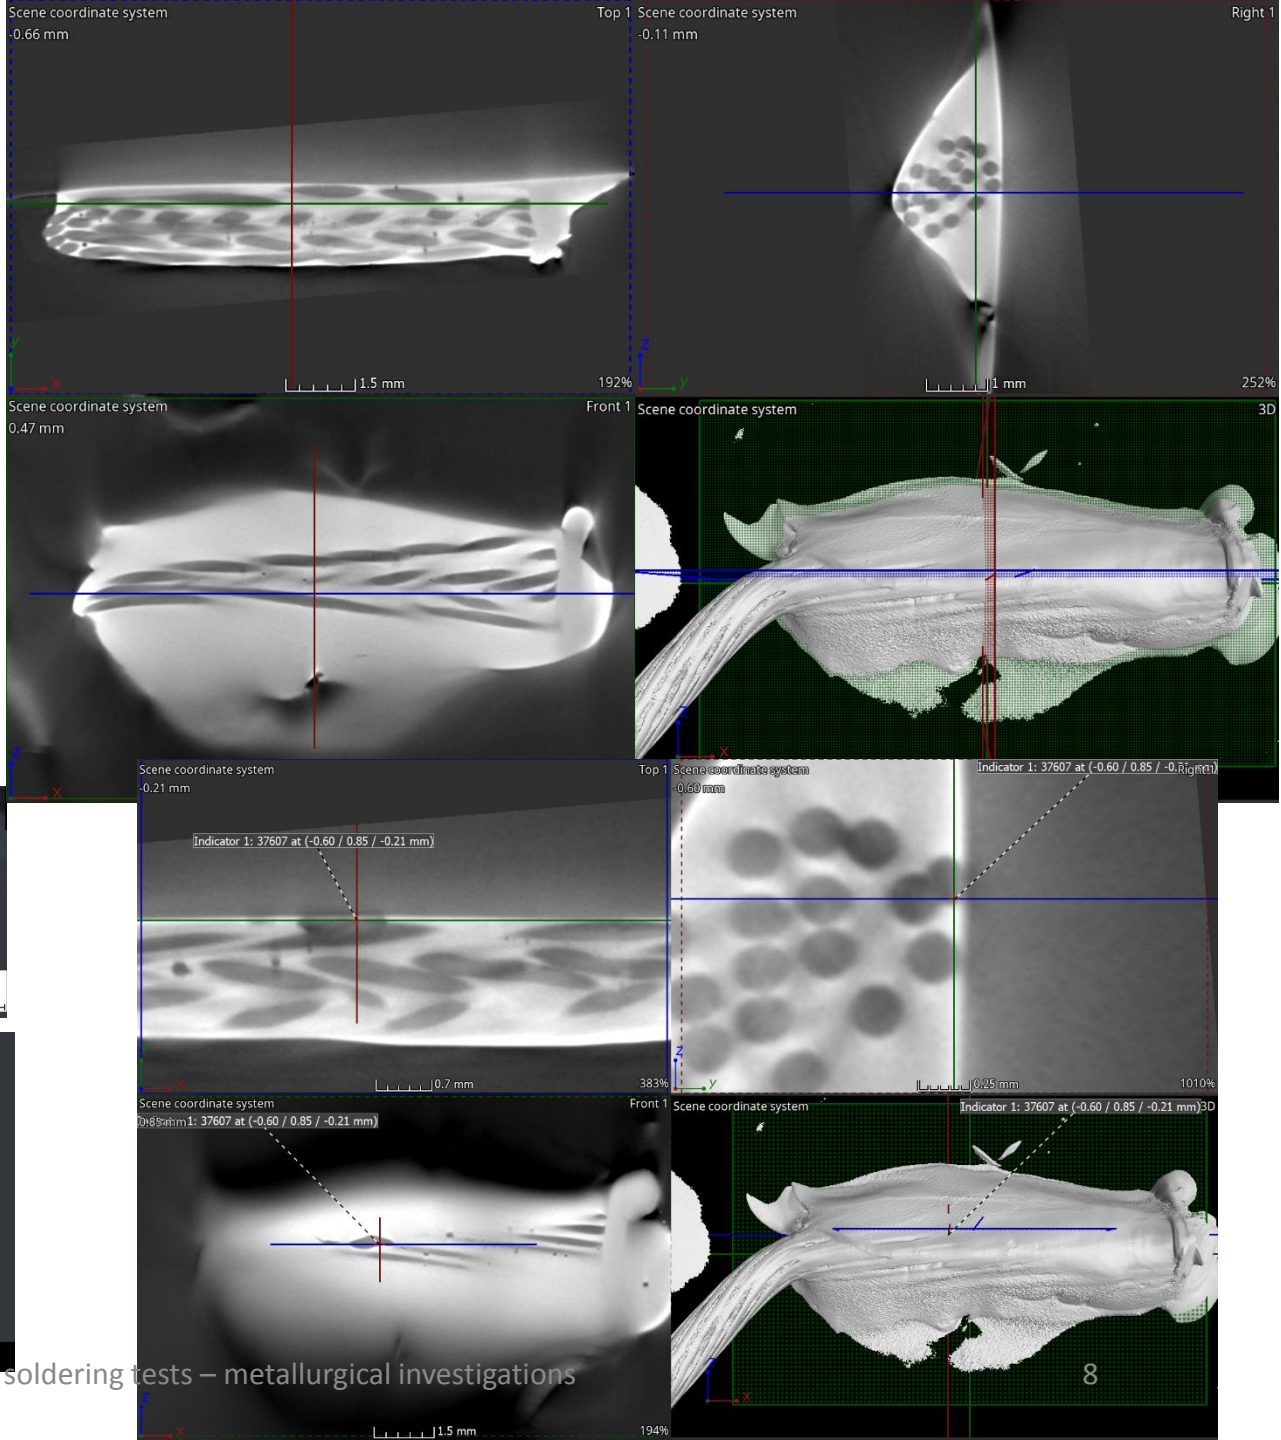
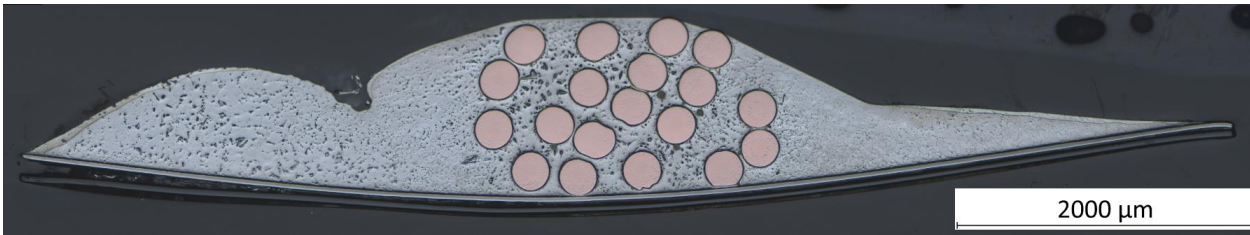
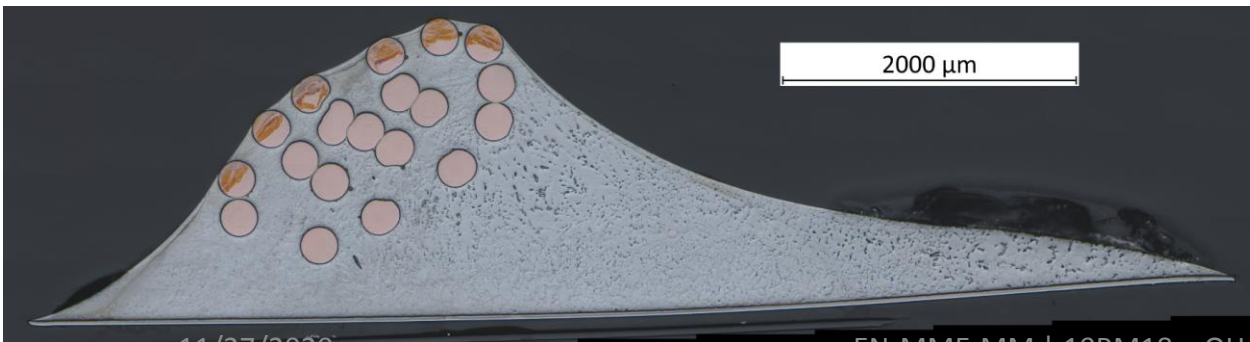
EF-AE : Tinning, Cleaning, Pickling

No significant defects were found. **General good quality**, both connector and QH copper surfaces are in contact with the solder.

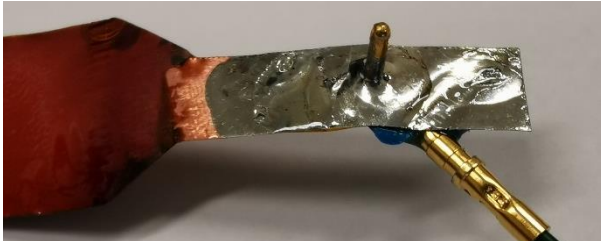
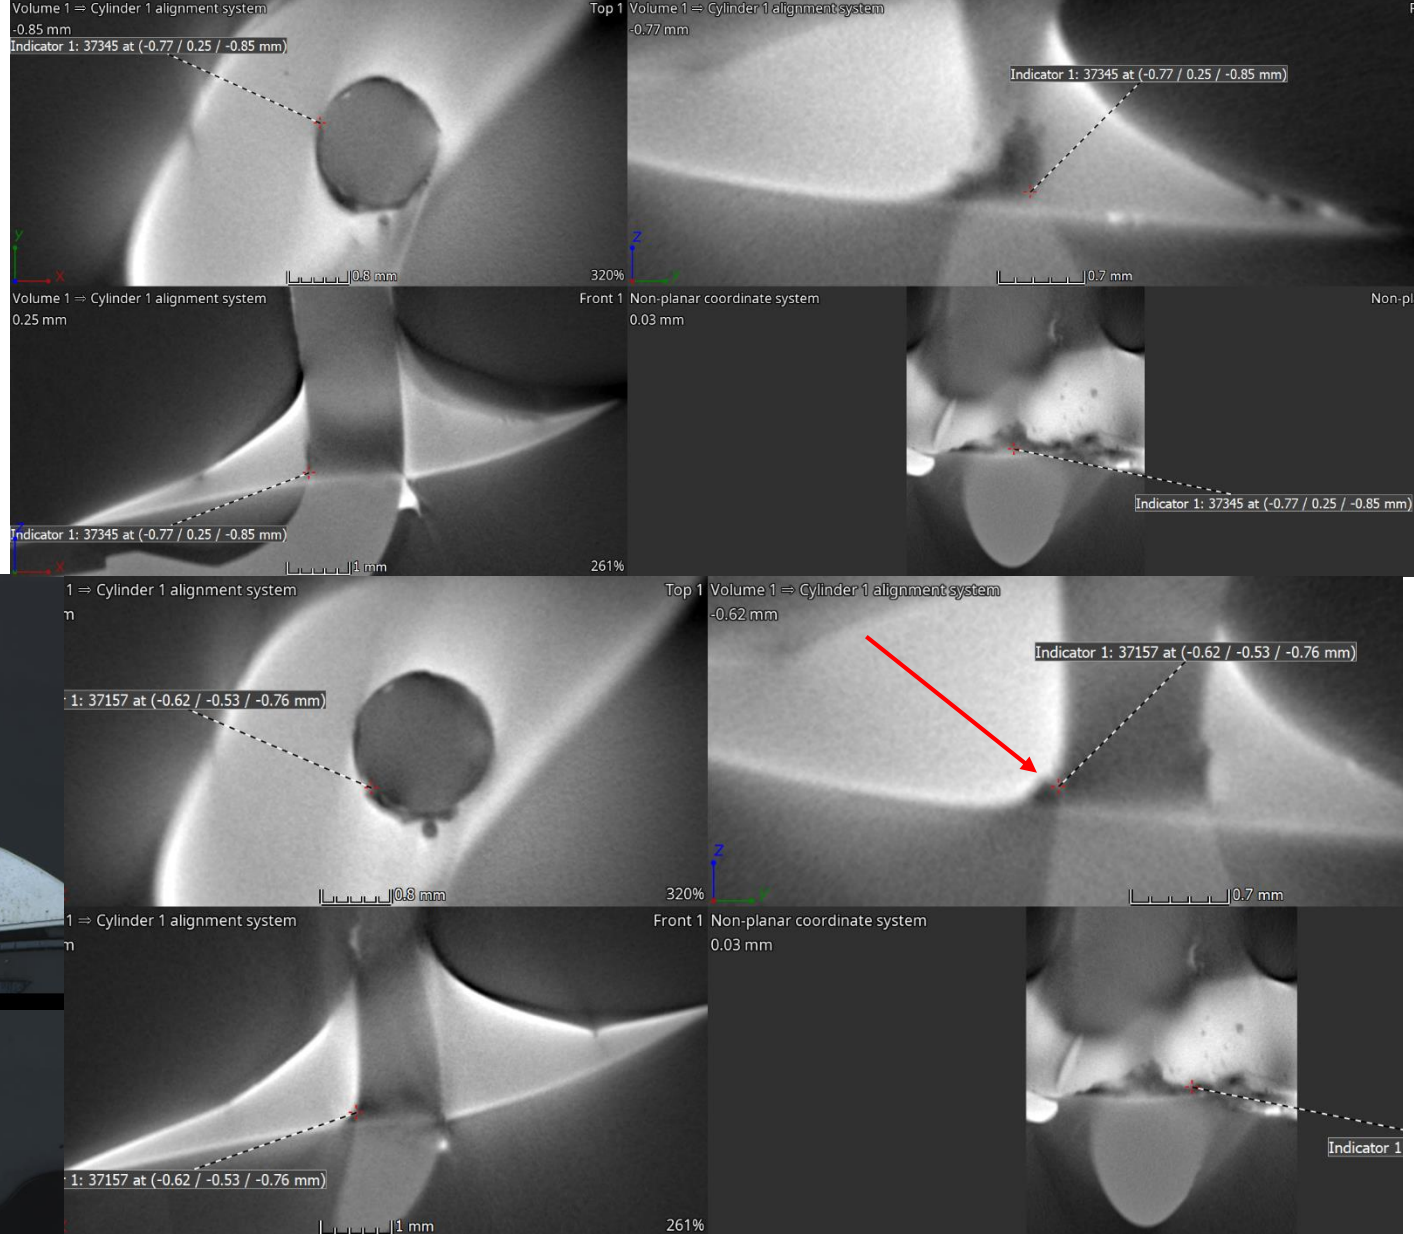
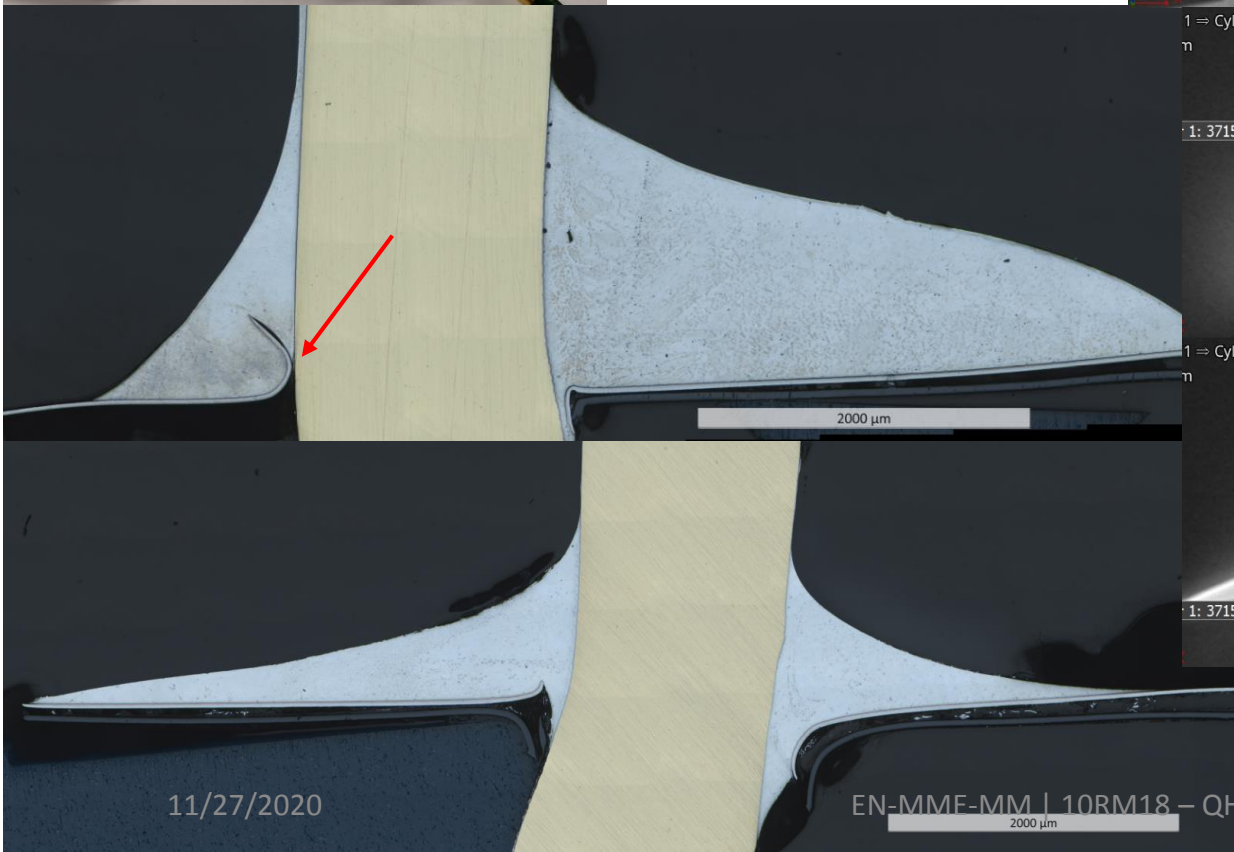
ES-AE : Tinning, Cleaning, Pickling

Minor defects were found (**QH tape embedded**), but overall the **quality** of the solder is good.

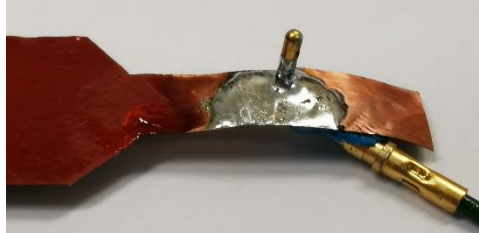
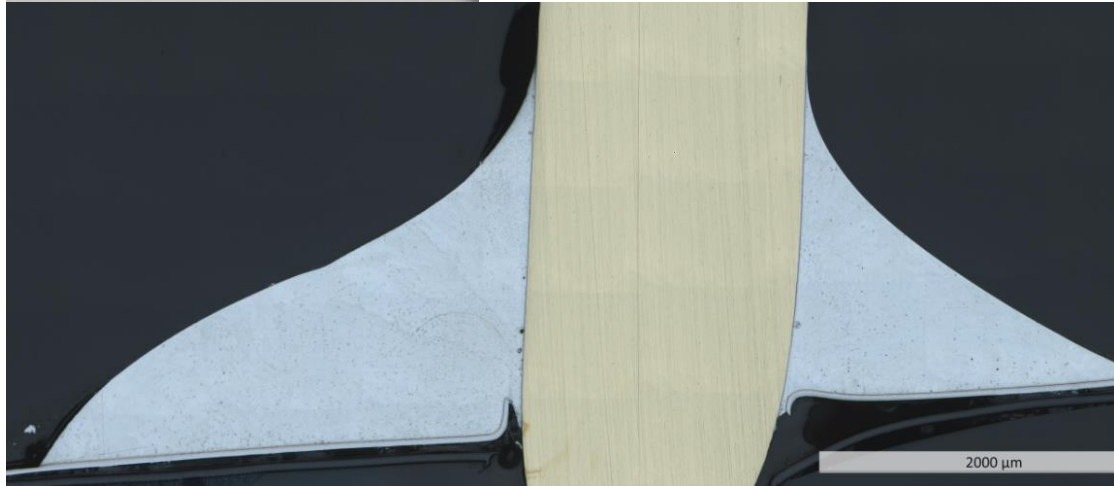
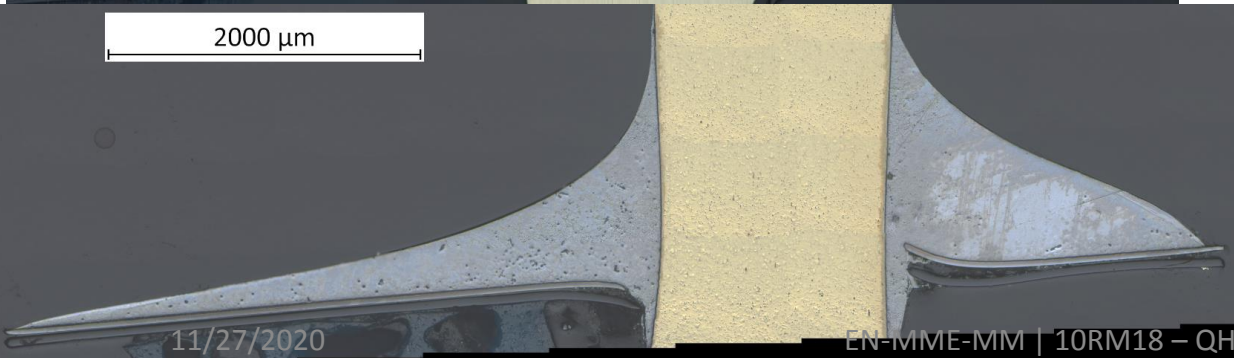
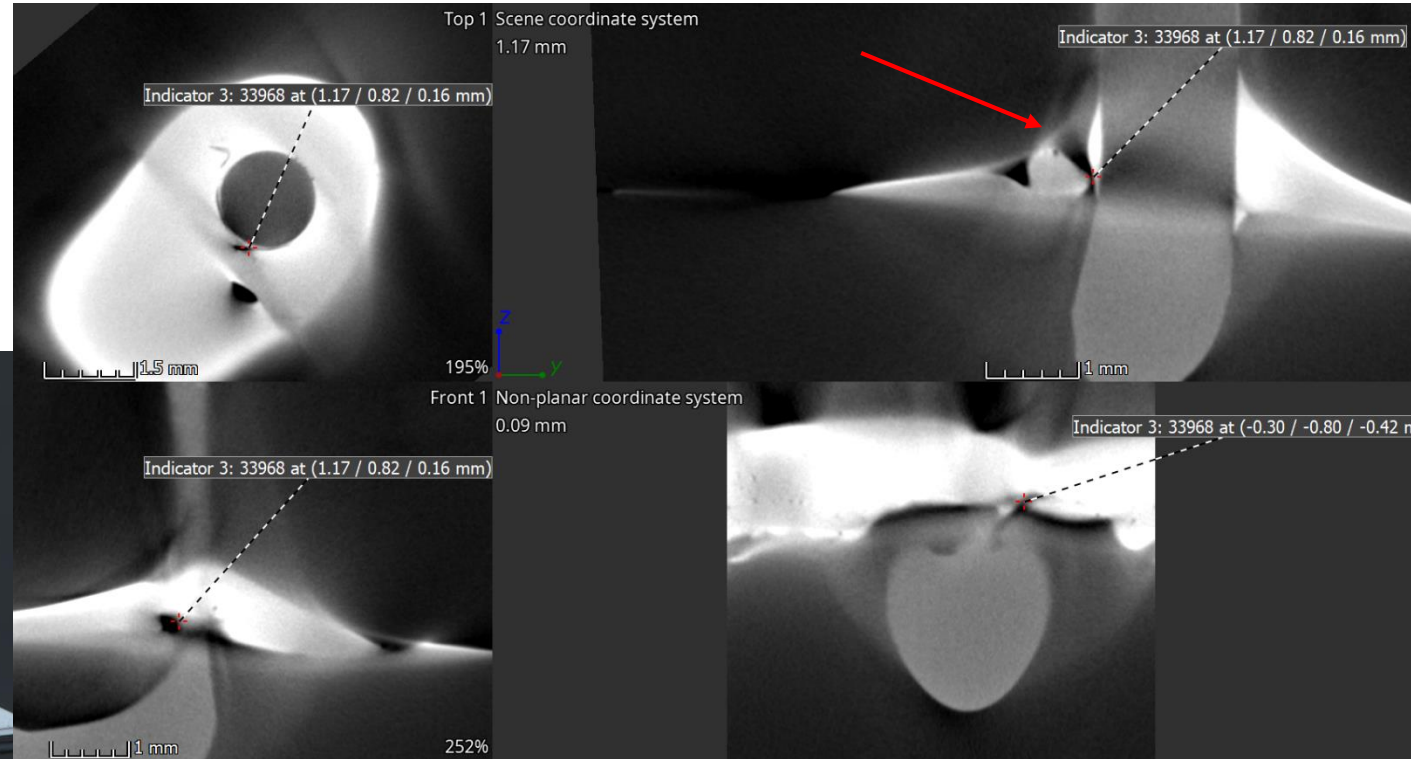
ES-SE : Cleaning, Pickling

Overall the **quality of the solder is good**, but one big open pore was found in CT scan.

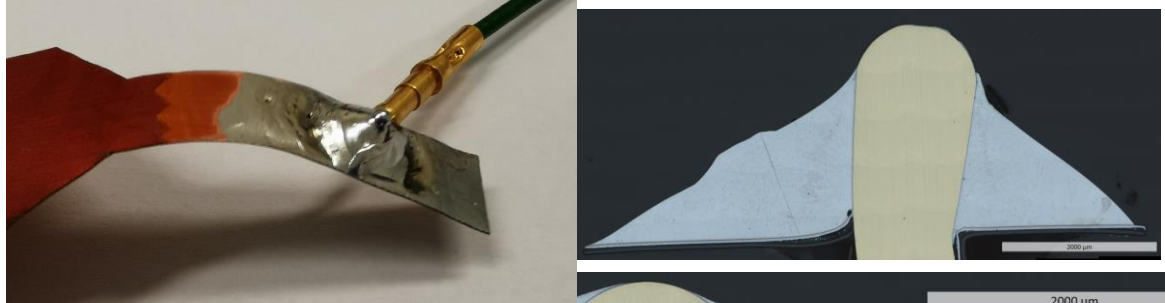
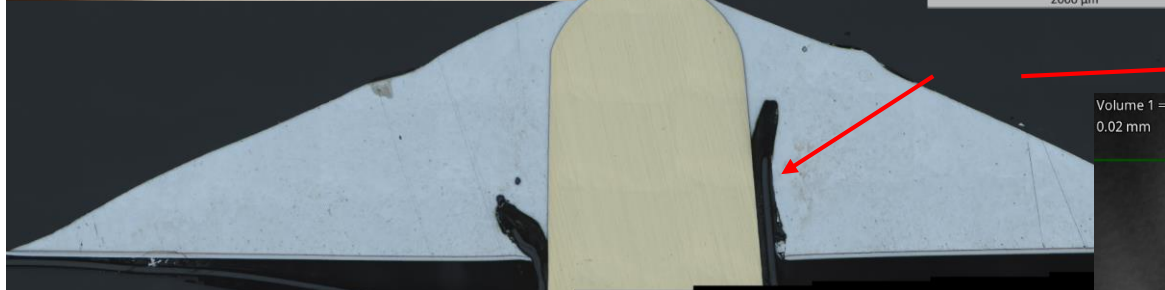
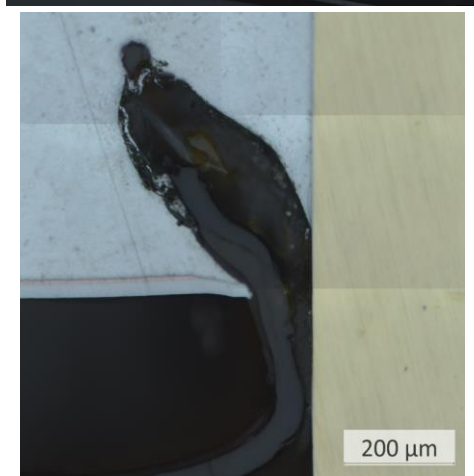
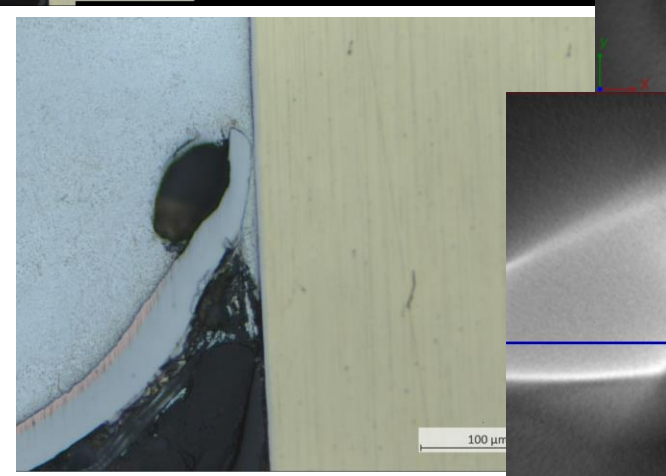
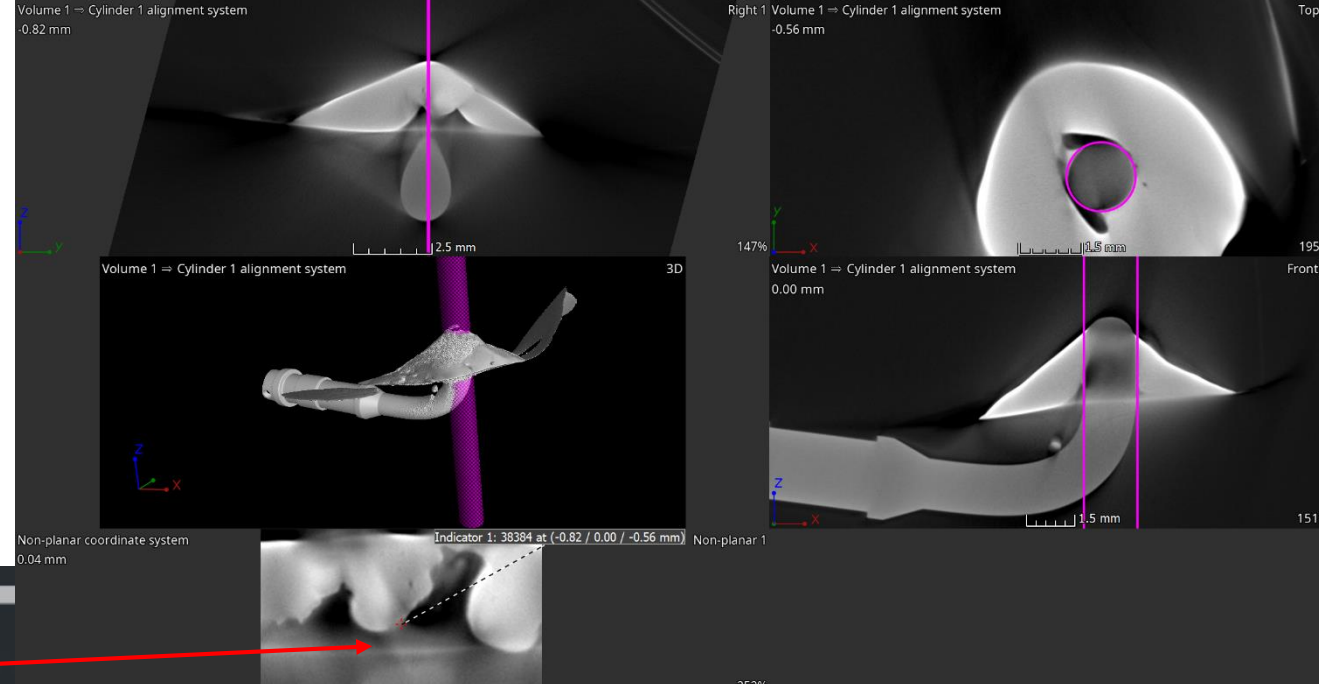
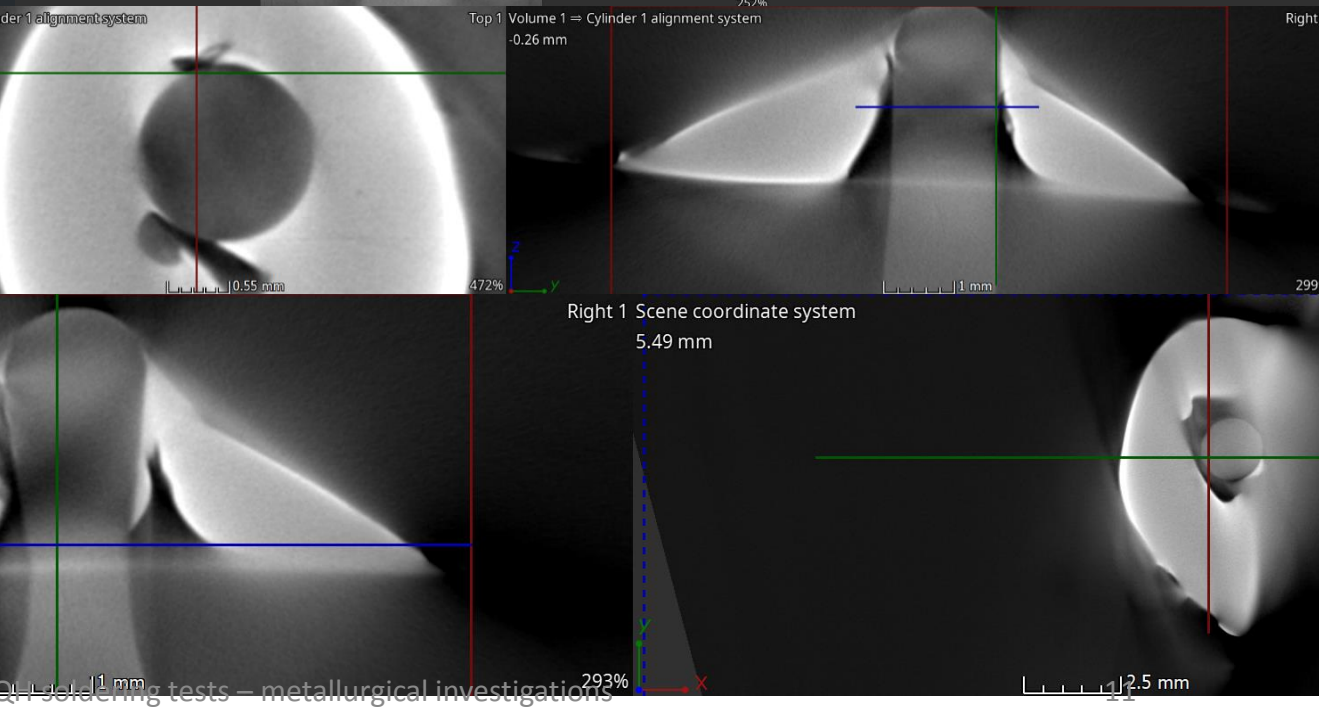
EGB-AE : Tinning, Cleaning, Pickling

Large bonding imperfections due the presence of polyimide film.

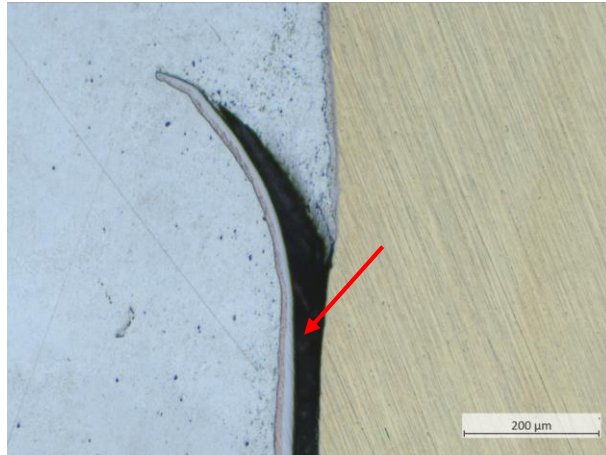
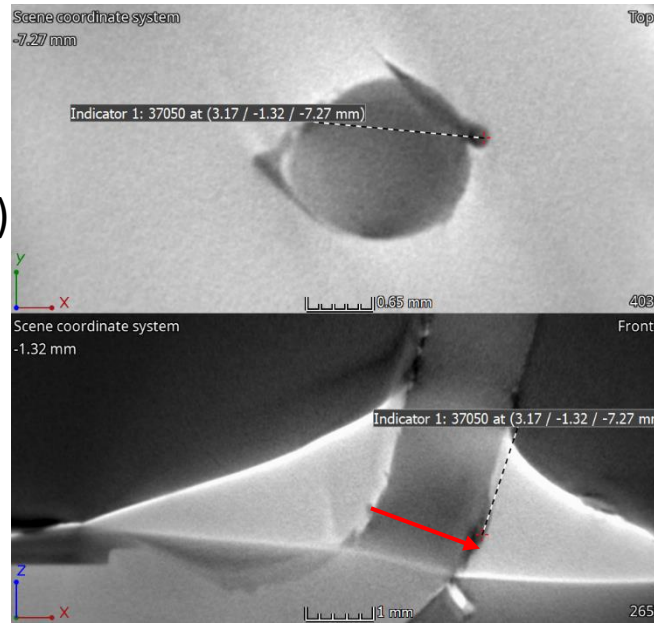
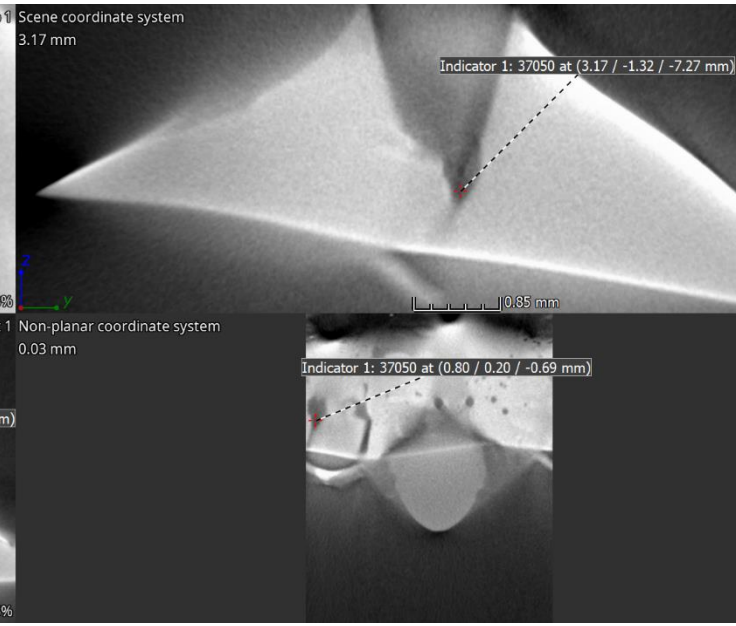
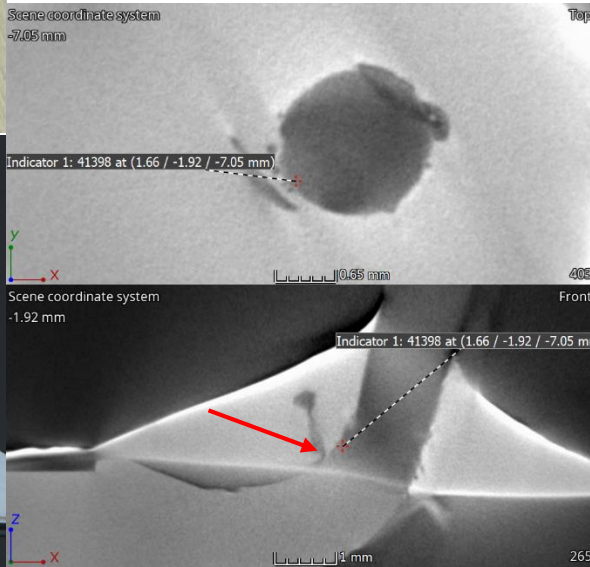
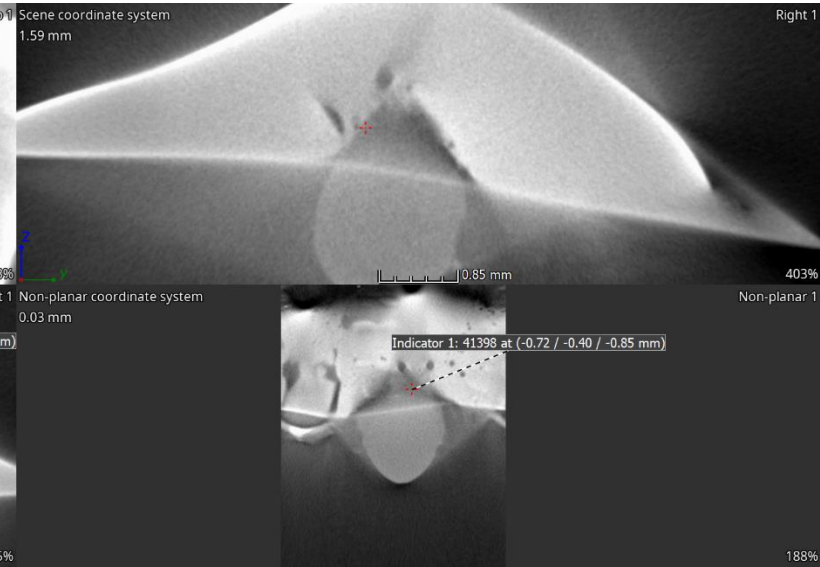
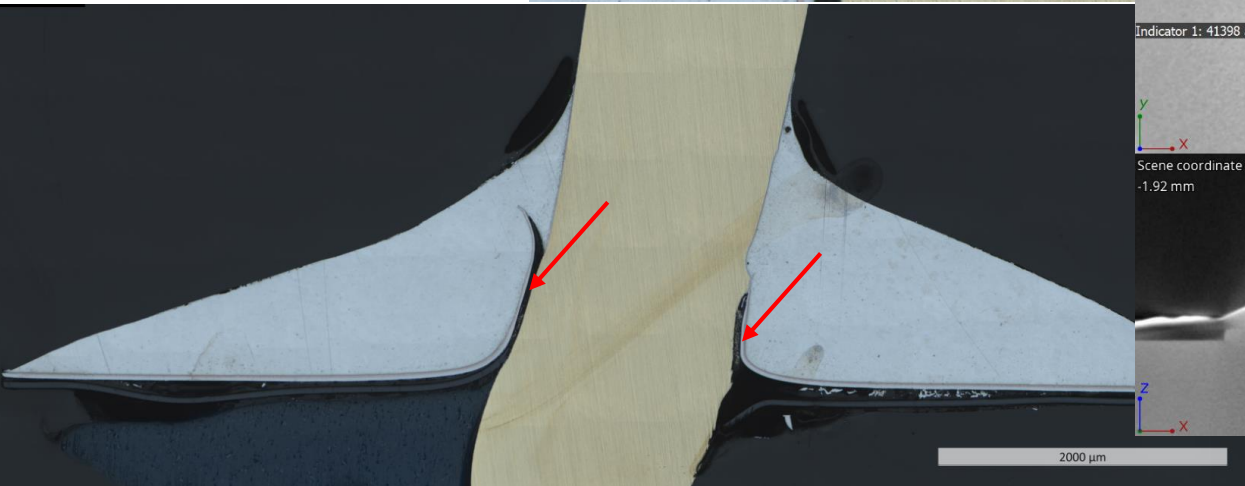
ENS-AE-DP : Tinning, Pickling

Reduced soldered interface due to embedded QH (arrows) and big void (CT scan).

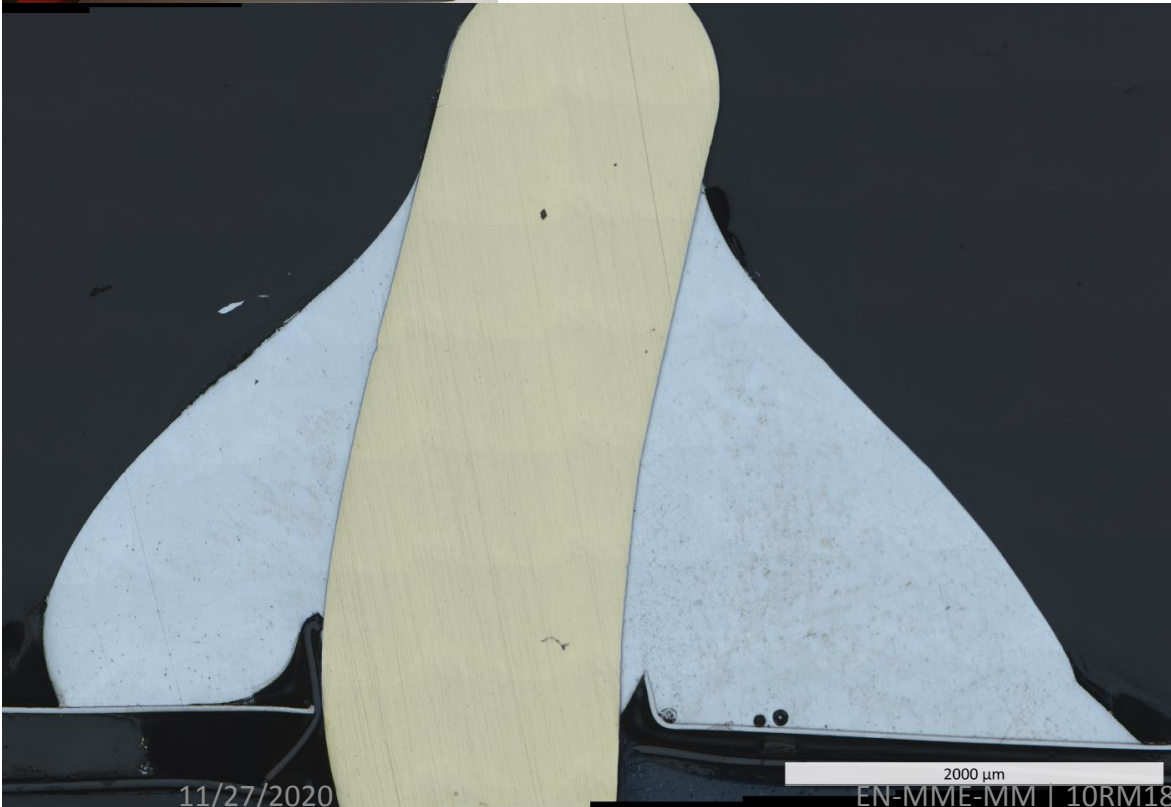
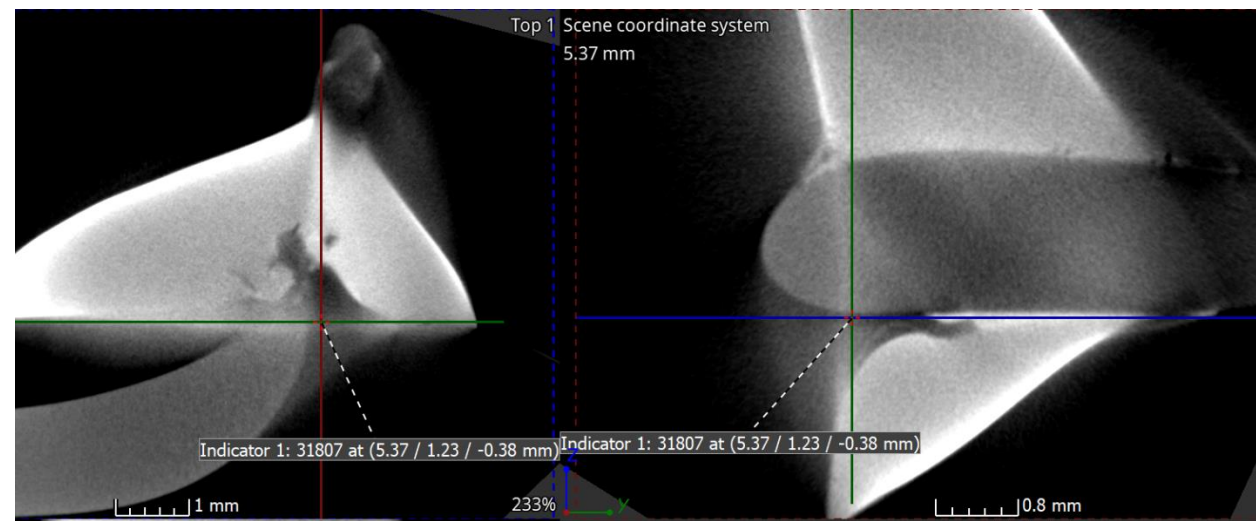
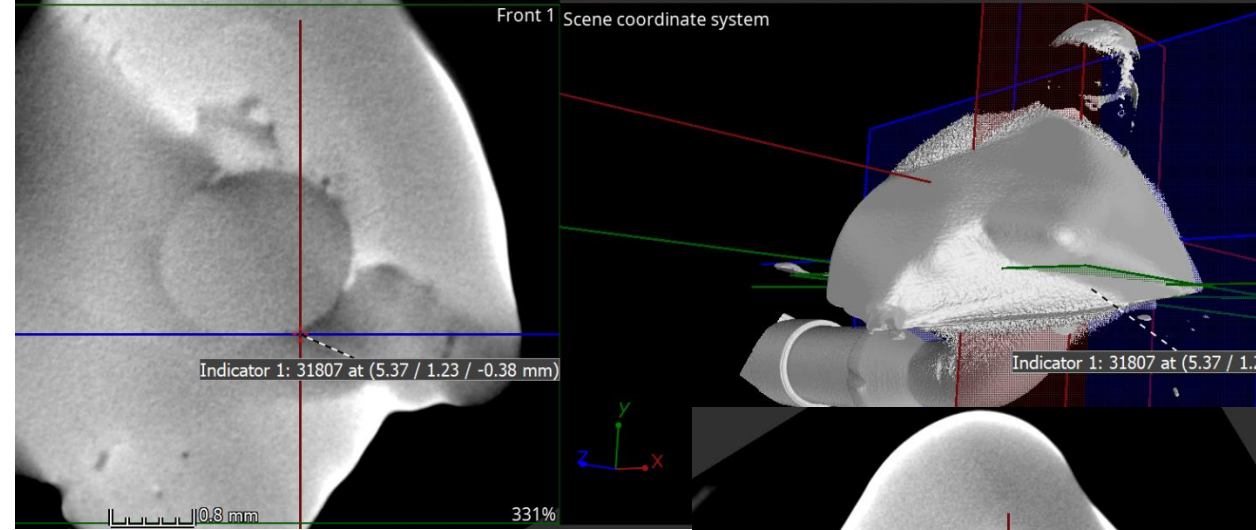
ENS-SE-DP : Pickling (partial)

Partial bonding due to the presence of polyimide film, large void under the solder.

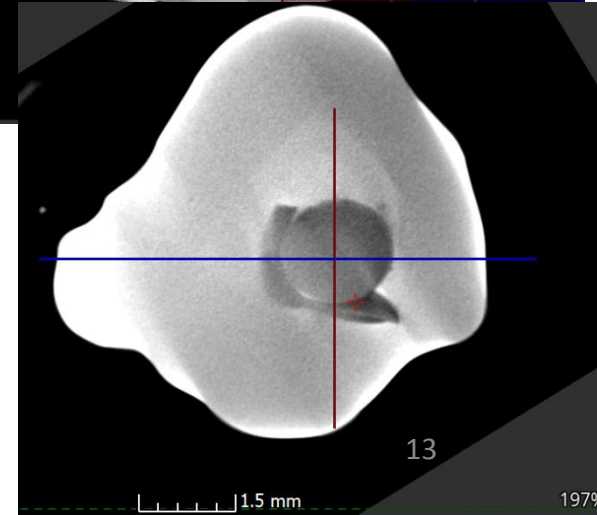
ENS-AE : Tinning

Solder is detached from QH copper tape.

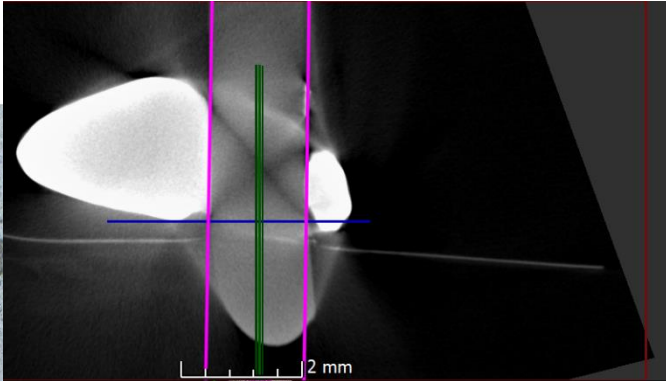
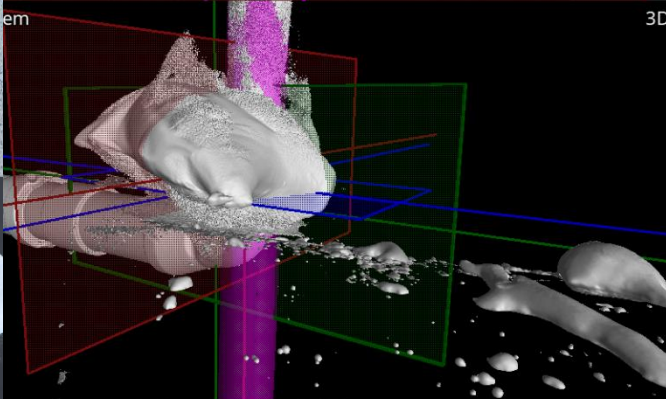
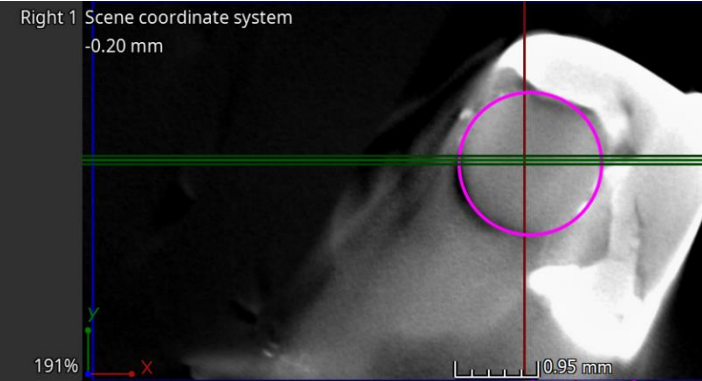
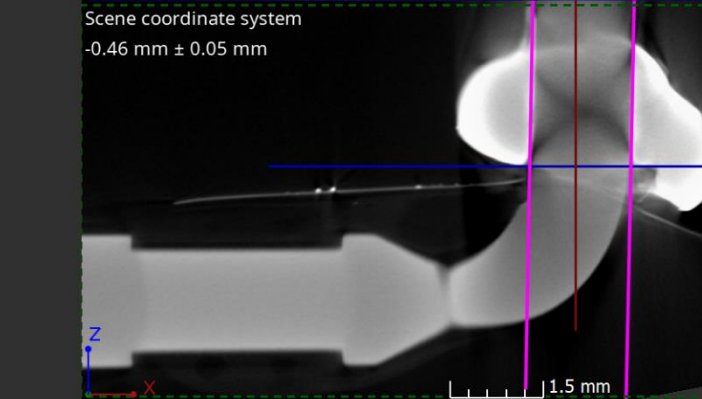
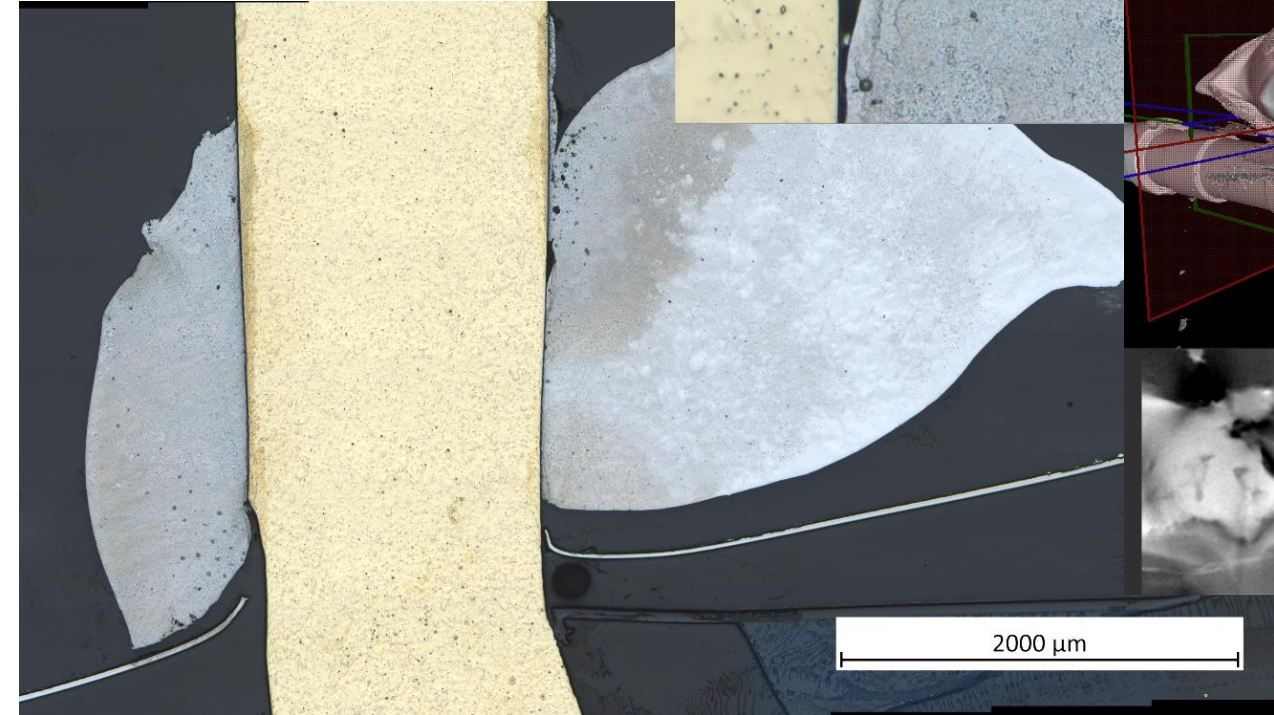
ENS-SE :without any preparation

Poor joint quality, the pin's connector is not soldered to QH copper tape

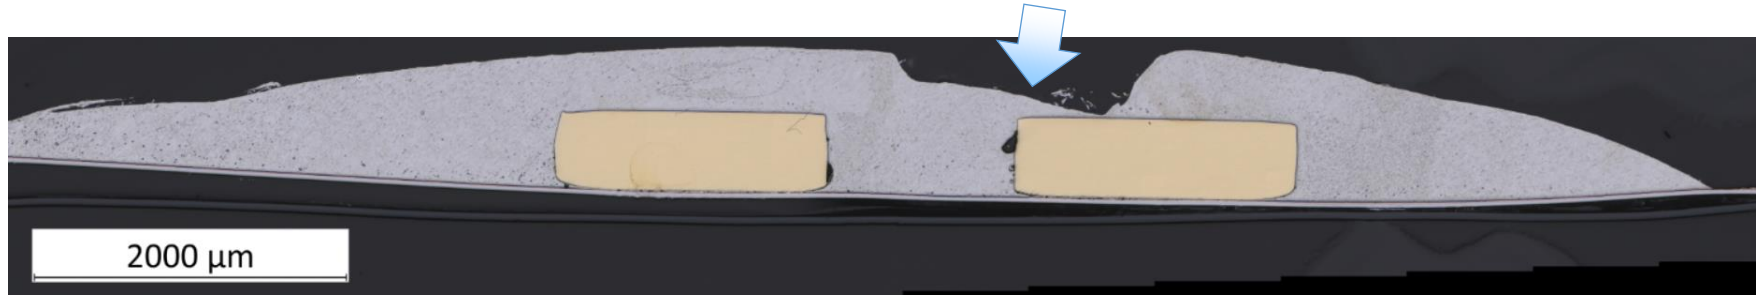
FCGB-SE #3 stitched picture, local depression at the solder due to pressure during soldering is visible (arrow)

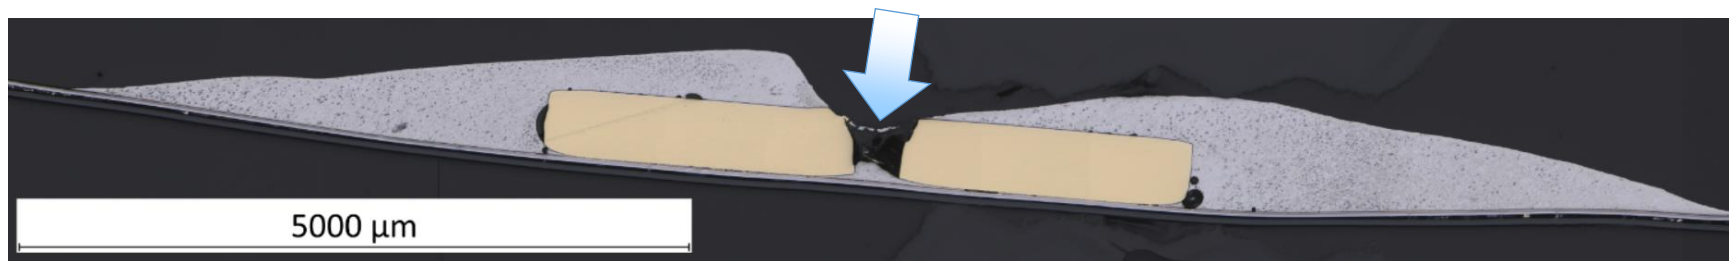
FCGB-SE #4 stitched picture, local depression at the solder due to pressure during soldering is visible

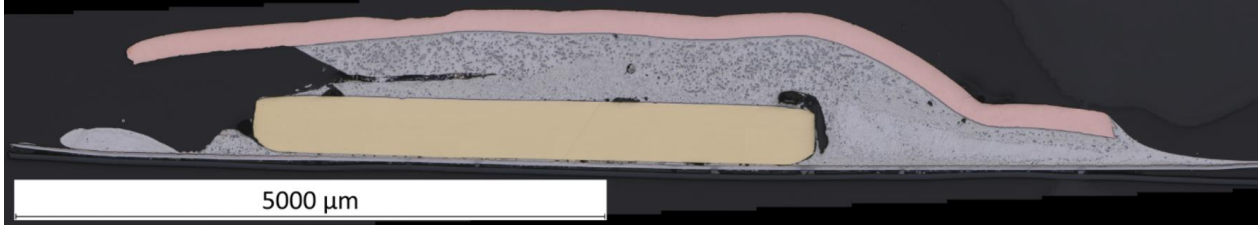
FCGB-SE with Omega #2, large porosities and bonding imperfections are observed

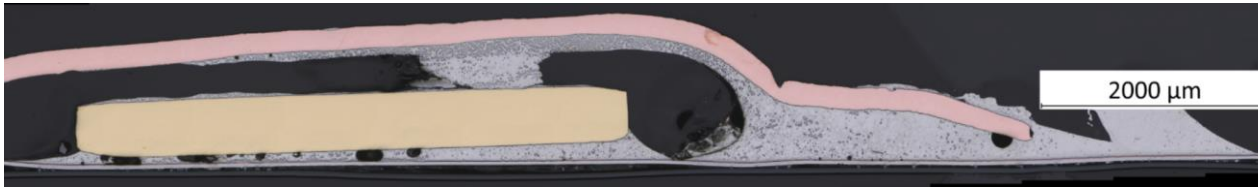
FCGB-SE with Omega #3, large porosities and bonding imperfections are observed

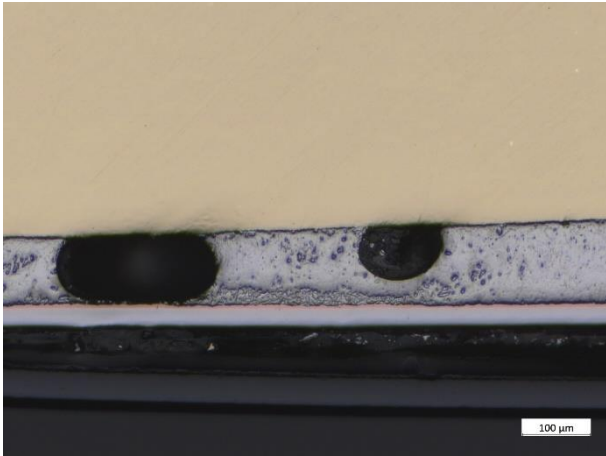
large gas pockets are observed between connector and quench heater tape

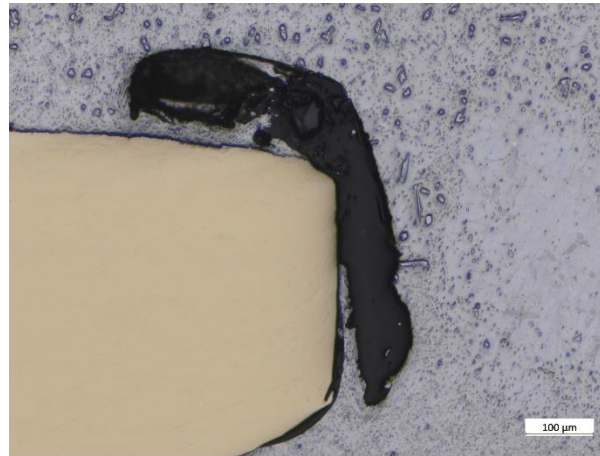
large porosities are observed all around the connector
