DOM Assembly SUBATECH status

DOM Integration

DOM Integration
ORCA Phase II
3.4/TSFP/7.691

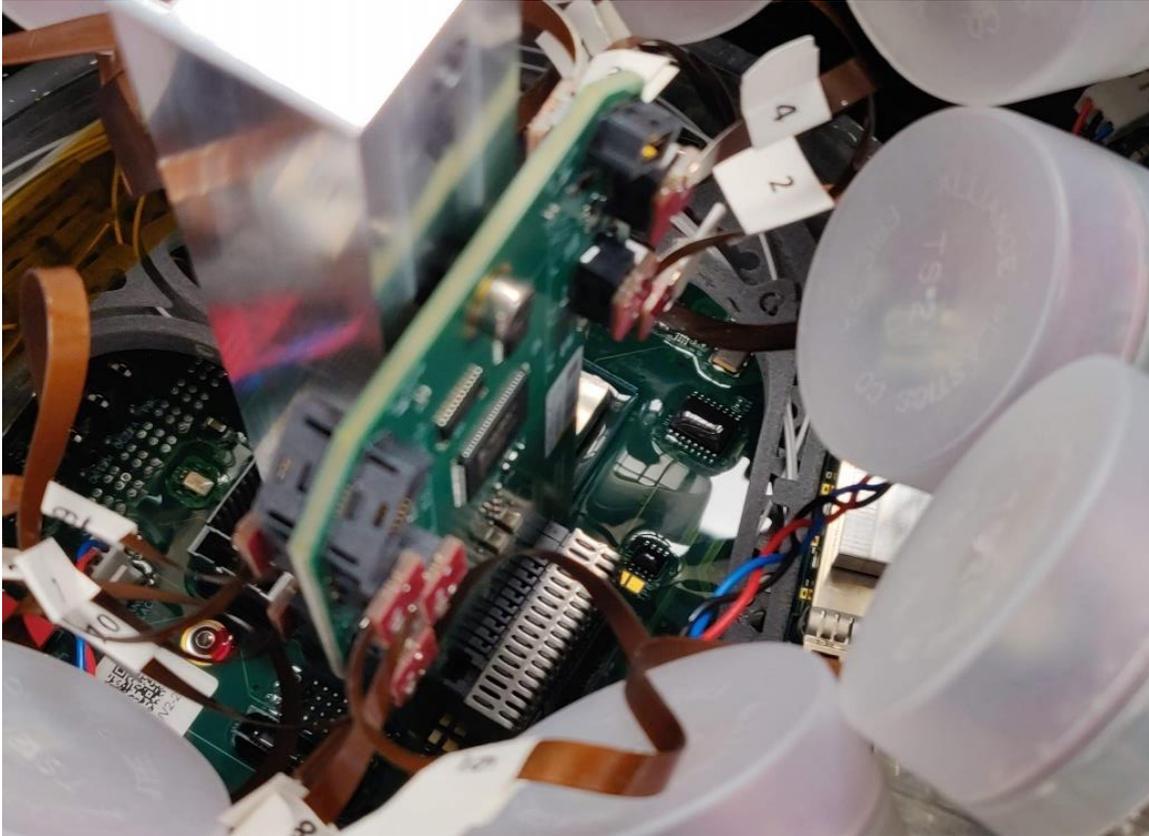
Pouring: Top hemisphere overflowed, several leaks:
Seal top structure/mushroom => Mastic
Pressure gauge => Mastic

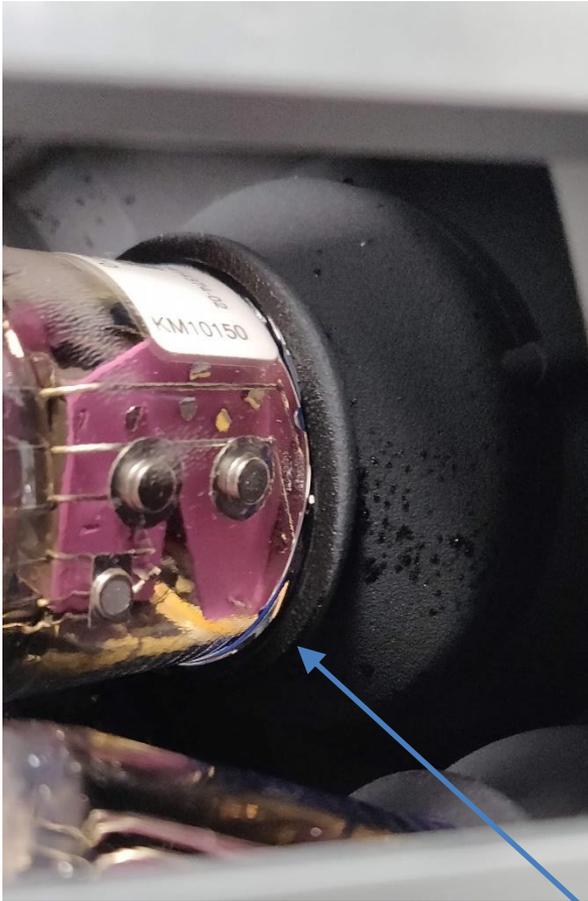
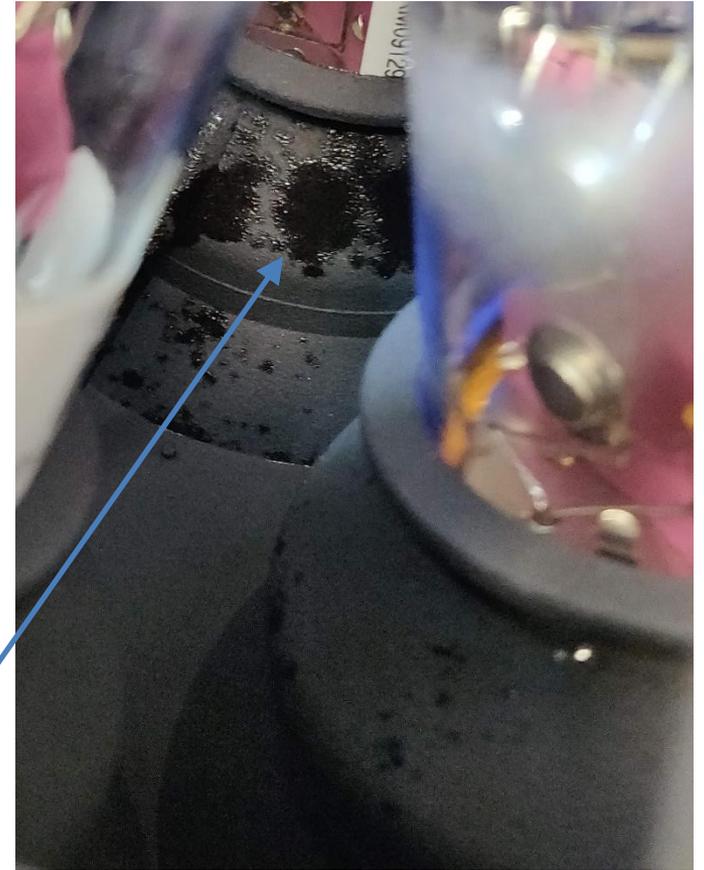
Pouring: Bottom hemisphere overflowed, several leaks:
Some O-ring don't seal their PMTs
Porosity of the structure

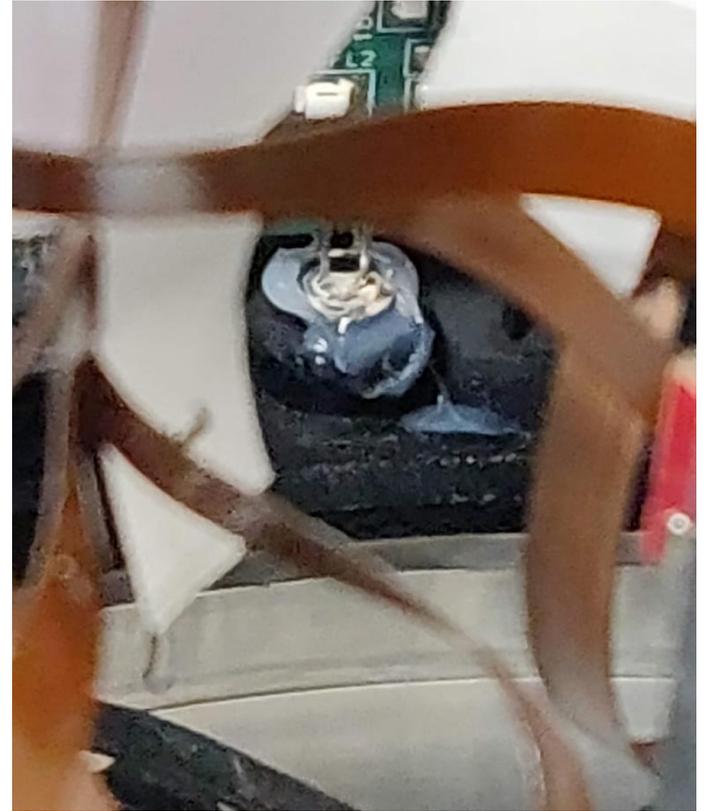
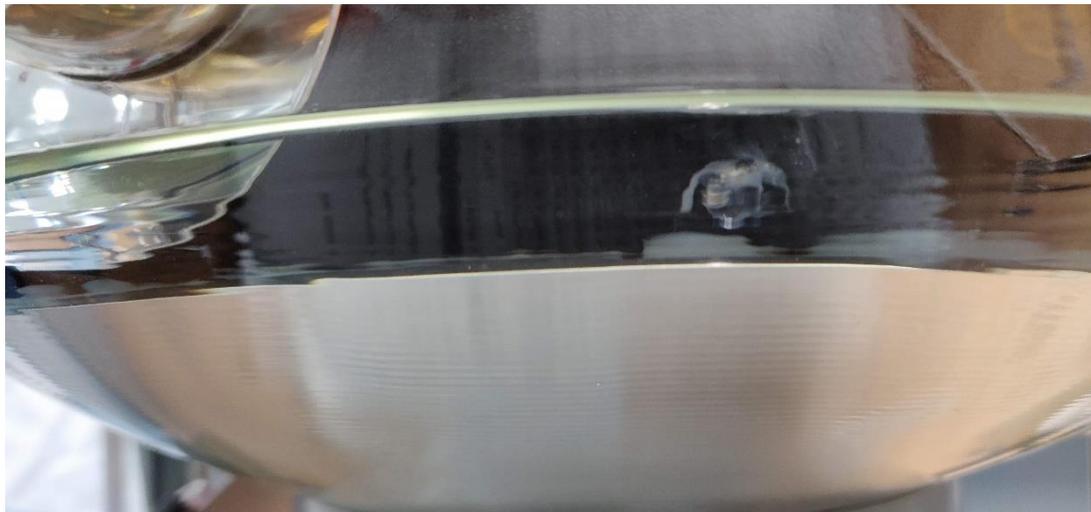
New leak near the nanobeacon, the pouring have been stopped during 4 h and gel pumped with a syringe. Pouring restart in the afternoon.

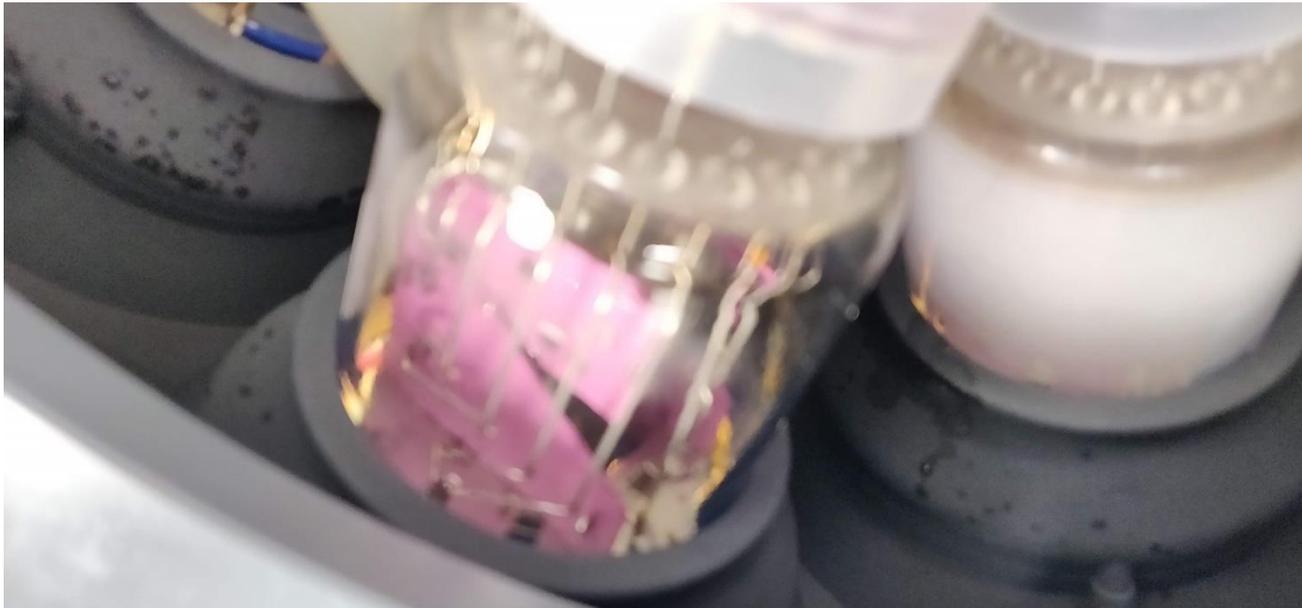
⇒ The structures are porous, a lot of points around the PMTs housing.

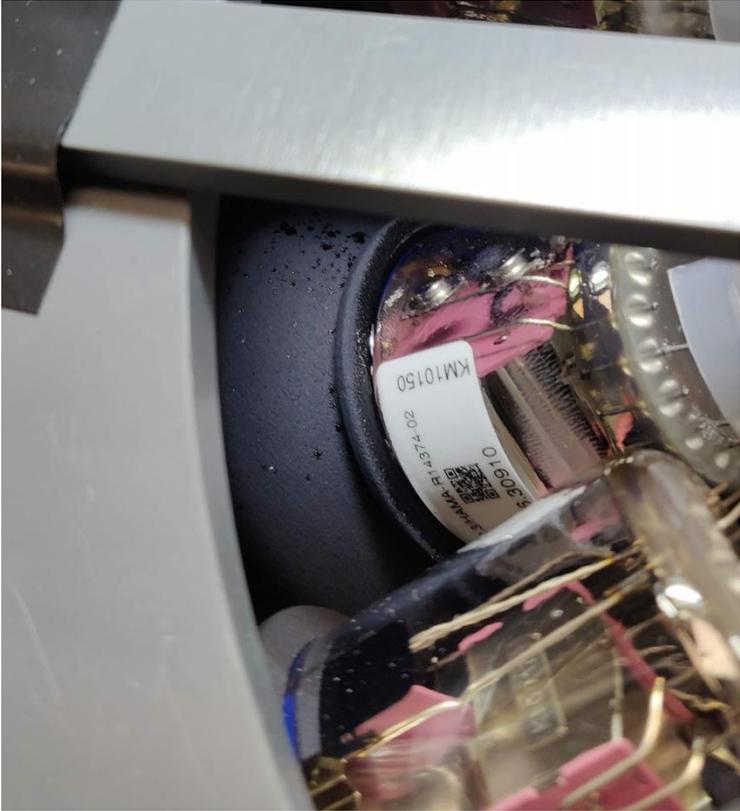
Bottom

⇒ Leaks between the O-ring housing and the O-ring.

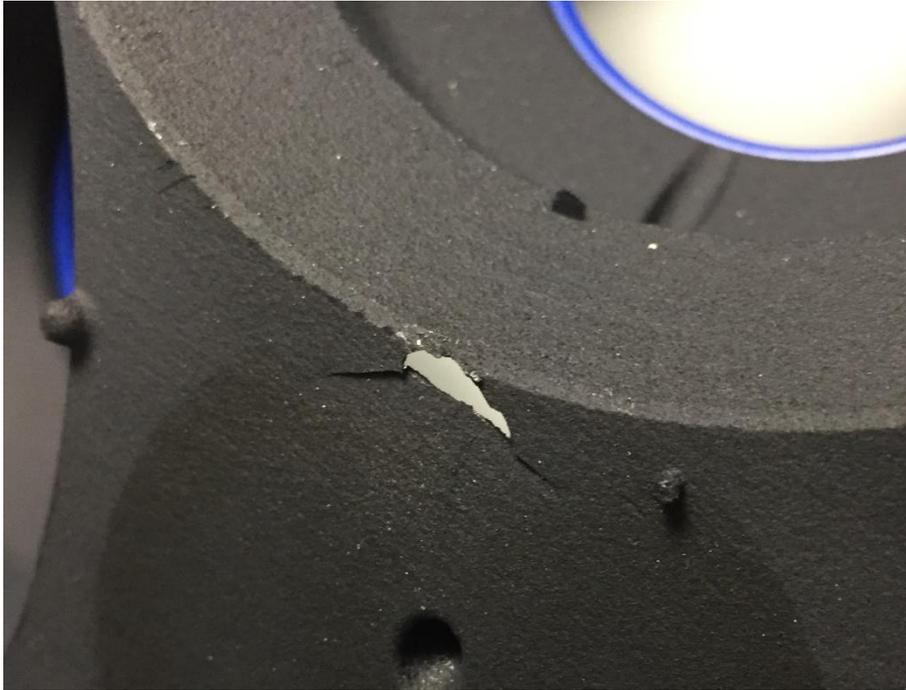
⇒ Support structure broken.

The Hole
Tape on the external side
mastic inside and outside
