Canted-Cosine-Theta (CCT) magnets

Optical examination

Manual polishing of 4 slices from CCT magnet

All original high definition pictures are set out in annexes in **EDMS 2453524**

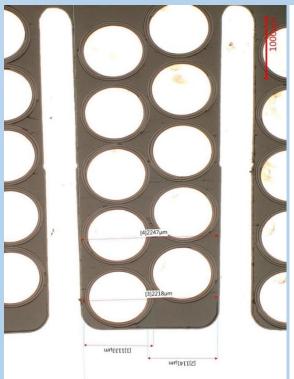
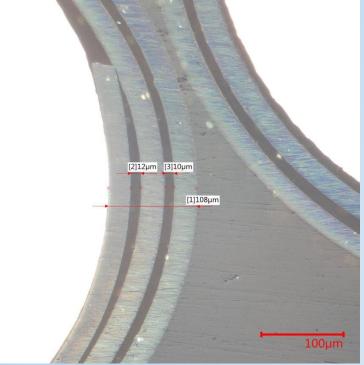
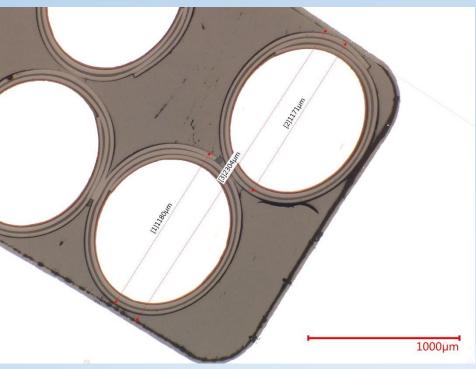
Measurement of throat width

- Throat width = 2218 μ m
- Wire + insulation = 1133 + 1141 = 2274 μm

Designed stacking is not possible due to lack of space!

Systematic stacking position errors are observed at all examined slices. Only rare channels exhibit good alignment.

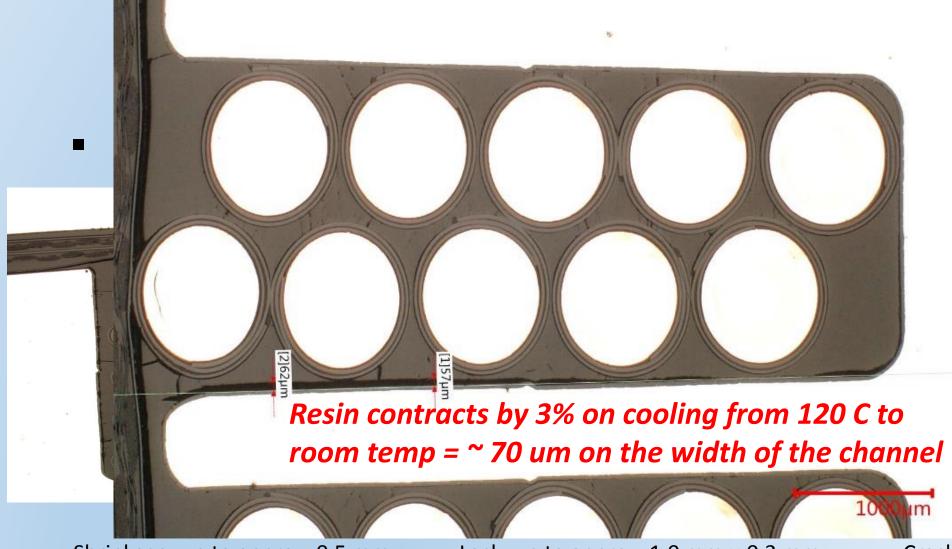
B 8mm sector 3

Shrinkage: up to approx. 0.5 mm

Lack: up to approx. $1.0 \text{ mm} \times 0.3 \text{ mm}$

Cracks: total length up to approx.

0.5 mm

Only few examples of worst/largest resin imperfections are illustrated here. The latter are commonly observed at all prepared slices (see stitched pictures in annexes)

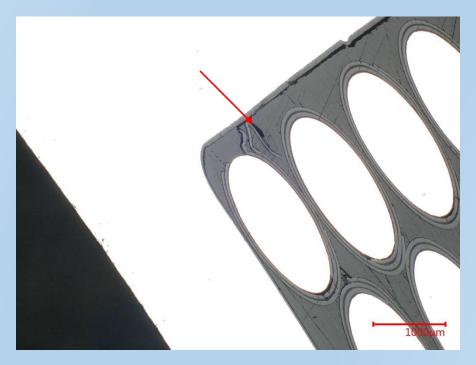
A 10mm sector 2

Damaged wire insulation / lack induced by insulation glue

To the extent of present examinations, the only case that has been observed

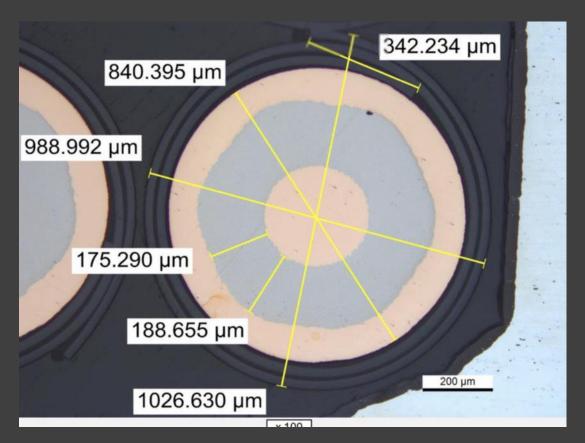
This cut is at 90 deg

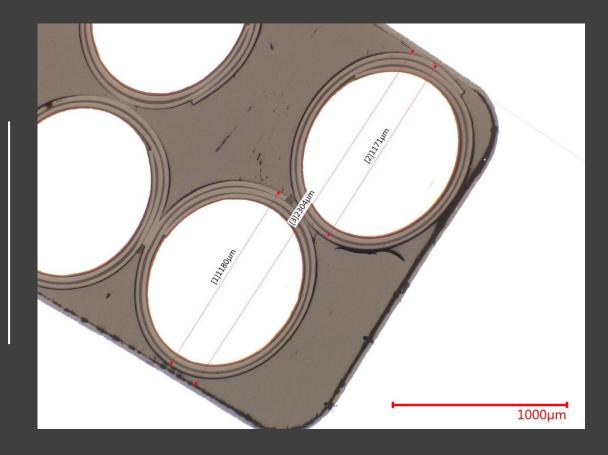
The cut is not at 90 deg so gives false value'
