ECAP: DOM integration status

Oleg Kalekin
KM3NeT DOM integration
Videoconference
09.12.2020

Old ORCA DU1 DOMs refurbishment

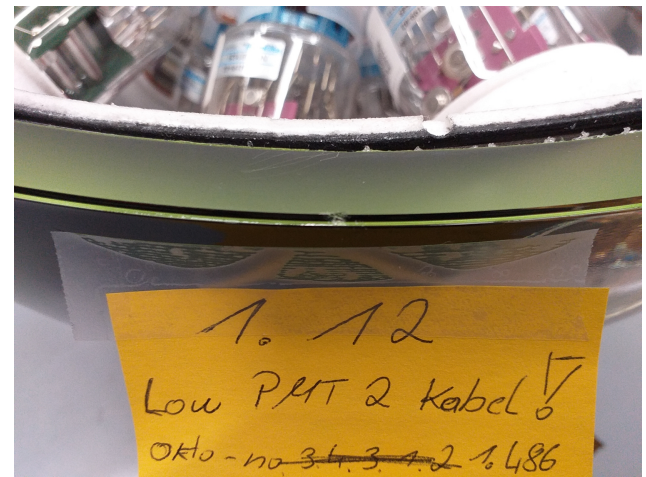
Found problems:

- All DOMs with AHRS firmware version 0.0
- 1 DOM had broken connector at the large octopus board. The board is exchanged
- 1 DOM with 6 channels with mixed up PMT SNs in the database
- 1 DOM - 3 PMTs plugged in wrong connectors, re-plugged
- 1 DOM with 1 channel with wrong PMT SN
- 2 DOMs with Promis ID flipping bit in 1 channel
- 1 DOM with collar made of steel, exchanged
- 2 DOMs with missing screw and screw/O-ring in vacuum valves
- 1 DOM with small damages on glass hemispheres
- 1 DOM with abrupted PMT cable
- Most pressure gauges show 0

NCRs have been opened for each problem
except pressure gauges
