Catania DOM integration site activities

9 12 2020 DOM Integration meeting

Emanuele Leonora

INFN, sezione di Catania

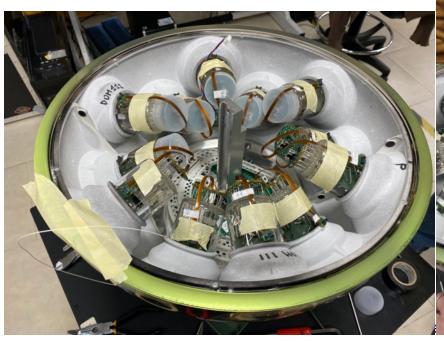
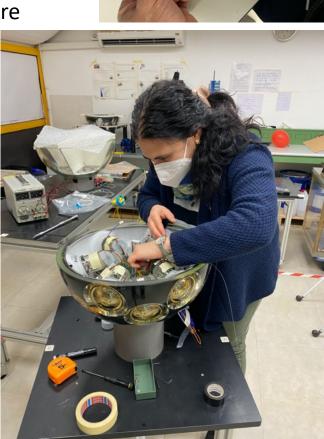
On-going activities: replacement of the penetrator type P on DOM 4.111

- Required maximum care
- Long and flexable tools to operate with PMTs mounted on TOP
- Safe and stable positions for inner cable before actions
- Main difficult with optical fiber treatment
- Thanks to Giusi La Rosa (LNS) for supporting the action on fibers
- Functional test was good, and we are going ahead with closure
- Shipment to DU integration foreseen for this Friday
