P-ONE Virtual Meeting

STRAW-b status update

STRAW-b – 2nd P-ONE pathfinder

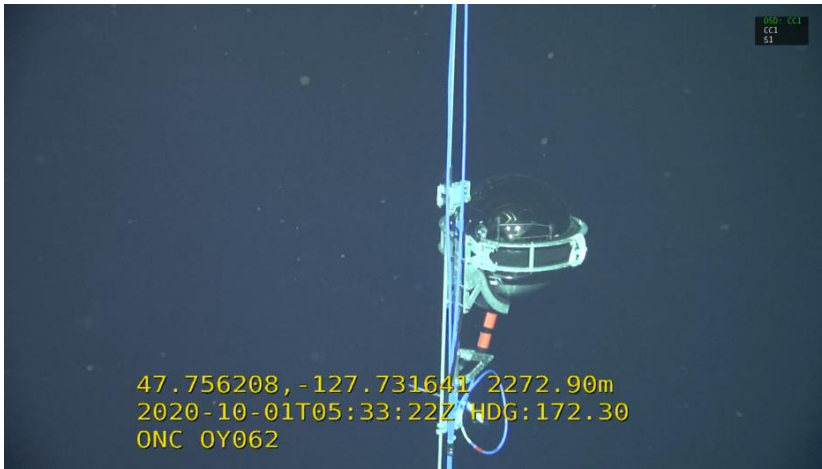
Standard module 3

Overcurrent

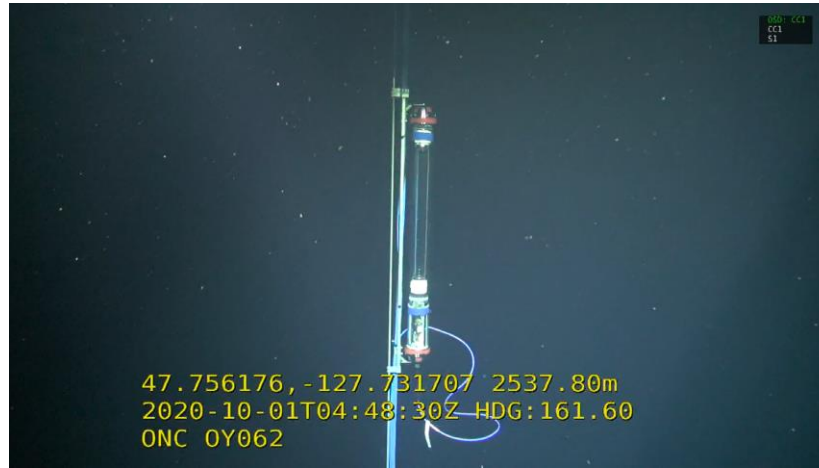
WOM

No communication
(since power outage)

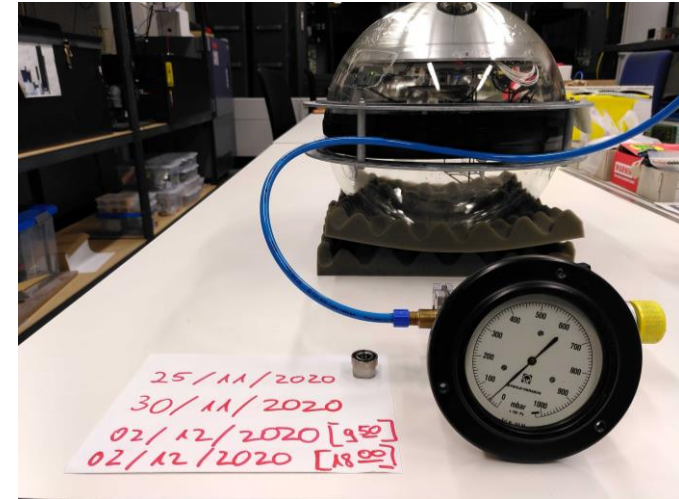
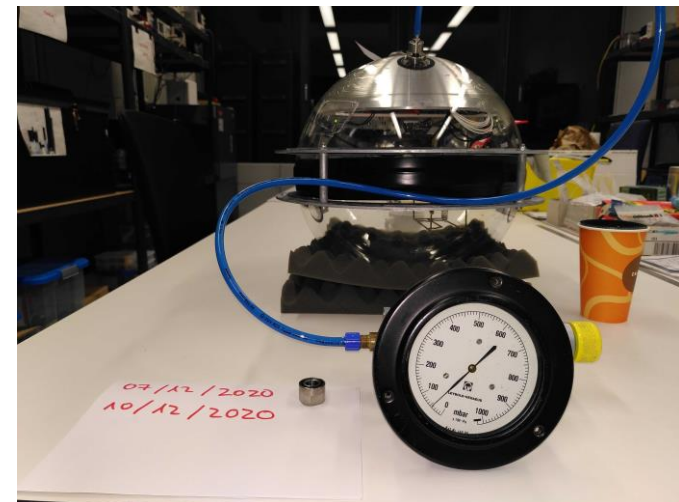
- Long term test shows no leak
- Failure origins most probably from penetrator
 - Vacuum port cannot be excluded – but tight if cap is closed correctly (must have happened several times)
 - Teroson can be excluded as fault location
 - Also loose contact of penetrator adapter as fault possible
- Long term monitoring with removed sealing compound
- Additional leakage search with coloured water (tank test)

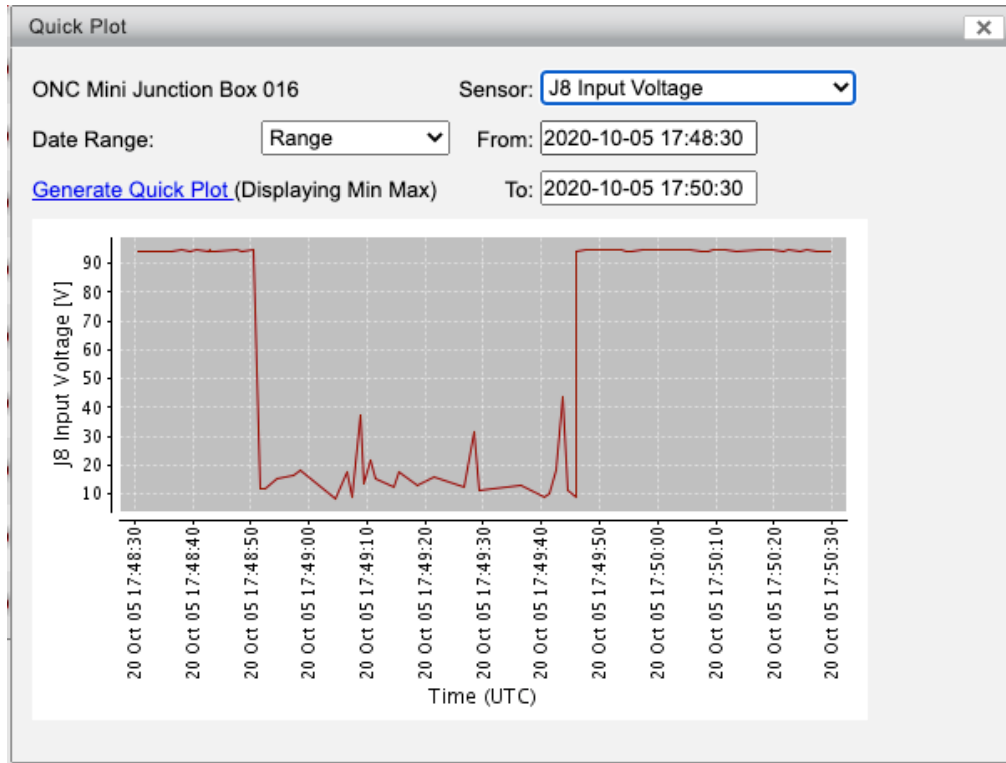
- Voltage drop to 10-20V (peaking at 40V)

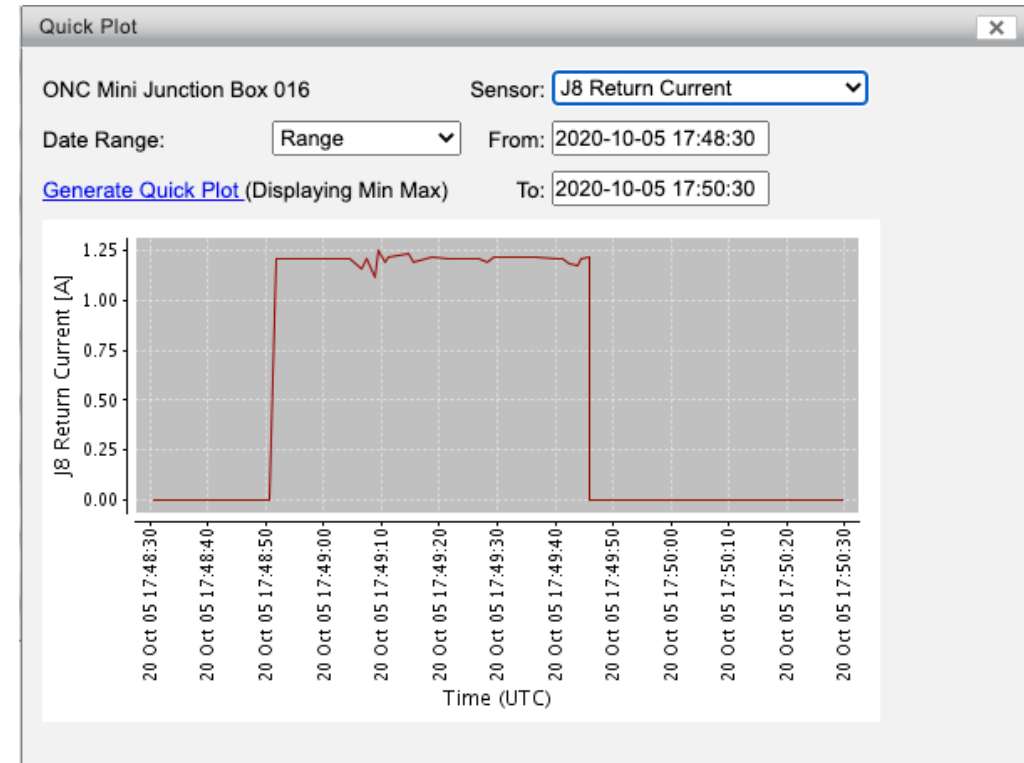
- Current peaks at 1.25A

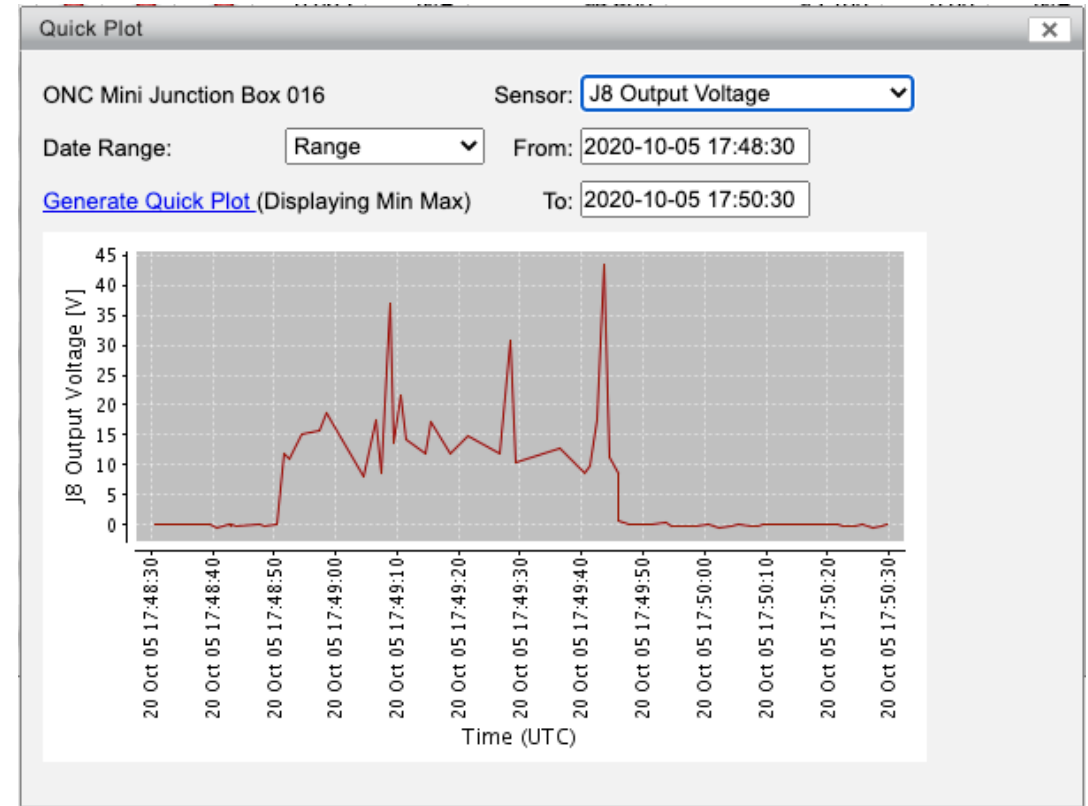
SM3 – possible fault location

- Voltage drops to 12.5 to 15V (fluctuating)
- Current rises to 1.25A
- Corresponds to a resistance of around 10-12 Ohm
 - VEOC at the SM3 has a length of 384m (with 39.3 Ohm one way)
 - Short at the SM3 is unlikely (voltage would be around 96V)
 - Low resistance indicates that the failure originates from the connector at the MJB
 - Probably caused by water in the connector – could explain voltage fluctuation due to changing resistance
