# DC status update

Vincent Andrieux

Technical Board Meeting  
July 13<sup>th</sup>

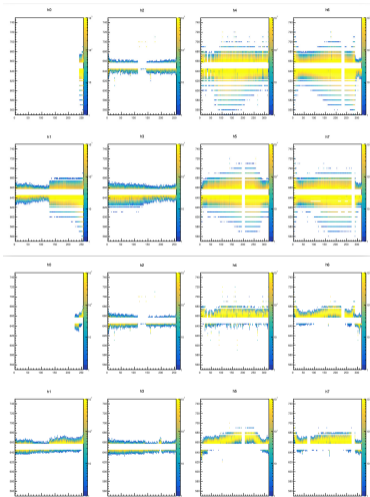
- High noise: Threshold  $\gtrsim 40$  fC necessary to keep rate  $\leq 30$  kHz (top)
- Difficult to diagnose as the baselines moves also with noise level
- Understanding of grounding scheme under study:
  - Digital
  - Power
  - Analog
  - Shielding
- Observation of fluctuating 60mV between FEM ground and Chamber ground

→ Improved grounding of FEM digital part through RJ45 cage (bottom)

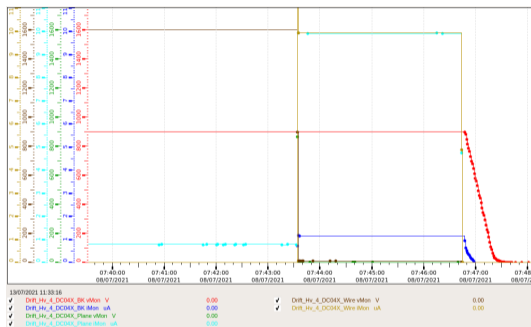
- Sudden raised of current in FW and Cathode:  $10\mu A \rightarrow 3\text{min}$  before it trips

Note: HV mapping mistake, X and Y are swapped

- Not possible to raise the HV
- Measurement with Shuddha:
  - $1\Omega$  to ground for Y' cathode and YY' cathode
  - Beyond accuracy of the device for BKs
  - Beyond accuracy of the device for FWs !?

Next: Localise the potential broken wire (most likely on top)

Isolate the region and check whether HV cannot be operated with partial RO

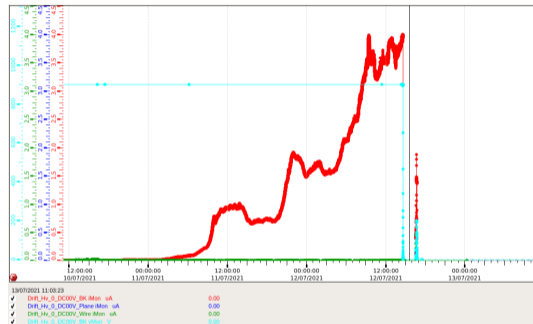
- HV mapping to be checked?
- Current growing on DC00V since 11/07/2021
- Reaching trip limit yesterday
- From CAEN, the leak current correspond to  $\sim 10 \text{ M}\Omega$   
Dust in the chamber? Can it be burned? To be investigated by detector expert
