COMPASS TB: W45 has purity

Carlos Azevedo
(cdazevedo@ua.pt)

28th September 2021

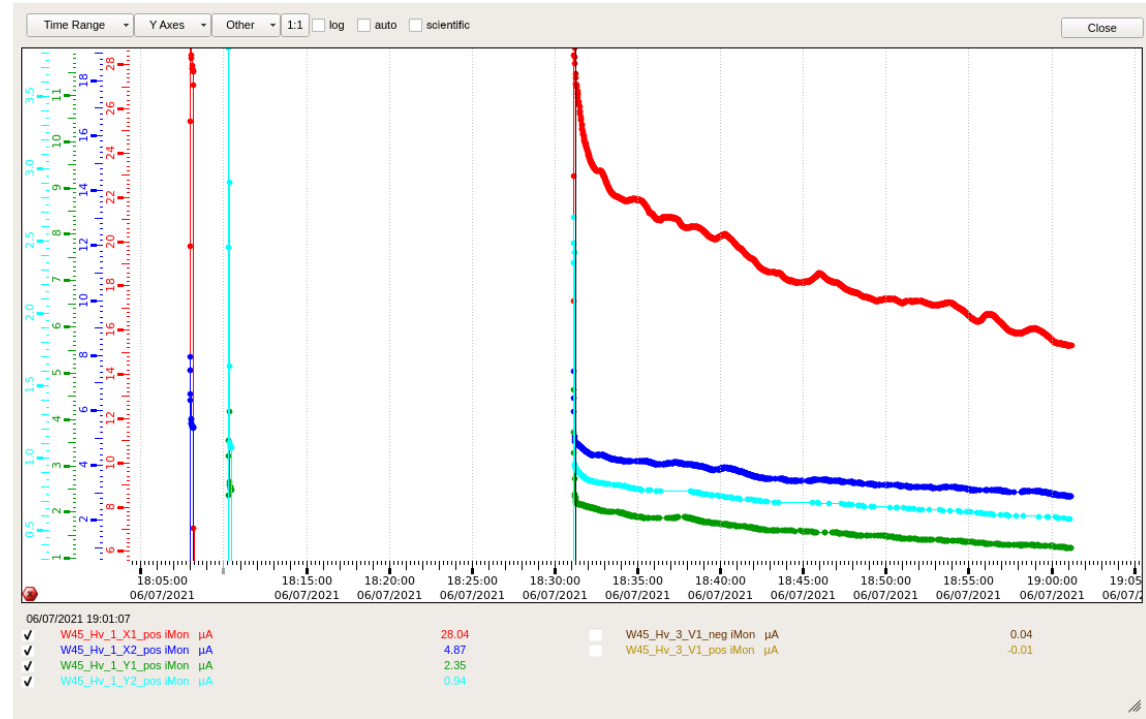
- Problem when rumping-up the voltages for the first time
 - More than a week to ramp-up
 - 50 μA limitation
 - Slow decrease with time
 - Not all channels are problematic

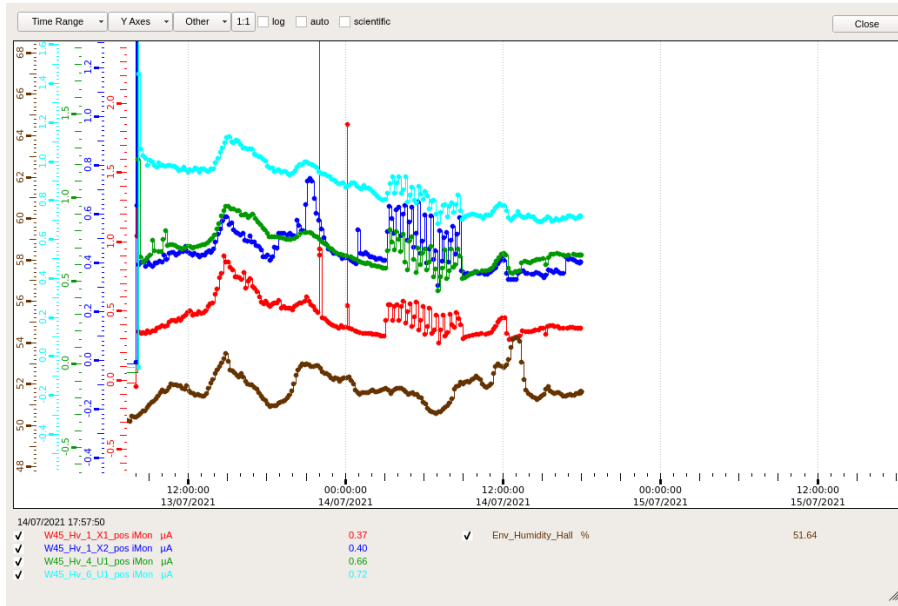
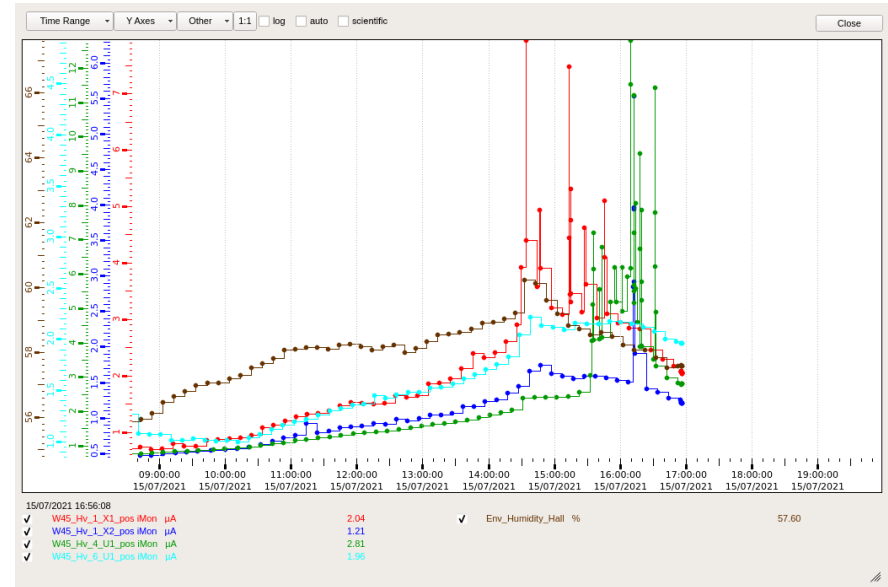
- Correlation with humidity found

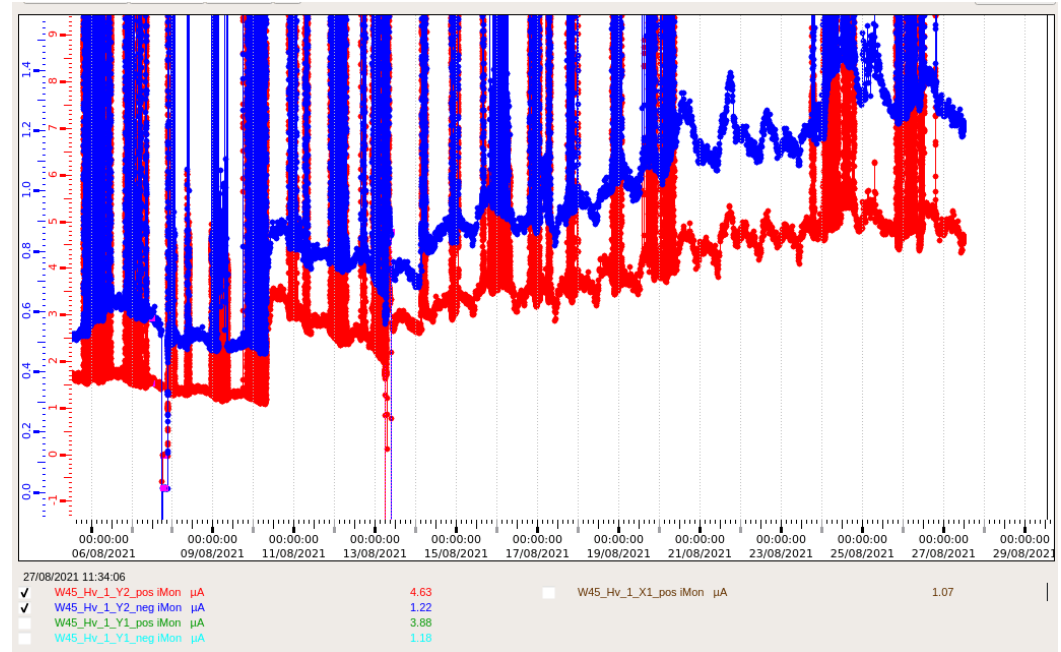
- August 2021
- Huge O2 contamination found in DW04 and DW05
- No correlation with humidity

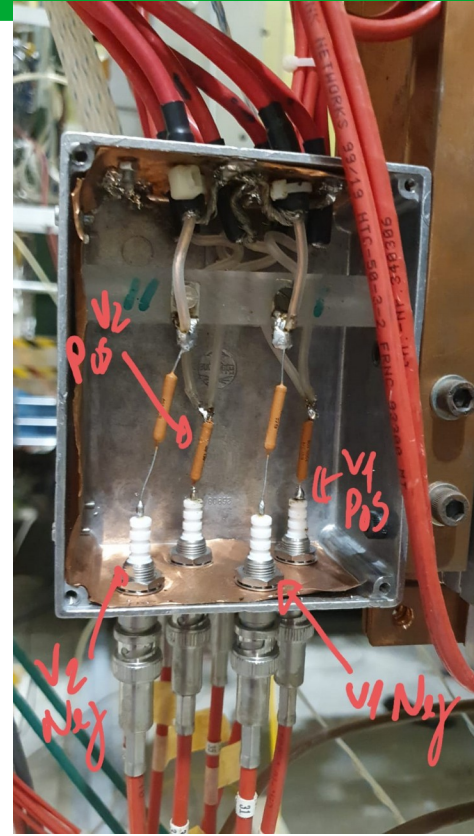
- Possible wire short-circuit
 - But can also be outside
 - Not possible to investigate in due time
 - Need to open the HV distribution...
 - No idea how it is done. No documentation.
 - HV channels and cool channels swapped (V1-V2)
 - In worst scenario chamber as to be opened
