# COMPASS Silicon Status and Planning 2021/2022

COMPASS/AMBER Joint Technical Board Meeting

November 16<sup>th</sup> 2021

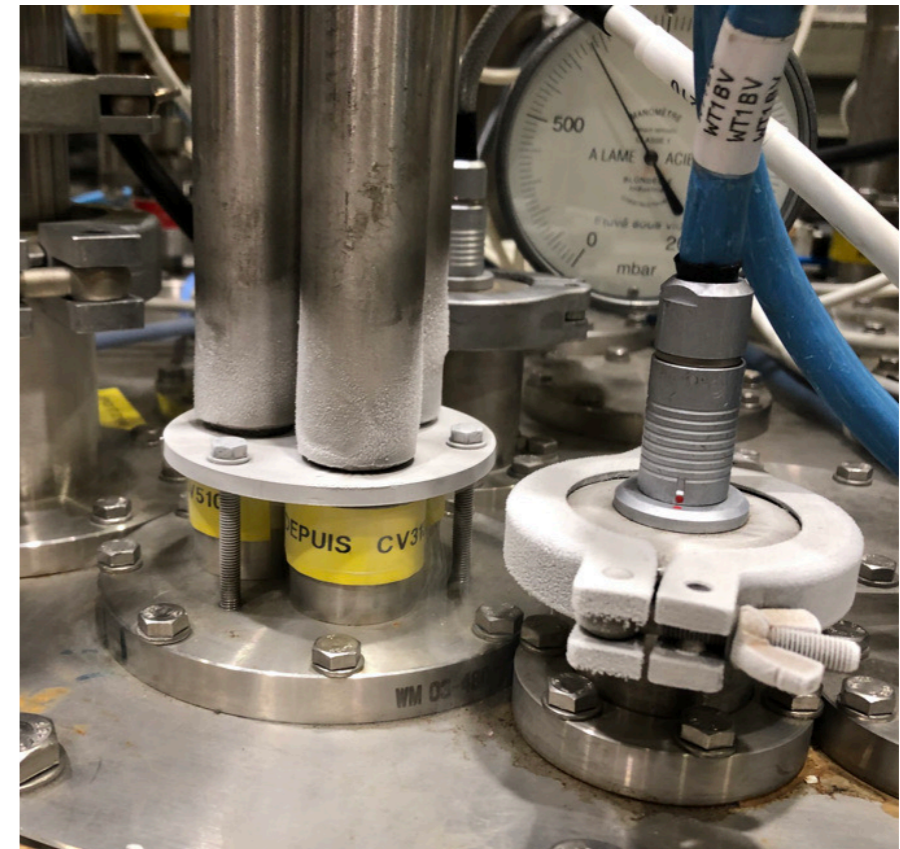
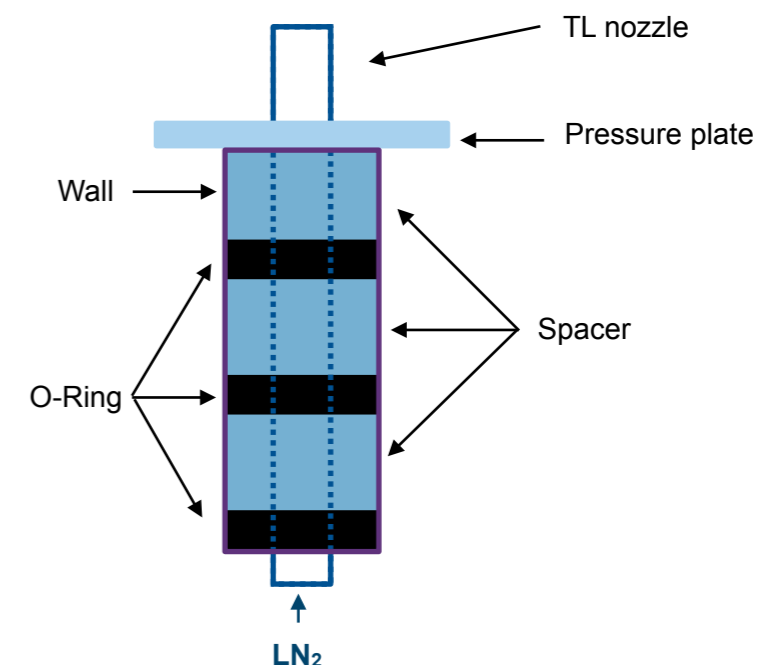
- Full test of the system
- First test of cooling system after refurbishment - some issues fixed:
  - Open/Closed valve status of inlet valves (“normally open”)
  - Heater for LN<sub>2</sub> reservoir not connected
  - Sealing for one station transfer line missing - LN<sub>2</sub> leak
- High voltage trips for SI02U - probably shortcut if repeater card is fixed with screws
- Incident: station windows blown up
  - All tested - all tight and stable after repair

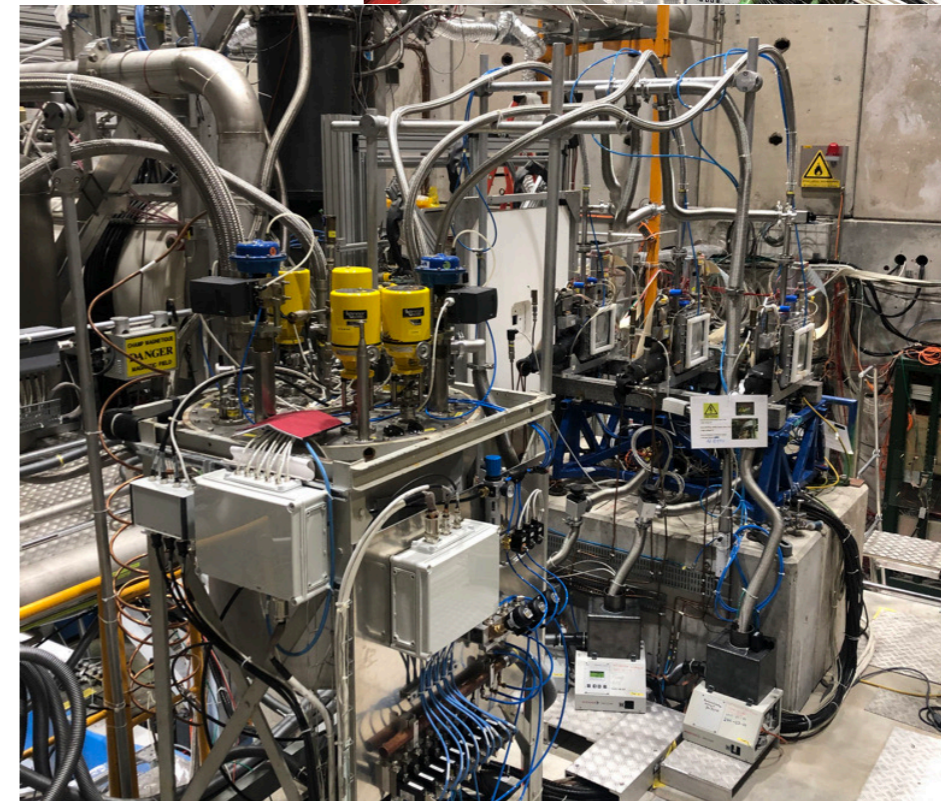
17.08. - beam position

- New: Pumping B-shielding for target magnet
  - Blowers and temperature read out
- Survey on 13.08. - complete installation 17.08.
- Issues during the run:
  - LV supply of ADCs problematic (Deutronix):  
Igor: Improvement during winter break possible
  - Lab power supplies as fall-back for 1x ADC LV
  - LN<sub>2</sub> supply problematic during co-operation of He-Liquifier: Inlet pressure not sufficient:  
Maybe this could be improved?
- All equipment stored in Clean Area and barracks

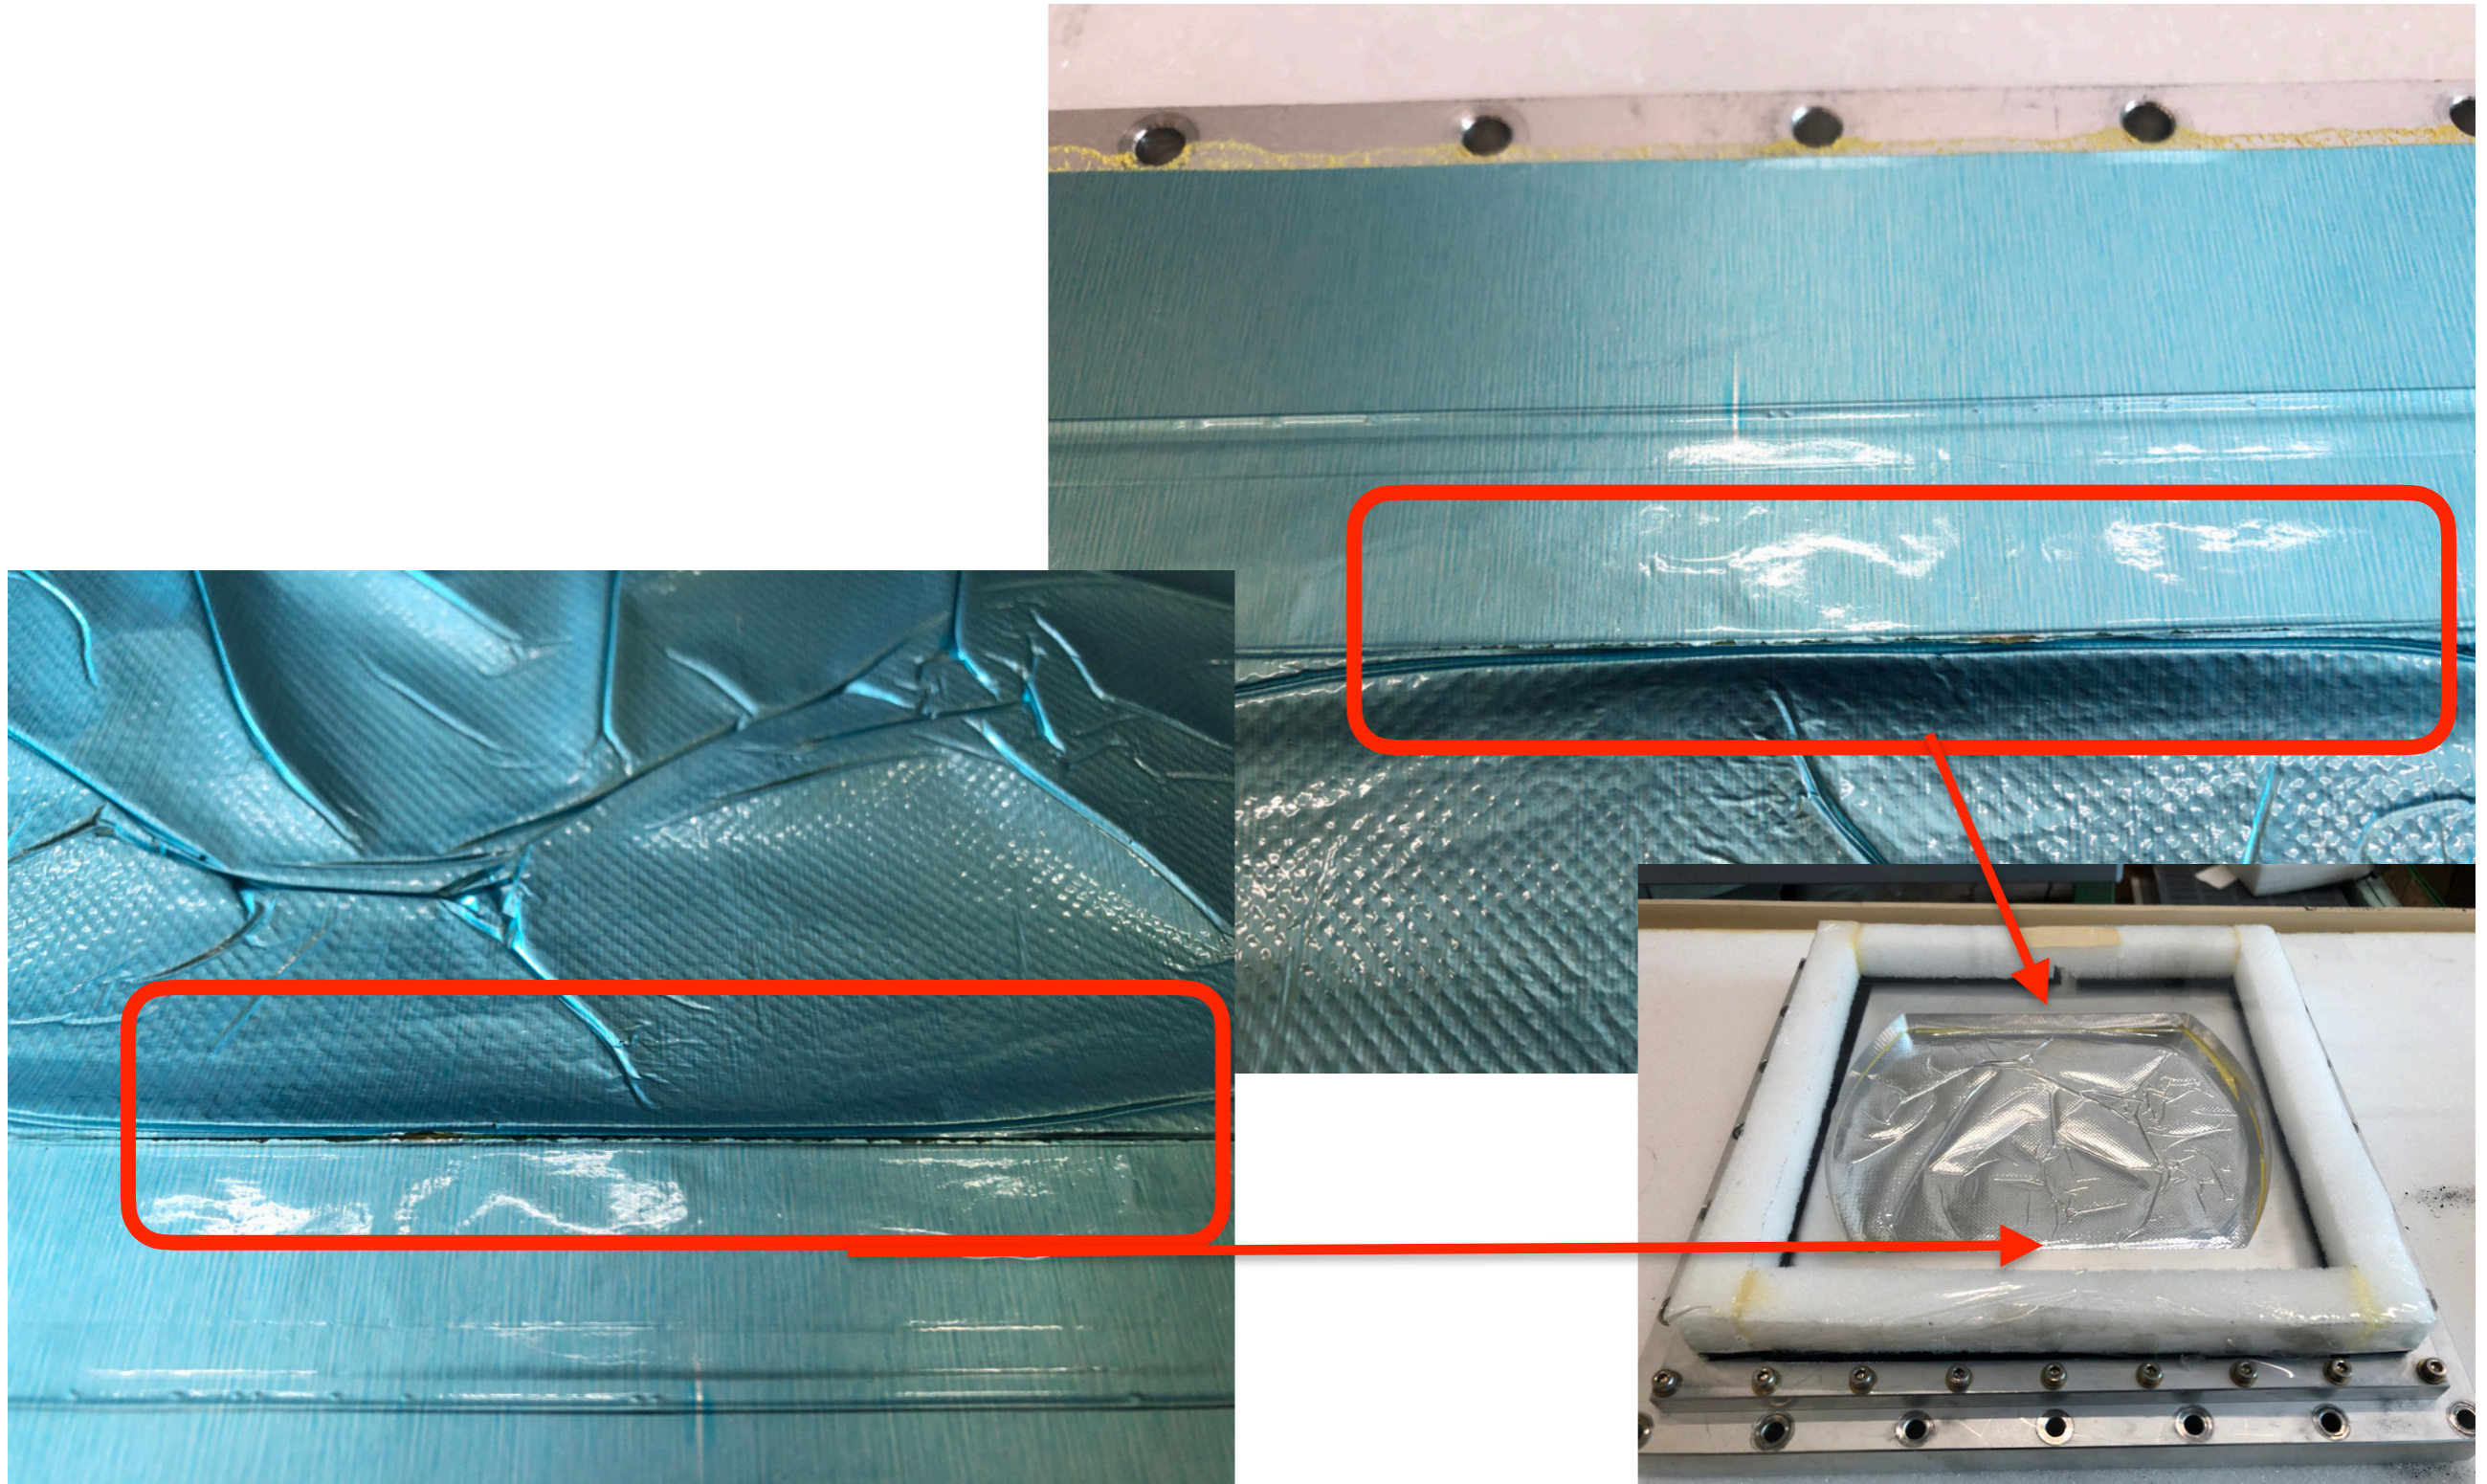
# Overpressure on Station Windows - Fix of SI01 Downstream

Detector	Value (E-4 mBar)	Value before (E-4 mBar)	Comment
SI01 Upstream	6.2	4.4	OK
SI01 Downstream	6.2	4.4	Fixed - OK
SI02 Upstream	4.5	3.8	OK
SI02 Downstream	1.1	1.2	OK

- All stations are fine from the vacuum side
- Open questions: Influence due to wrinkles on windows - stability? beam?
