# DC5 repair plans

## COMPASS Technical Board Meeting 2021-11-16

Caroline Riedl (UIUC)

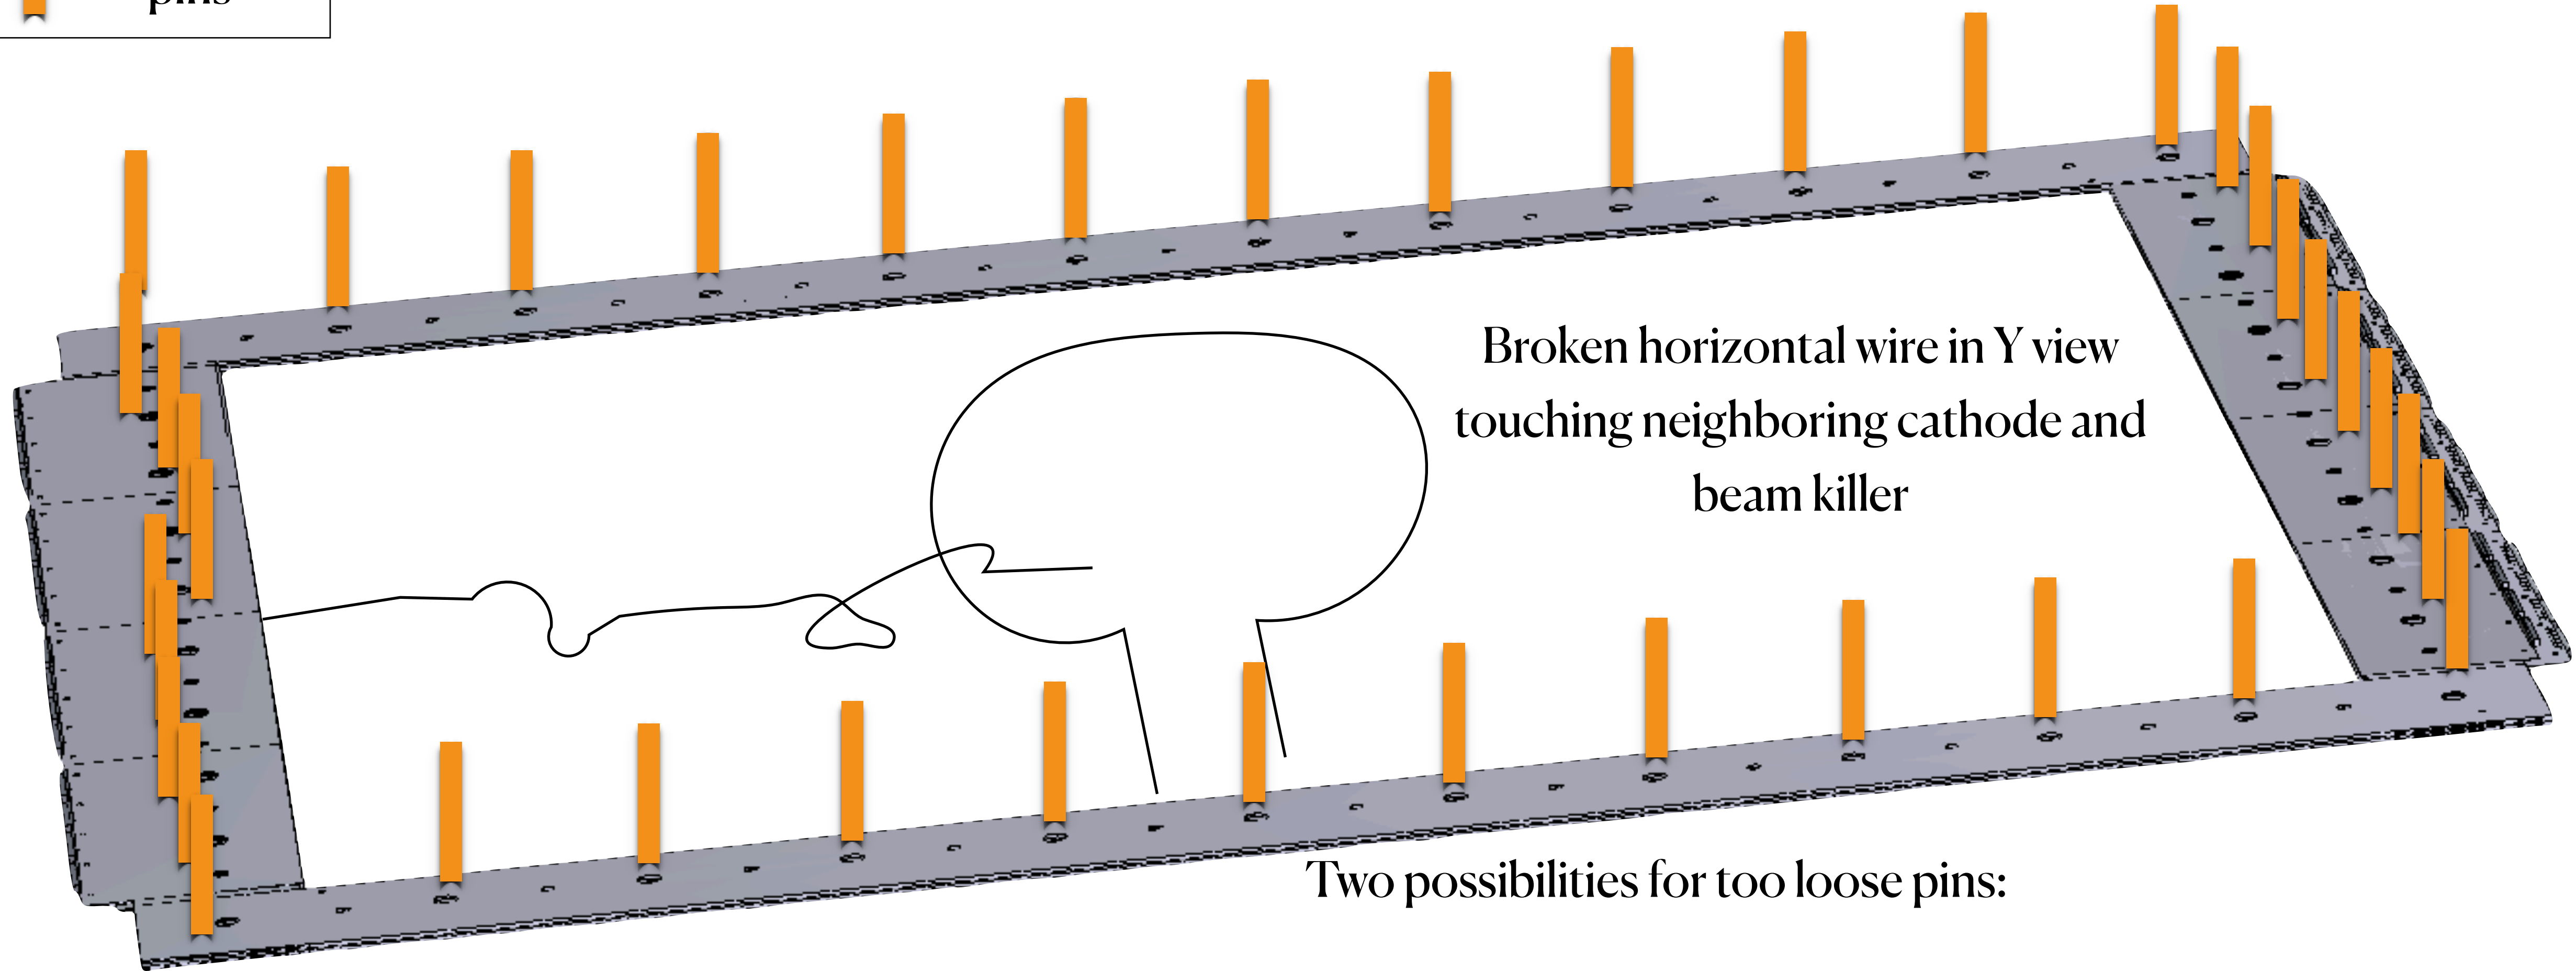
Broken horizontal wire in Y view touching neighboring cathode and beam killer

Two possibilities for too loose pins:

- Corner assembly pins are very tight
- Some (5-6) pins towards the center of G10 strips are very loose (they fall right through)
- G10 frames worn out → insert pins of slightly larger diameter
- Pins worn out → insert new pins of nominal design

- First repair the broken wire
- Then replace too loose pins...
- One at a time, while nearby pins are fully engaged
  - ... with knurled pins (if holes got wider), or
  - ... with new nominal-design pins (if old pins show wear)
- Decide on case-by-case basis.
  - 5-6 are really bad.
  - Corners are probably fine.
- If needed, knurl more at CERN using knurling tools (?) in COMPASS workshop (French knurl = moleter?)

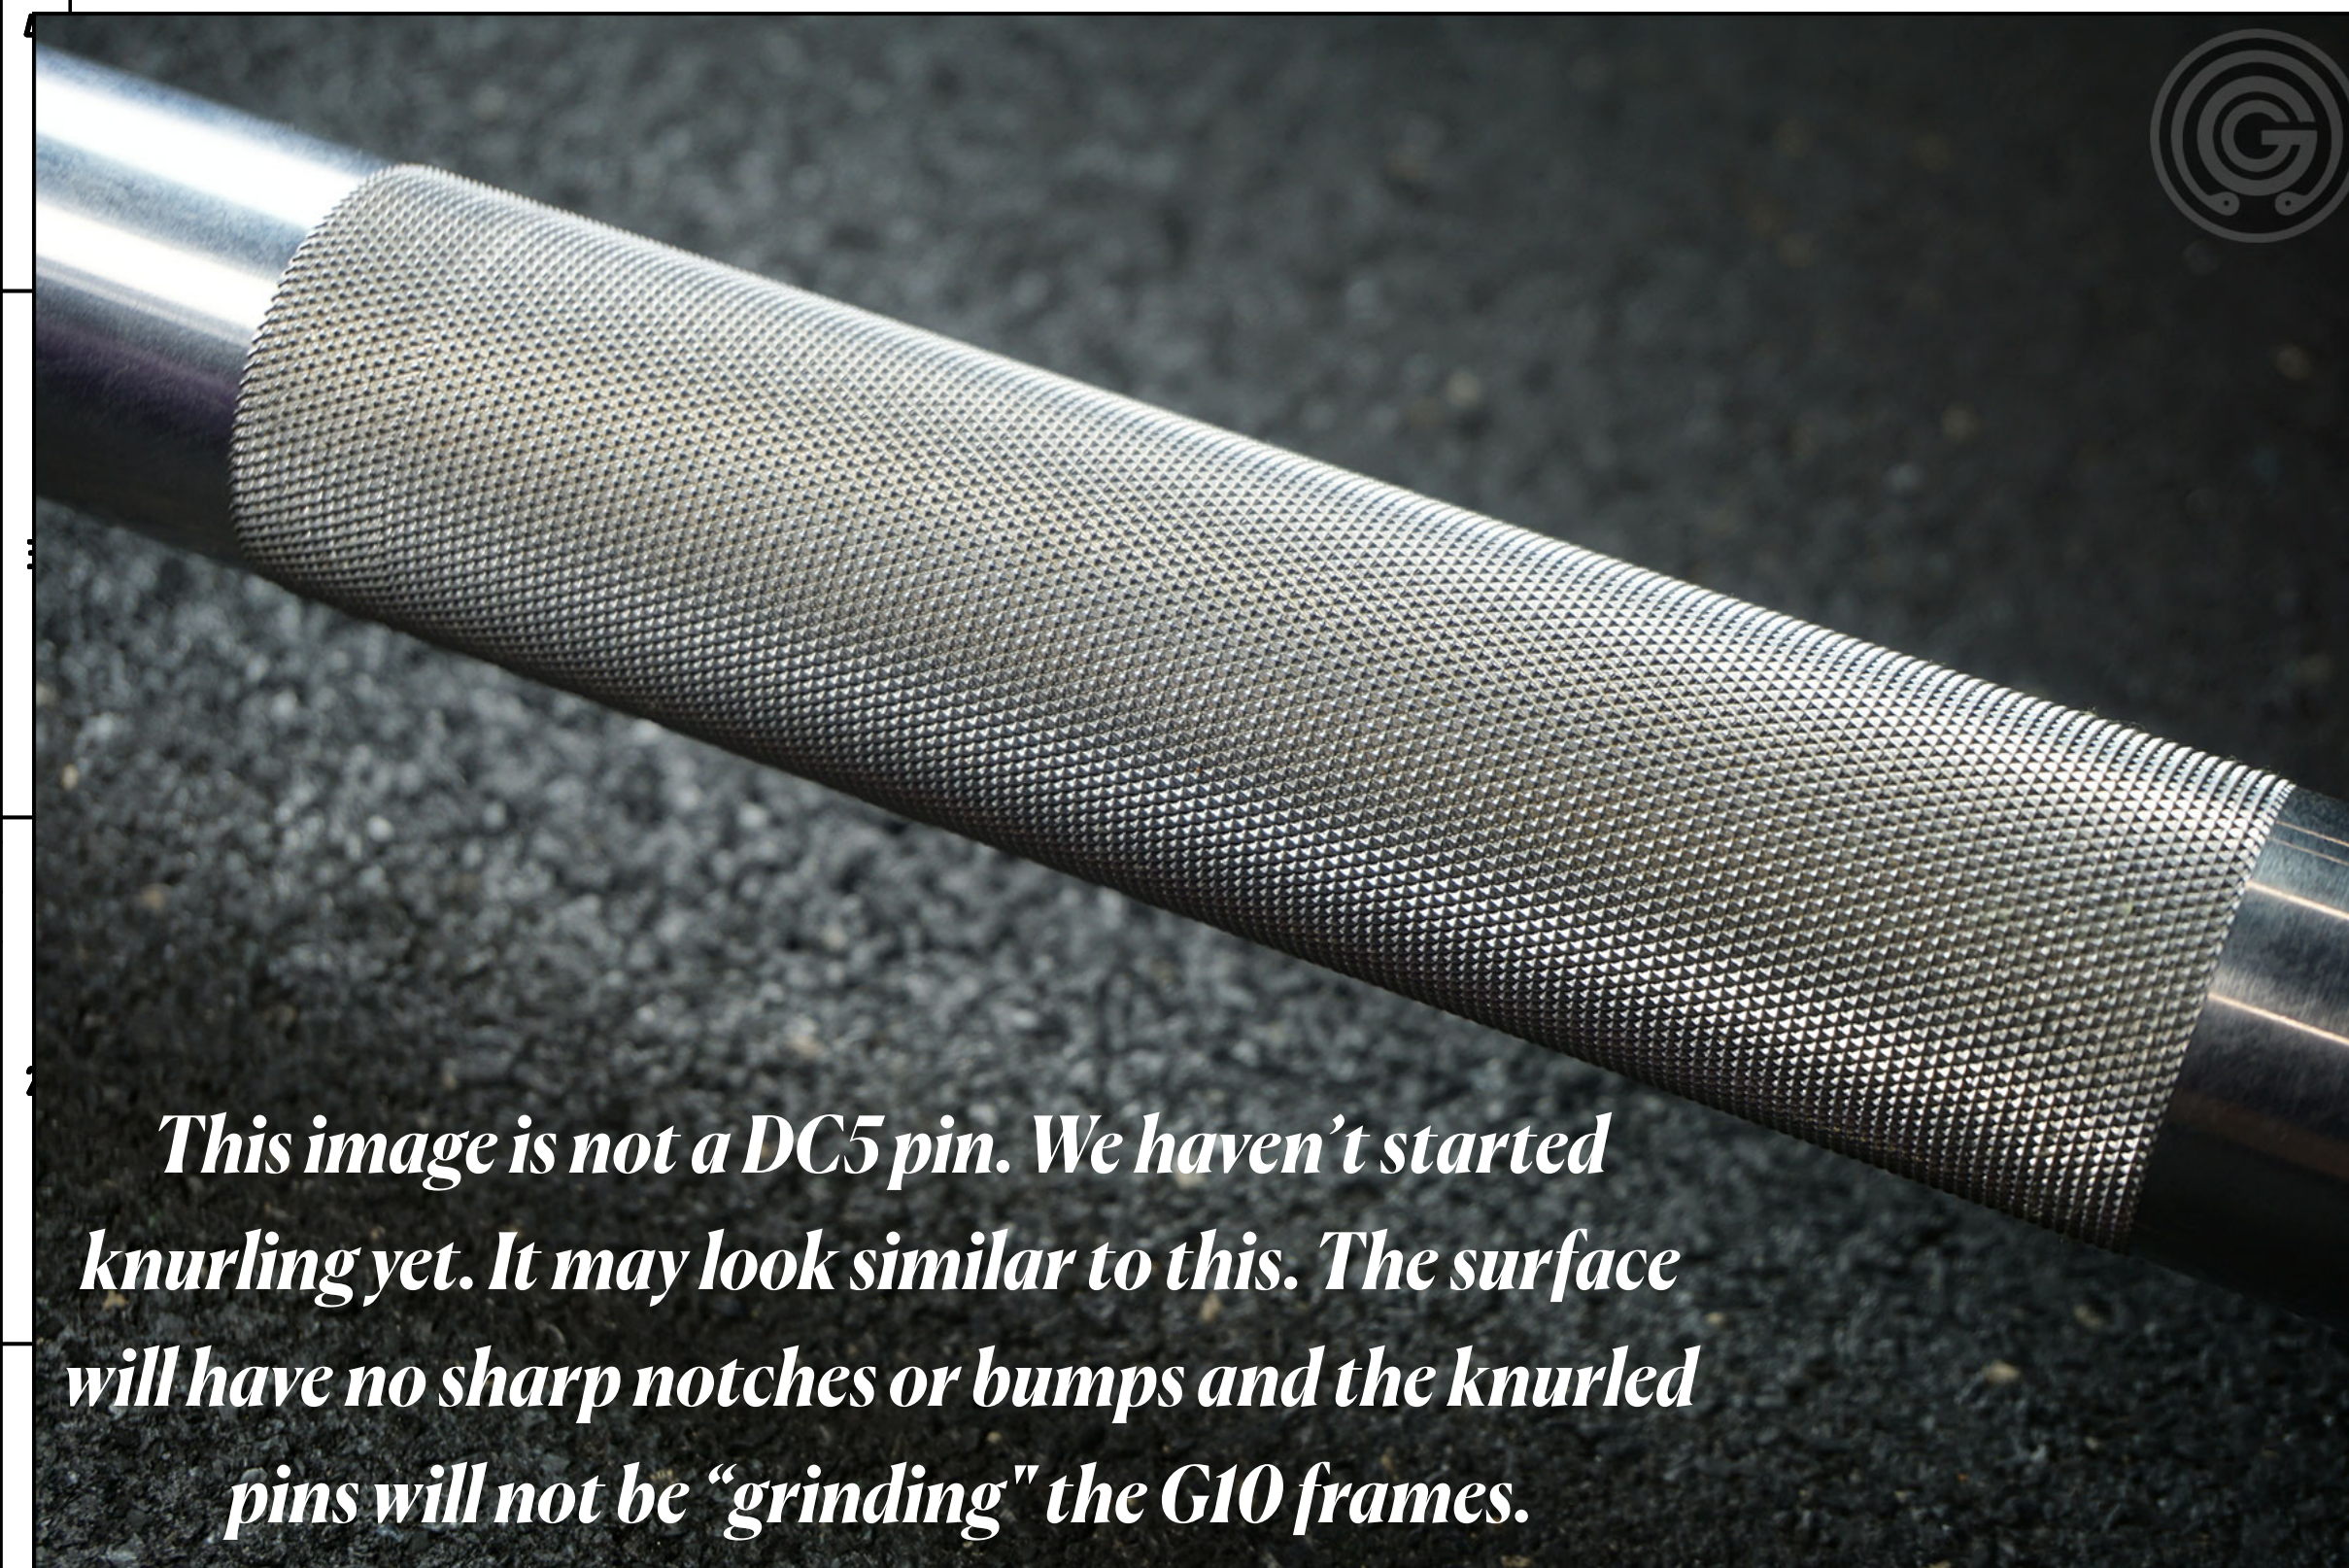
*This image is not a DC5 pin. We haven't started knurling yet. It may look similar to this. The surface will have no sharp notches or bumps and the knurled pins will not be "grinding" the G10 frames.*

**Knurling** is a finishing process in metalworking where grooves or patterns are formed on the surface of a finished part. This process displaces the material and *increases the diameter* of the workpiece.
