LNE50 SUPPORT COLUMN UPDATE

Antti Kolehmainen

2021-11-18

INSTALLATION CLASH

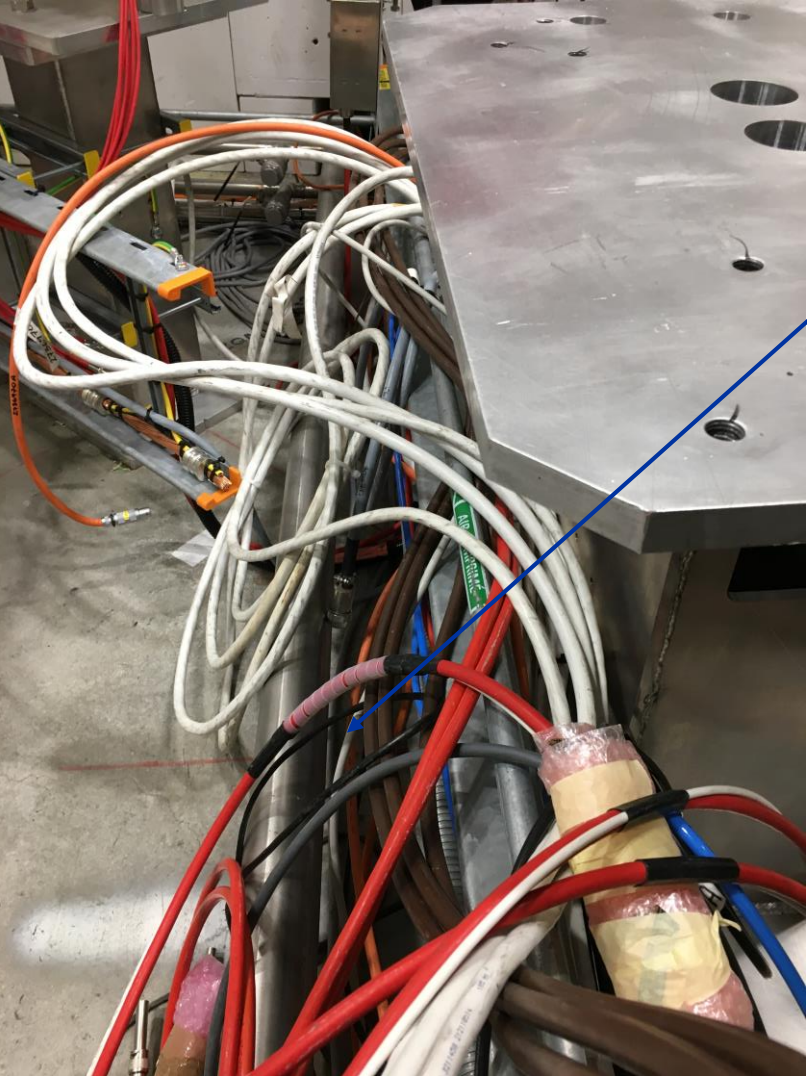
Column left approx. 155 mm away from its installation position due to the cable tray and compressed air line

1. Relocate cable tray and relocate and modify the compressed air line
 - EN/EL & EN/CV

2. Modify the support column
 - EN/MME & EN/ACE
