# Quality assurance of TOTEM T2 GEM detectors

Timo Hildén

Helsinki Institute of physics

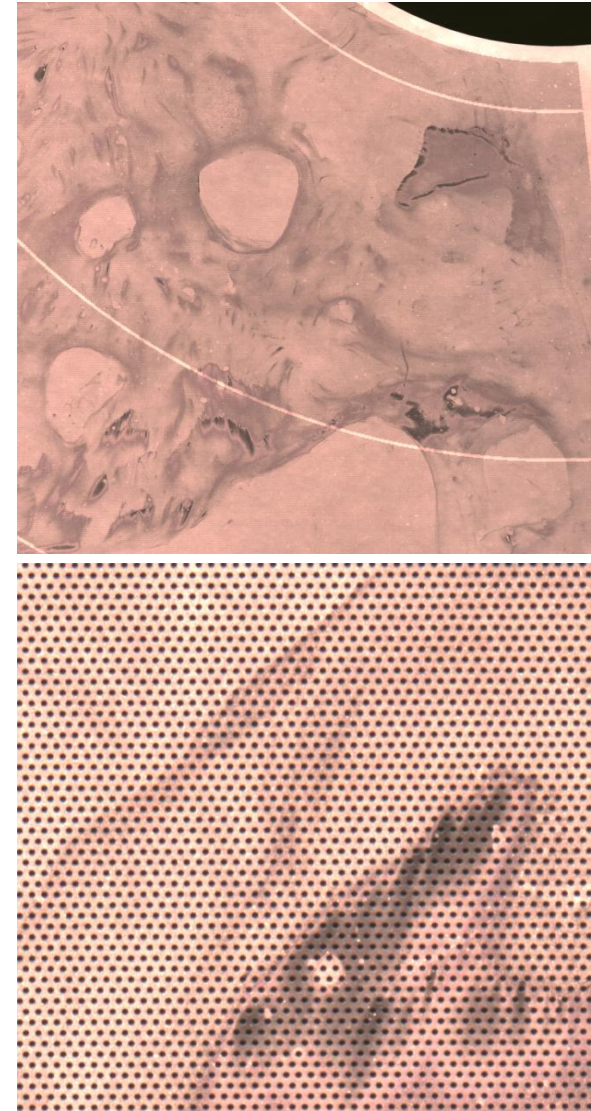
- Few foils had a short circuit
- Some were found dirty and discarded by visual inspection only. These were sent to Cern for cleaning/passivation and recovered.
- Some shorted foils were cured in Helsinki by baking in vacuum oven for several hours.
- 6 foils out of 150 were discarded in total

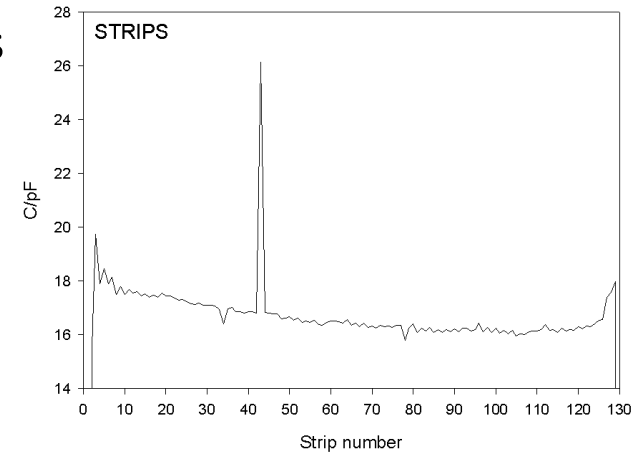
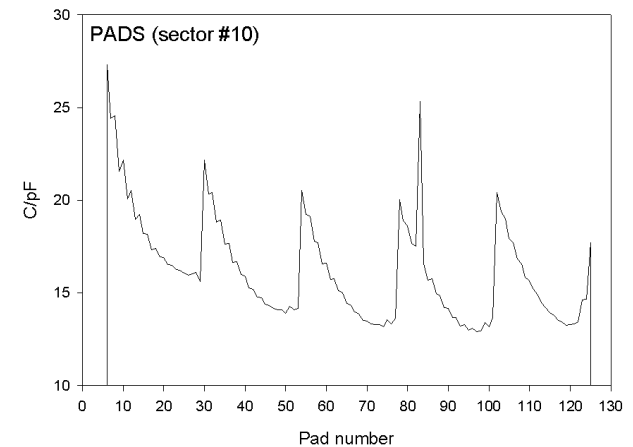
- Readout boards were tested for short circuits and broken strips/vias
- Semi automatic capacitance measurement system with LCR meter and a XYZ-table was developed
- 12 ROBs with 18 short circuits in total were found. 7 were recovered by burning the shorts
- 11 broken strips/vias on 6 ROBs were found
- 7 ROBs had problem with blocked canals for gas.
- Some ROBs had crystallized residue on the electrodes and were sent to be cleaned at Cern
- All ROBs were assembled

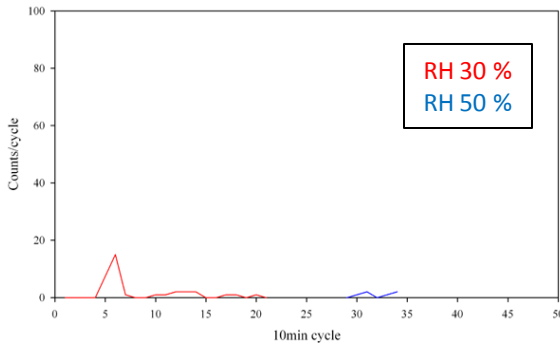
HG39, big pulses at 25°C, 4.5 kV, different humidities

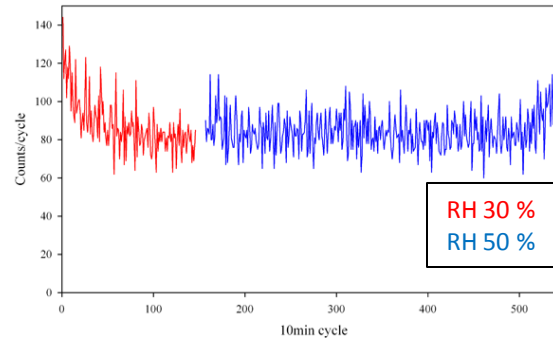
HG26, big pulses at 25°C, 4.5 kV, different humidities

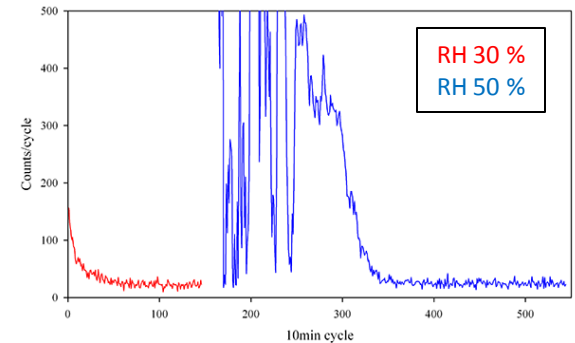
HG26, big pulses at 25°C, 4.5 kV, different humidities

- Problems with HV system in humid conditions
- A layer of Dow Corning conformal coating was supplied over the HV board and the Polyimide HV strips outside the chamber
- Environmental chamber to test the detectors in 50% humidity with nitrogen
- Stability tested for 12 hours in 4.5 kV, eventually ramped up to 5 kV for an hour
