BPS Status Report 🐙

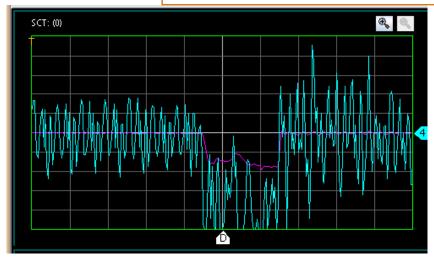
- Results of the BPS readout chain test (ringing problem) [CERN week 48]
 - After installing the BPS2 (IFIC) + AFE/Amplifier (UPC) + DFE (LAPP), the origin of the ringing was located at the Amplifier due to low immunity to Electro- Magnetic Interferences (EMI).
 - The in-situ rework was performed in the Amplifier achiving good enough results of ringing attenuation (see UPC / G. Montoro).

BEFORE / with ringing problem (Blue trace)

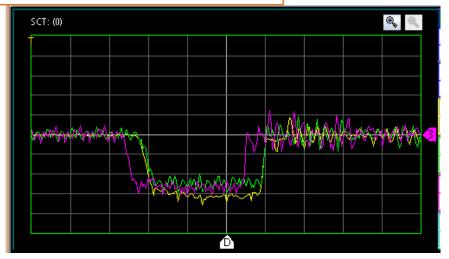
AFTER/ Ringing attenuation (Yellow trace)
