TOTEM GEM assembly and quality control procedures

Timo Hildén

Helsinki Institute of Physics

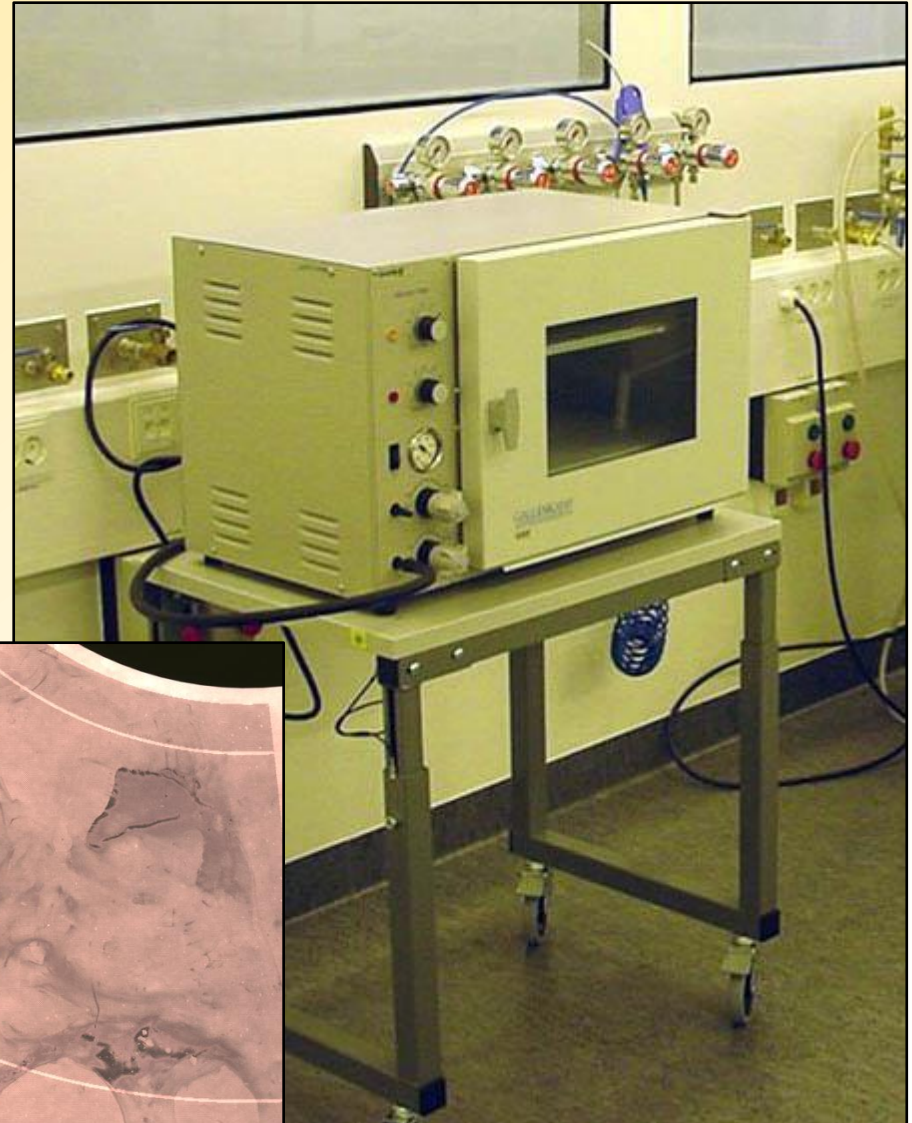
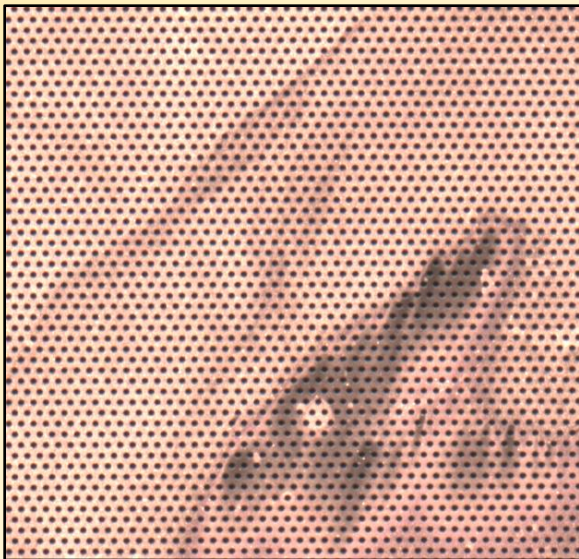
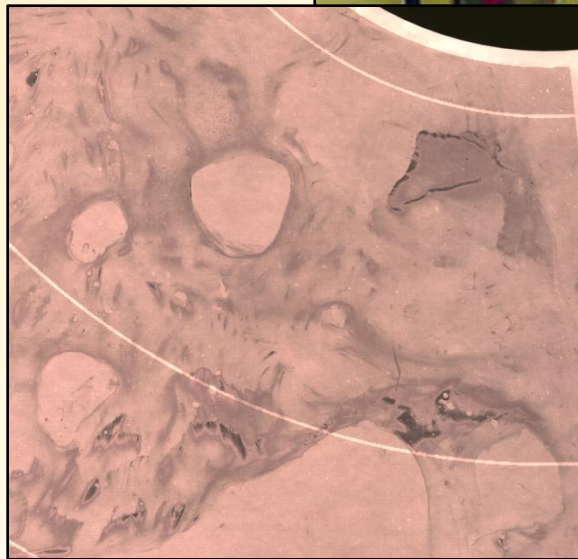
- Several foils were found to have shorts
- Some dirty foils were discarded by visual inspection
- Some were cured in Helsinki by baking in vacuum oven at 50° for several hours
- Some bad foils were sent back to Cern to be cleaned/passivated

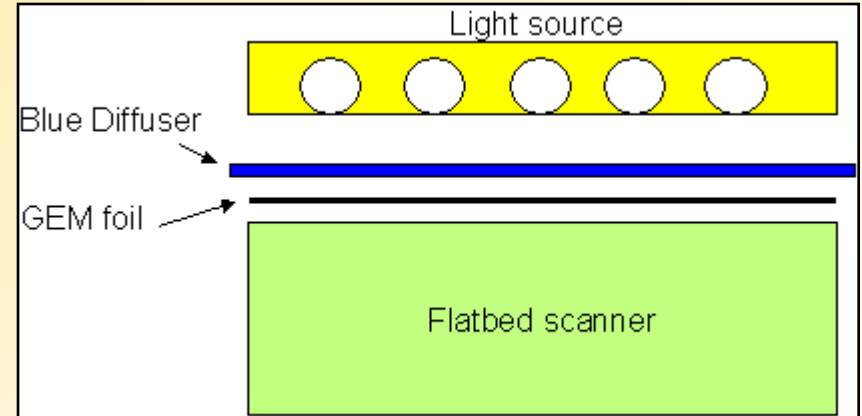
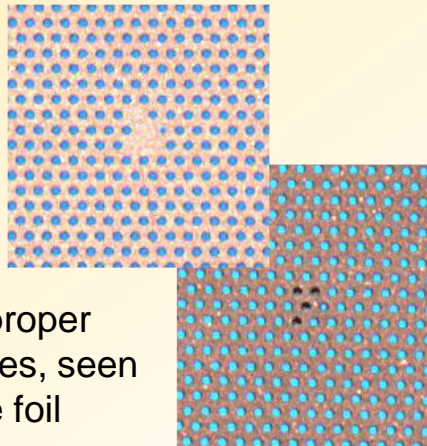
Defect caused by improper etching of several holes, seen from both sides of the foil

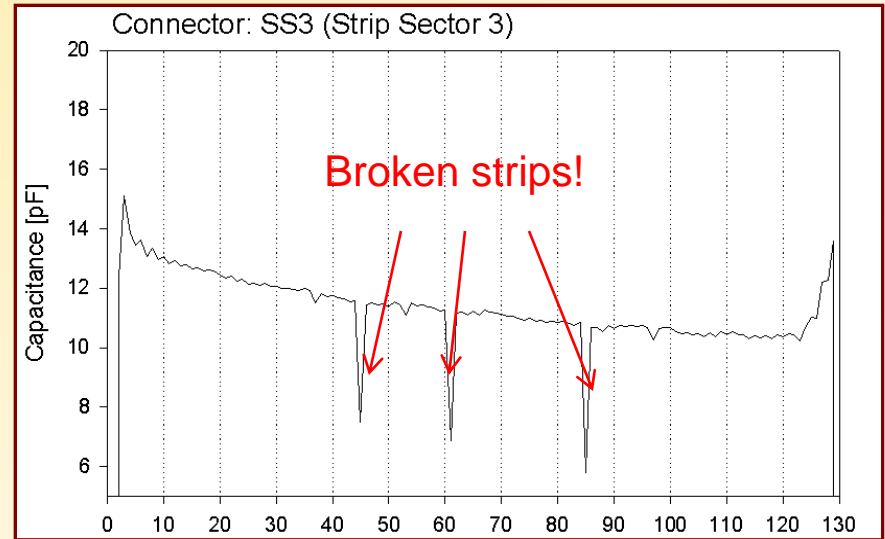
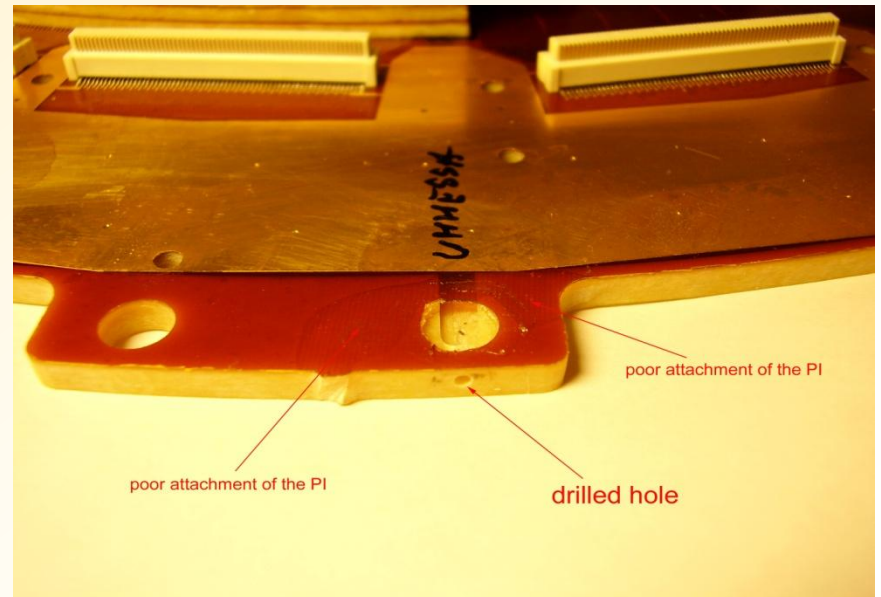
- Some readout boards had shorts (12 ROBs) – 7/18 shorts were successfully burned away
- Few broken strips were found (in 6 ROBs, 11 in total)
- Some ROBs had problems with blocked canals for gas
- Some ROBs were found to have a crystallized residue on the electrodes – cleaned at Cern

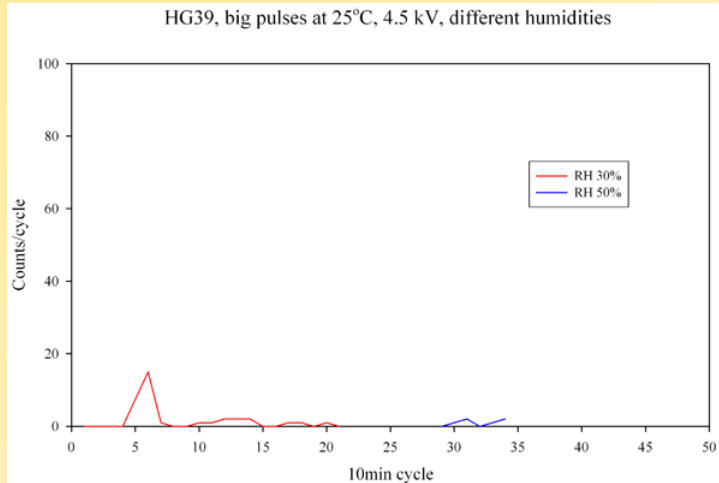
"good" detector

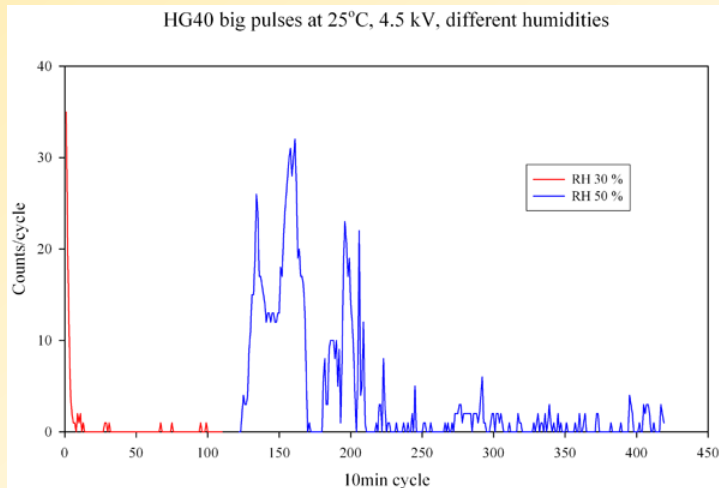
reacts to humidity increase

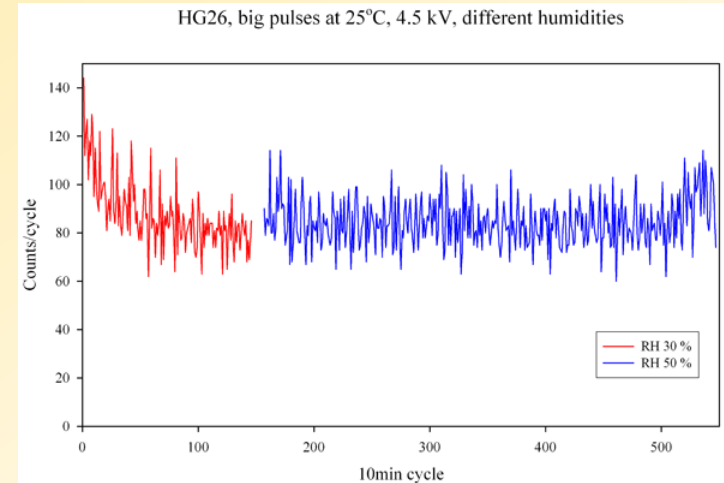
"bad" detector, high base frequency of pulses

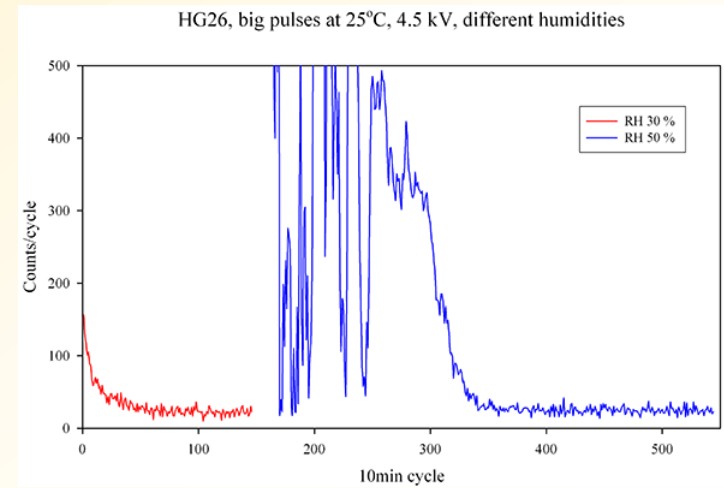
reacts to humidity, small frequency left

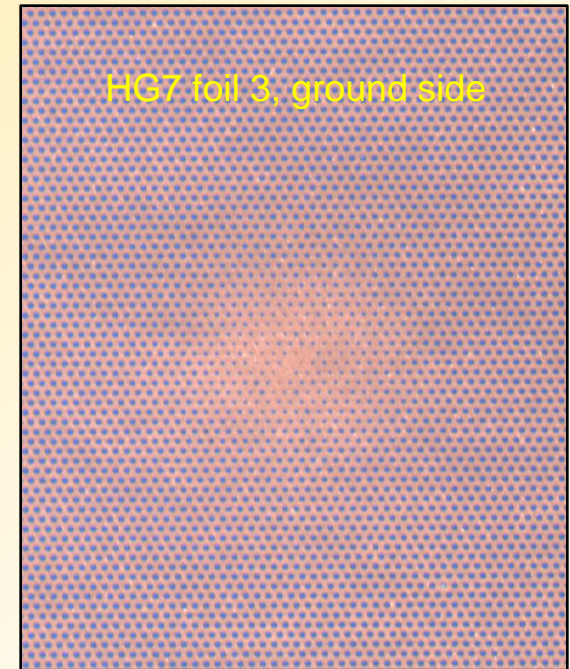
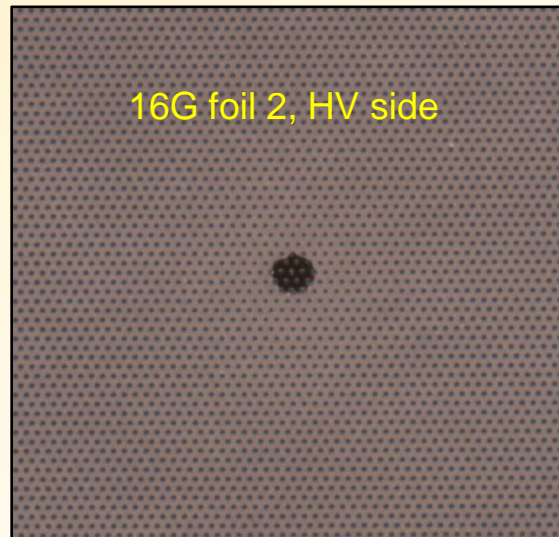
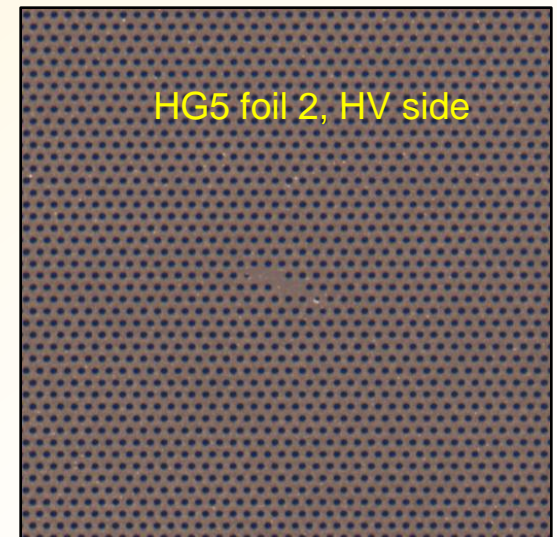
Some examples of defects
found with optical scanning
system
