Status Update
Electromagnetic-size
Prototype Module Preparation
Dual-Readout Calorimetry

Jinky Agarwala
On Behalf Of Pavia Group

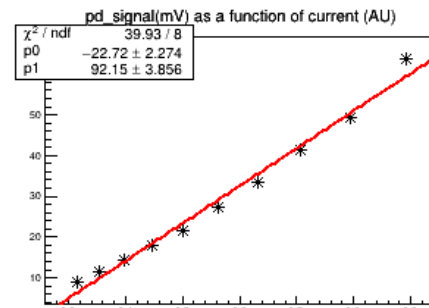
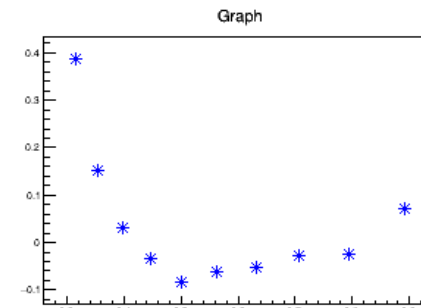
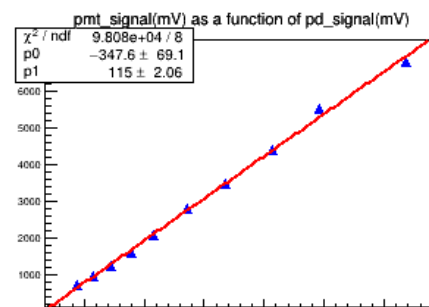
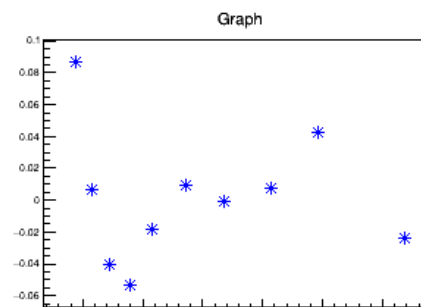
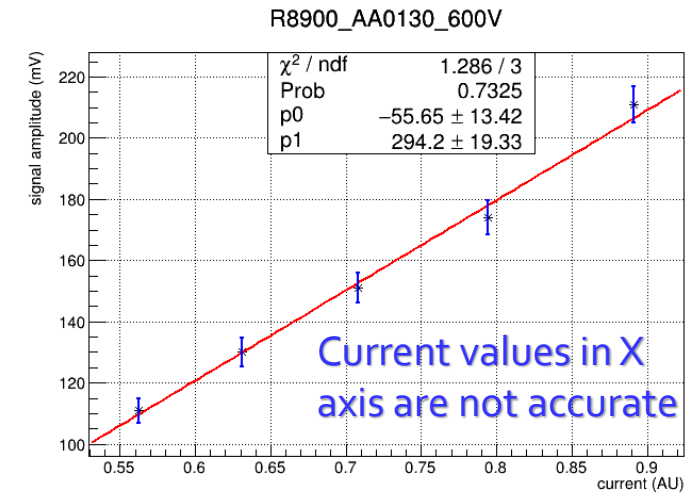
All chosen PMTs are linear within **6%** (except AA0134 which is **13%**)

- Datasheet of the attenuator tells: **Poor Reproducibility!**
- For AA0134, Optical Coupling Compound was missing during test. **Optical Loss!**

- A test setup with photodiode
- Photodiode itself not perfectly linear

- Most of the non linearity comes from the system
- Further improvement on the system not possible now

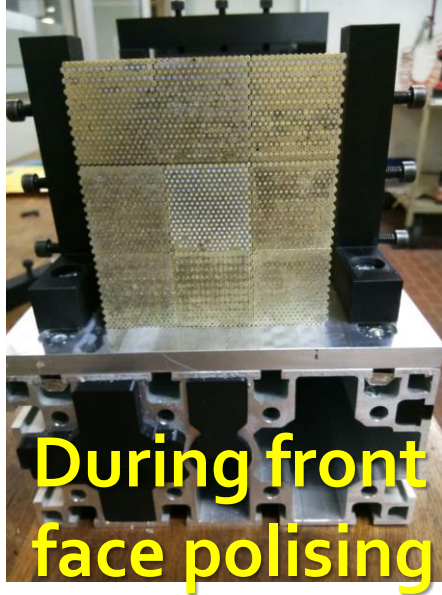
Milling machine stopped

- Fibers reloaded
- Glued
- Damages Recovered
