# The ATLAS TRT ageing laboratory

## TRT automated ageing setup

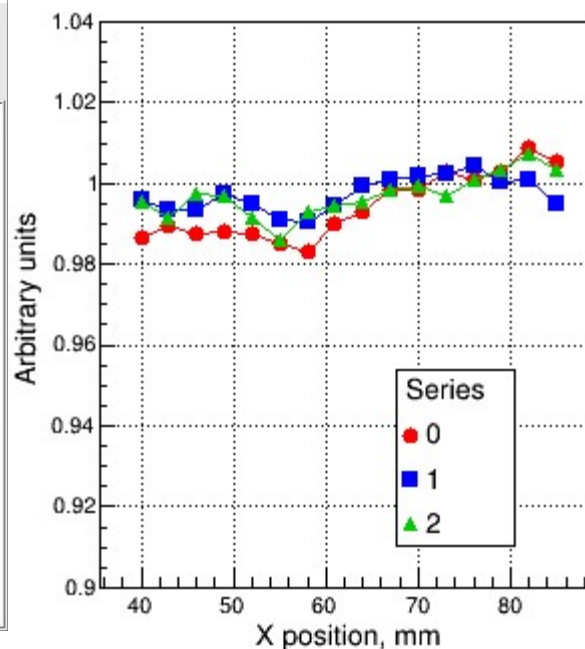
Straw 4 normalized coordinate dependence

This is example of plot of amplitude scan of the straw with no Ageing seen after X-ray exposure

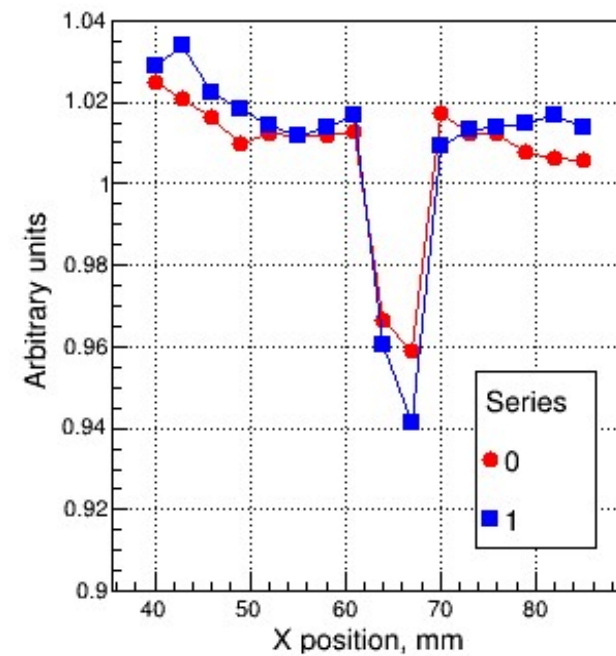
Straw 1 normalized coordinate dependence

This is example of plot of amplitude scan of the straw with Ageing. It is Si - ageing seen in the exposure region of 65mm.

- After tests if straws showed ageing potentially can be polluted. Usually they can be recovered after operation under radiation with Ar+CF<sub>4</sub> + CO<sub>2</sub> mixture.

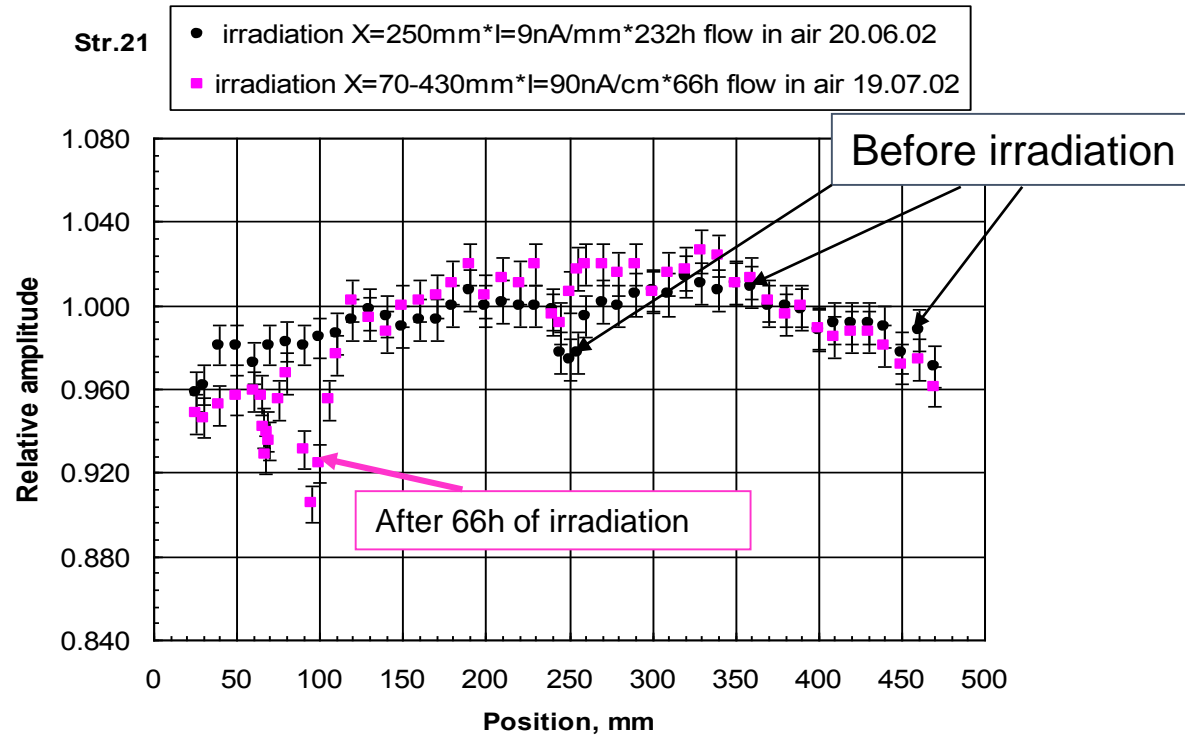
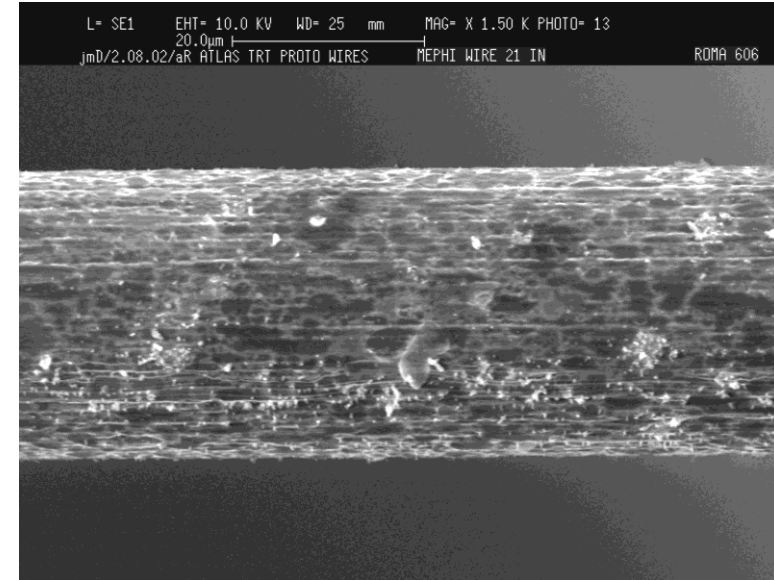
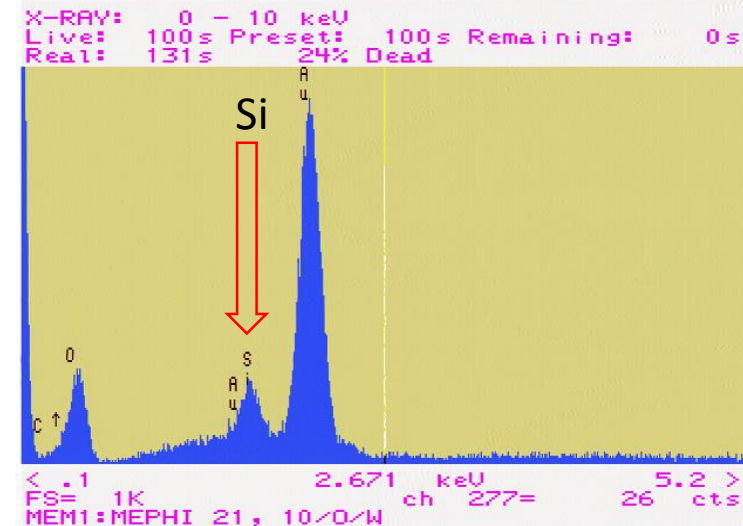
## Si ageing in the Xe-CO<sub>2</sub>-O<sub>2</sub> gas mixture

The most probable reason for this effect is Si pollution of the gas system components (residual of the Si-based lubricants).  
**Aging happens at the beginning of the irradiation area.**
