## PS Report W28-29

### PS Supervisor of the week 29 – Heiko Damerau

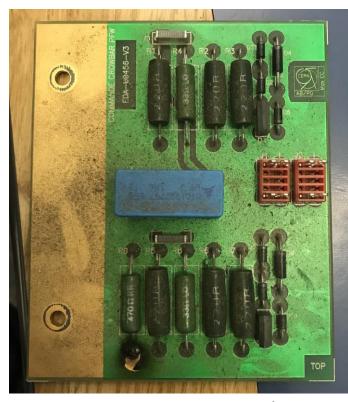
- Tests couldn't be completed immediately on Thursday morning (objects left in the area, cabling issue with beam imminent warning)
- Issues resolved during the day on Friday —> beam permit signed
- W8L repair and access in the shadow of the DSO tests
  - ◆ Electronic card (crowbar control) found to be damaged inside the W8L converter
  - Presence of dust might be a reason for the failure —> cleaning campaign of the converters in this room to be envisaged
  - Repair of C66 amplifier, SEH23 calibration, bumper and septum in SS61

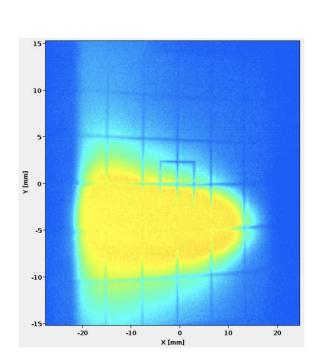
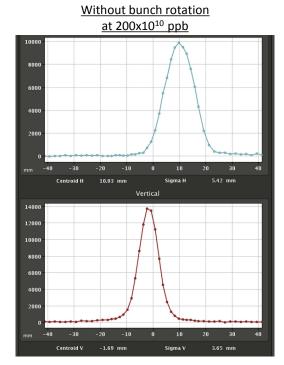
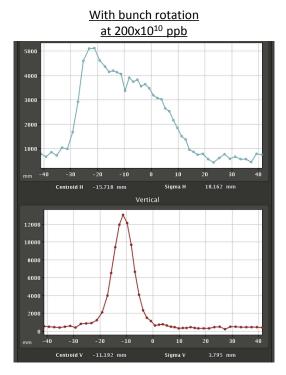
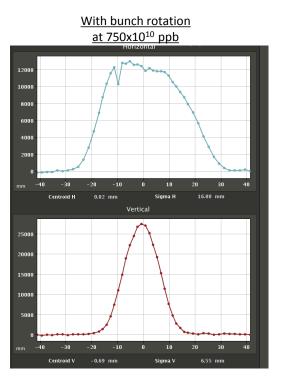
- First beam sent to the new nTOF target on Monday 10am
  - First shots didn't reach target due to wrong settings on FTN quadrupoles —> settings generation to be put in place
  - New SEM grids upstream the target worked immediately
  - Intensity of 200x10<sup>10</sup> ppb to be used during the early commissioning phase
- Intensity increased to almost nominal (700x10<sup>10</sup> ppb) with fewer cycles
  - Quadrupole scans to optimize beam size on target
  - Compromise between transverse size and losses to be discussed
