The Interlocked BPMs of the LHC in Pt.6

- Issues
- Modification proposals
- Commissioning plan

Eva Calvo (BE-BI)

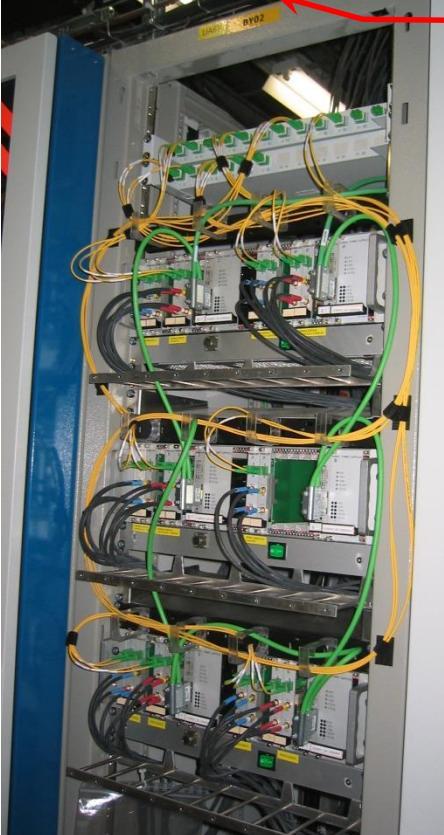
The attenuators issue

Attenuators are placed in each of the 44 cables, attached on the top of the rack, with very difficult access.

An error in the documentation reporting the cabling numbering was the cause that the attenuator changes during first part of the year produced so strange behaviour.

Additionally, details like the the complicated naming, does not facilitate locating the channels (errorprone)

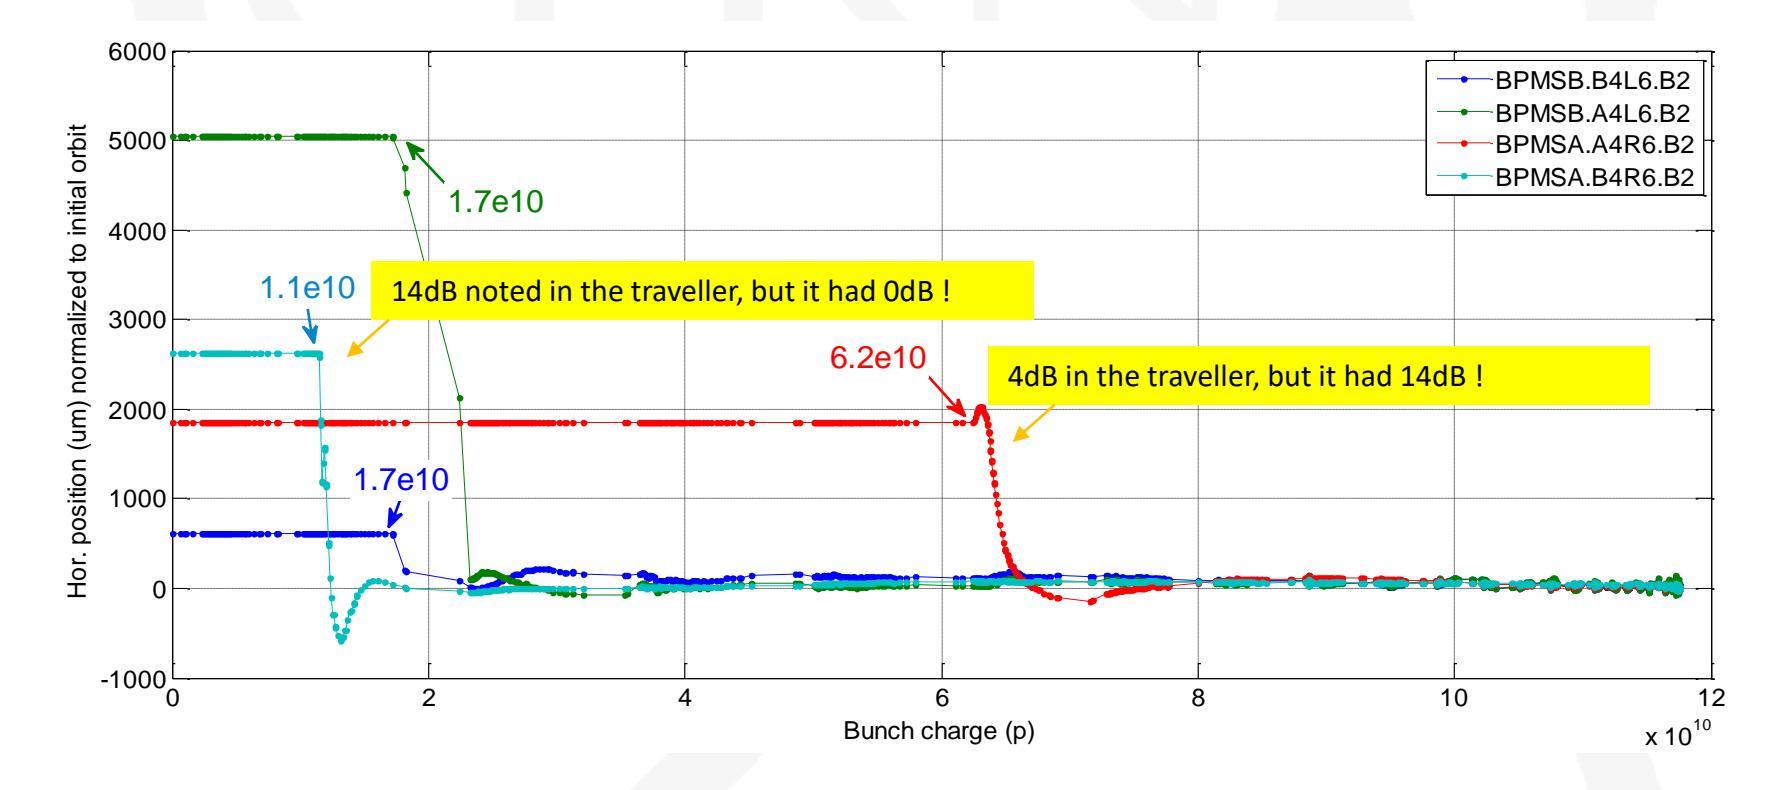
Changes in attenuation

- Attenuation increased for BPMSA.B4R8 twice to counter injection issues
- A scrapping on 24/5 showed attenuation had been increased on wrong channel
 - Explained both continued problems at injection & higher intensity limit for B2

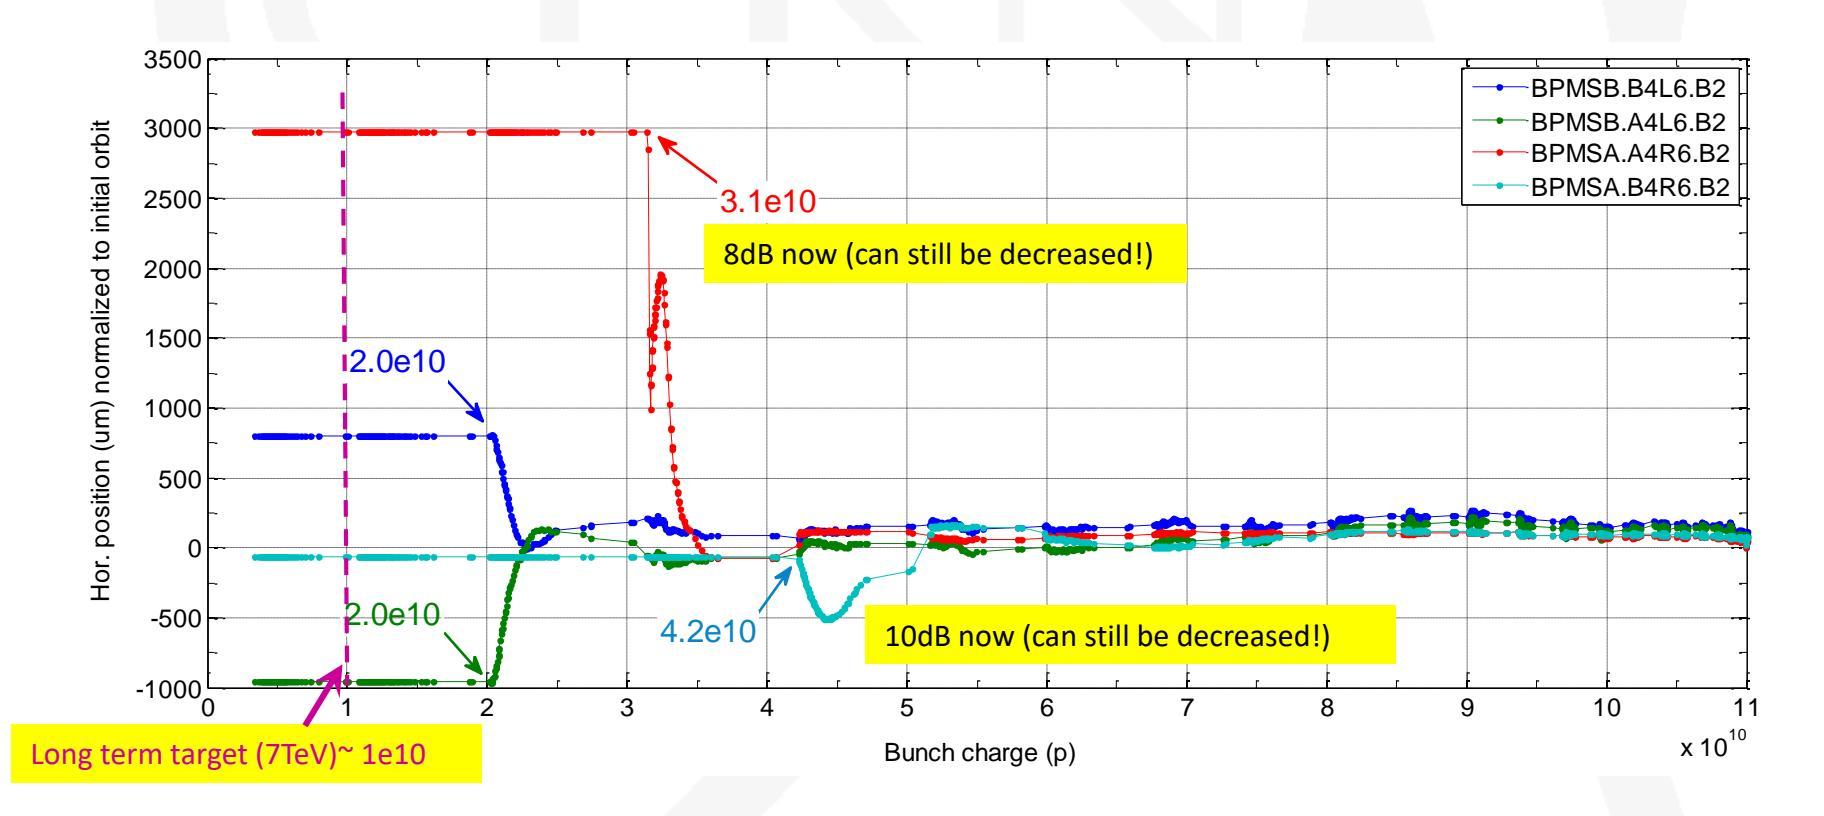
Today's status

- Attenuation modified on 25/05 for B2 BPMSAs limit now at 4.2e10
- Both beams can be further optimised
- Aim is to align all interlock BPMs to limit around 2e10 3e10

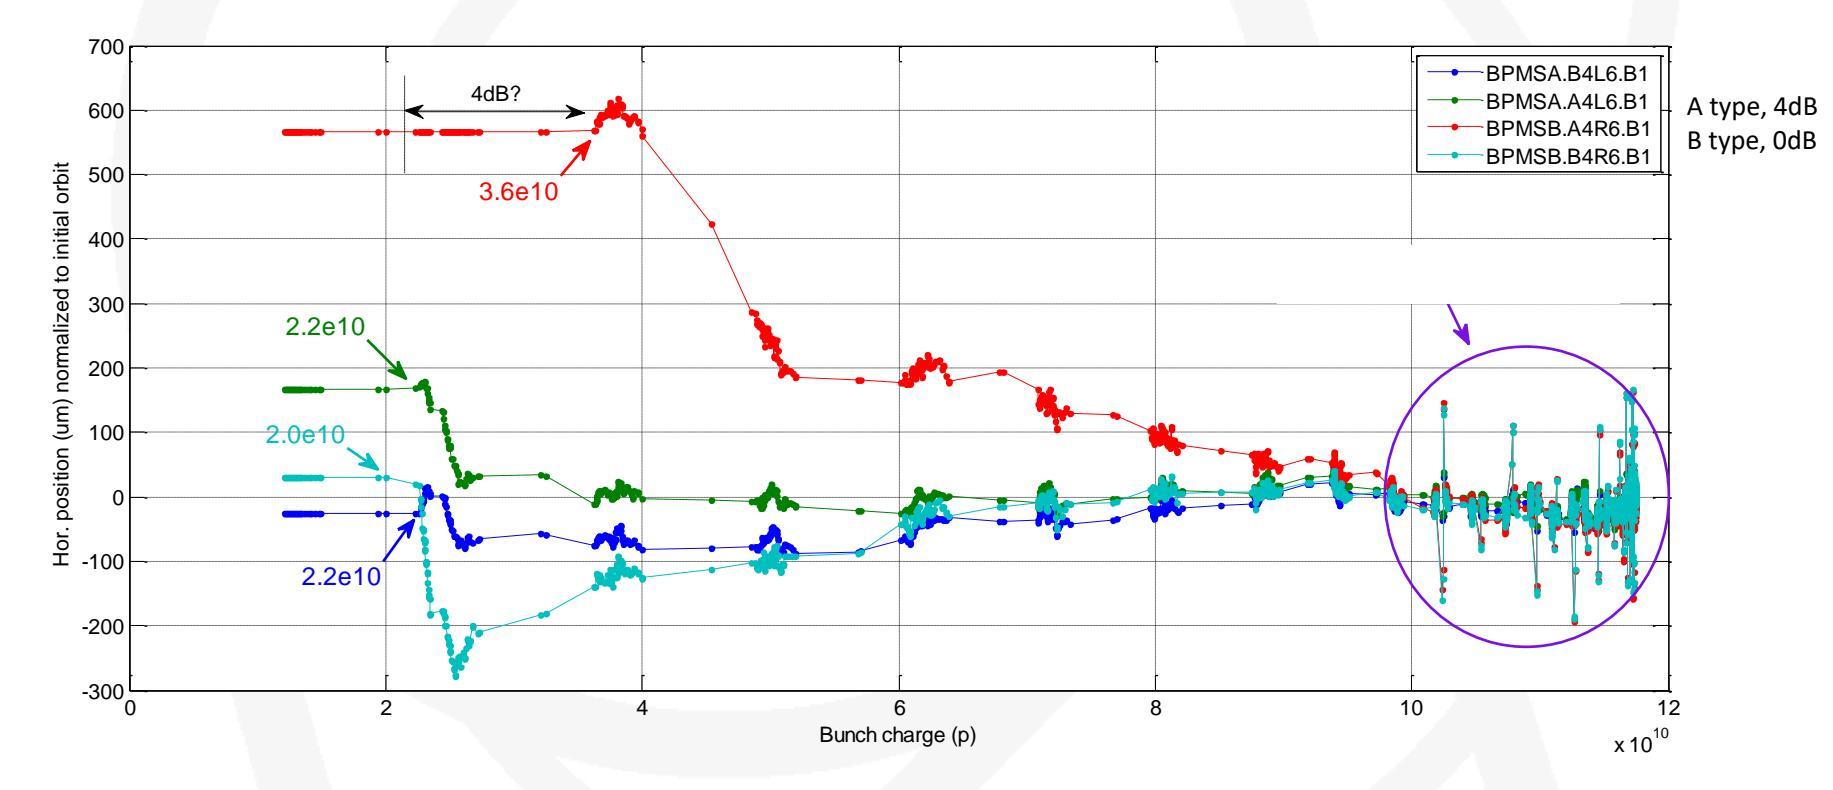
B1 (status at 24/5/2012)

Suspected there are 4dB instead of the 0dB noted in the traveller in BPMSB.A4R6.B1

Now that the cause of the successive problems is understood, "there is no risk" for optimising the system.

- During TS: Replace the attenuators of BPMSA.A4R6.B2 , BPMSA.B4R6.B2 and BPMSB.A4R6.B1.
- After TS : Verification of the attenuator change
 - B1 and B2 scrapping (~30 minutes)
